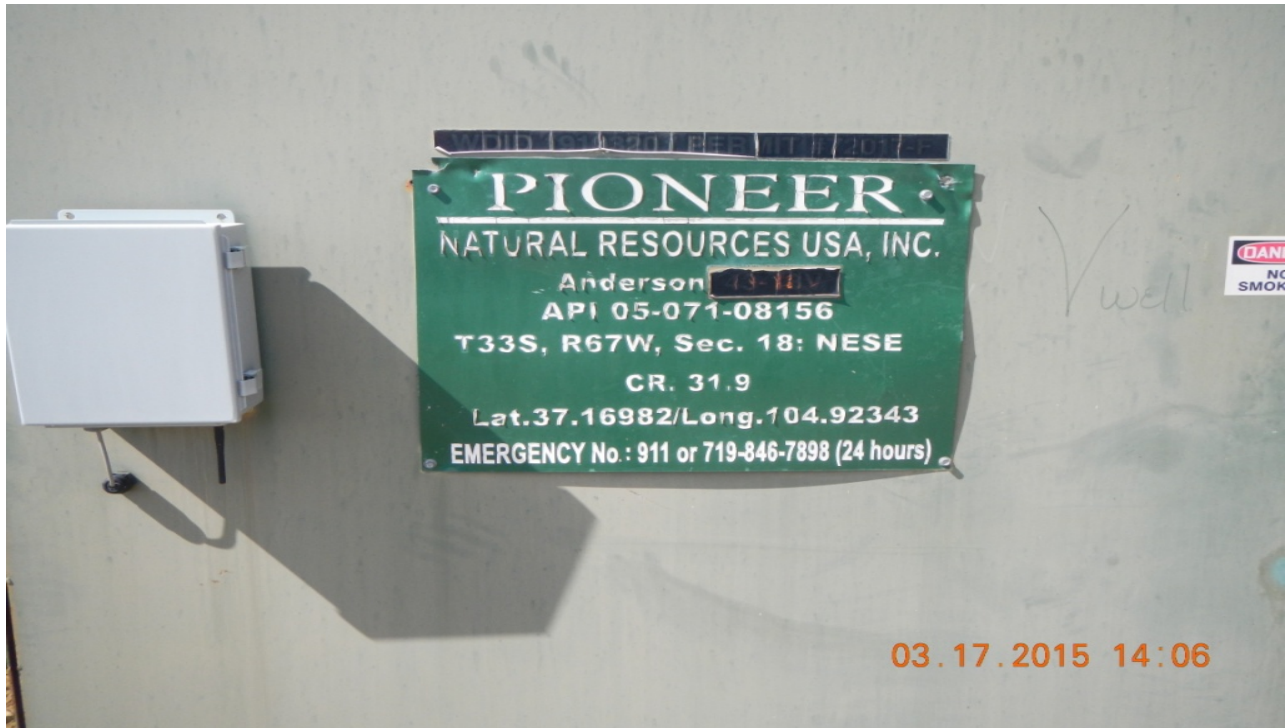
photo 1: Well sign, Anderson 43-18V

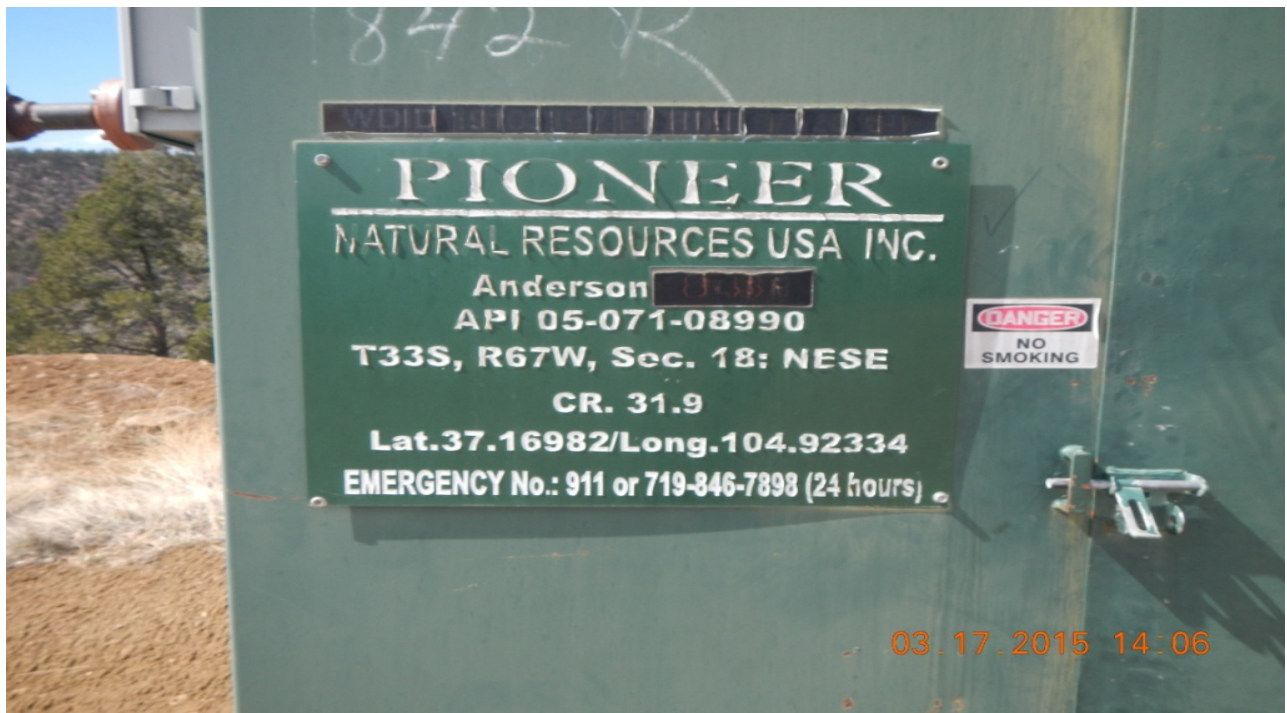
photo 2: Well sign, Anderson 43-18R

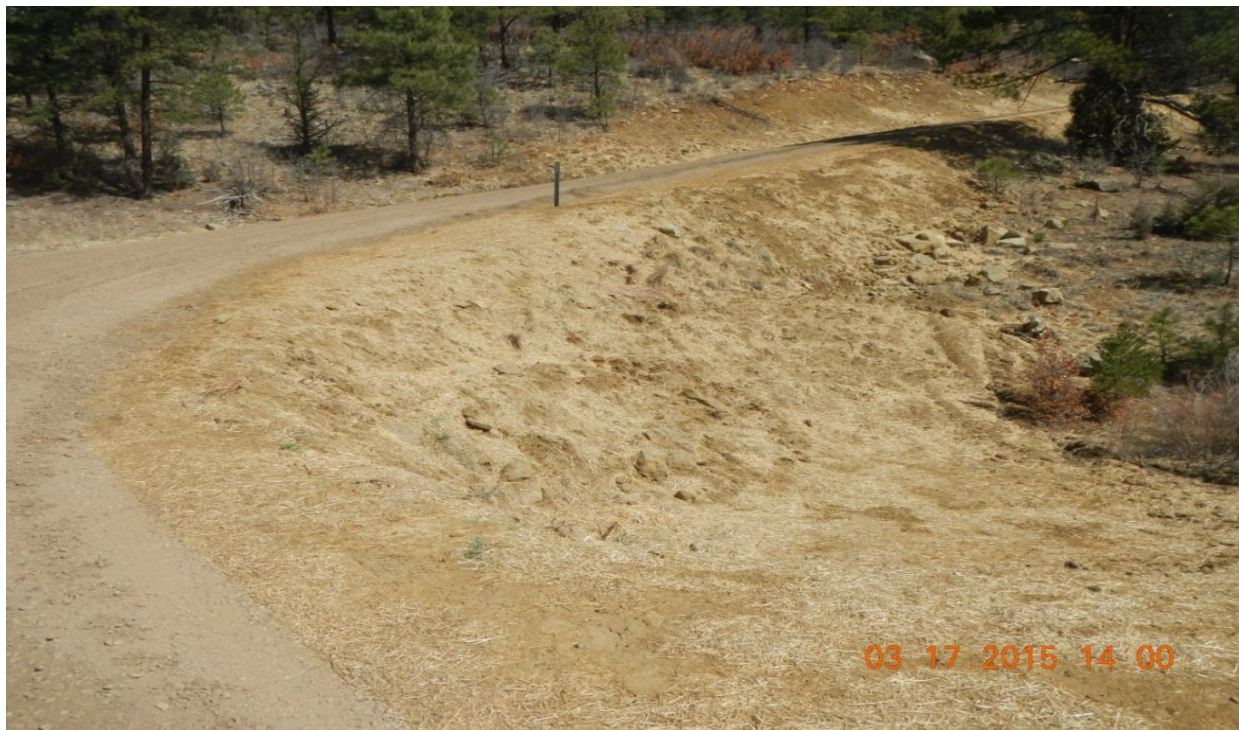
**photo 3:** Access road towards the location has recently been mulched/seeded.

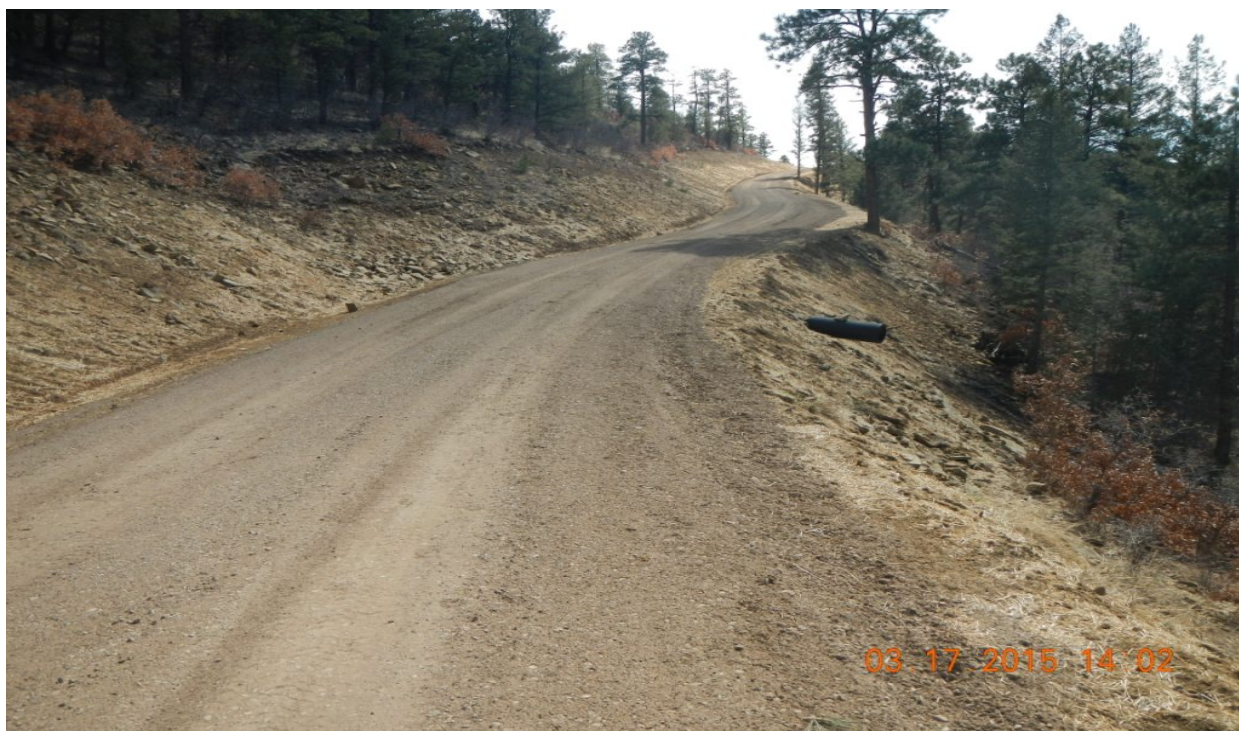
**photo 4:** Access road towards the location has recently been mulched/seeded.

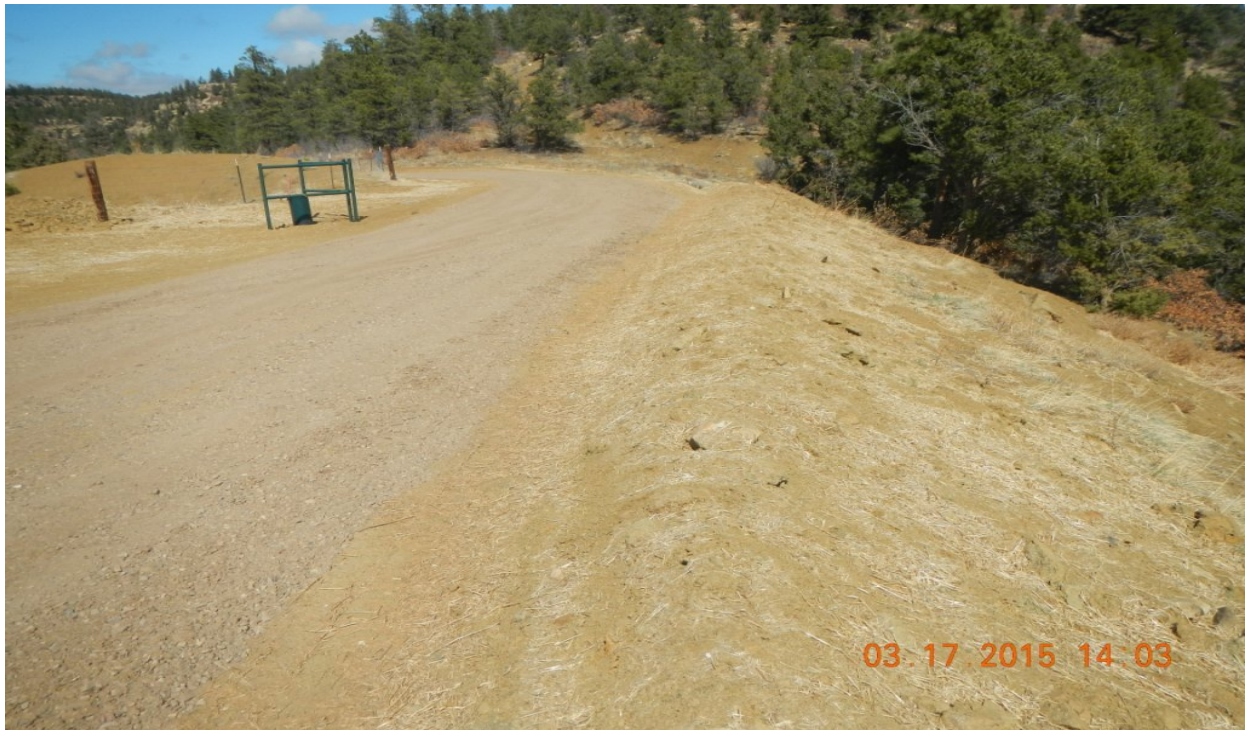
**photo 5:** Southeast corner of the location facing north.

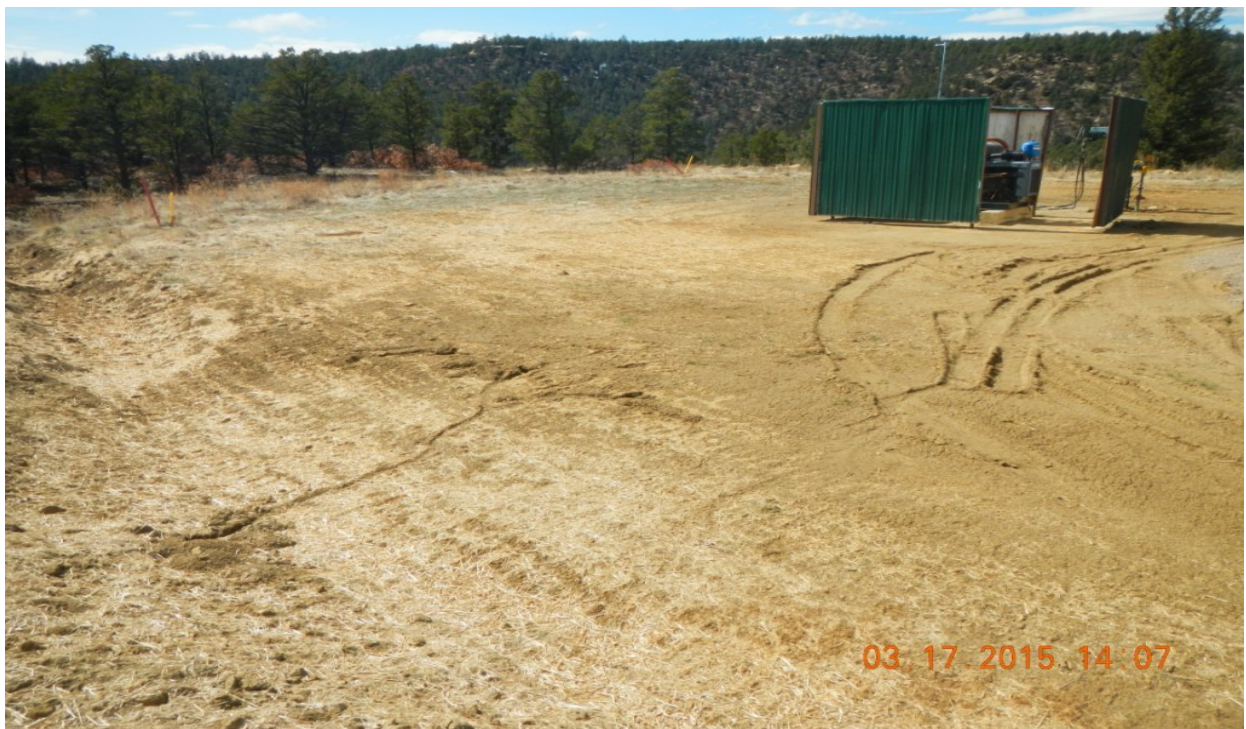
**photo 6:** Southeast corner of the location facing west.

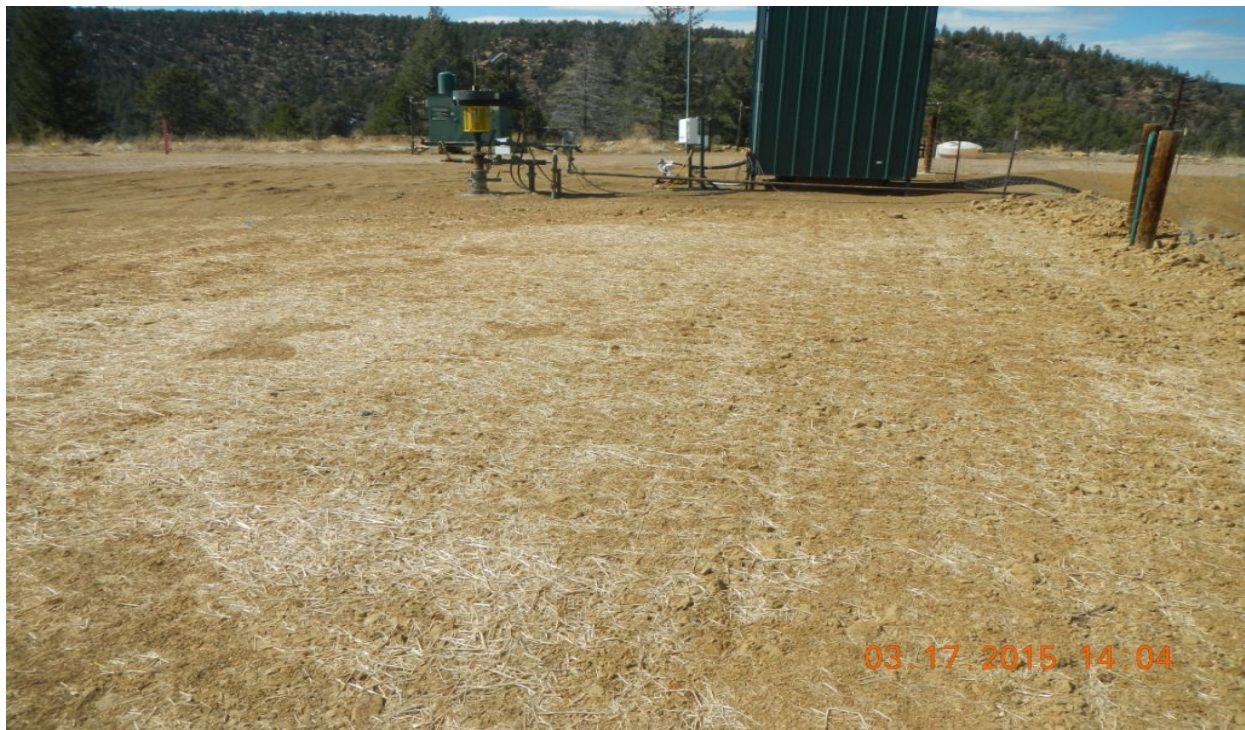
**photo 7:** The location has recently been straw mulched and likely seeded.

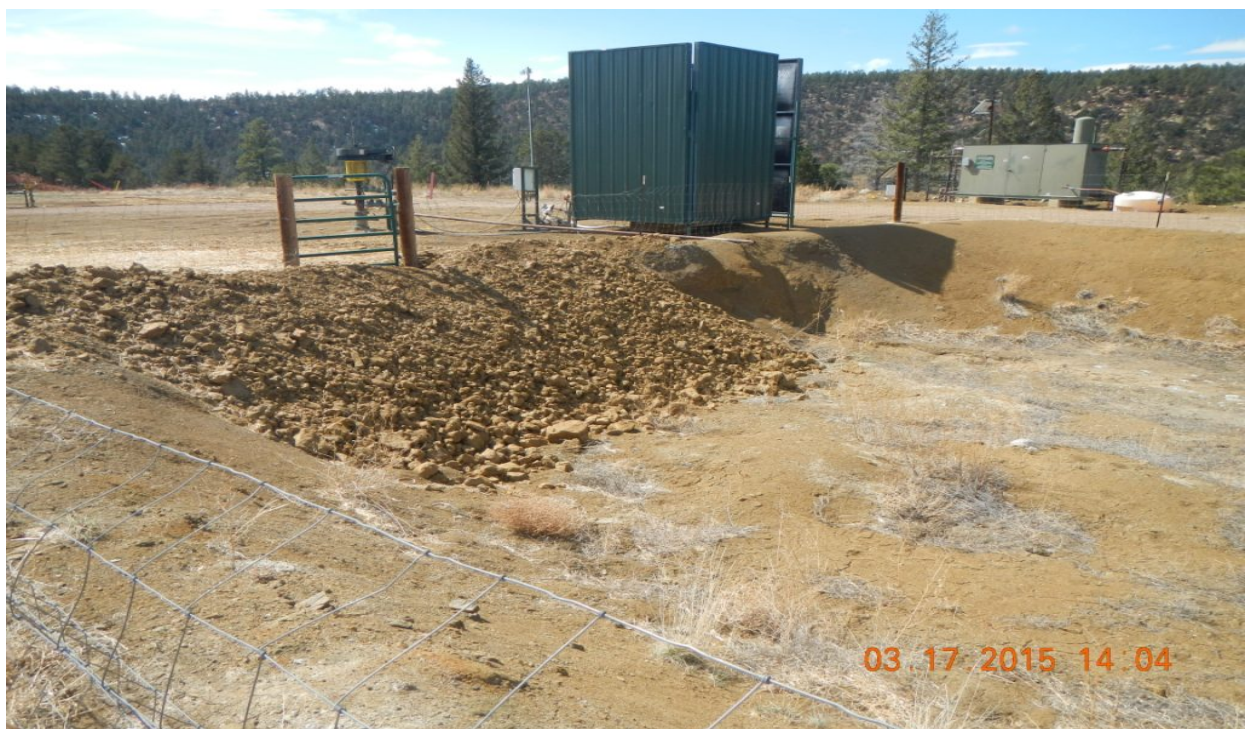
**photo 8:** Fence around the perimeter of the pit. Did not see a marker indicating 2ft. freeboard.
