Federal 6-25

Inspection# 673401912

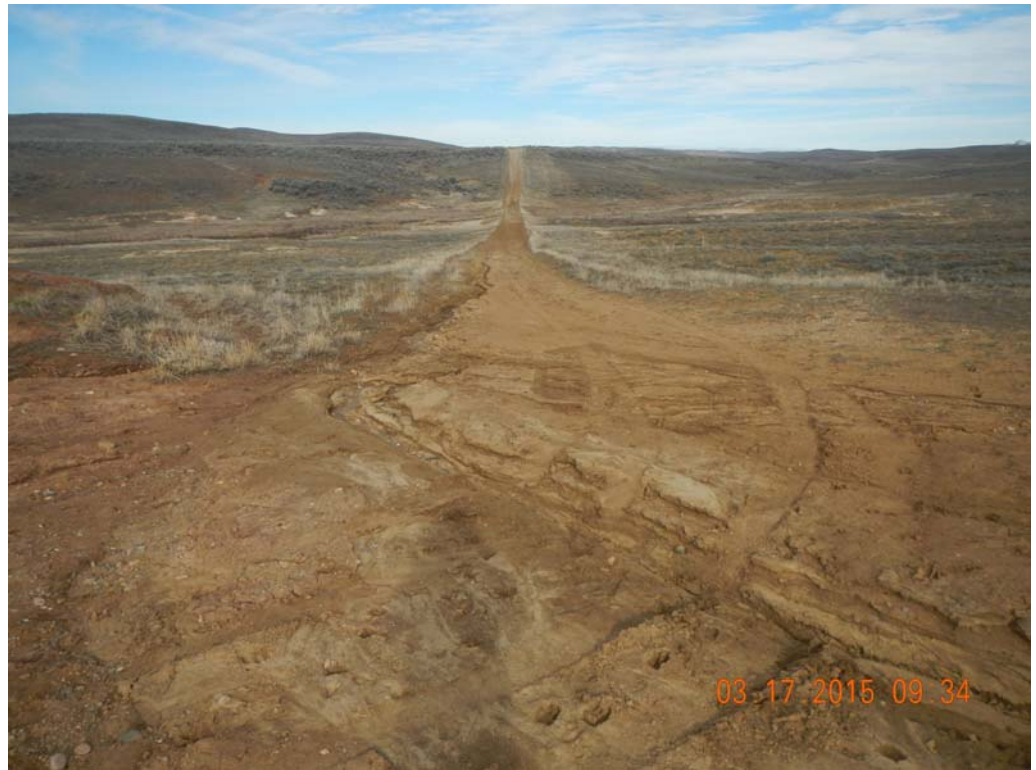
Rills on access road and
leaving location onto access
road. No BMPs apparent.

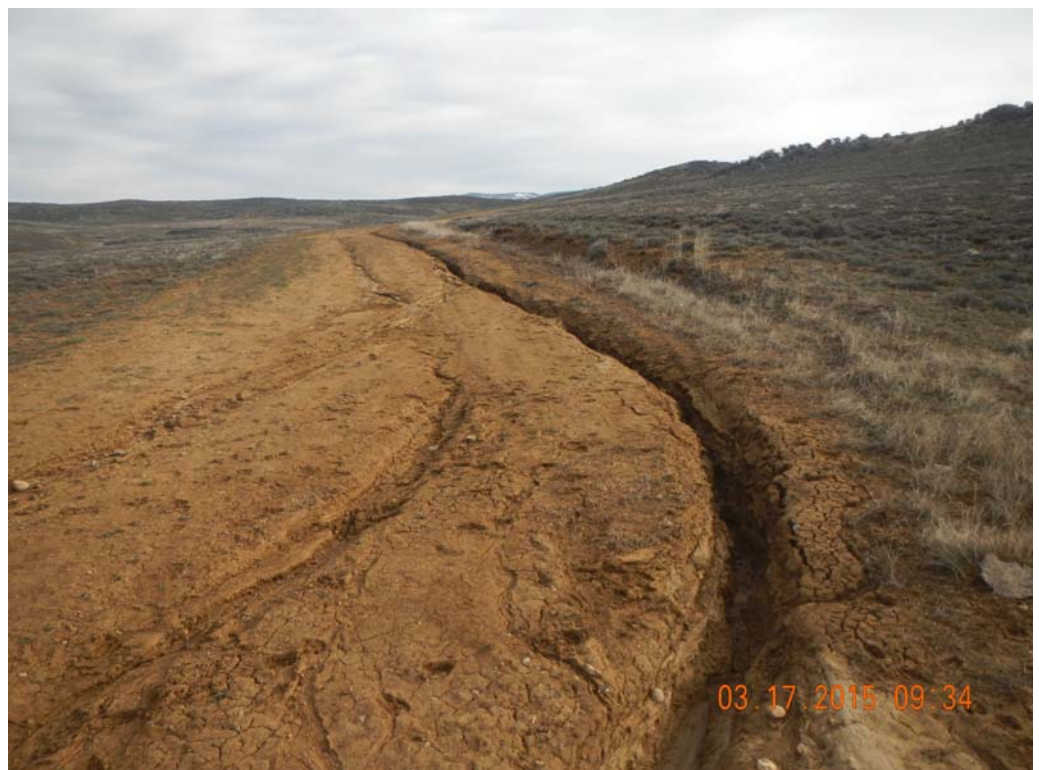
Rills on access road. No
BMPs apparent.

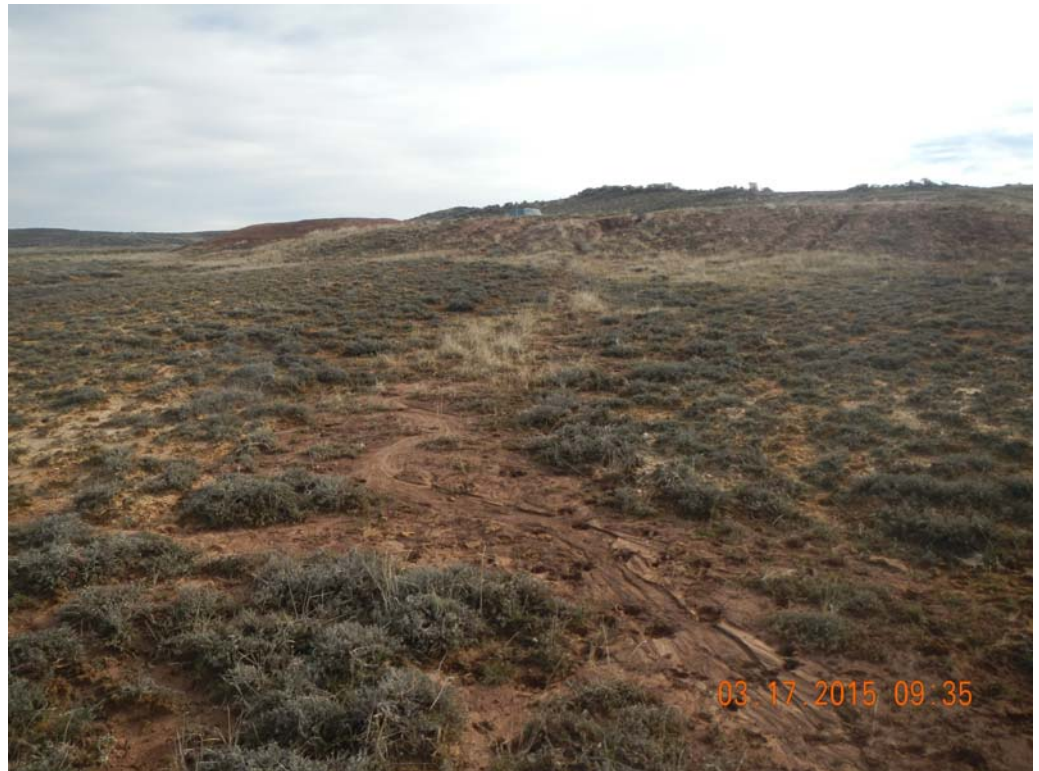
Rills on west side of location, evidence of sediment transport.

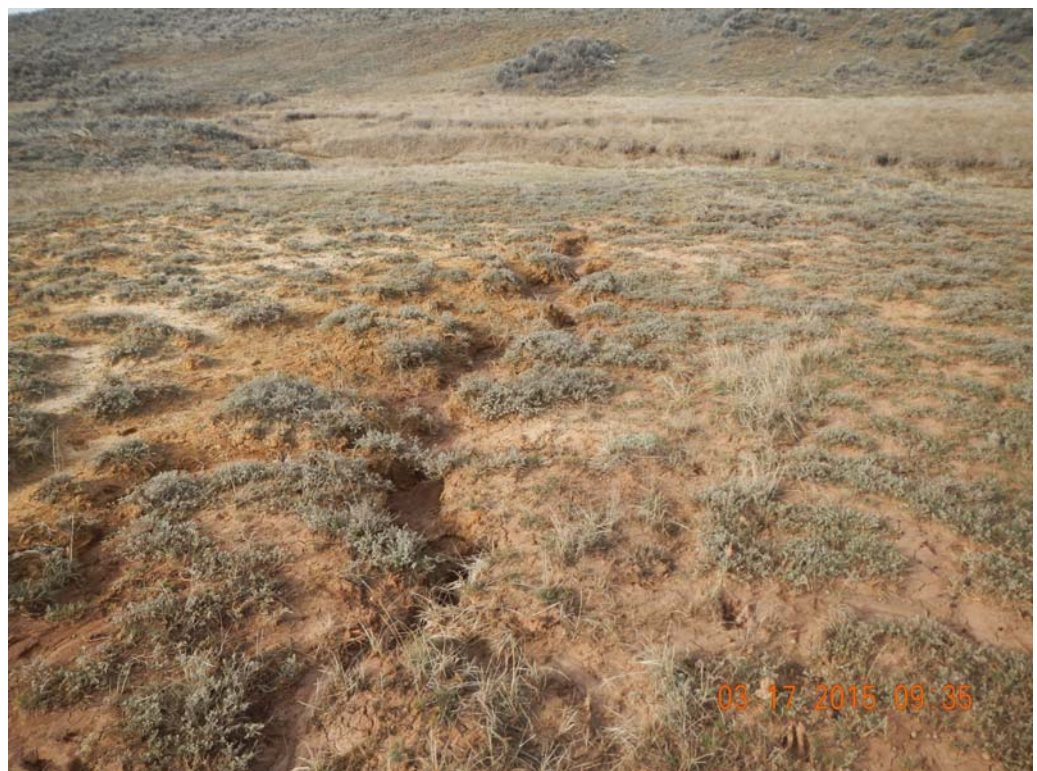
Rills from west side of location (previous picture) continuing into adjacent drainage.

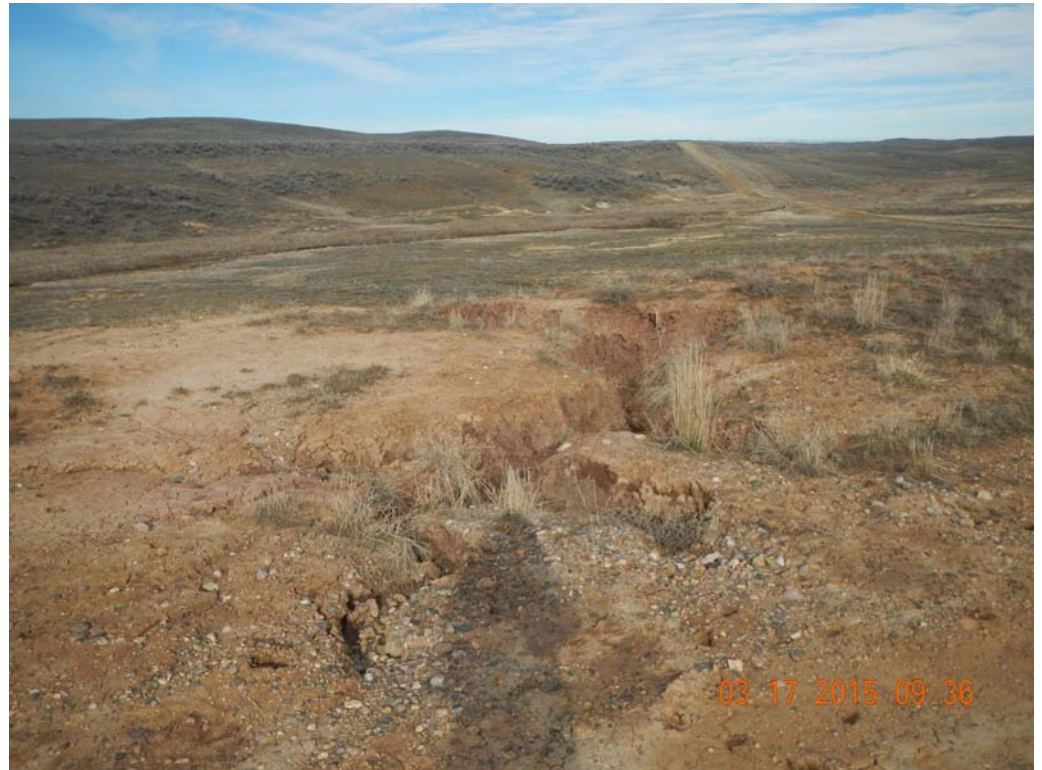
Rills leaving location.

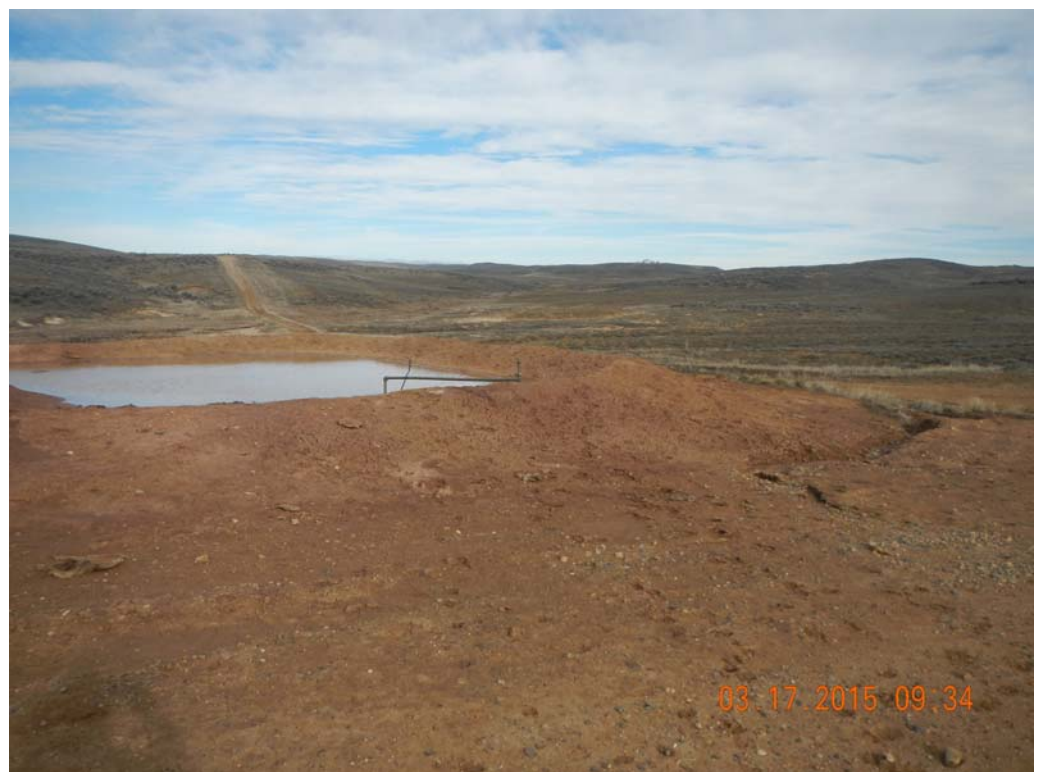
Former tank battery berm holding stormwater. Rill leaving location.

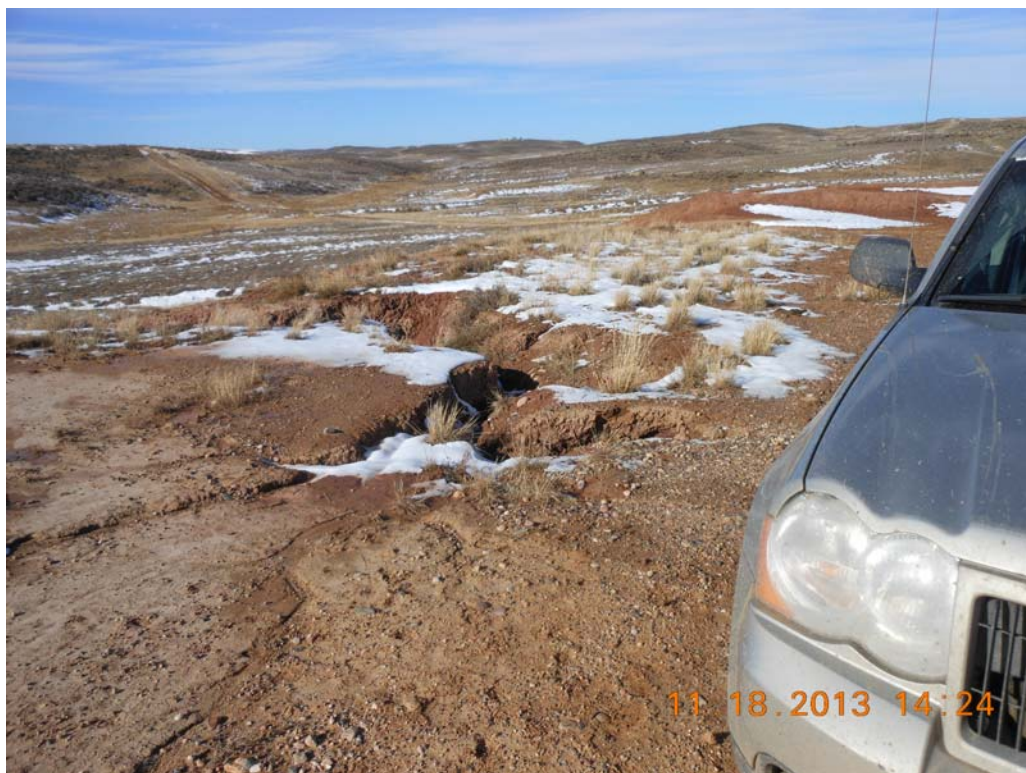
Rill leaving location.

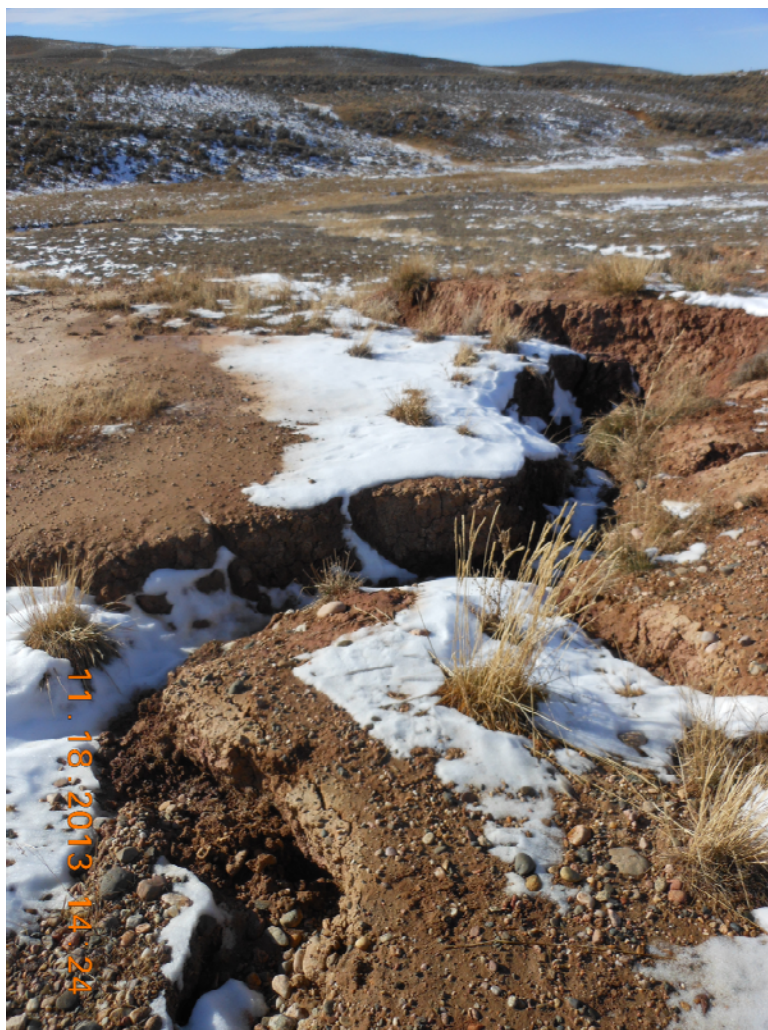
Rill leaving location.

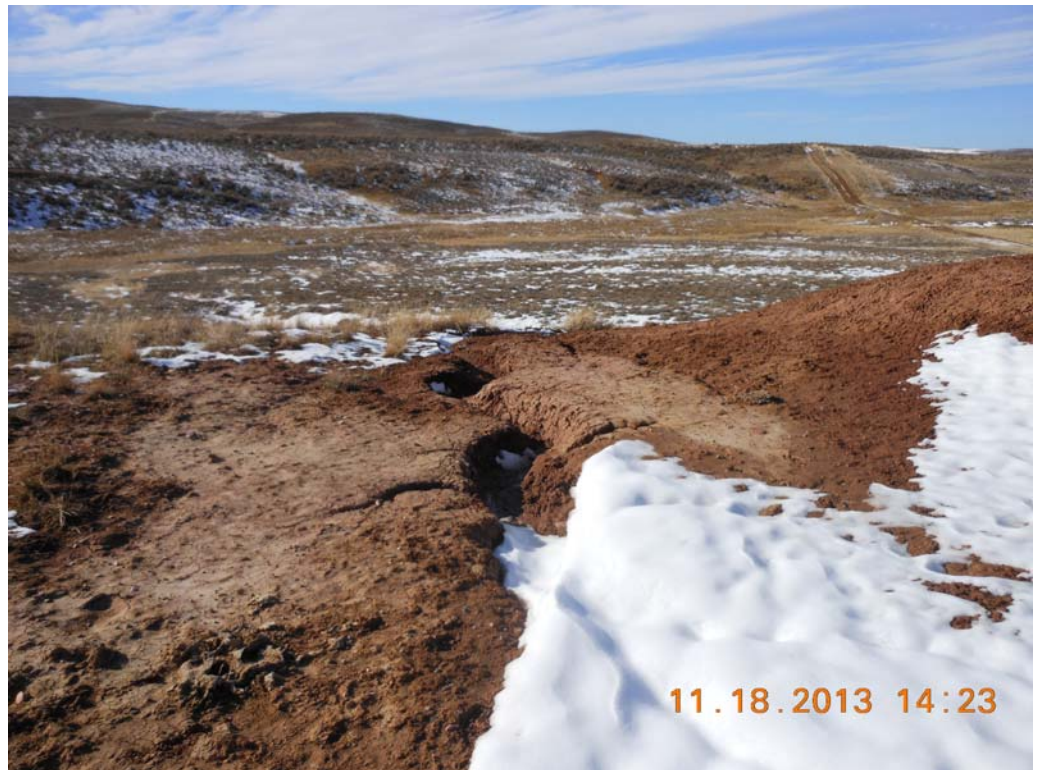
Rill leaving location.
