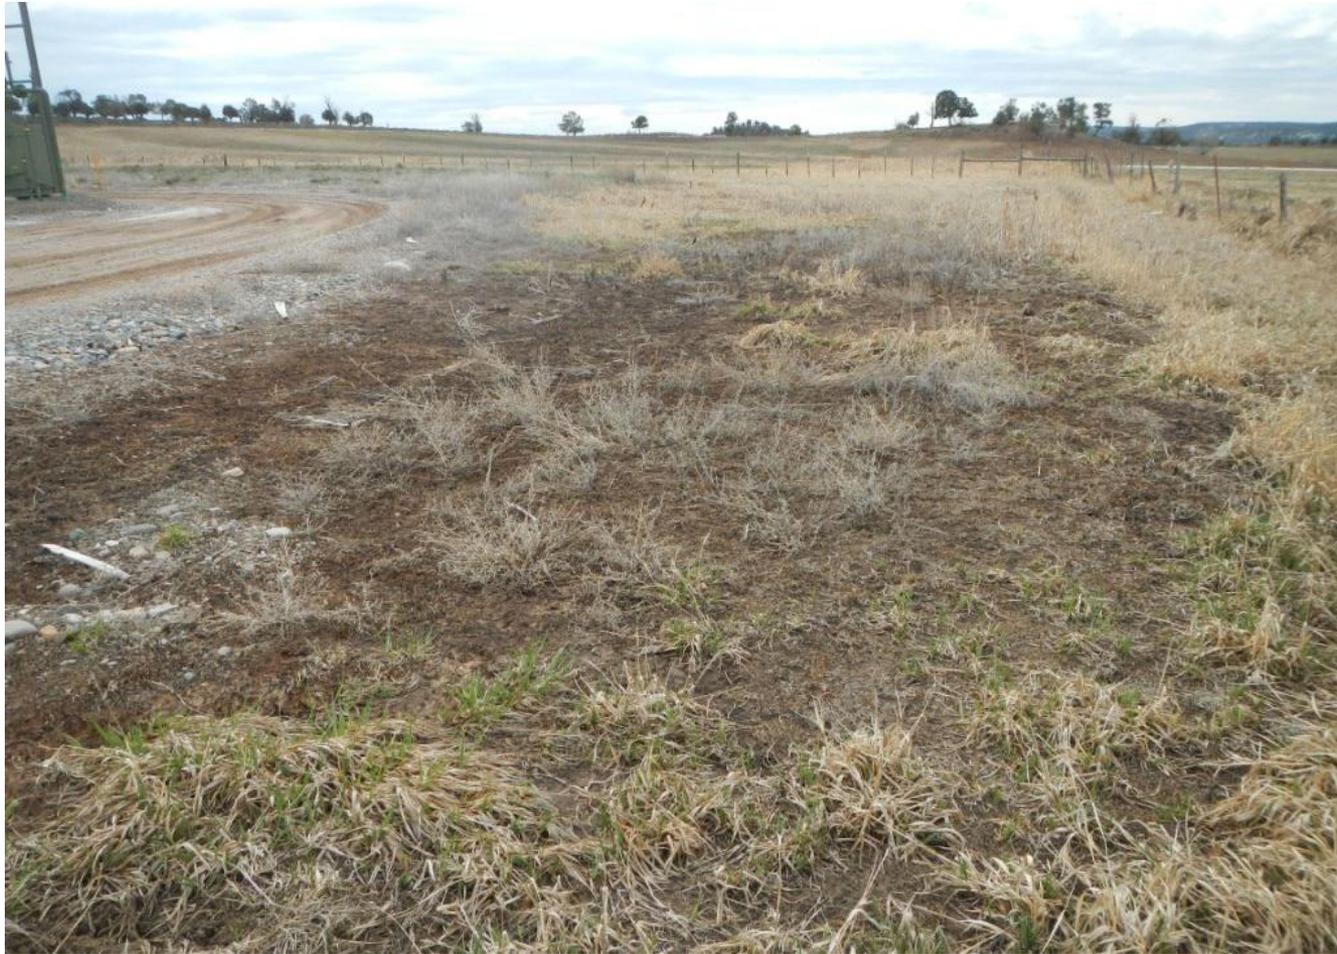
Photo 4. View of area of vegetation that appears burned in western portion of project area. This area should be re-seeded and weeds carefully monitored.
