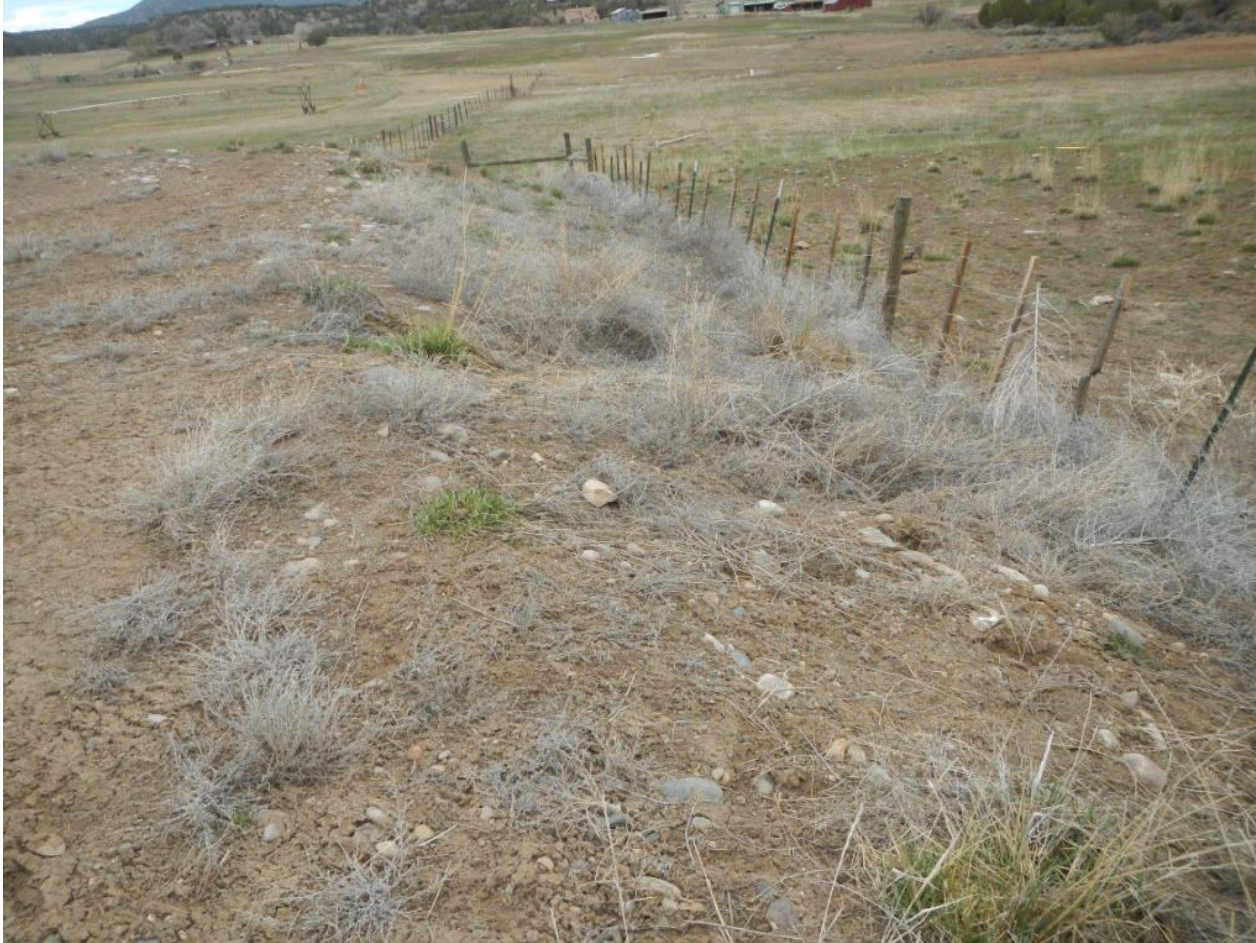
Photo 1. View of kochia (*Kochia scoparia*) and Russian thistle (*Salsola tragus*) debris accumulated along the eastern portion of the project area.

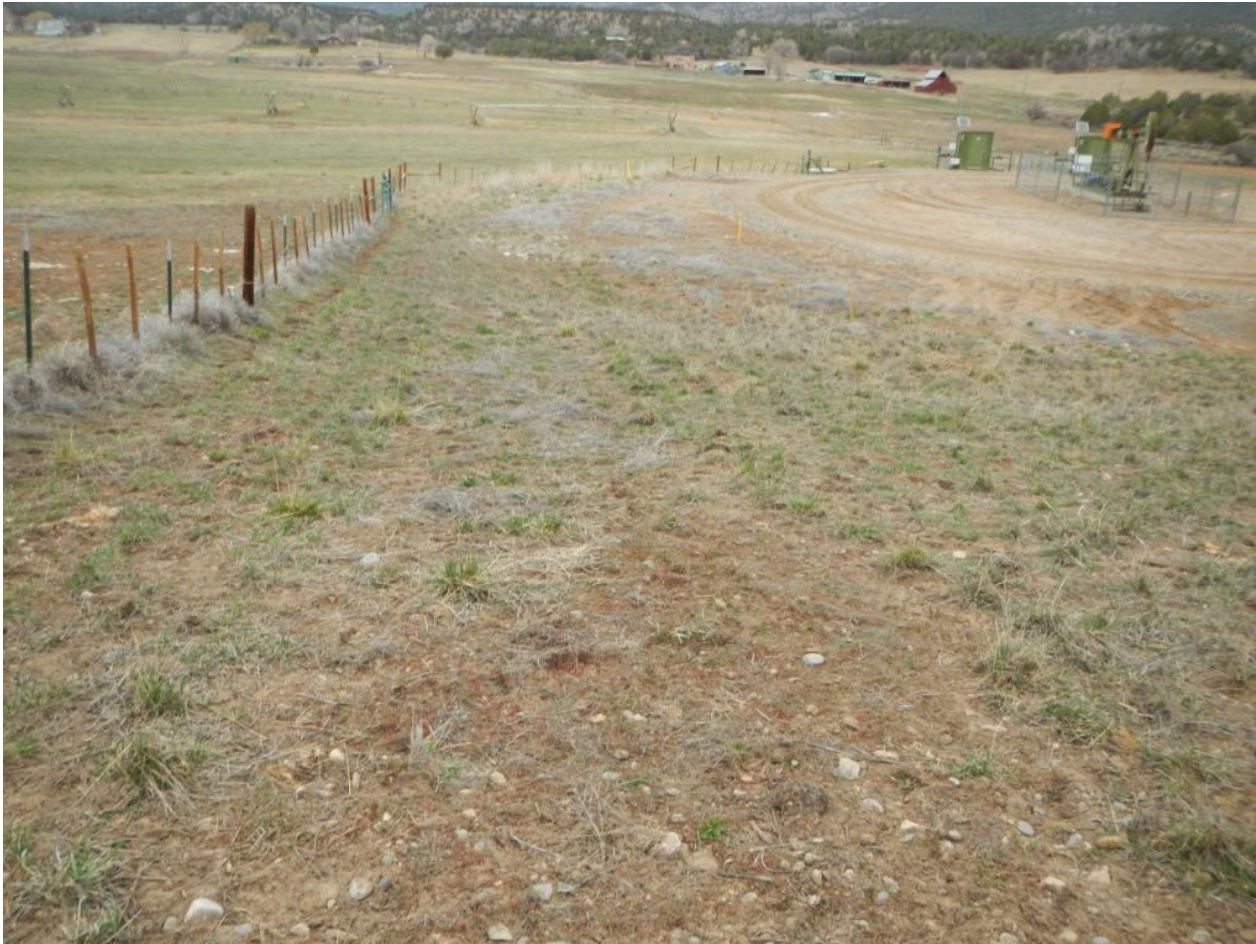
Photo 2. View of revegetation in western portion of project area from southwestern corner facing northward.

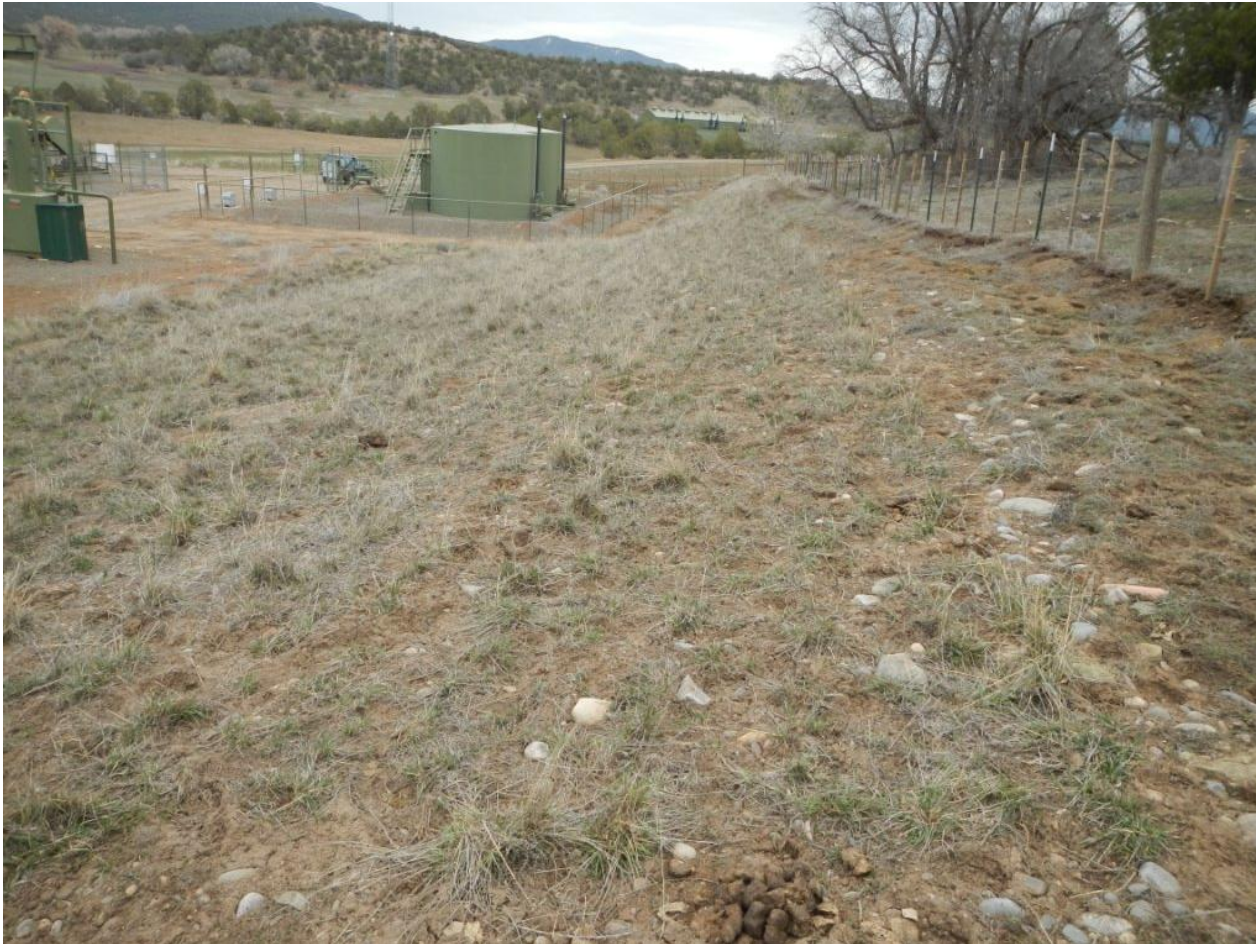
Photo 3. View of revegetation in the southern portion of the project area from southwestern corner facing eastward.

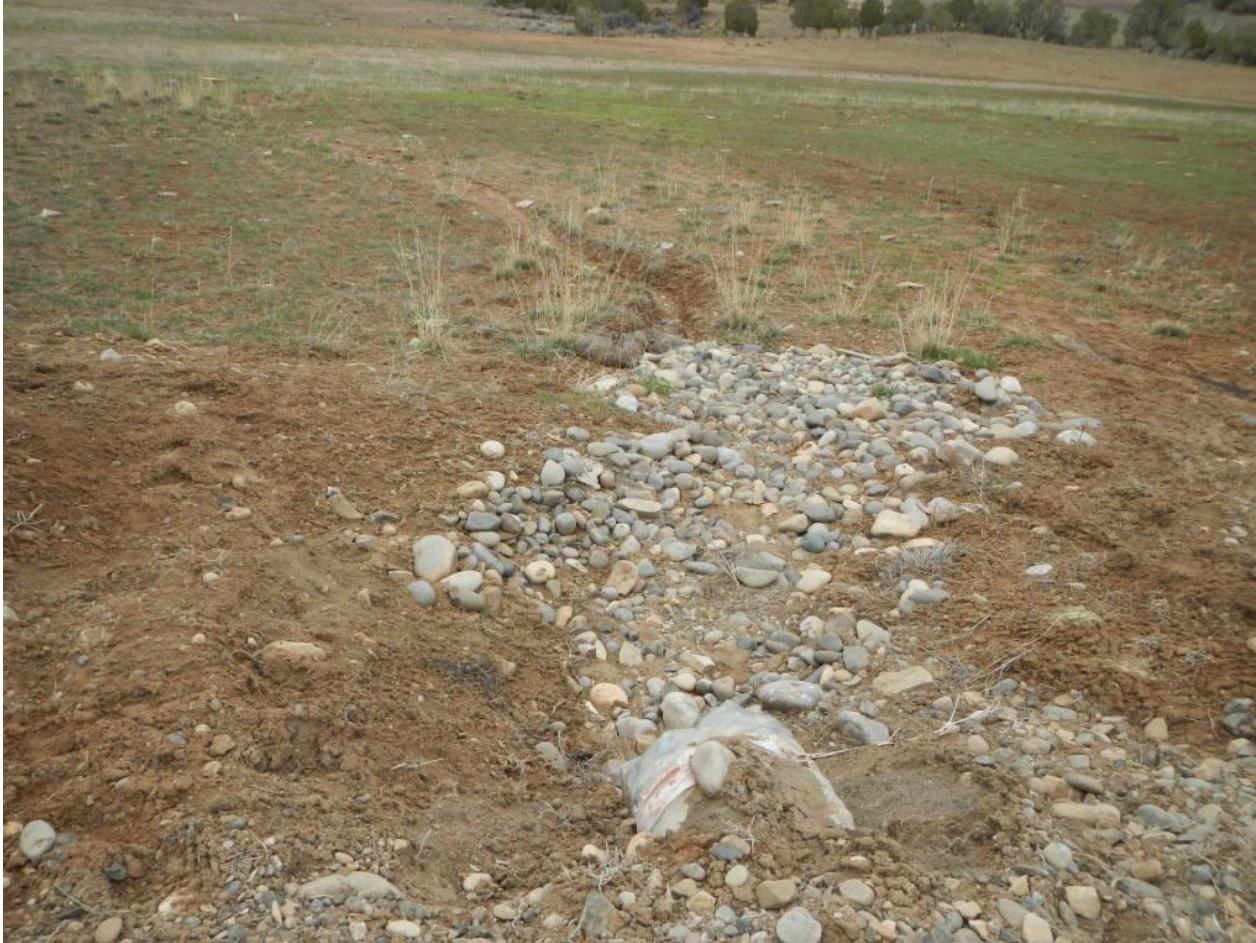
Photo 4. View of culvert outlet along access road where it appears cobble BMP may not be sufficient to de-energize concentrated flows that are diverted from the well pad.
