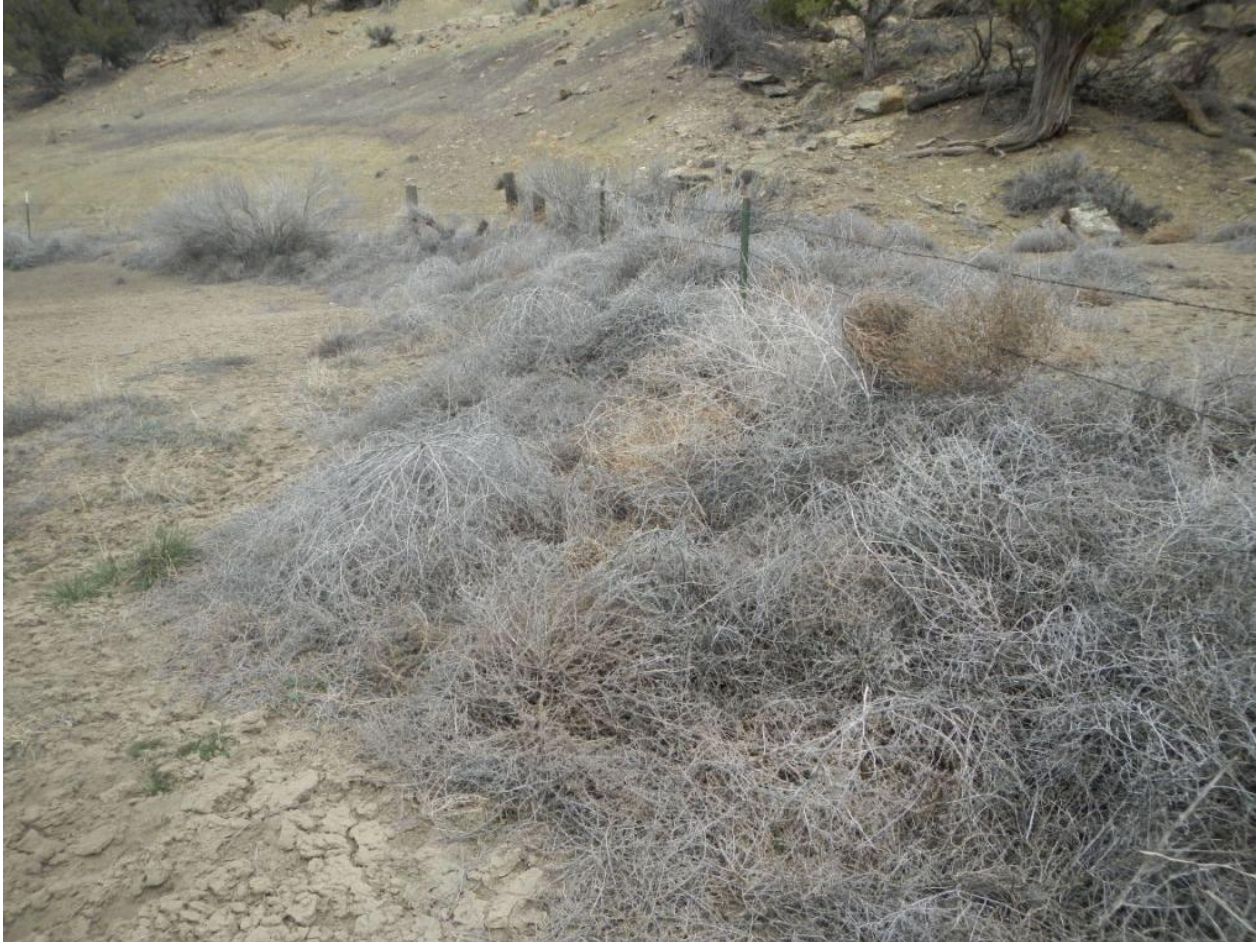
Photo 1. View of Russian thistle (*Salsola tragus*) and kochia (*Kochia scoparia*) debris within southeastern portion of project area.

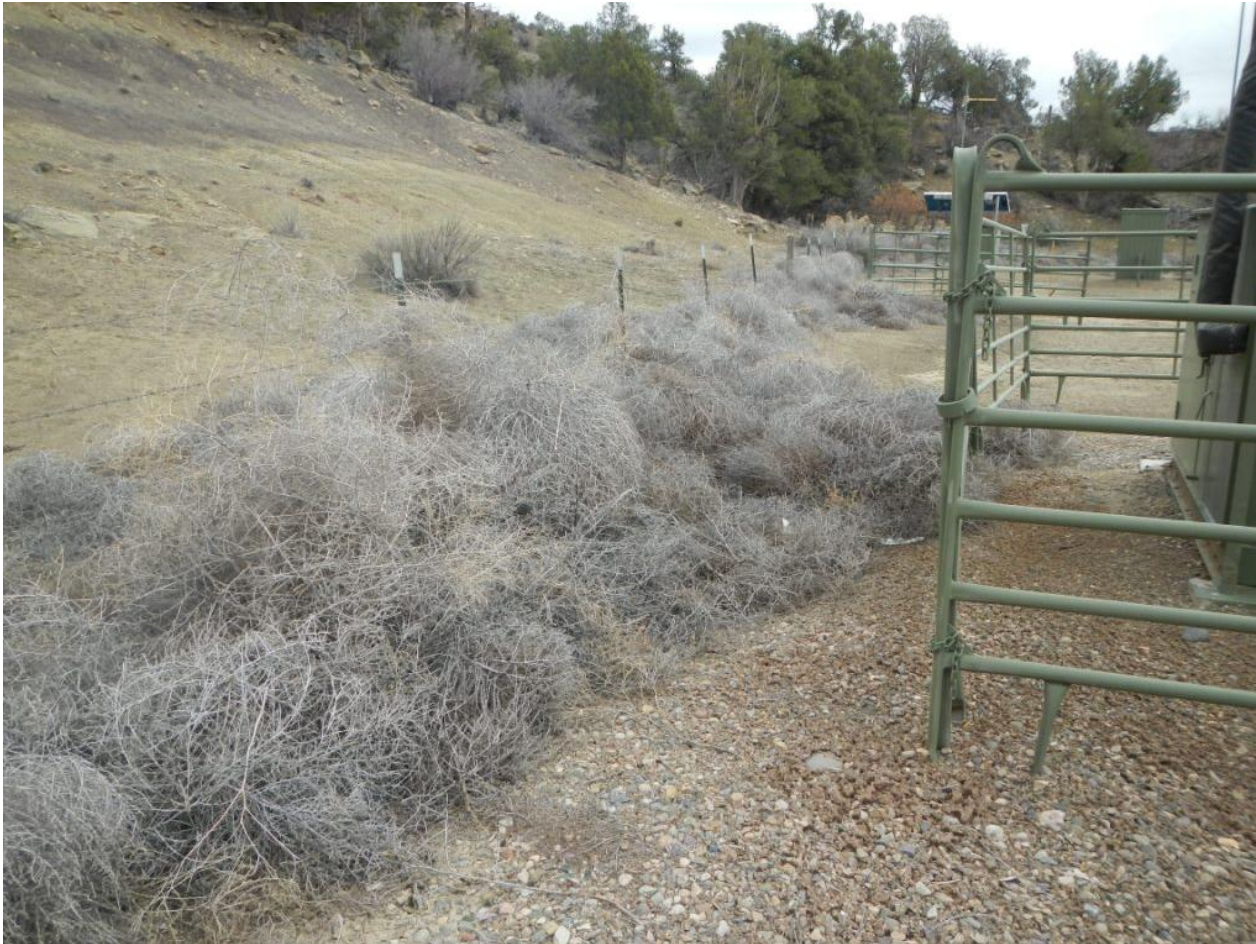
Photo 2. View of kochia and Russian thistle debris in eastern portion of project area.

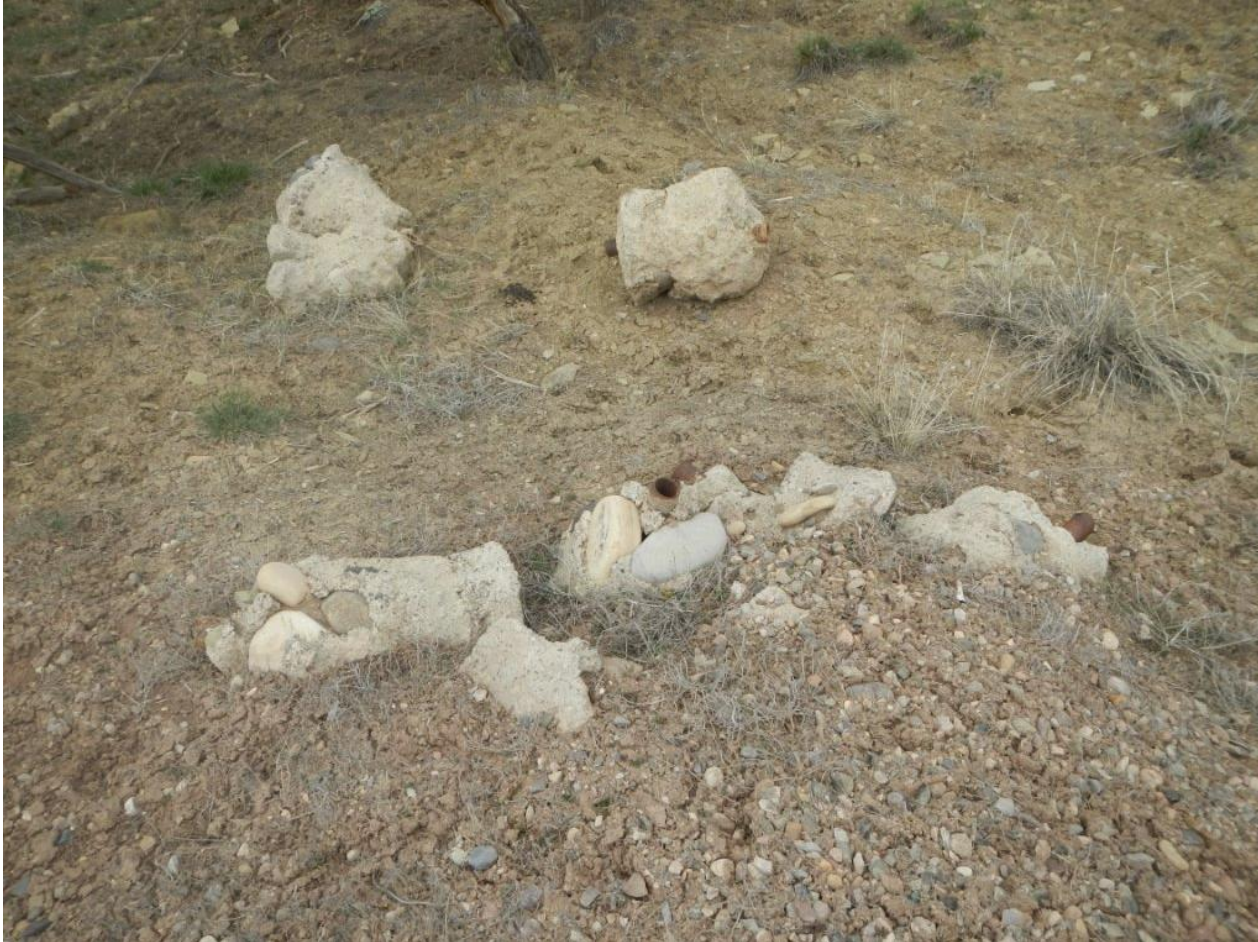
Photo 3. View of large blocks of cement waste in northern portion of project area.

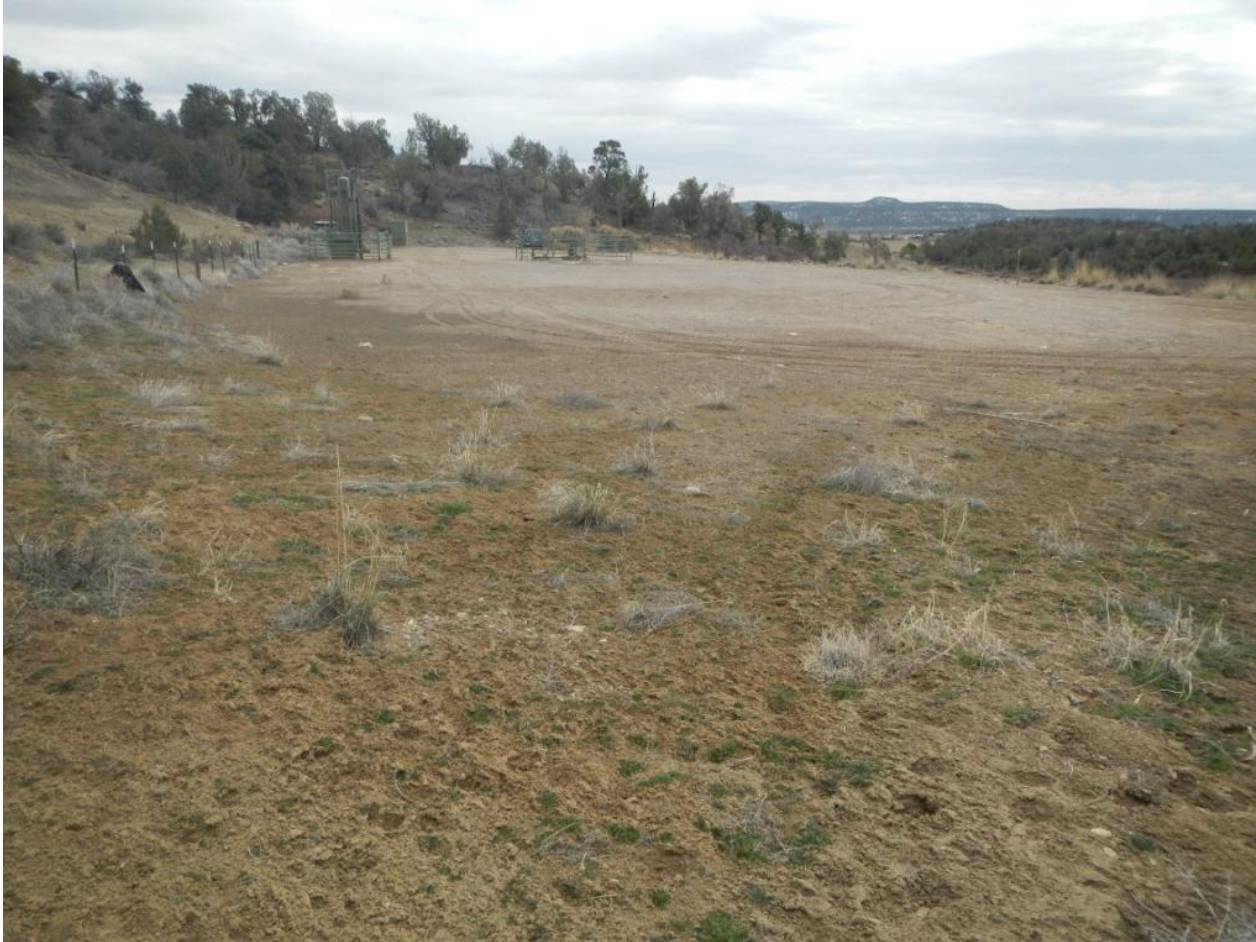
Photo 5. View of large area in northern portion of project area that does not appear necessary for production operations. From northeastern corner facing center.

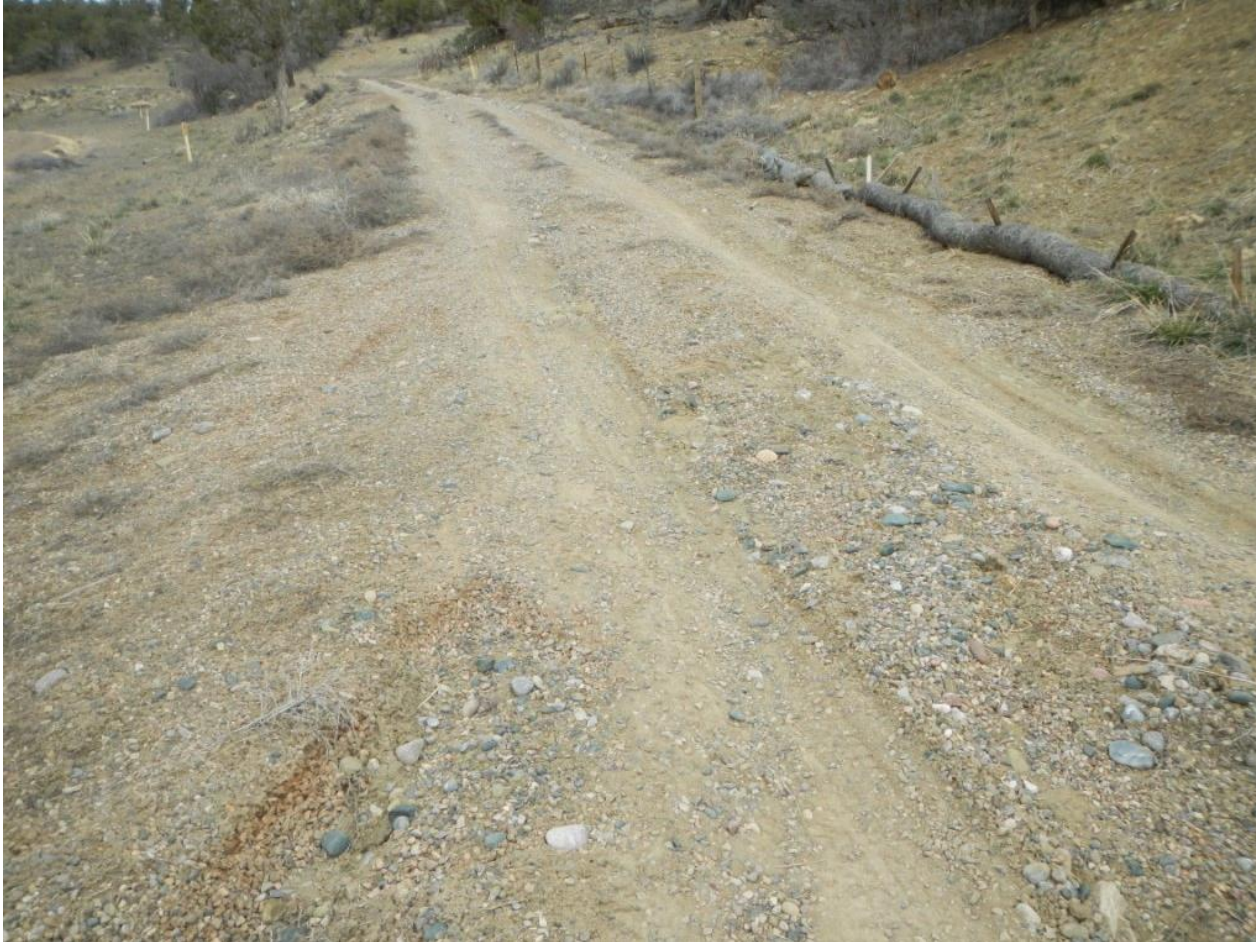
Photo 6. View of stormwater erosion along access road. A flow pattern can be seen on road and downstream (on left) where stormwater flows beneath wattles across road and down the road shoulder.
