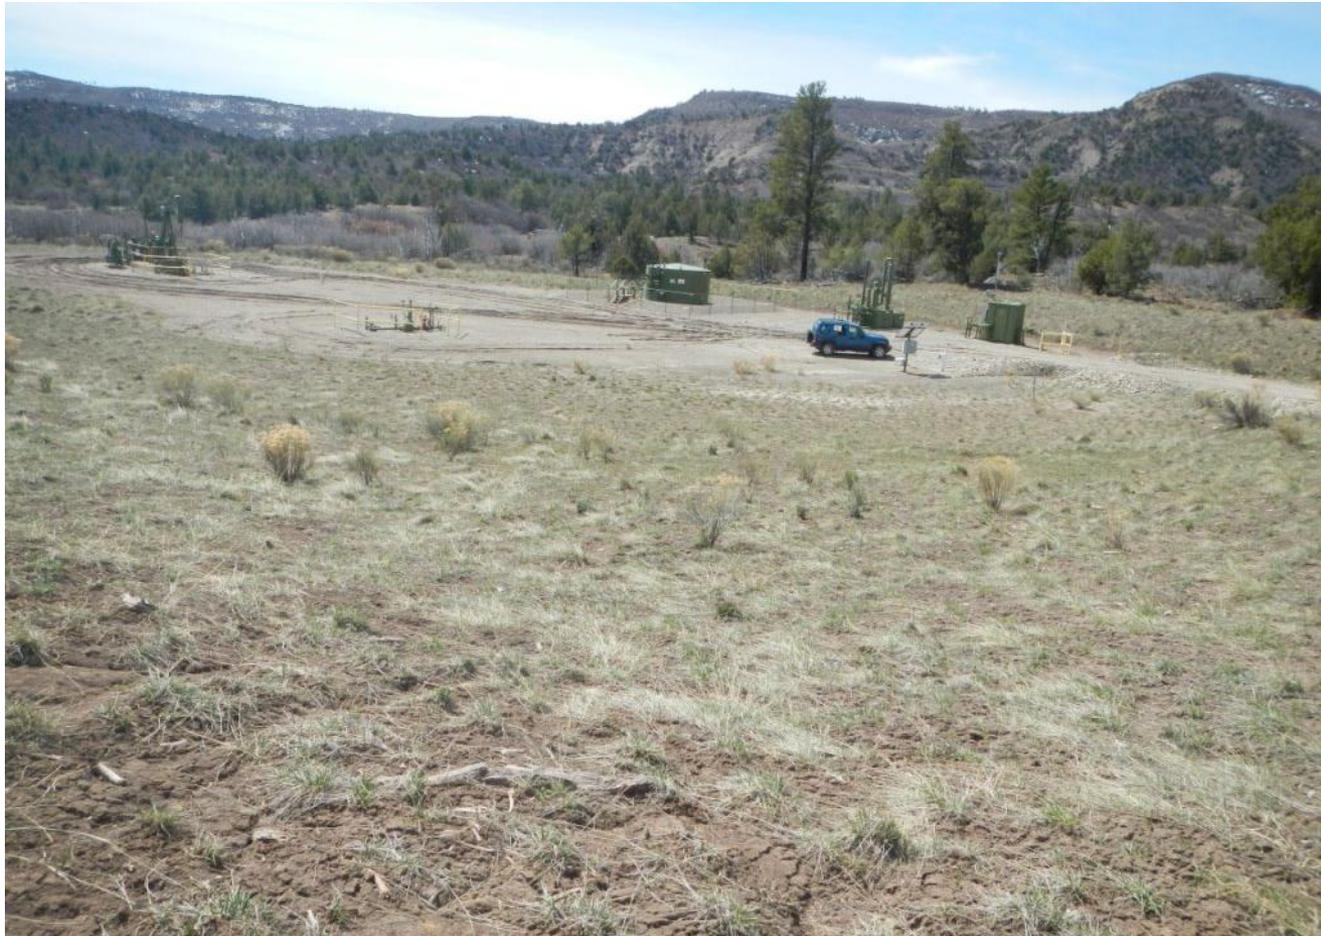
Photo 1. View from northeastern corner of well pad facing center.

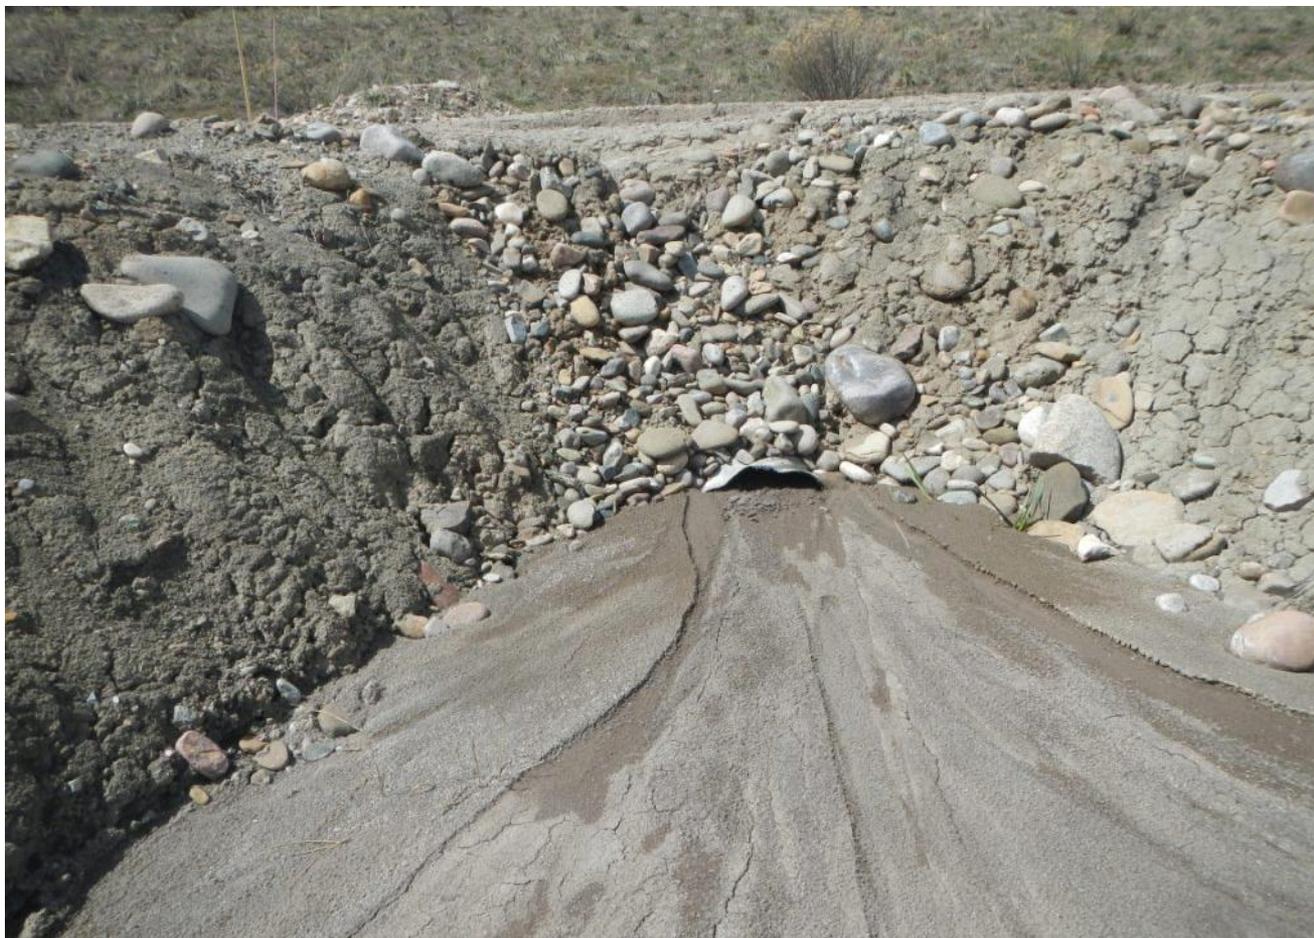
Photo 2. View of culvert outlet near entrance to well pad. Culvert is largely full of sediment.

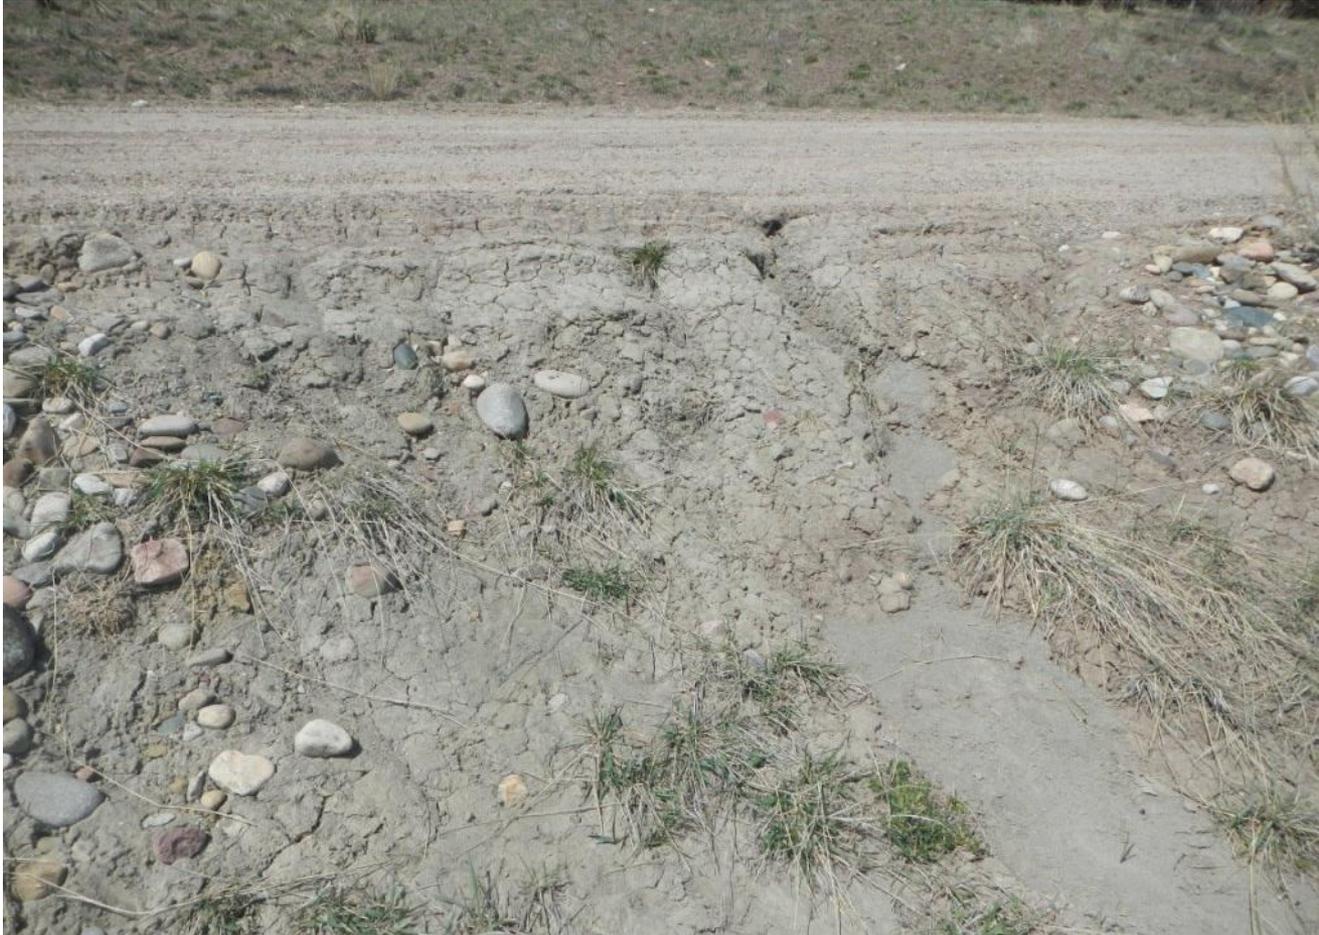
Photo 3. View of rill erosion on shoulder of access road.

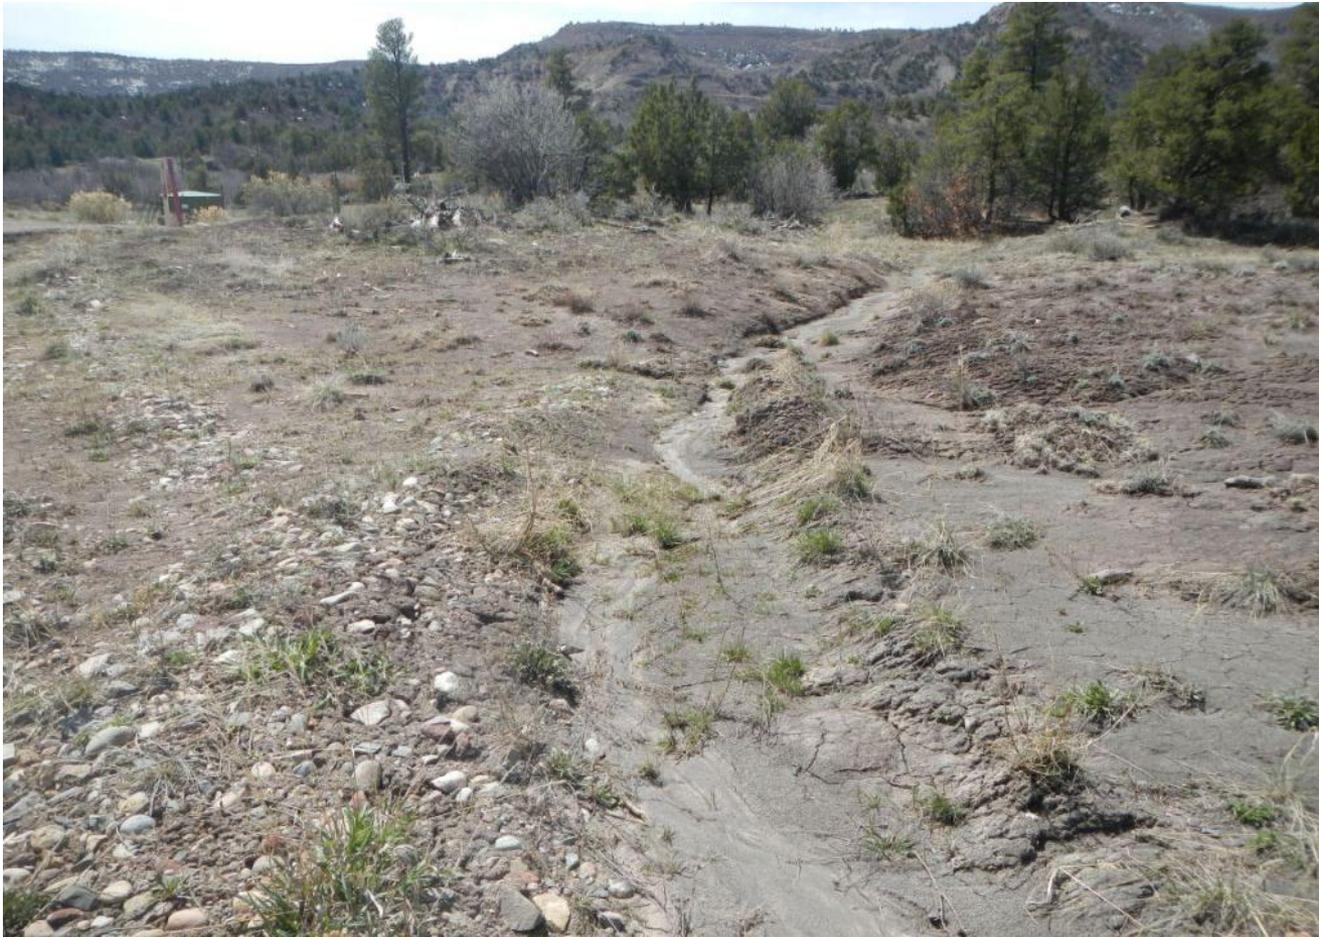
Photo 4. View of bar ditch on western side of access road. Stormwater flows along bar ditch are not sufficiently de-energized and causing erosional downcutting.

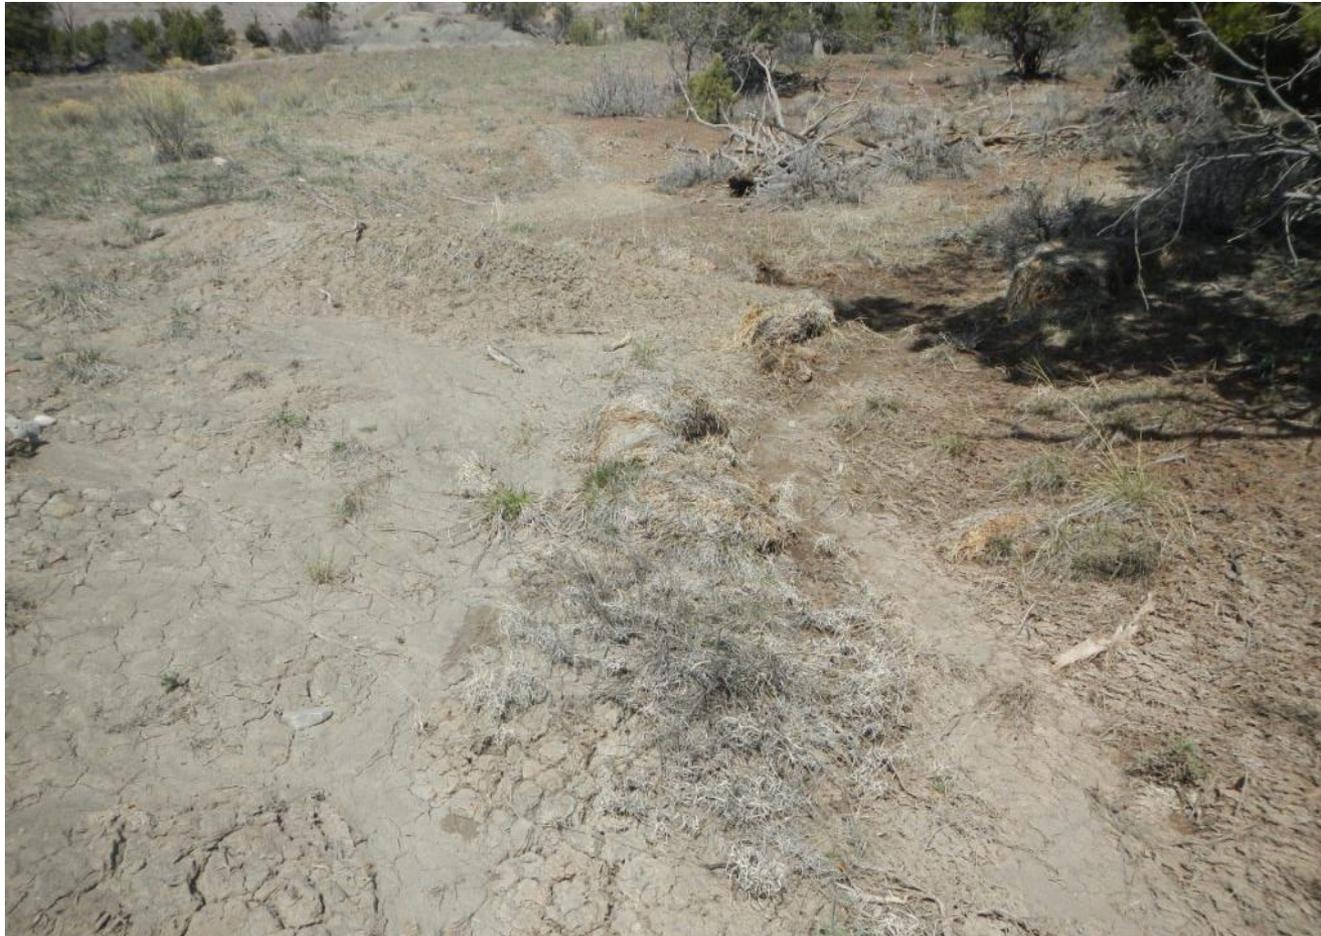
Photo 5. View of stormwater diversion along eastern edge of project area facing northward. A deteriorated silt trap berm and deteriorated straw wattles can be observed.

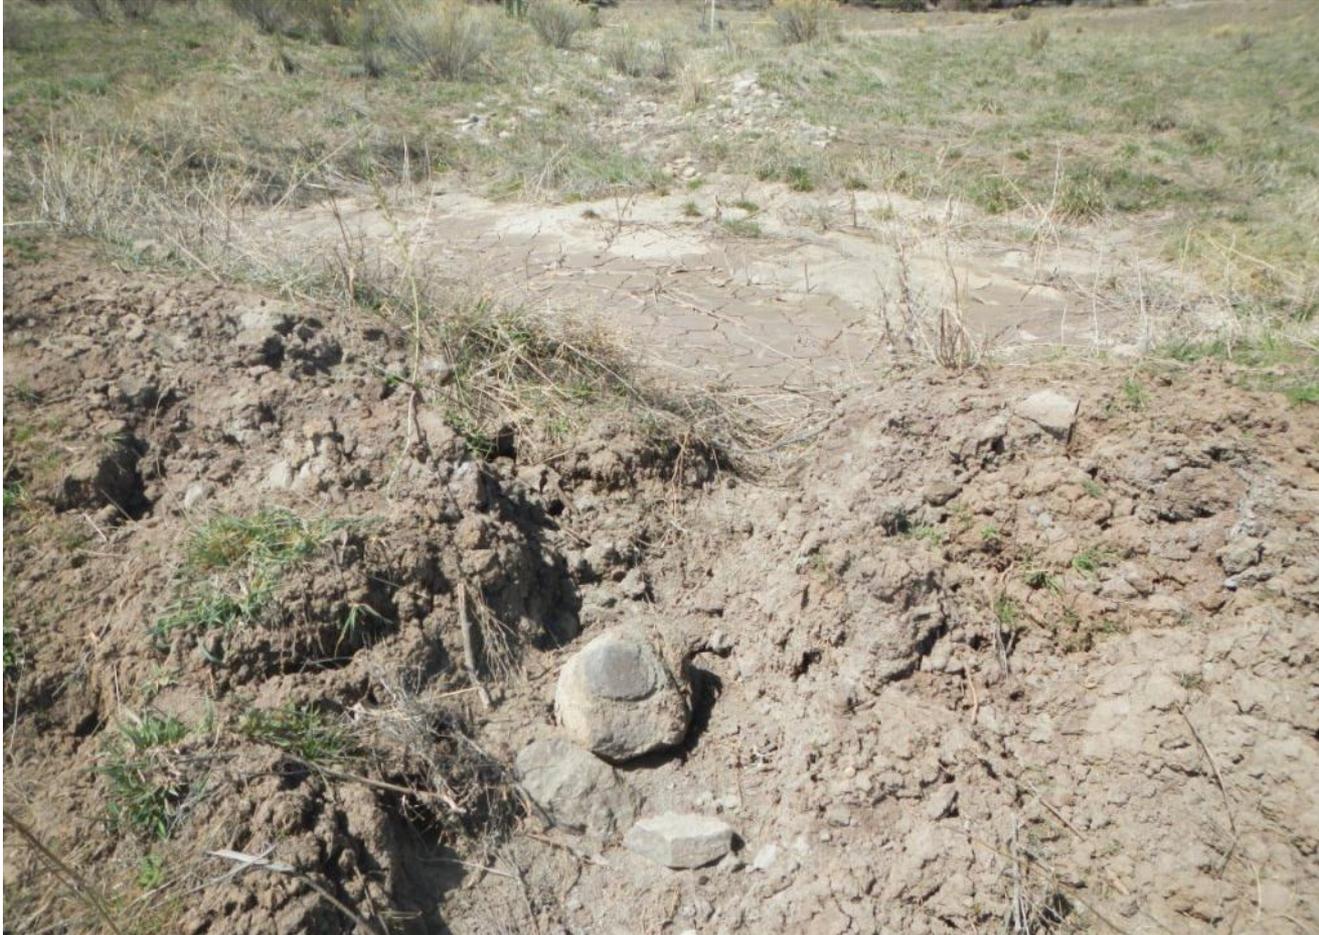
Photo 6. View of silt trap in southern portion of project area. A breach in the berm can be seen in the center of the photo.

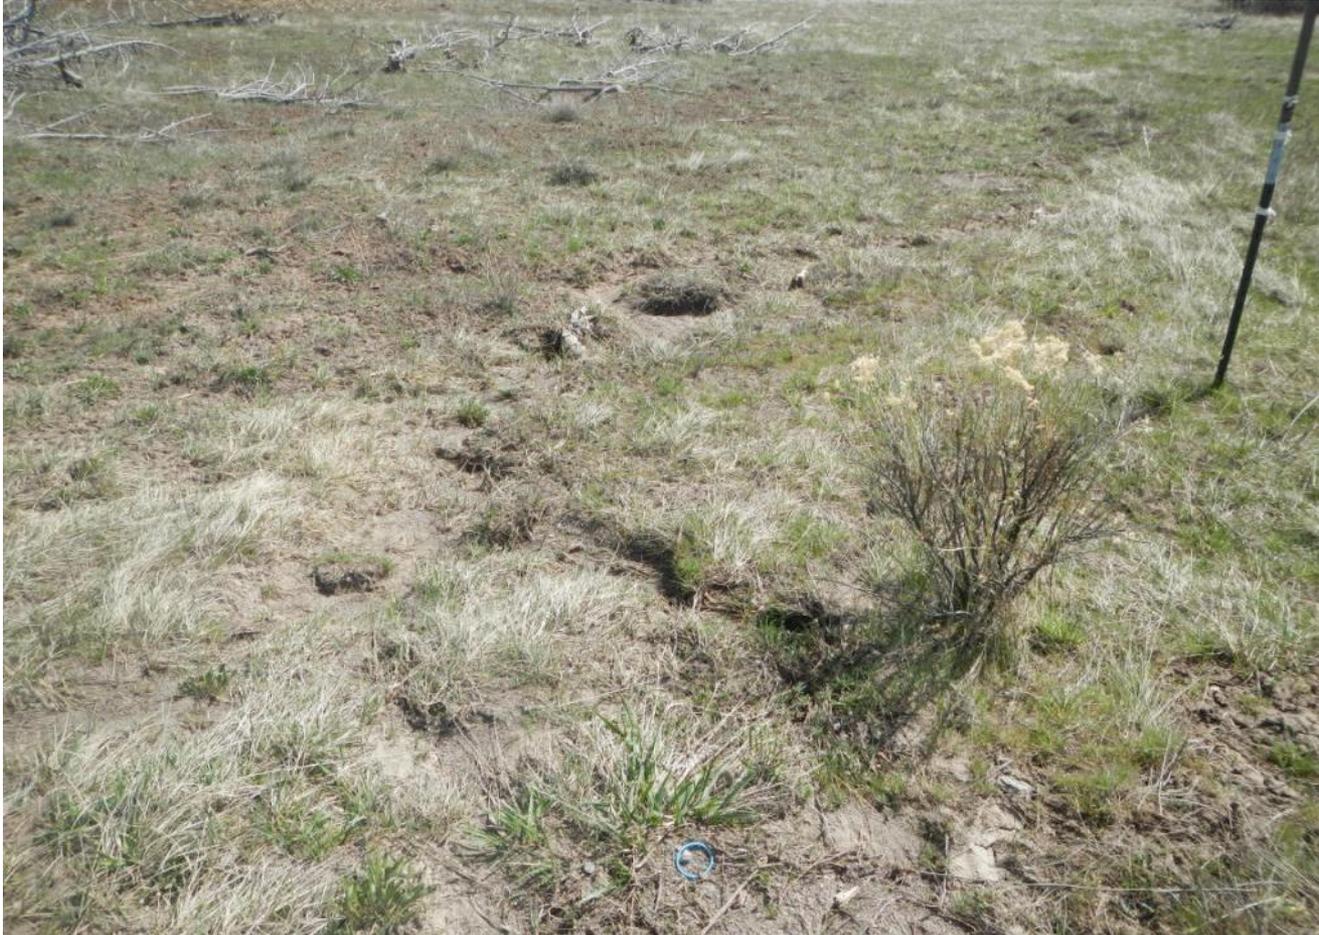
Photo 7. View of stormwater erosion downstream from breach in silt trap shown in Photo 6, facing southward.
