Duckworth 6-0-16

- Rig release: 01/04/09
- Completion start 01/09/09
- Frac J-Sand & Niobrara 1/14/09
- Perforating gun stuck while perforating Niobrara.
- Fished gun 1/20/09
- Perforate Niobrara 1/26/09
- Frac Niobrara 1/29/09 pressure anomaly noted, job shut down.
- Ran temperature log 1/30/09, possible part @ 6500'
- Attempt coil cleanout 2/8/09 unable to get down, possibly out of casing
- Ran downhole camera 2/13/09 found casing parted
- Ran casing inspection log 2/22/09 casing pitted from DV down to part
- Cost to date: \$1,198,163 (approved: \$1,209,750)

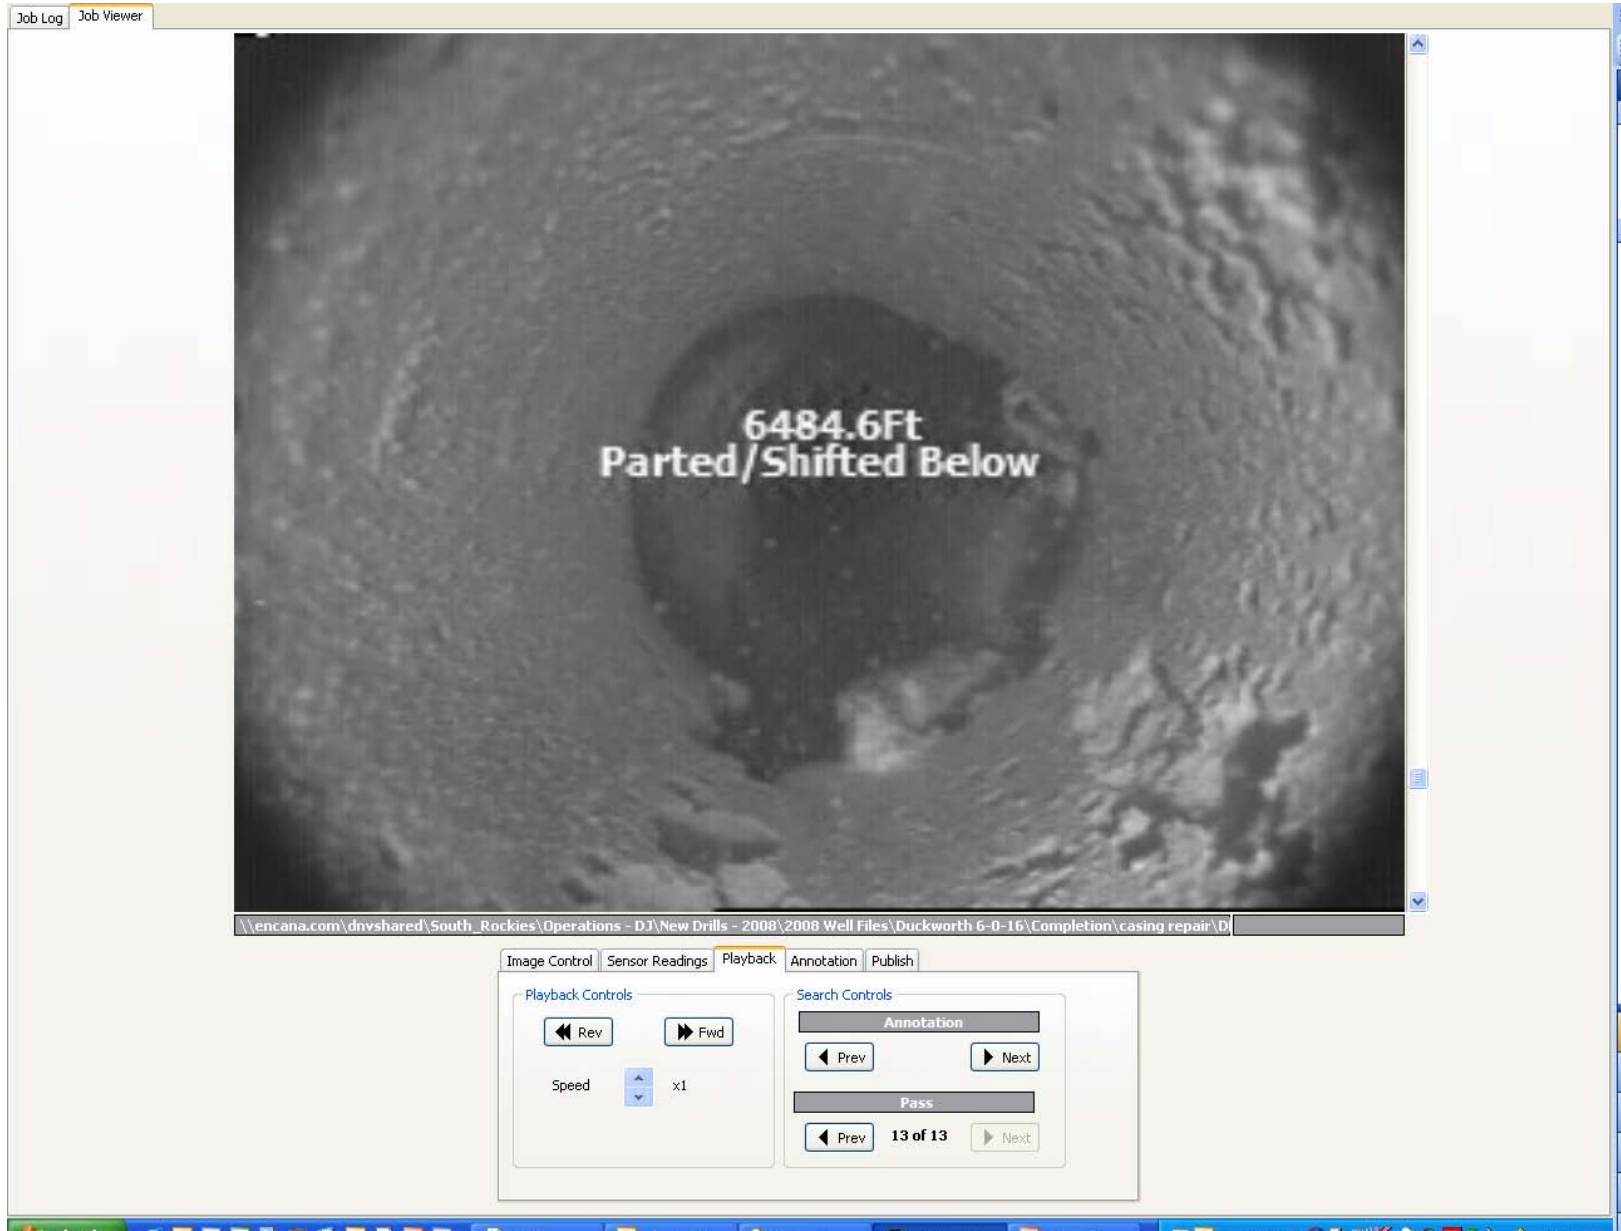
Original view of parted casing

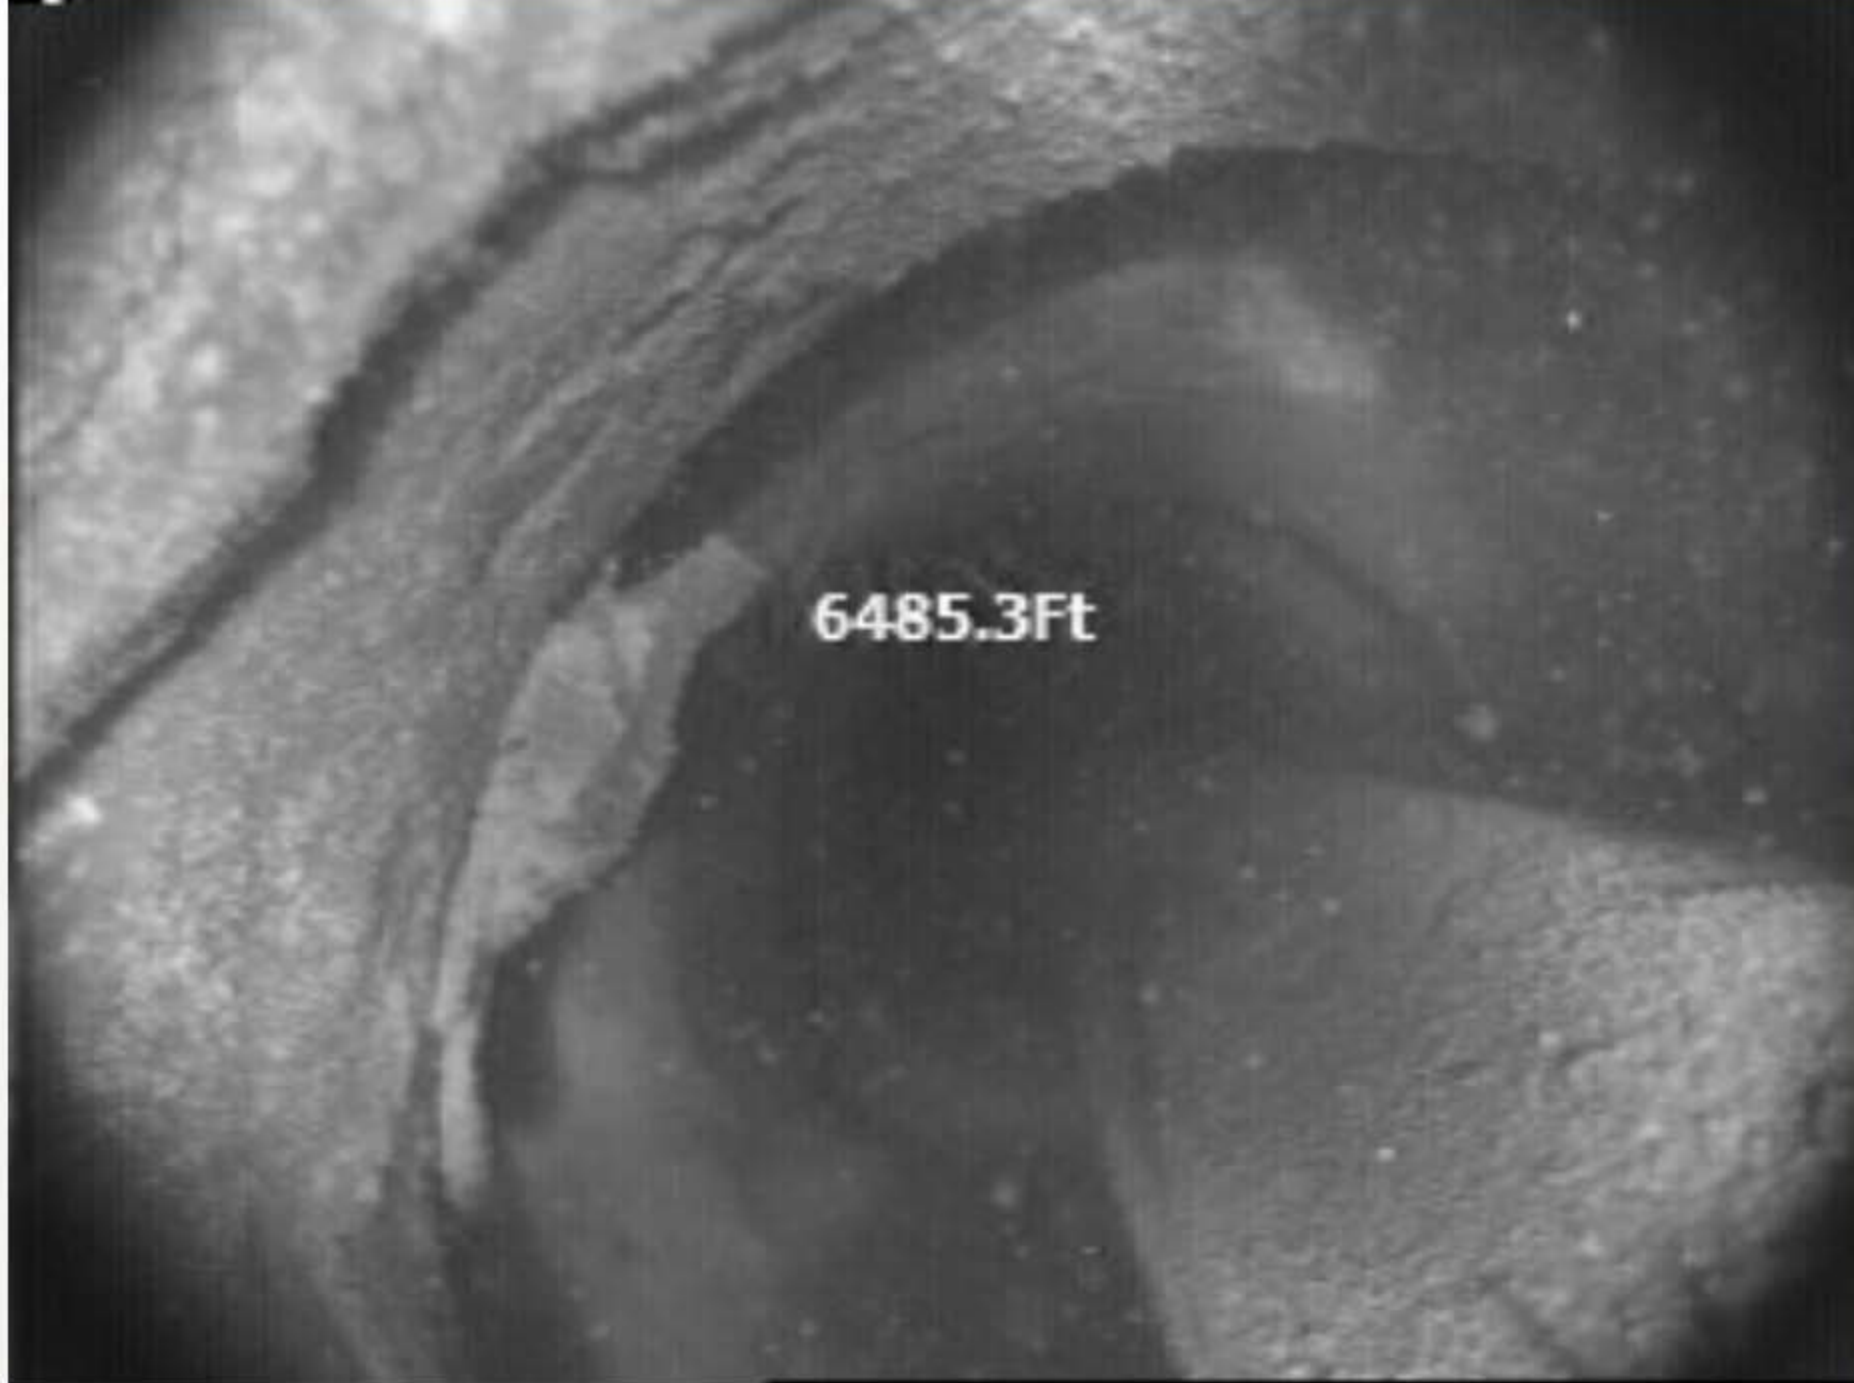
6485.7ft

6485.0Ft
Stub @ 3 O'Clock

About 1"

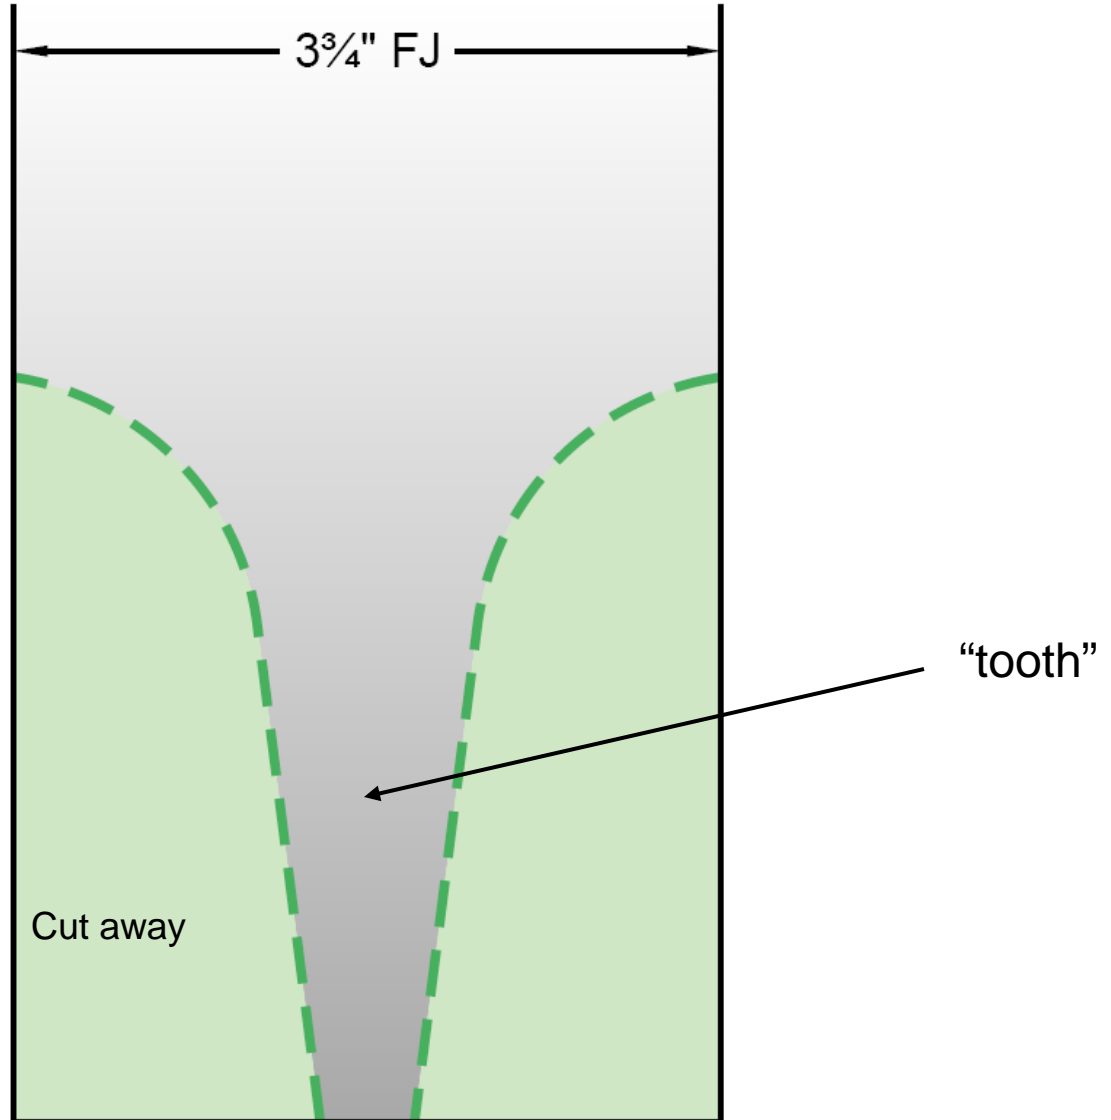
Fishing tool

Minimum overlap $\frac{1}{2}$ "

4 $\frac{1}{2}$ " casing in 7 $\frac{7}{8}$ " hole

- **Run 3 joints 3 $\frac{3}{4}$ " flush Joint wash pipe, with "tooth" cut on end to part**
- **Run liner hanger on top of wash pipe**
- **Use downhole camera to line up tooth to lower "stub"**
- **Rotate wash pipe into "stub", and center across part**
- **Set liner hanger to keep casing aligned**
- **Spot sand on Niobrara, and squeeze "patch" using coiled tubing**
- **Clean out sand and drill plugs with coiled tubing**

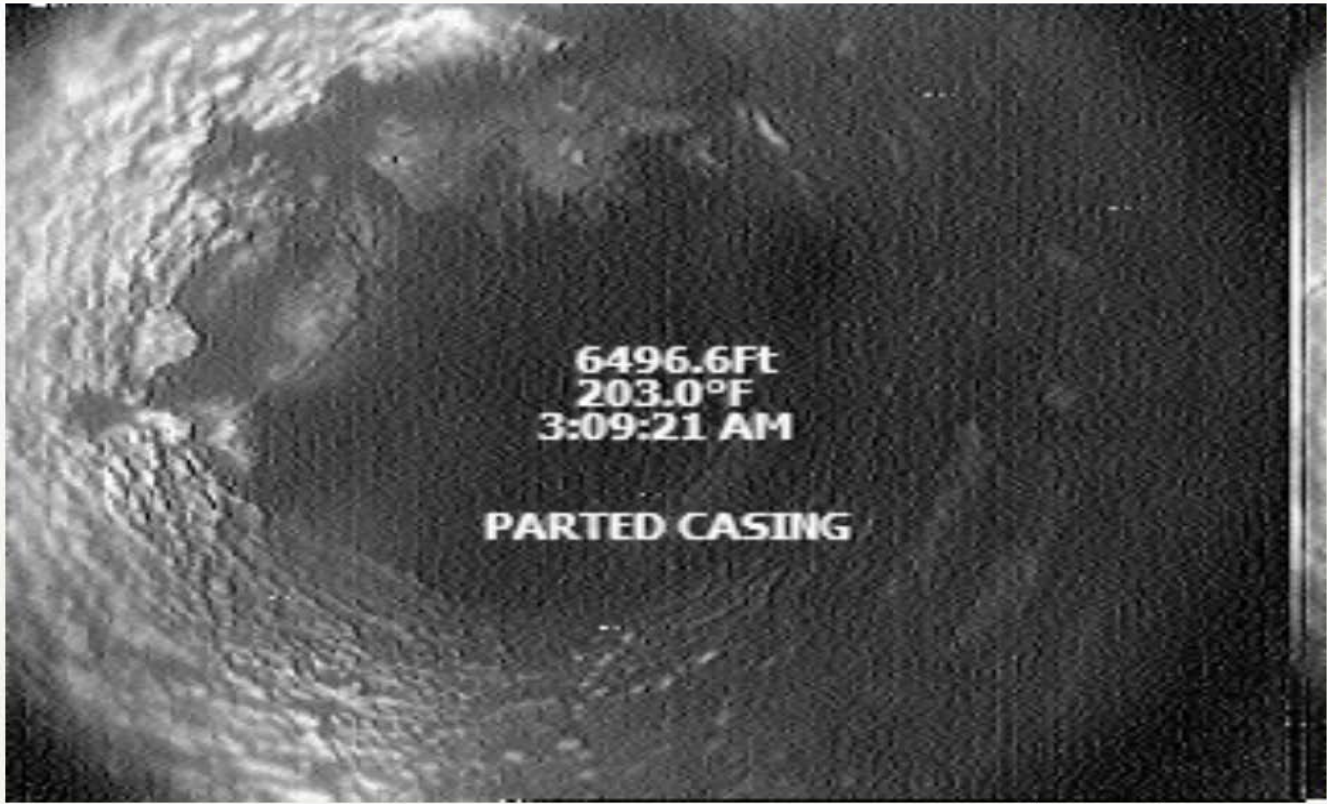
6496.6Ft
203.0°F
3:09:21 AM
PARTED CASING

Outside of lower casing @ 7:00 oclock

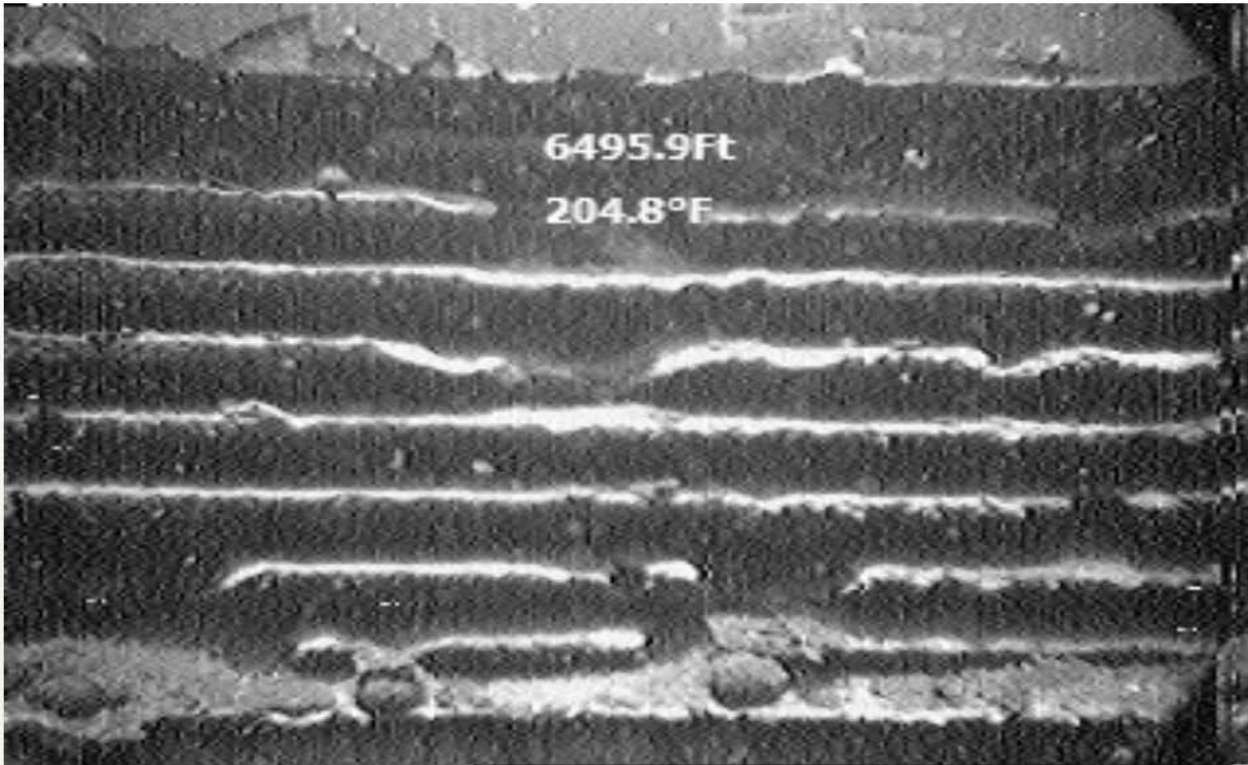
6495.9Ft
204.8°F

Threads
