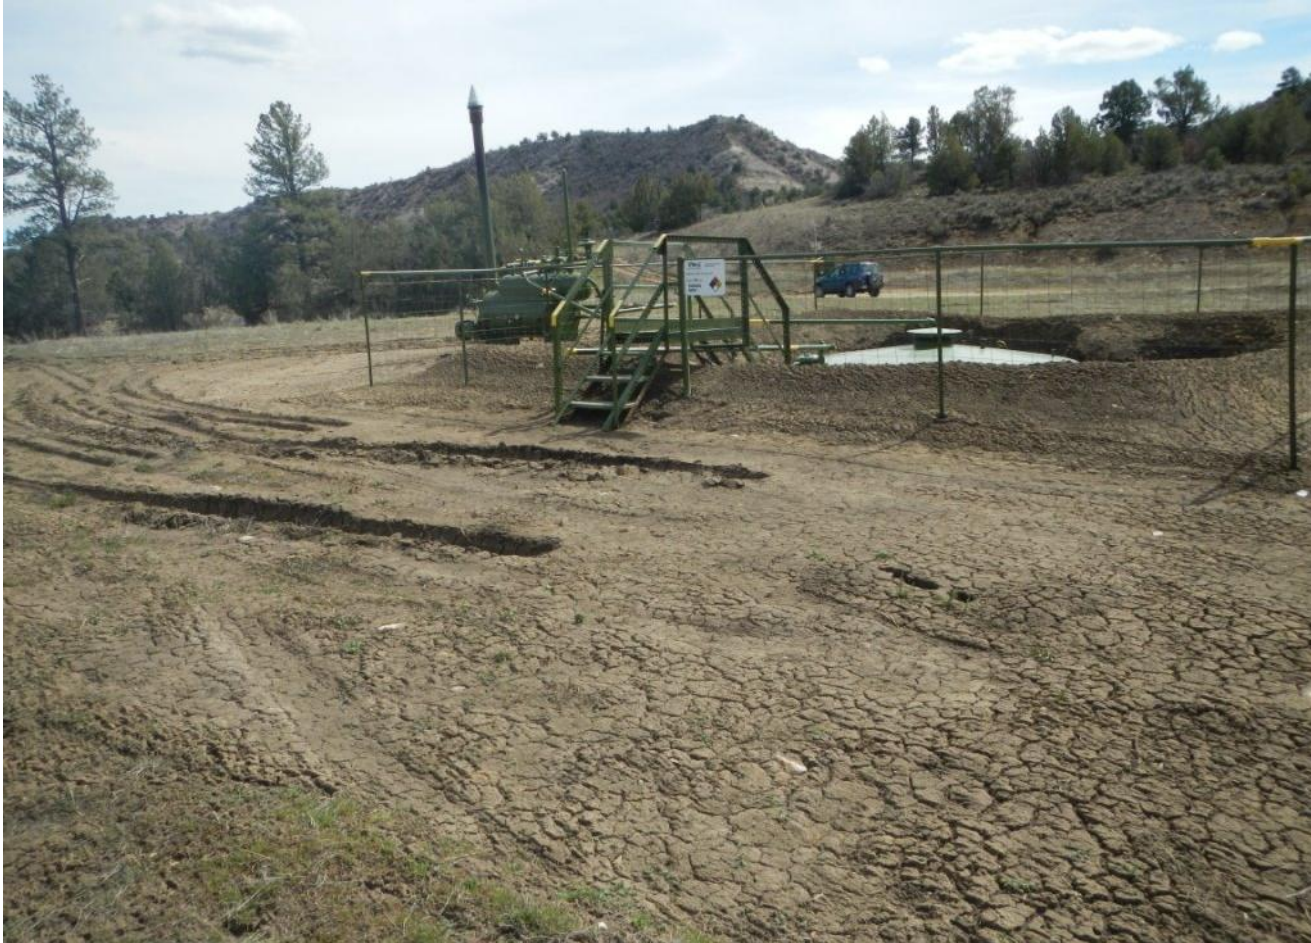
Photo 1. View of well pad from northwestern corner facing center.

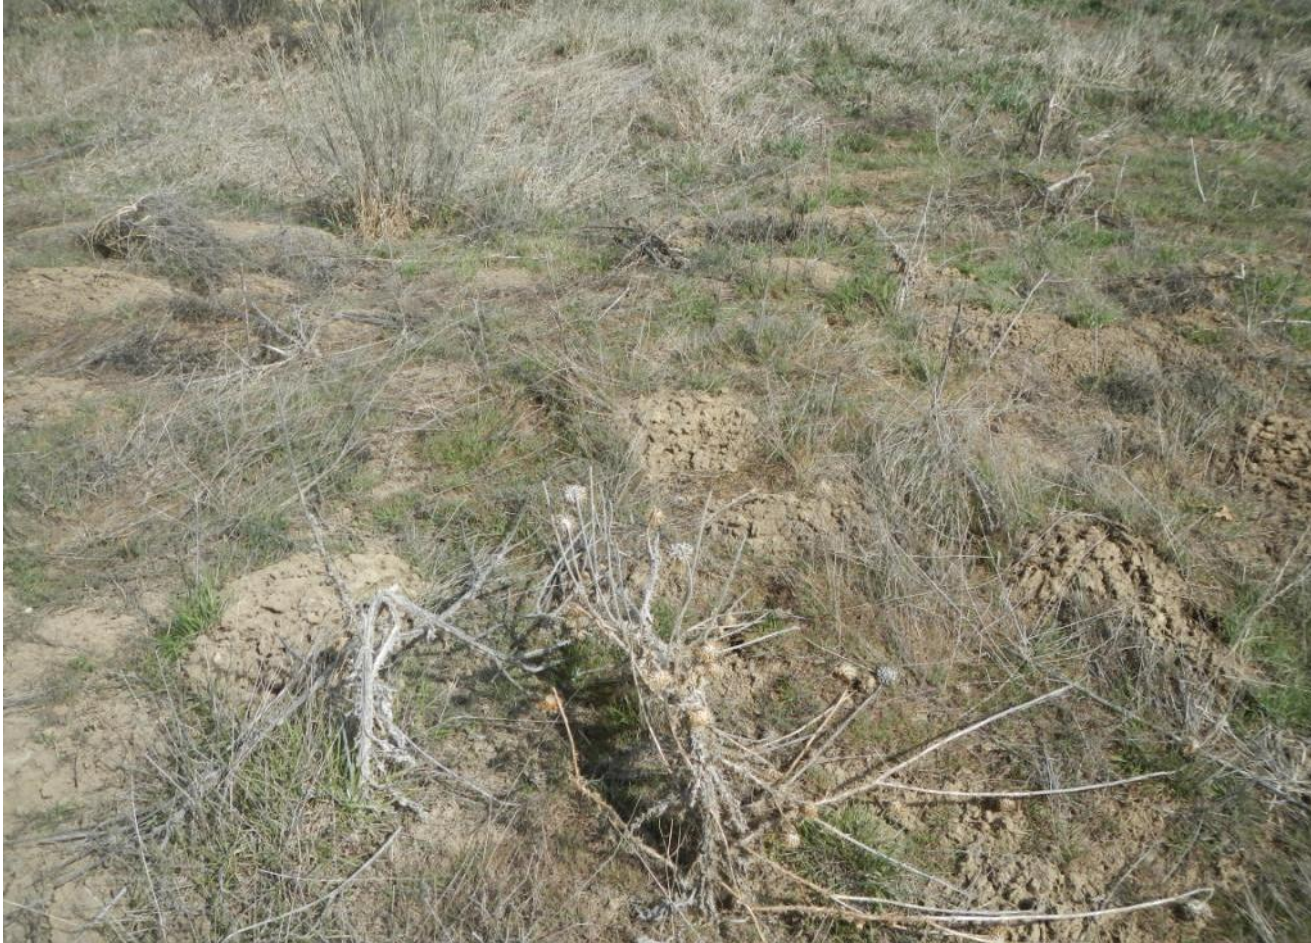
Photo 2. View of residual musk thistle from previous season within the interim reclamation area.

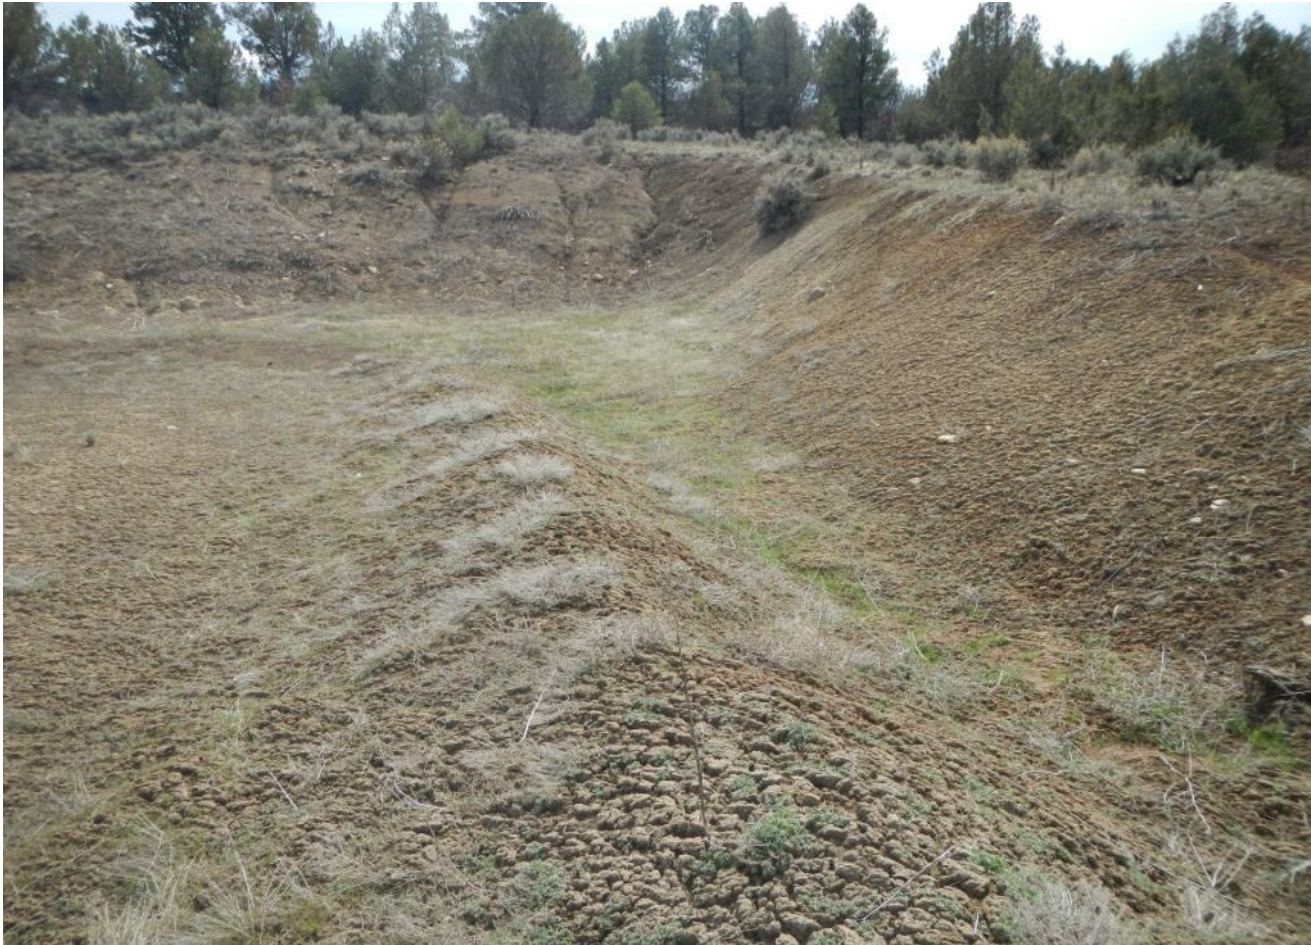
Photo 3. View of cut-slope in southwestern portion of well pad. Poor revegetation along cut-slope. Vegetation at the toe of the slope is largely cheatgrass (*Bromus tectorum*).

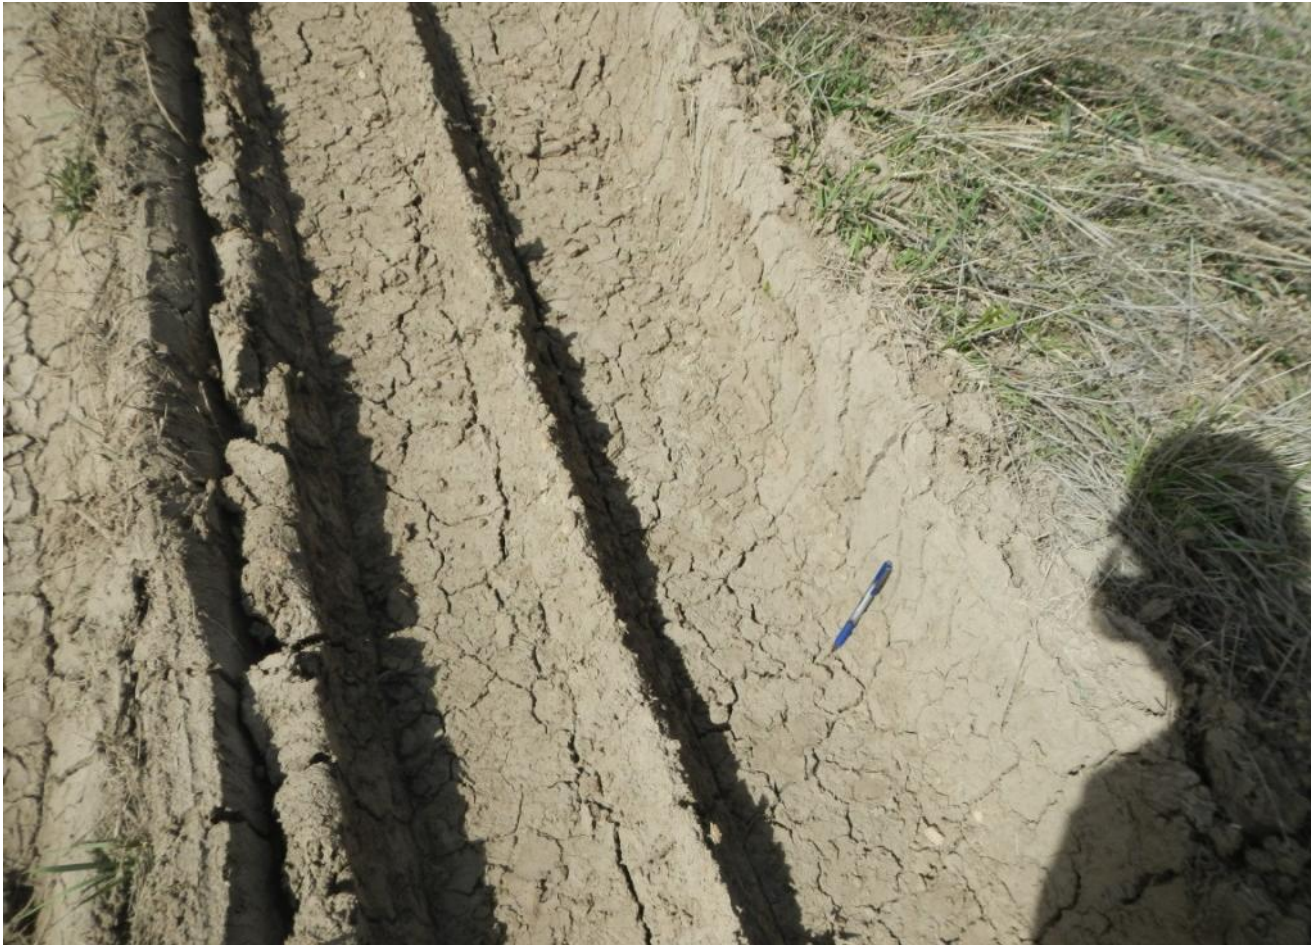
Photo 4. View of ruts approximately 12 inches deep within access road.

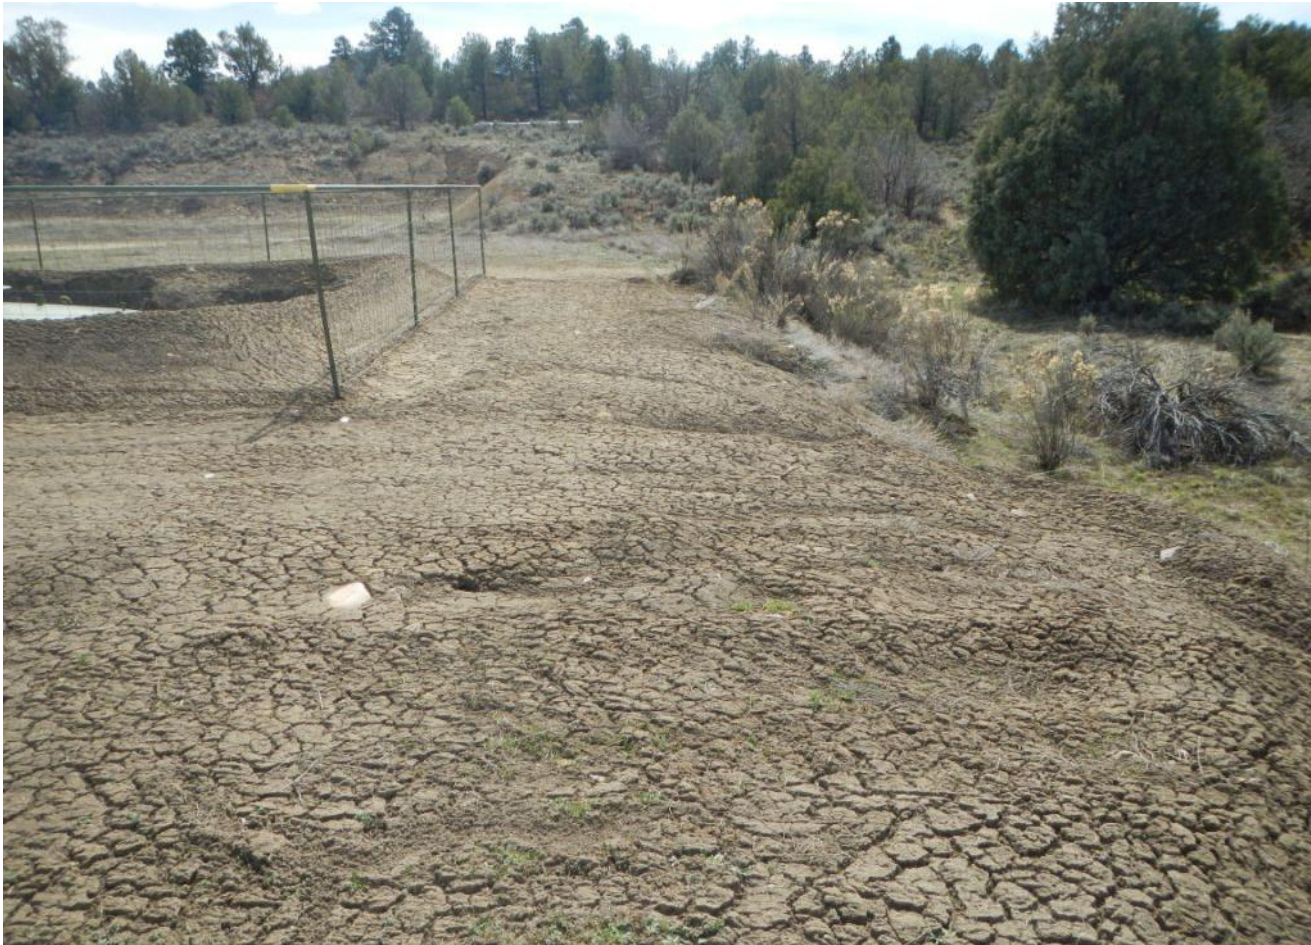
Photo 5. View of western edge of well pad where it appears stormwater flows over the edge, eroding the well pad surface.
