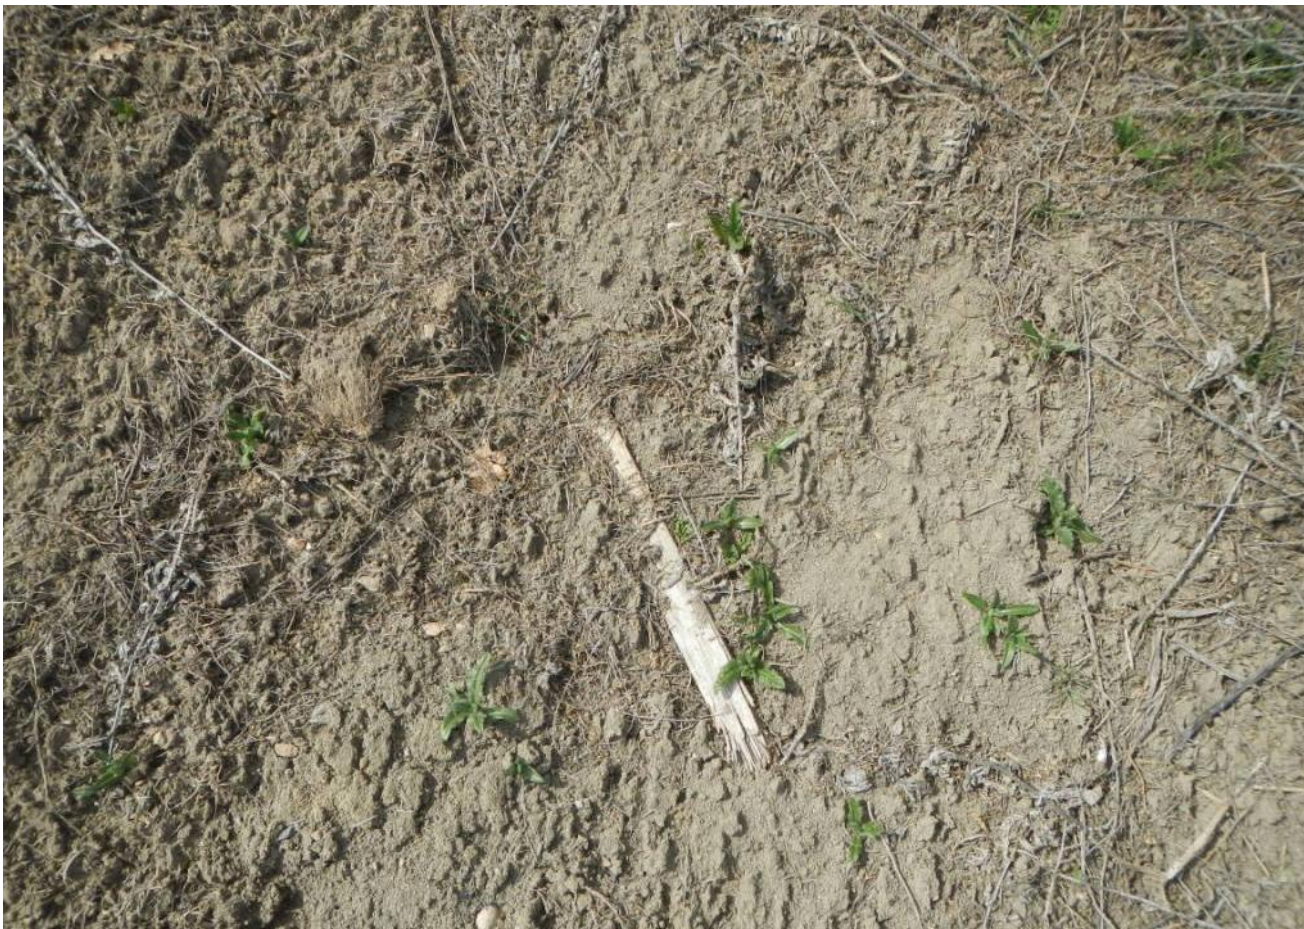
Photo 1. Birdseye view of musk thistle (*Carduus nutans*) seedlings within the interim reclamation area.

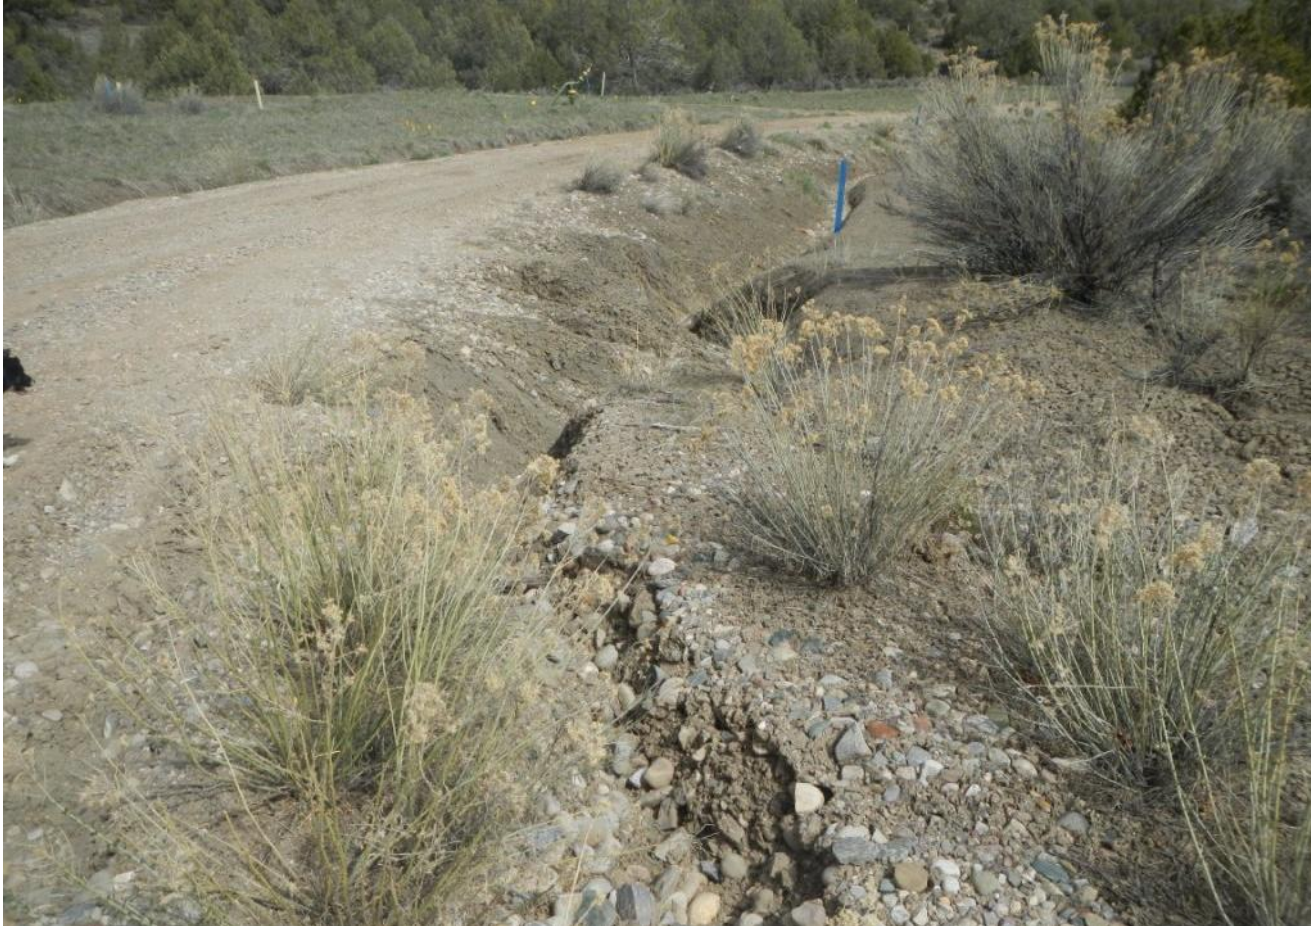
Photo 2. View of erosional channel along the southern edge of the access road.

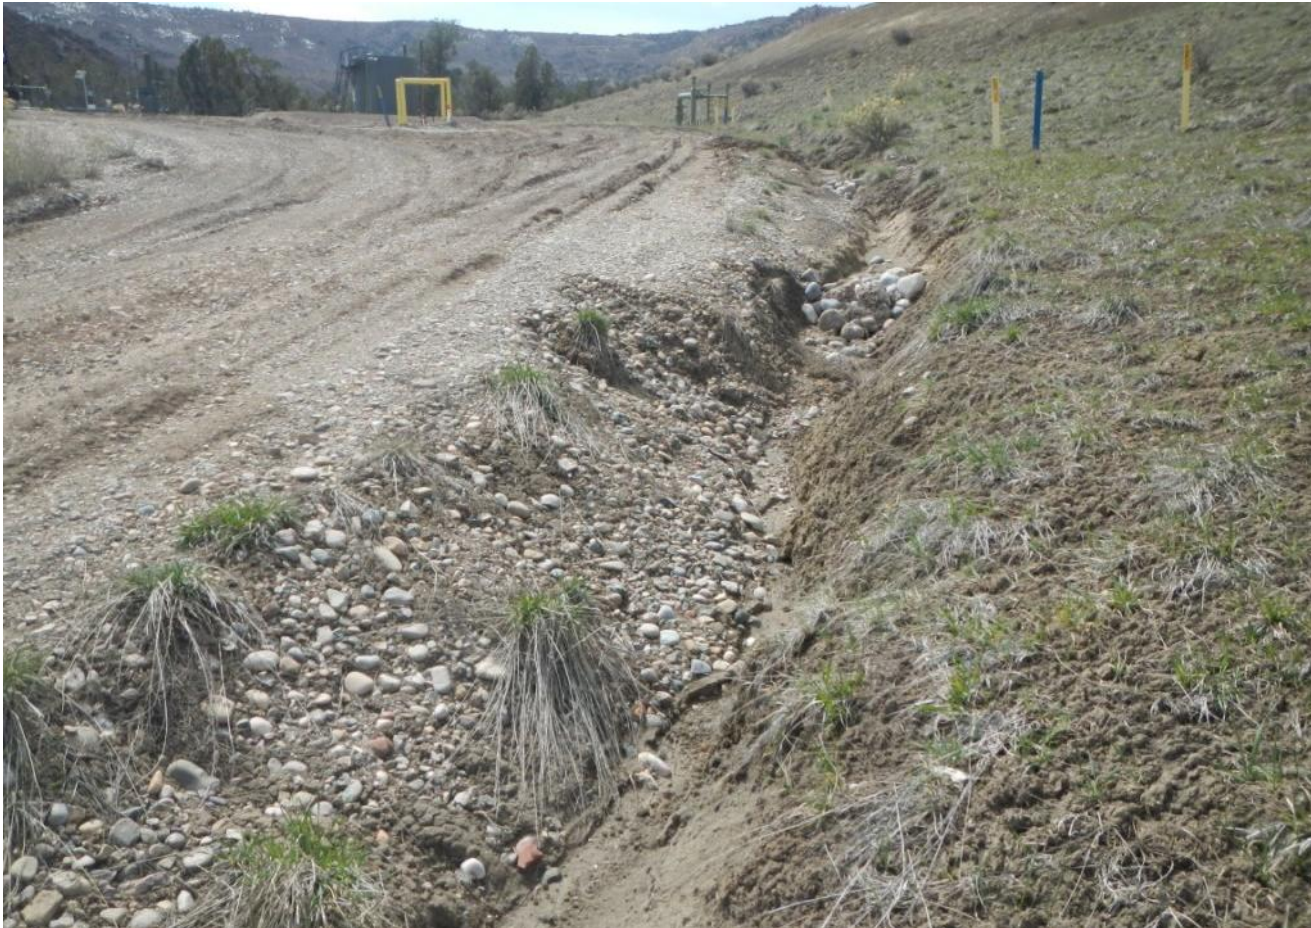
Photo 3. View of erosional channel along the northern edge of the access road.

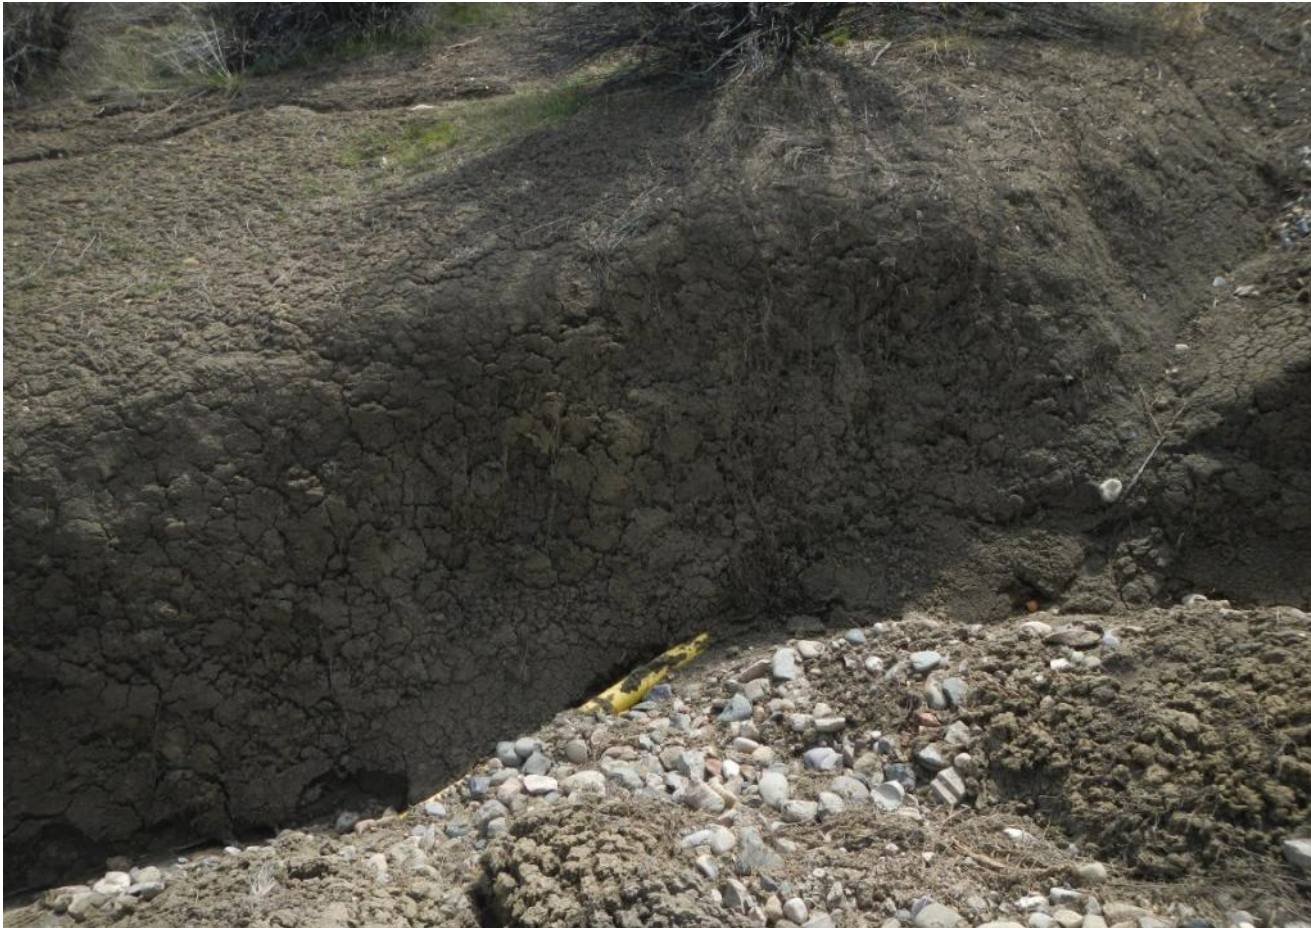
Photo 4. View of exposed pipe within the erosional channel on the southern edge of the access road.

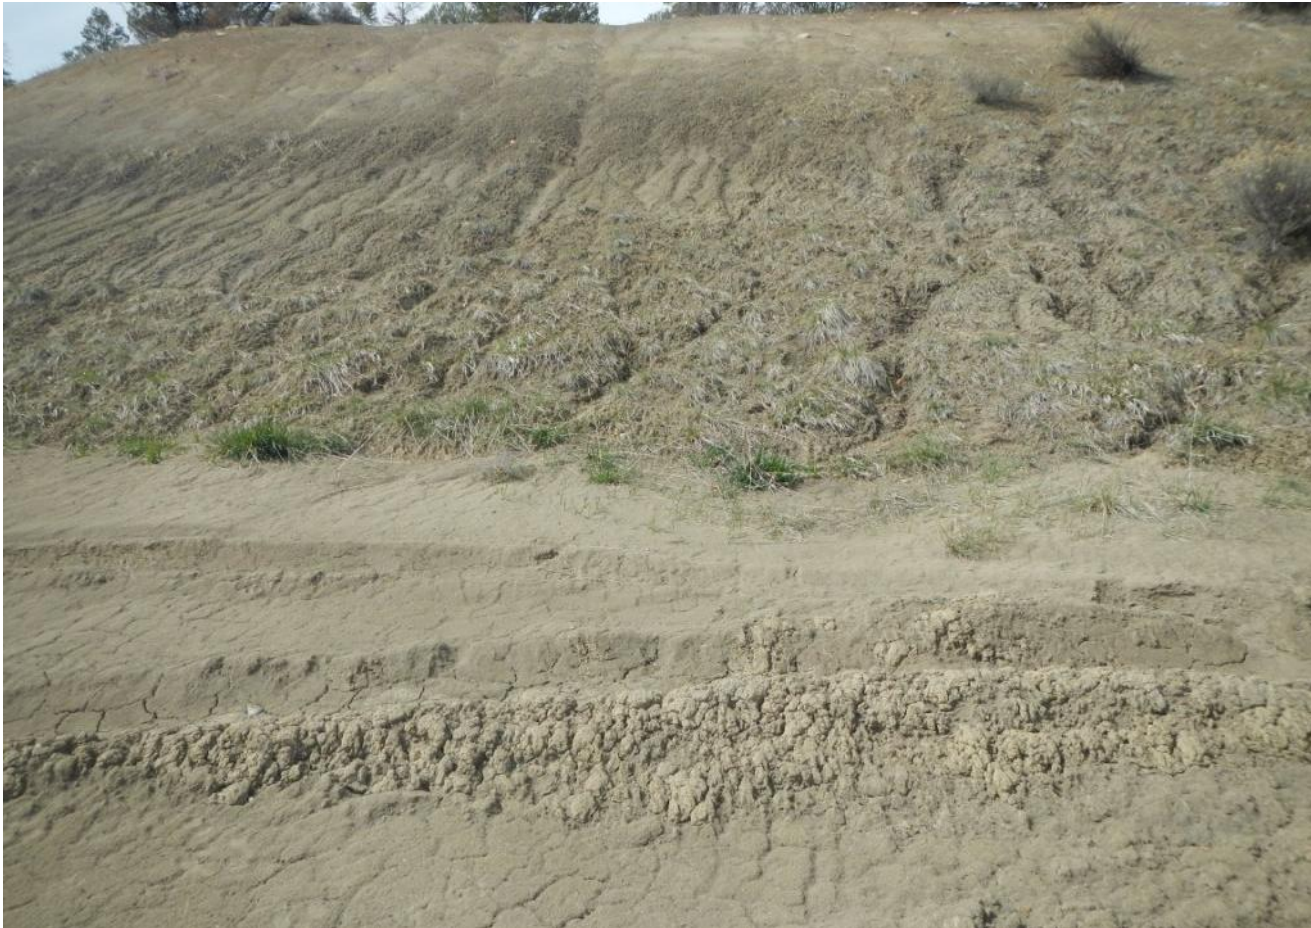
Photo 5. View of sediment deposition (bottom) and stormwater erosion (top) occurring on the well pad cut slope.

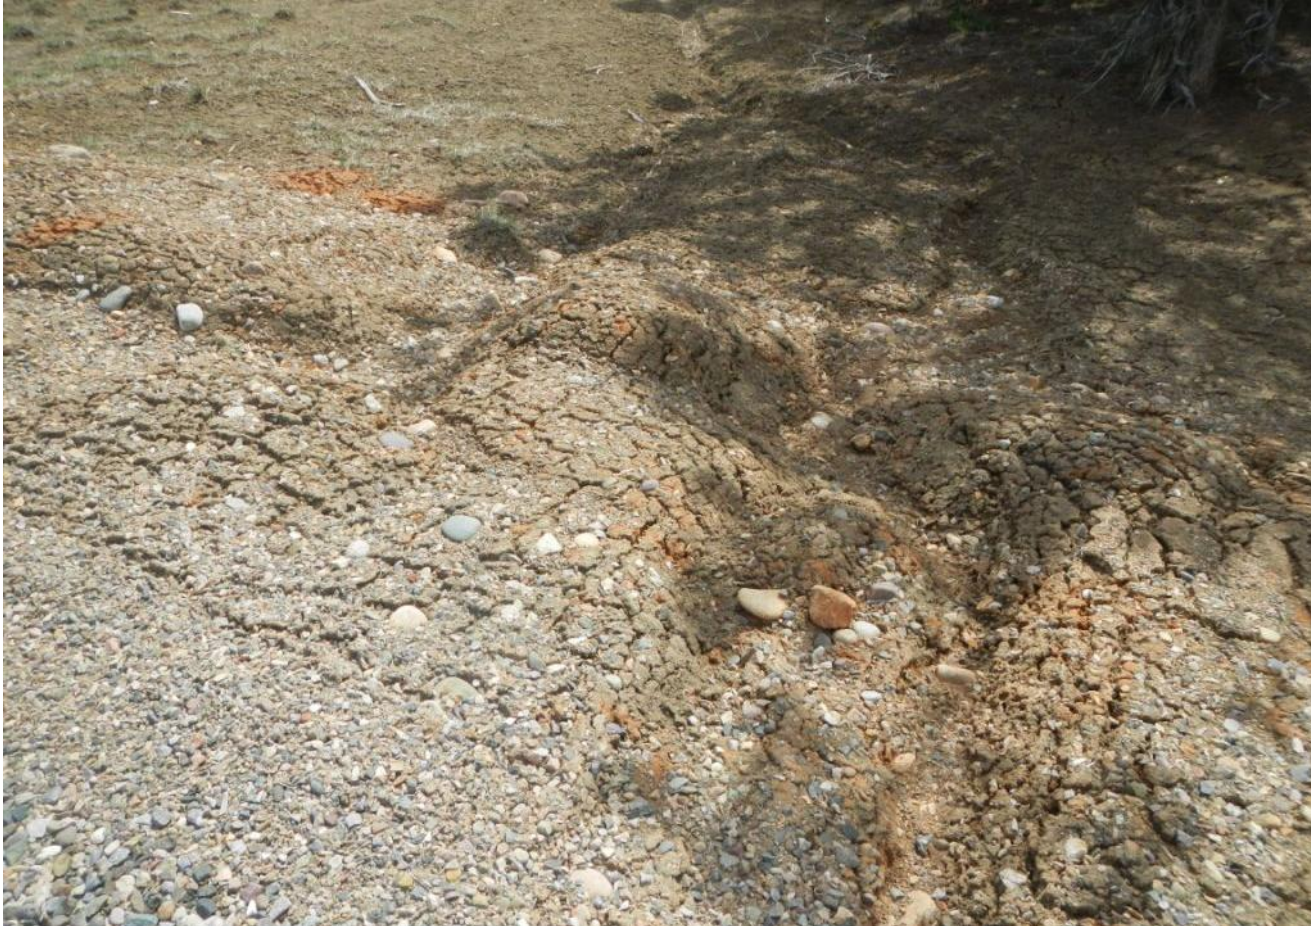
Photo 6. View of erosional channels forming along the southwestern edge of the well pad.

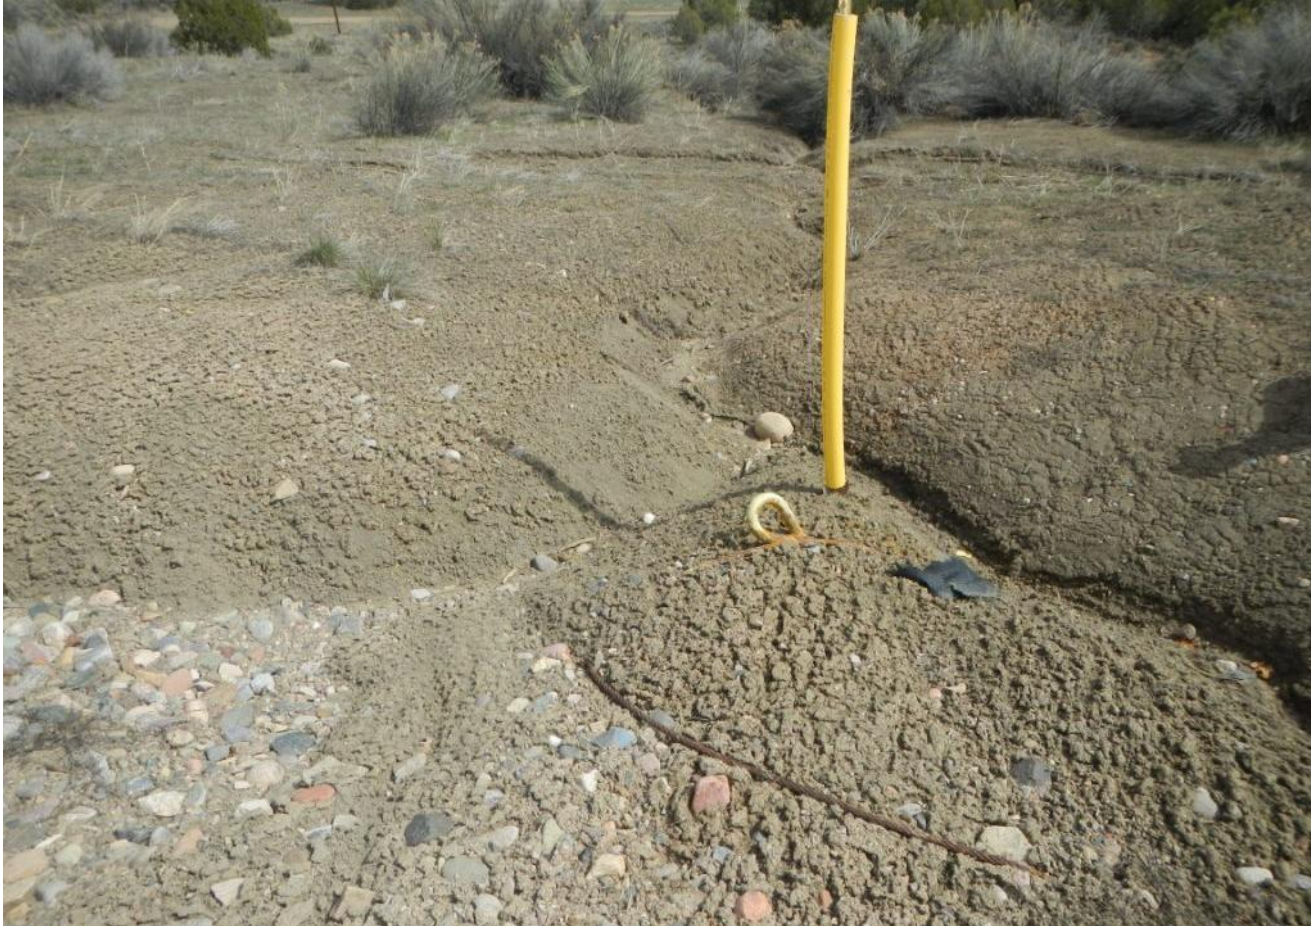
Photo 7. View of erosional channels forming along the eastern edge of the well pad. Rig cable and debris can also be seen adjacent to guy line anchor.
