Federal 4-35

Inspection# 673401996

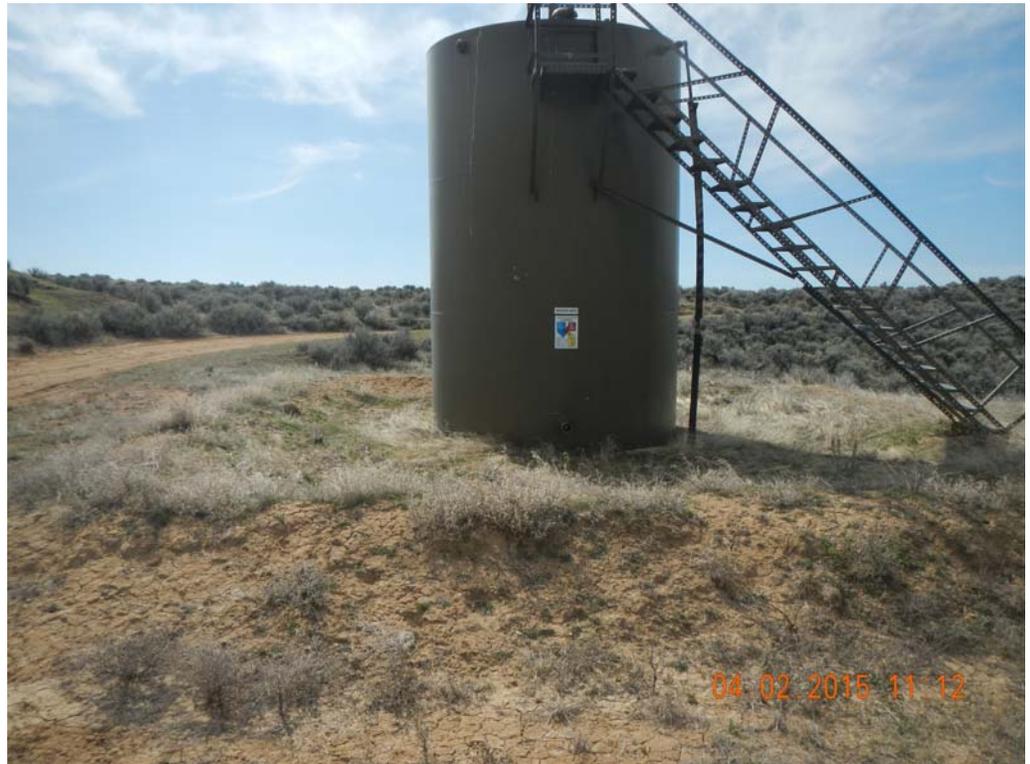
No capacity on tank label.
Overgrown berm.

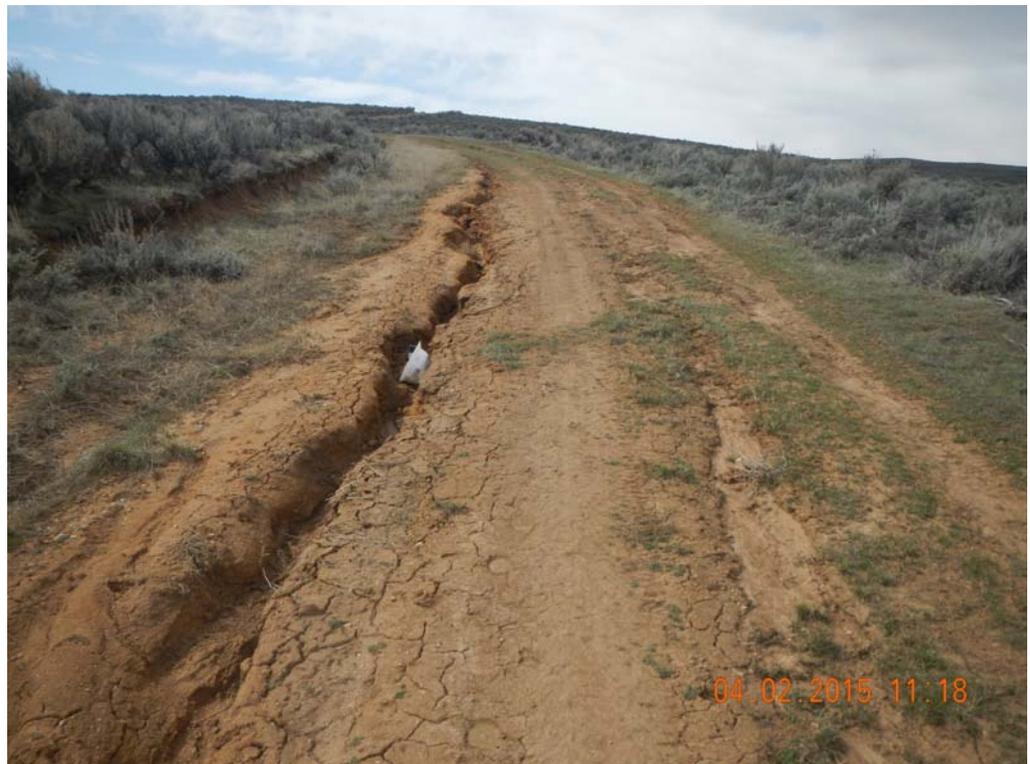
Rills transporting sediment
down access road.

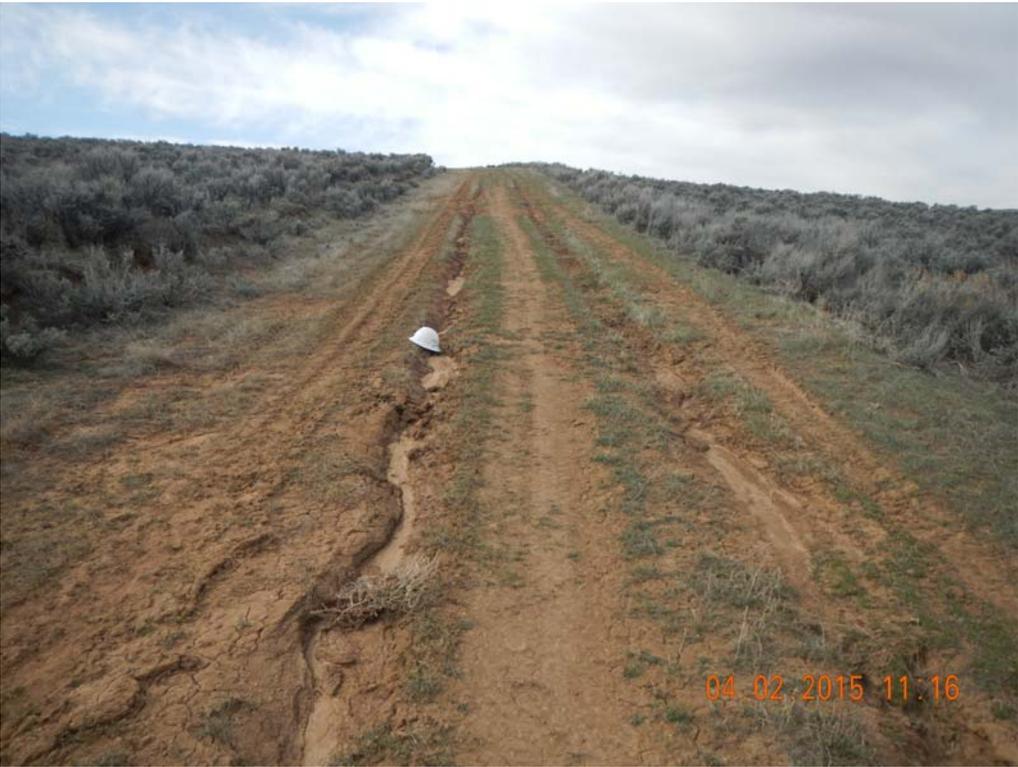
Rills transporting sediment down access road.

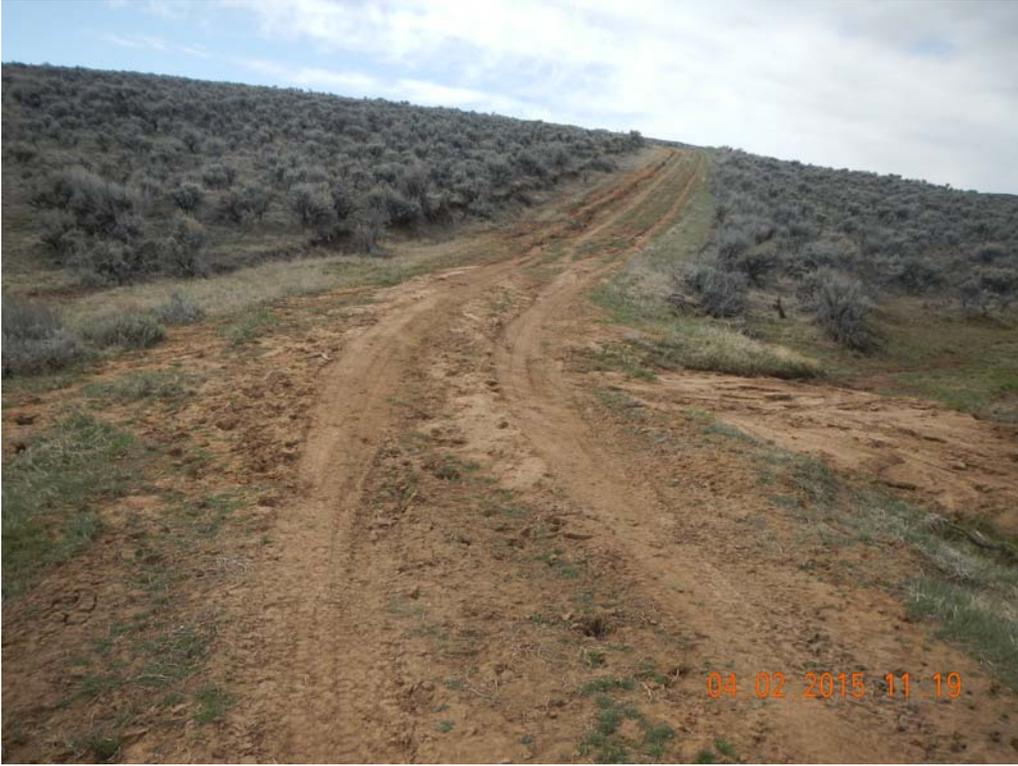
Sediment entering drainage.

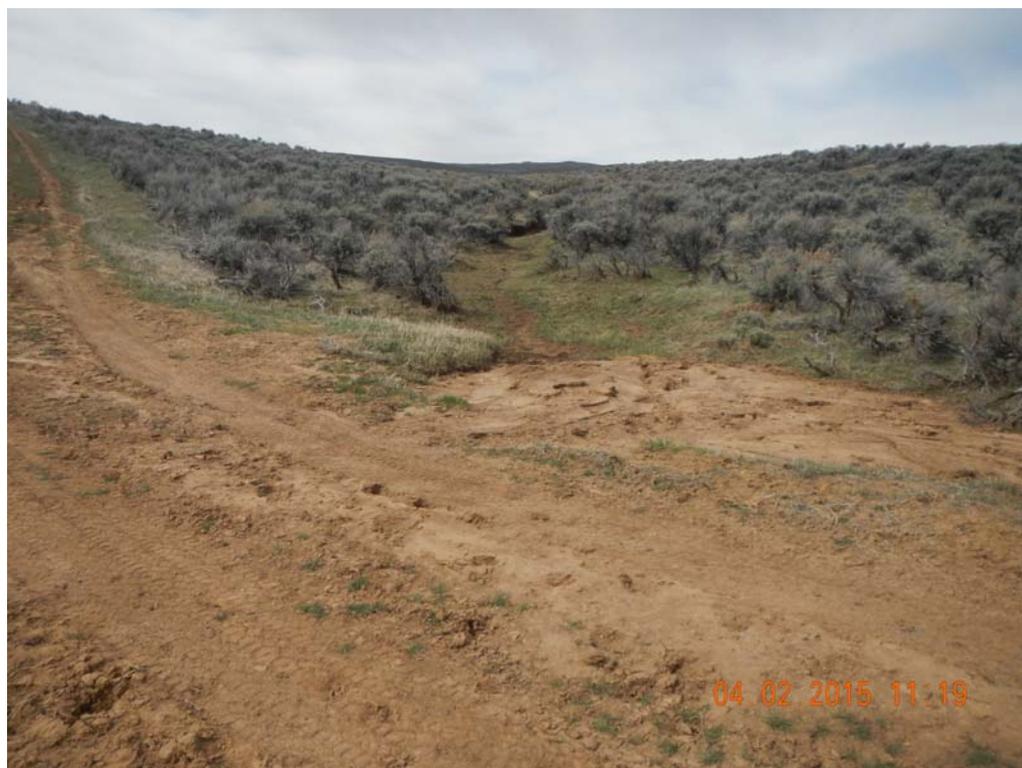
Sediment entering drainage.

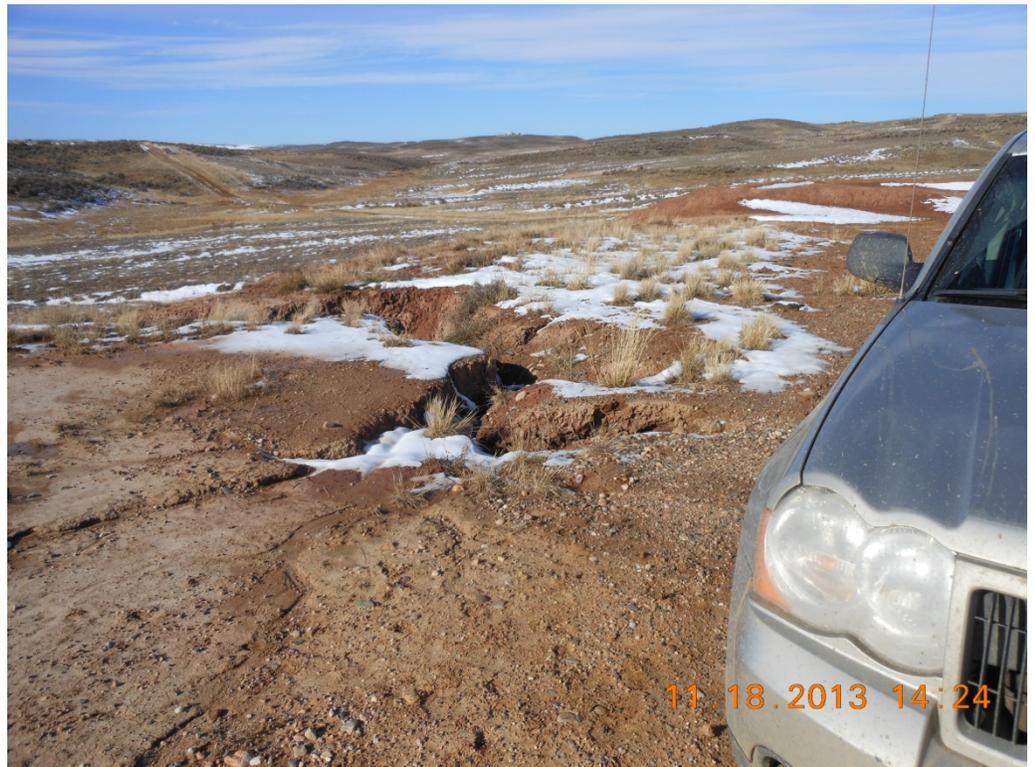
Rill leaving location.

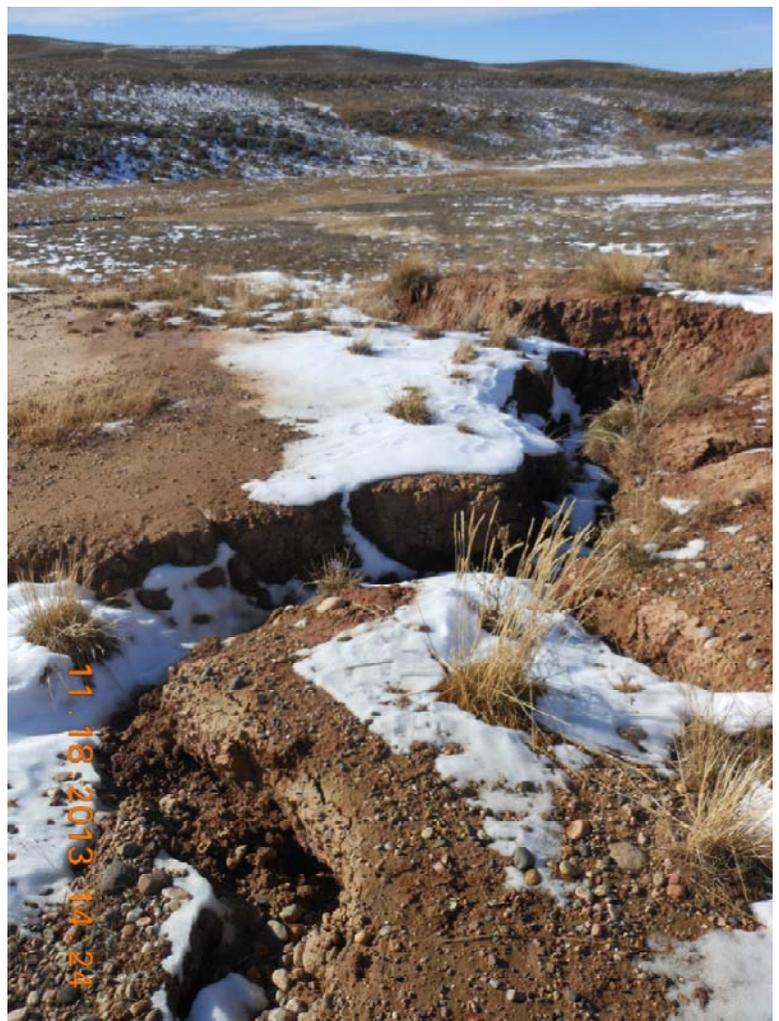
Rill leaving location.

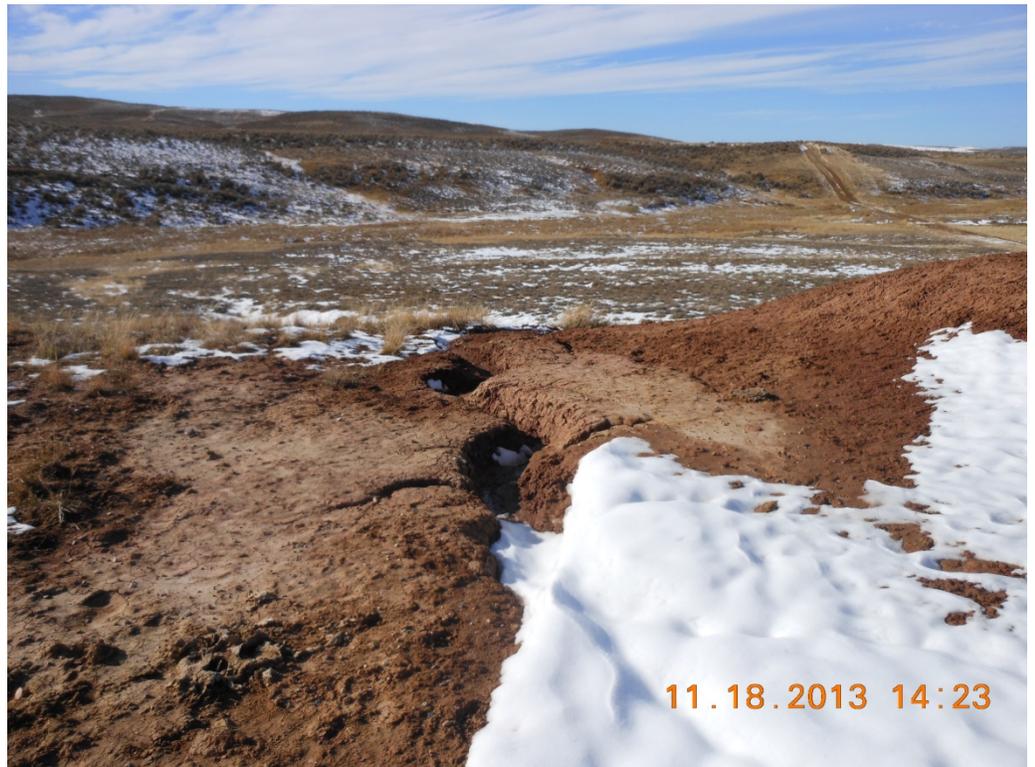
Rill leaving location.

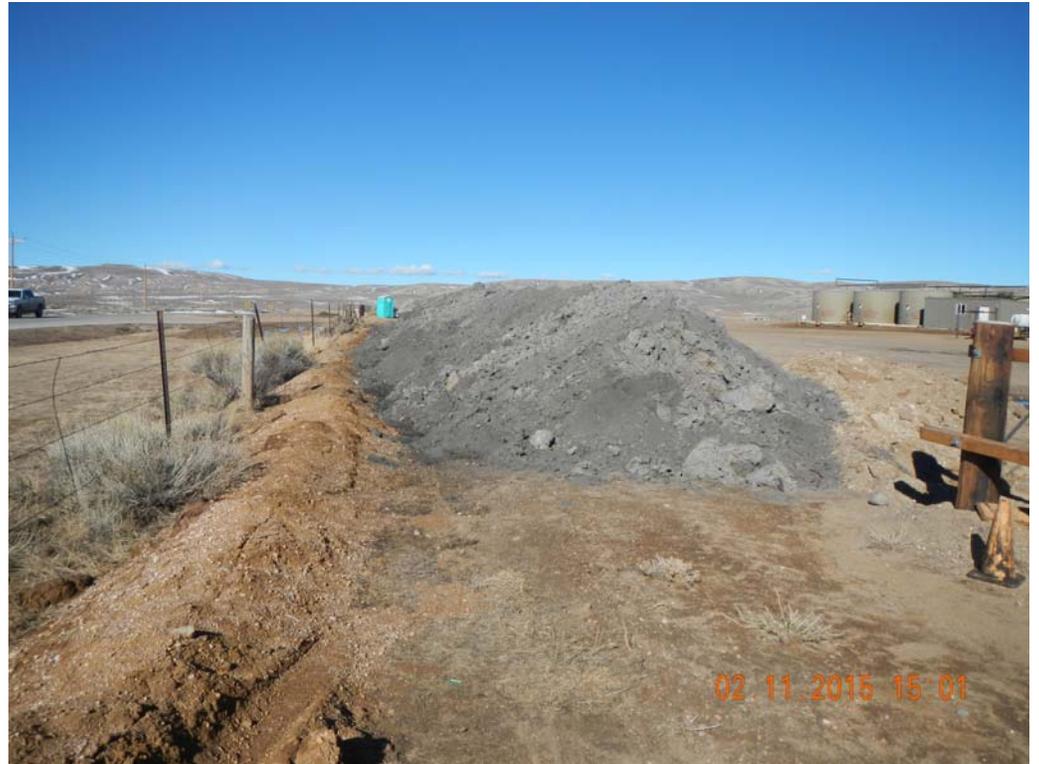
Cuttings with no berm.

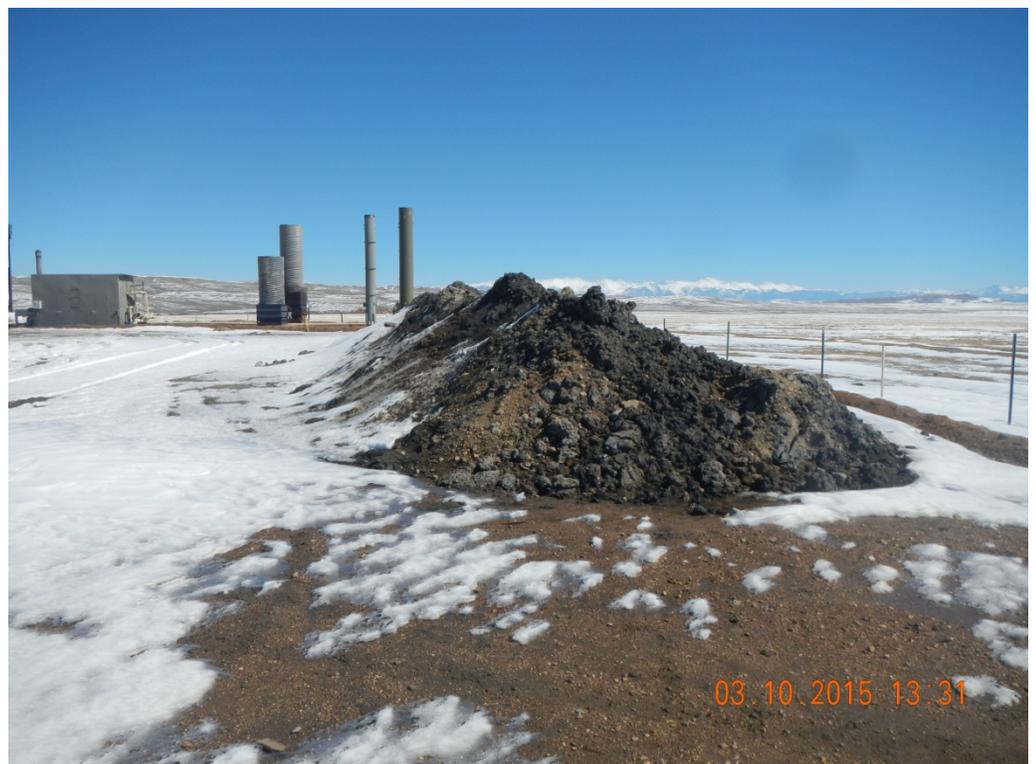
Cuttings with no berm.

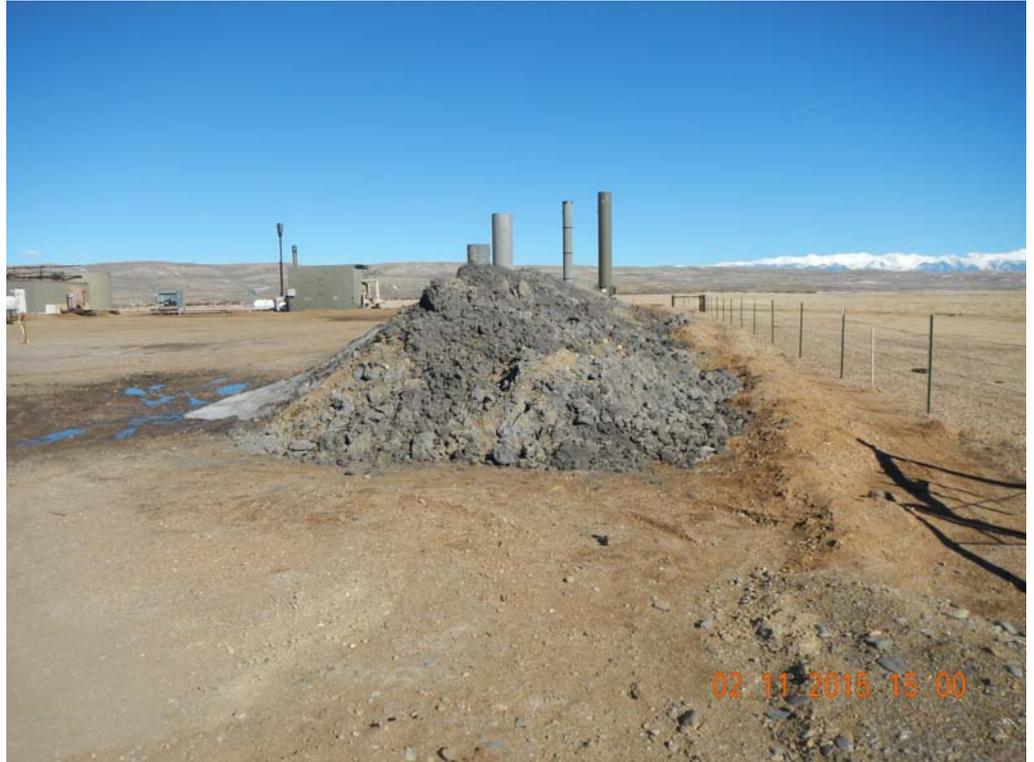
Cuttings with no berm.

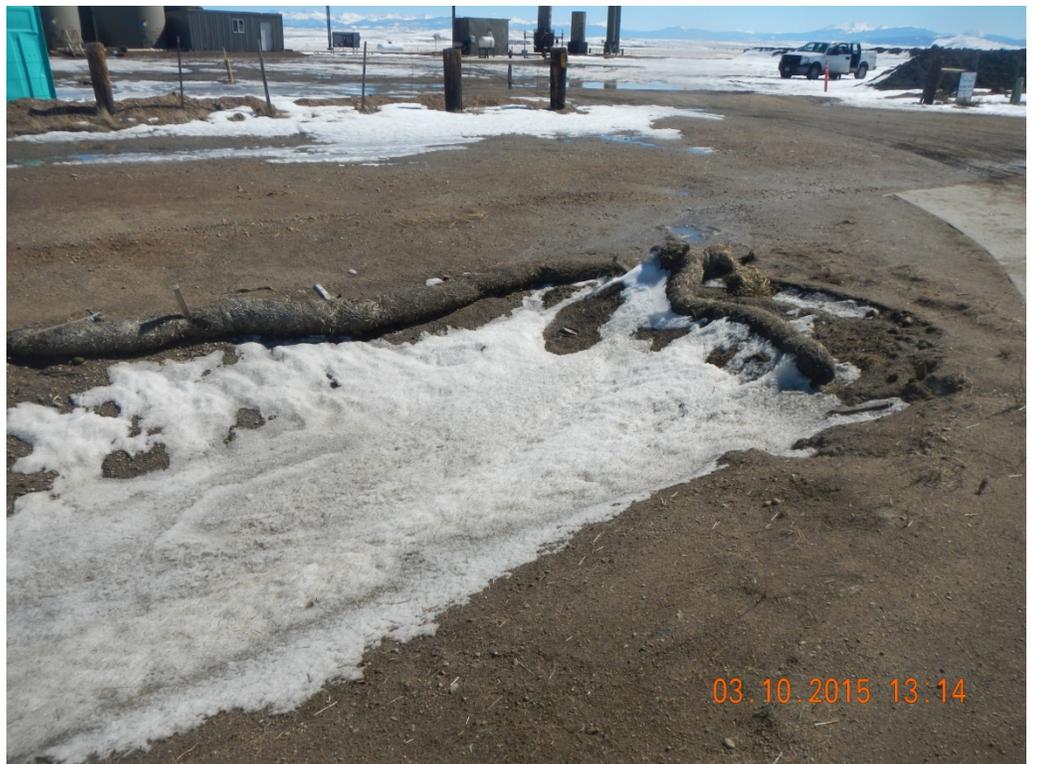
Waddles blocking culvert
at entrance.

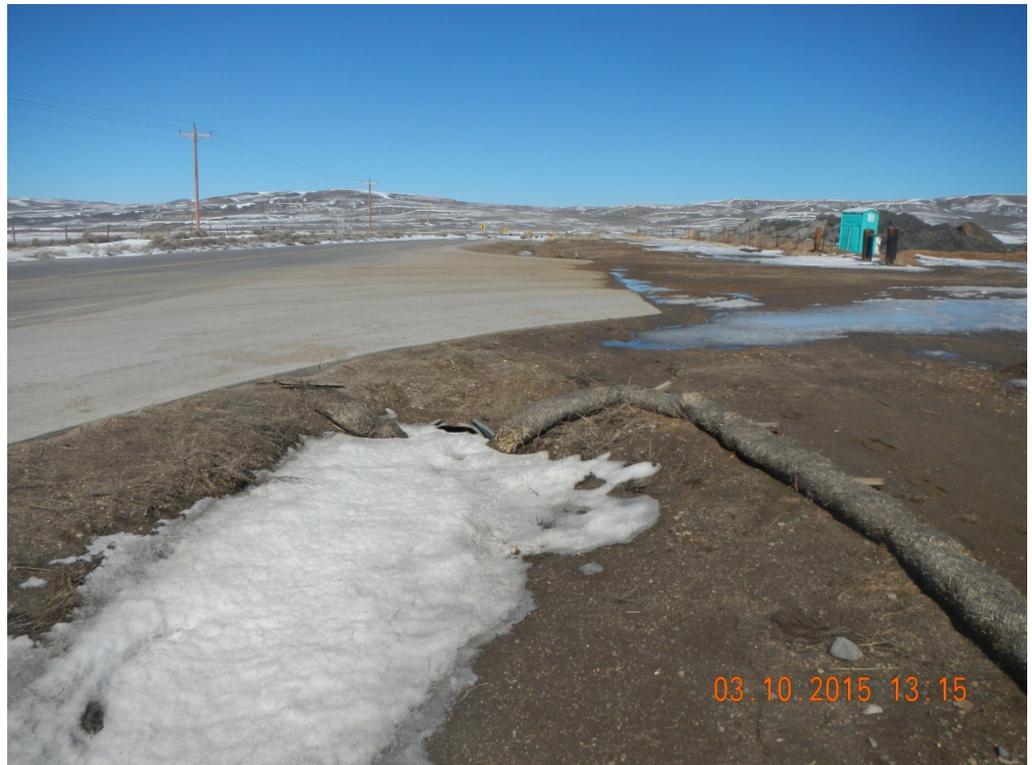
Waddles blocking culvert at entrance.

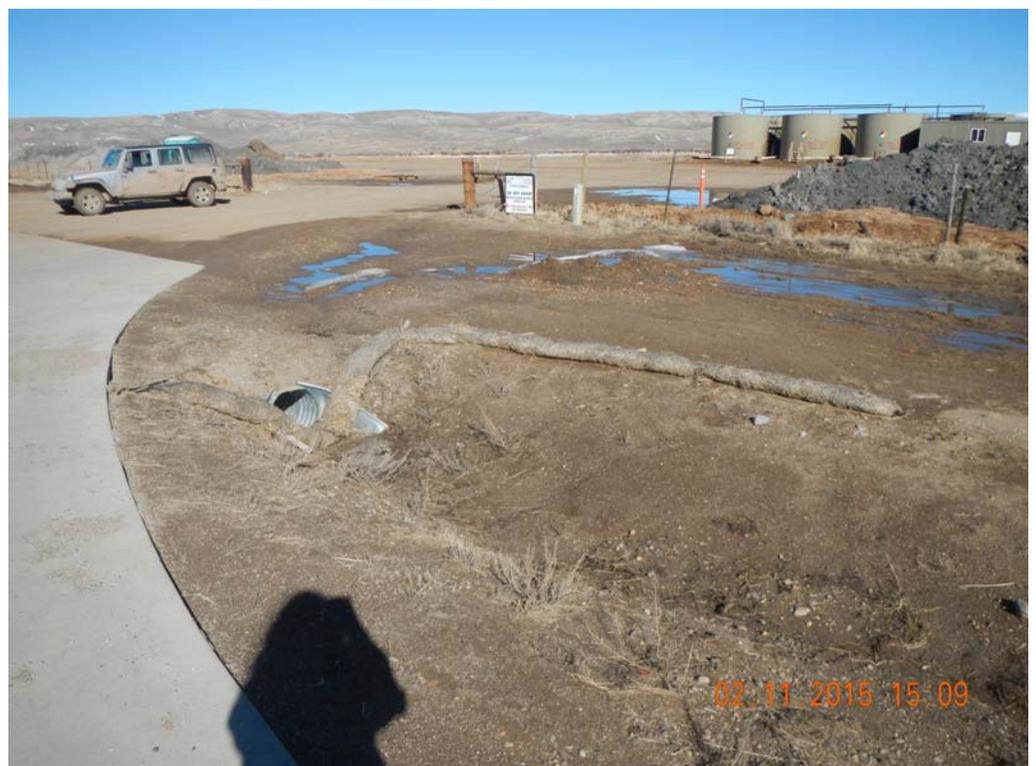
Waddles falling into culvert at entrance.

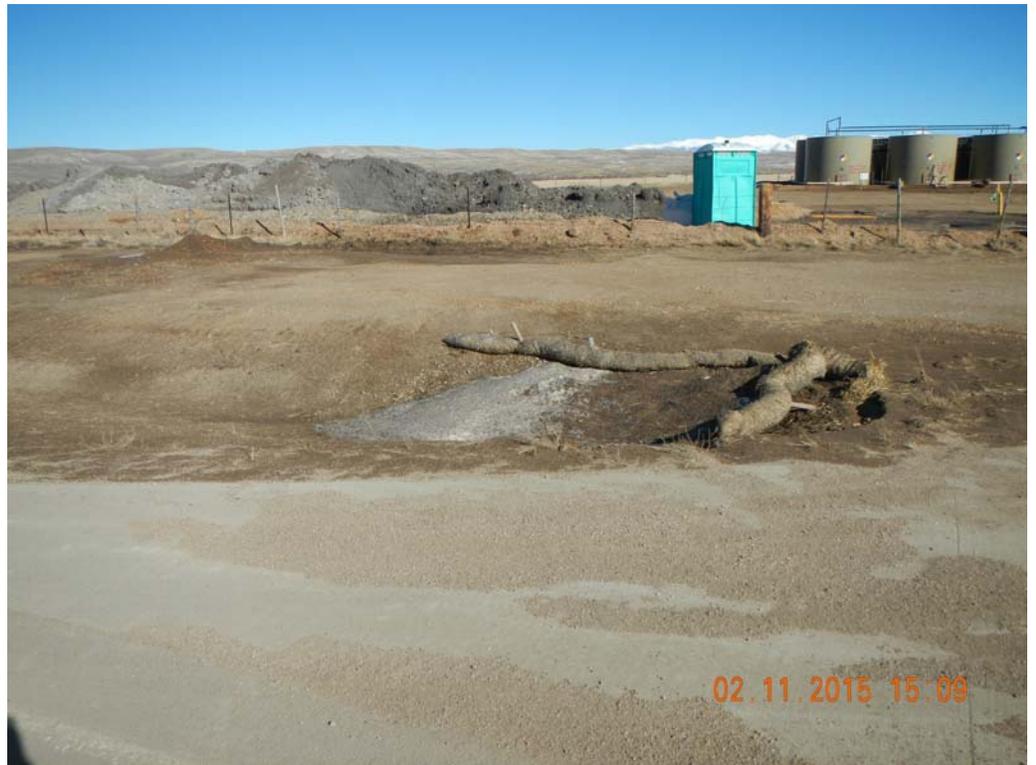
Waddles falling into culvert
at entrance.

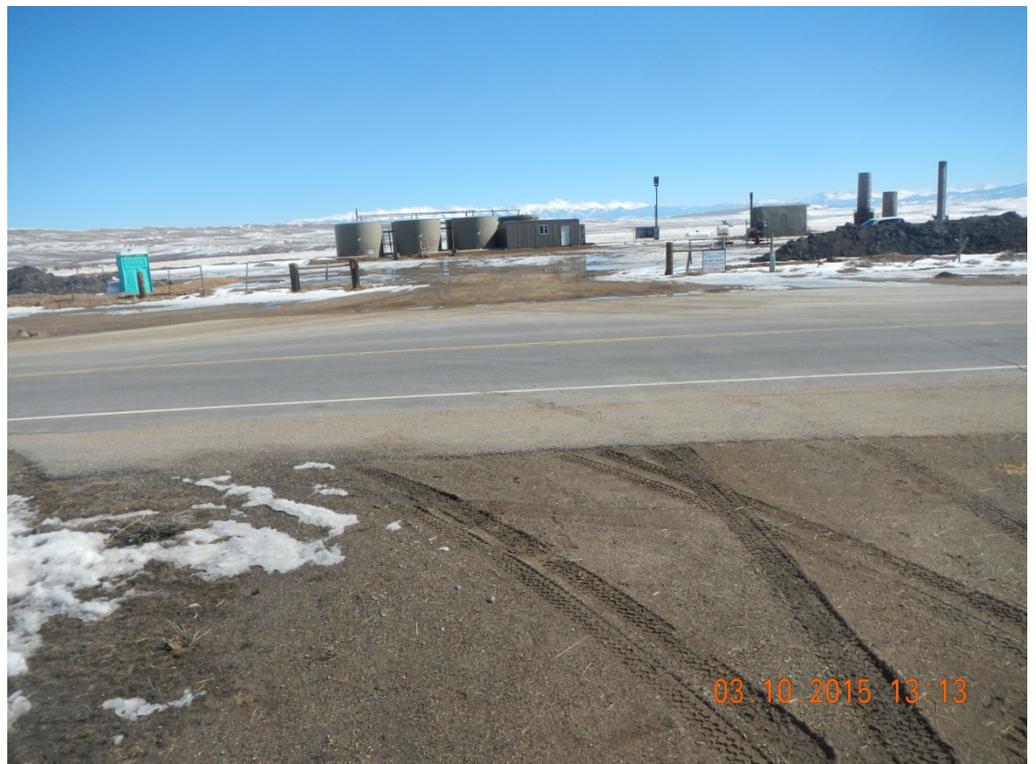
Vehicle tracking off of
location.
