photo 1: Well sign, Apache Canyon 16-13

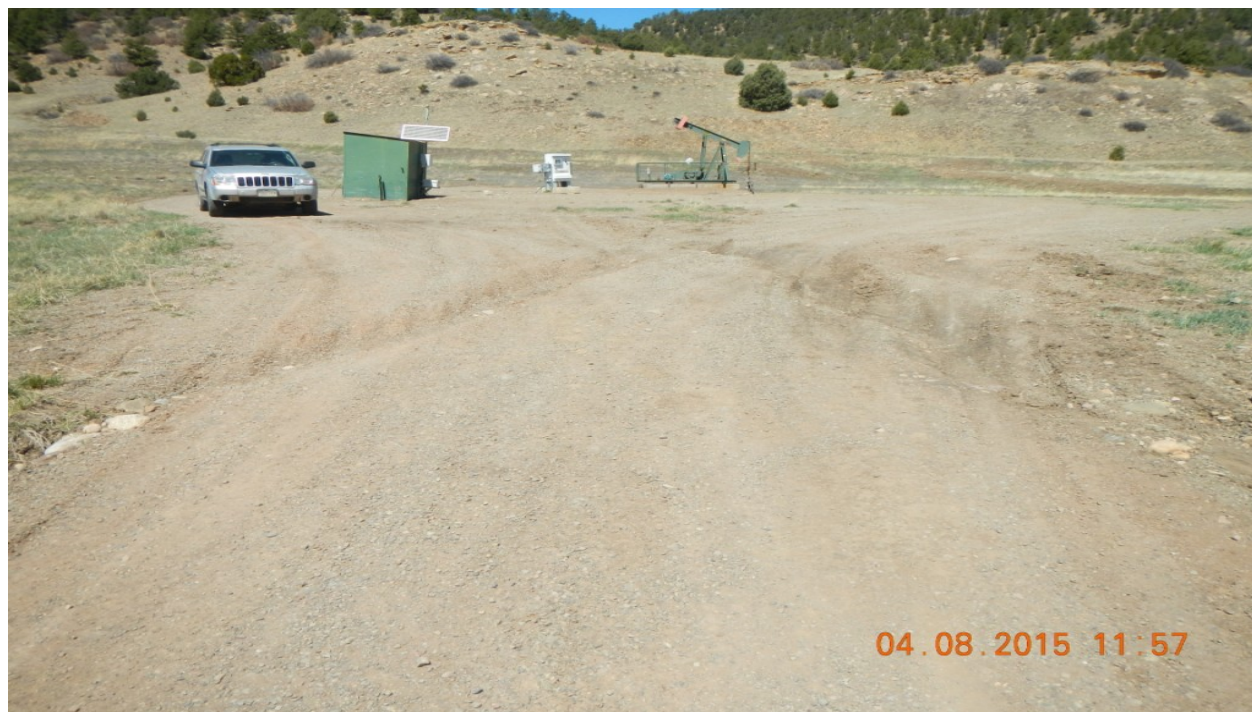
photo 2: Facing west towards the location.

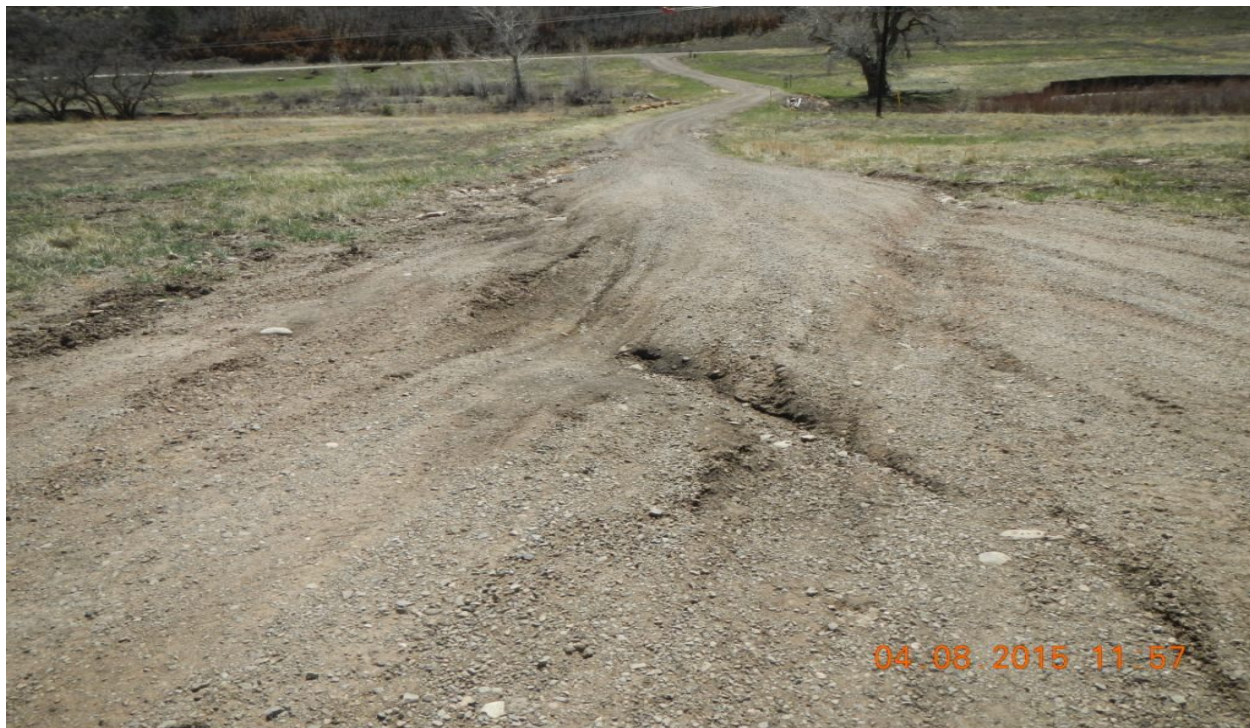
photo 3: Facing southeast towards the access road. Erosion channels developed across the access road.

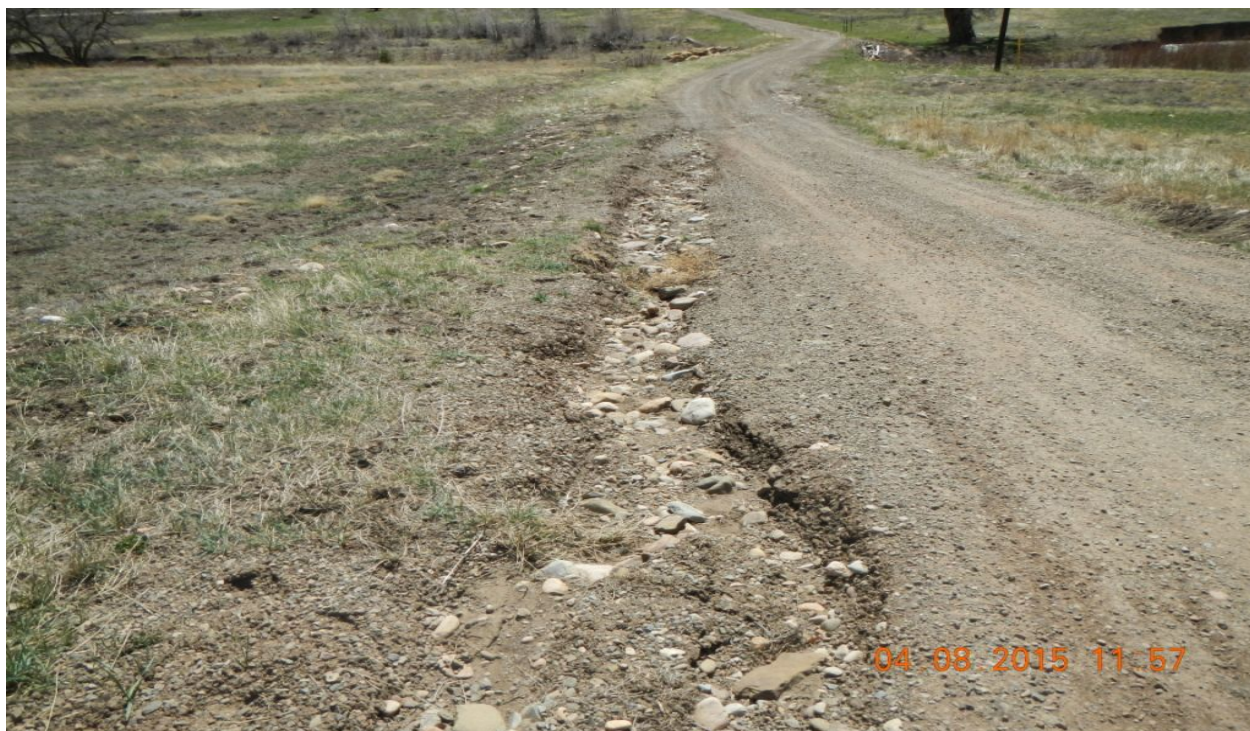
photo 4: Erosion channel along the access road.

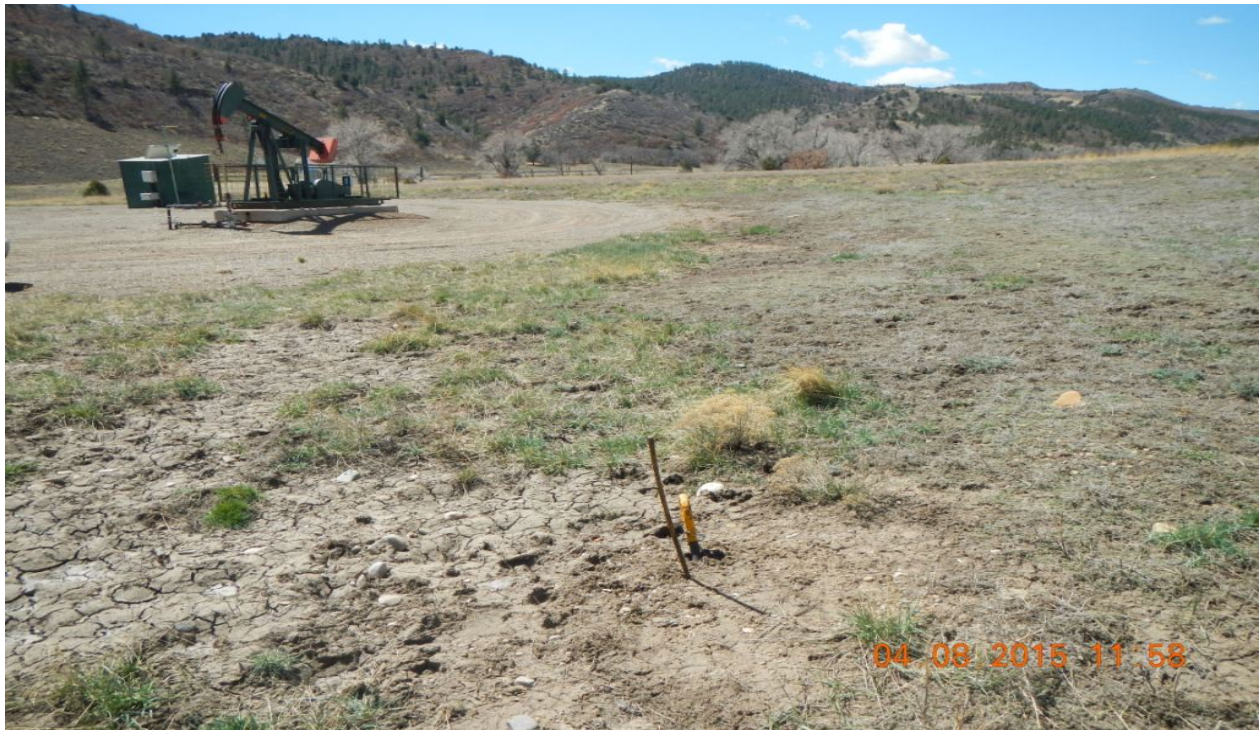
photo 5: Facing south towards the location

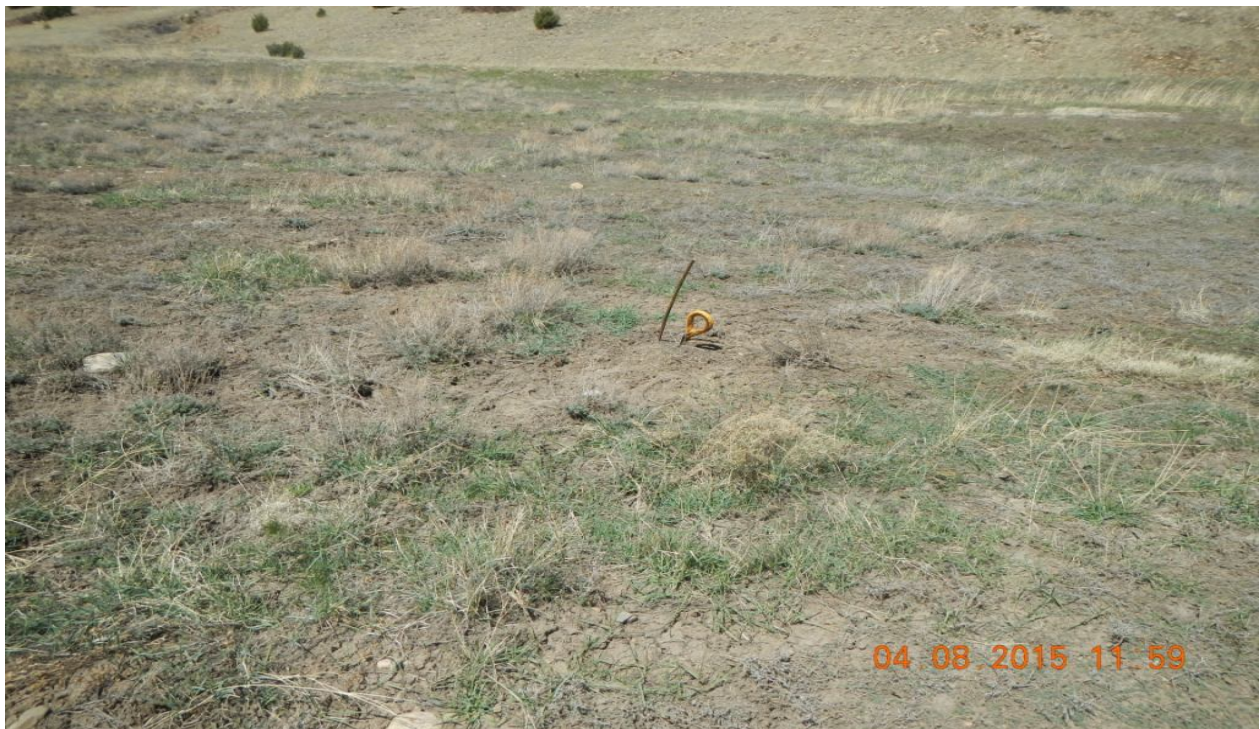
photo 6: Guy line anchor is not properly marked.
