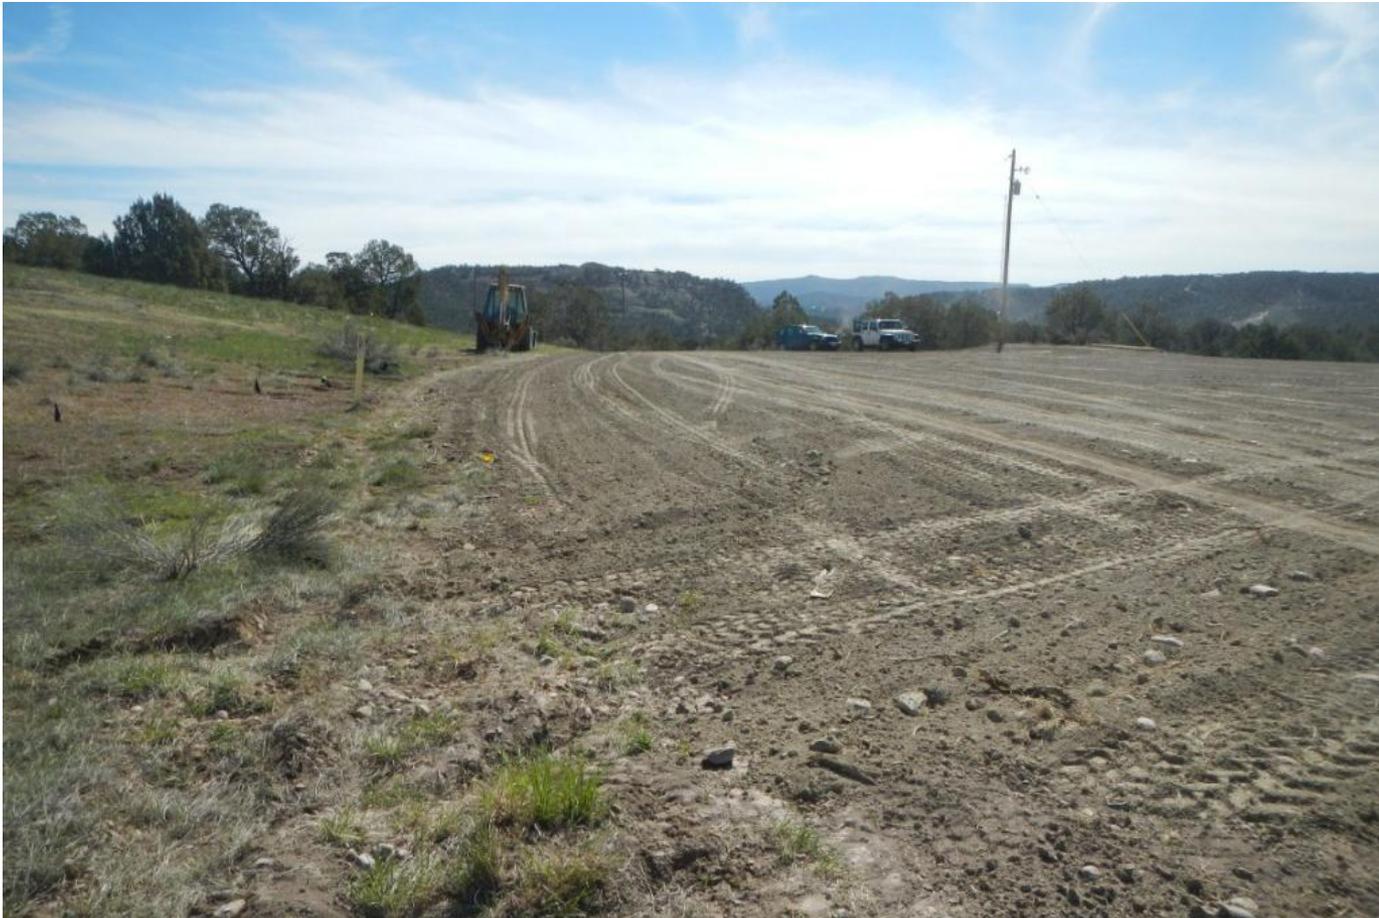
Photo 1. View of northern portion of well pad from northwestern corner facing eastward. An existing surface owner road crosses through this portion of the well pad.

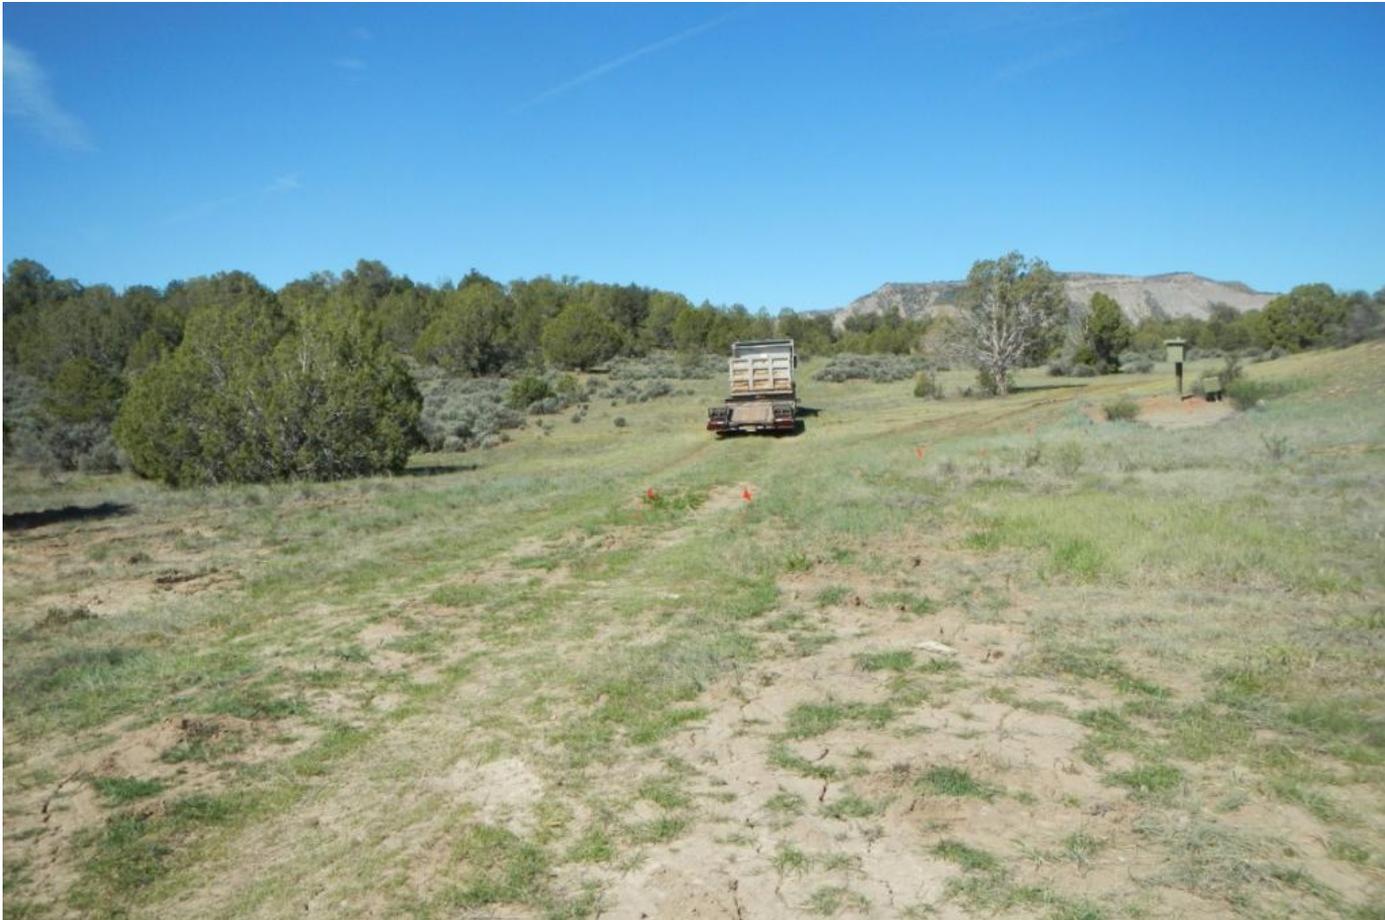
Photo 2. View of surface owner road (two-track) where it continues westward from the well pad. Truck is on the road and is a contractor for surface owner who is improving this portion of the road for access to home site.

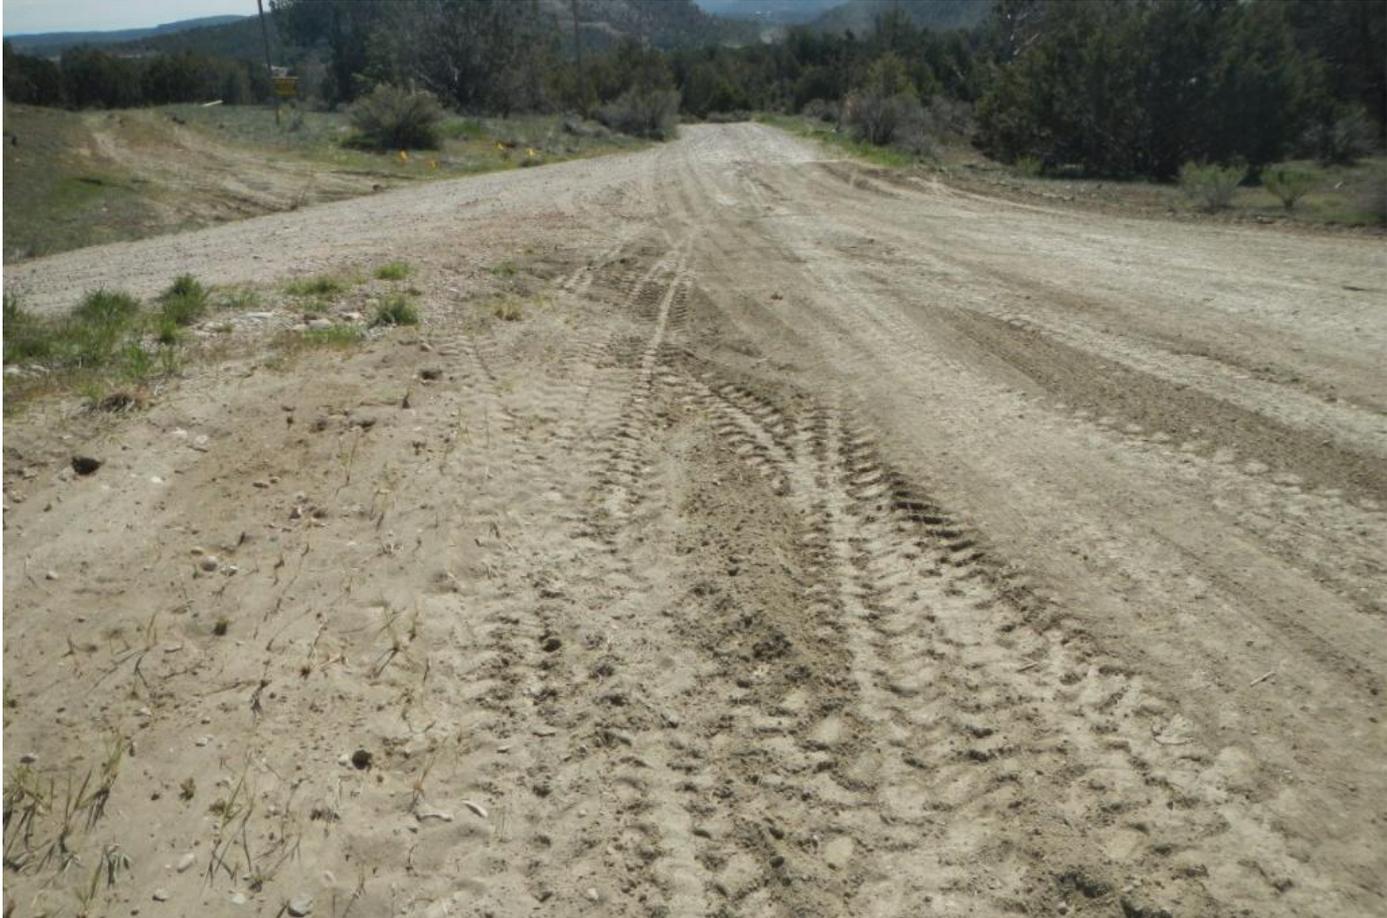
Photo 3. View of entrance to well pad area facing southeastward along road alignment.

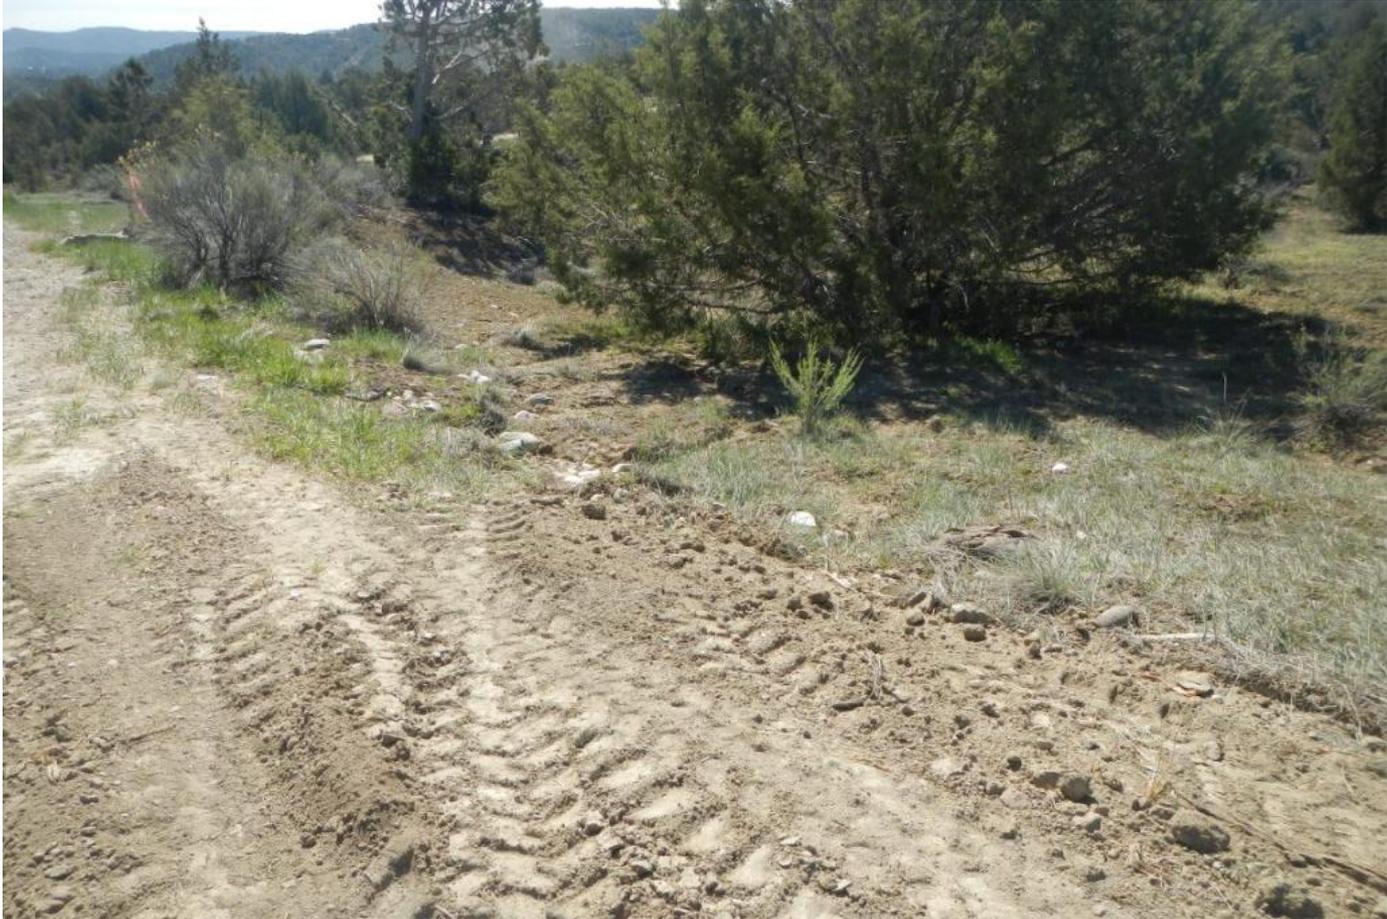
Photo 4. View of southern portion of road shown in Photo 3. This is where it appears stormwater runoff is eroding downstream of the project area.

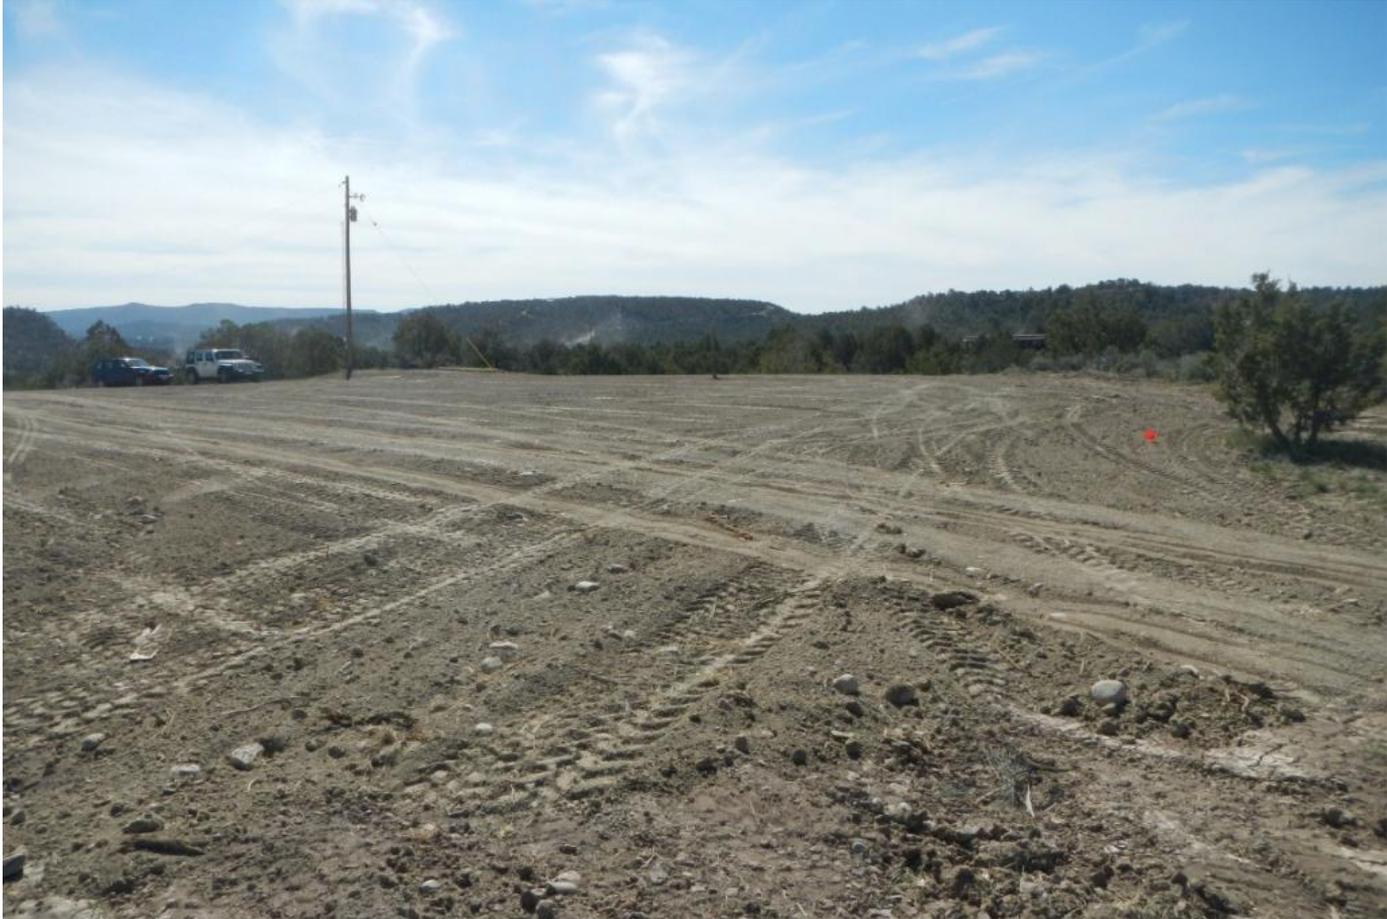
Photo 5. View of status of final reclamation from northeastern corner of well pad facing center.
