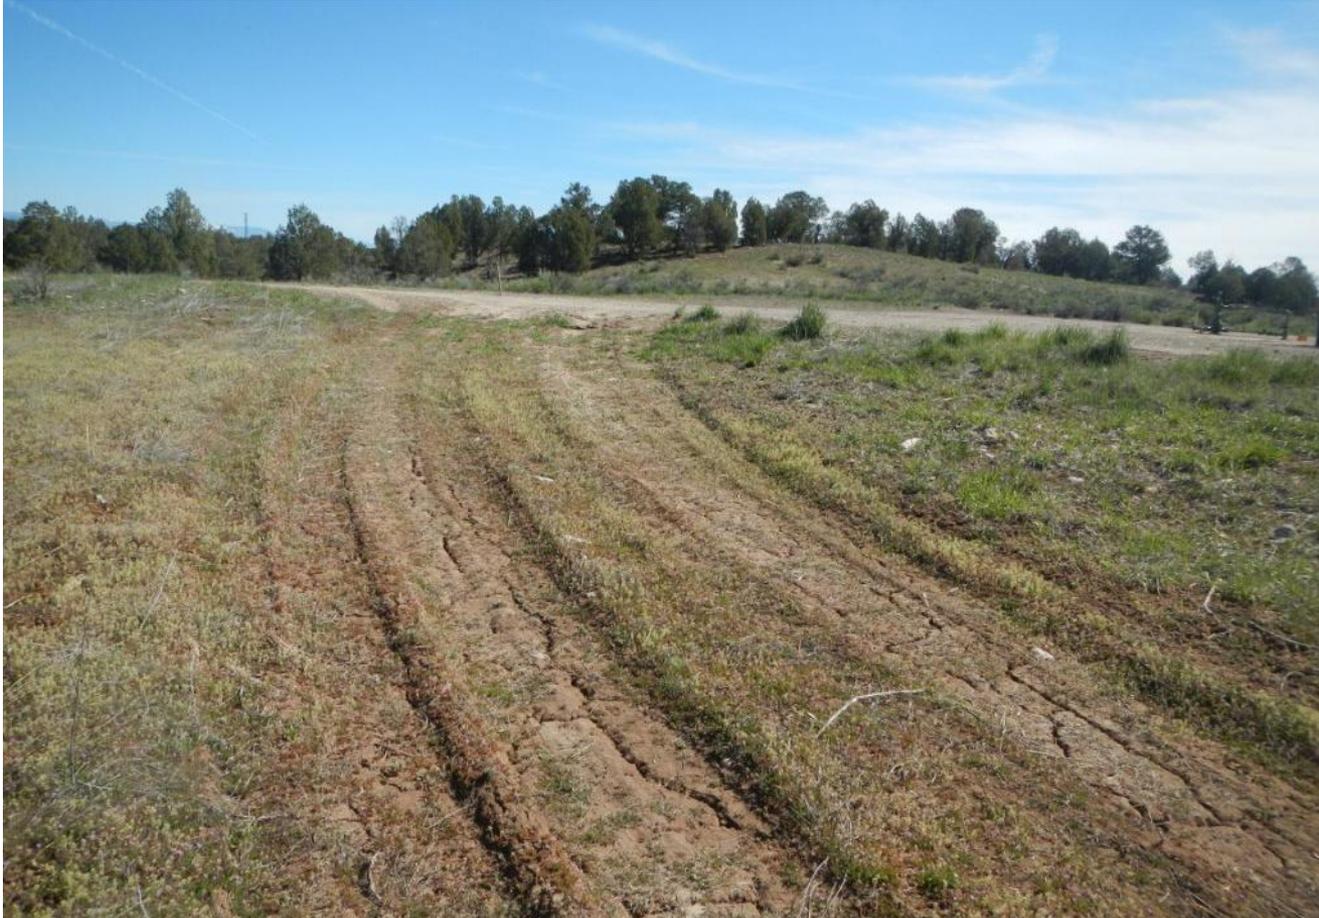
Photo 1. View of two-track road exiting western edge of working area facing northeastward. This road needs to be reclaimed.

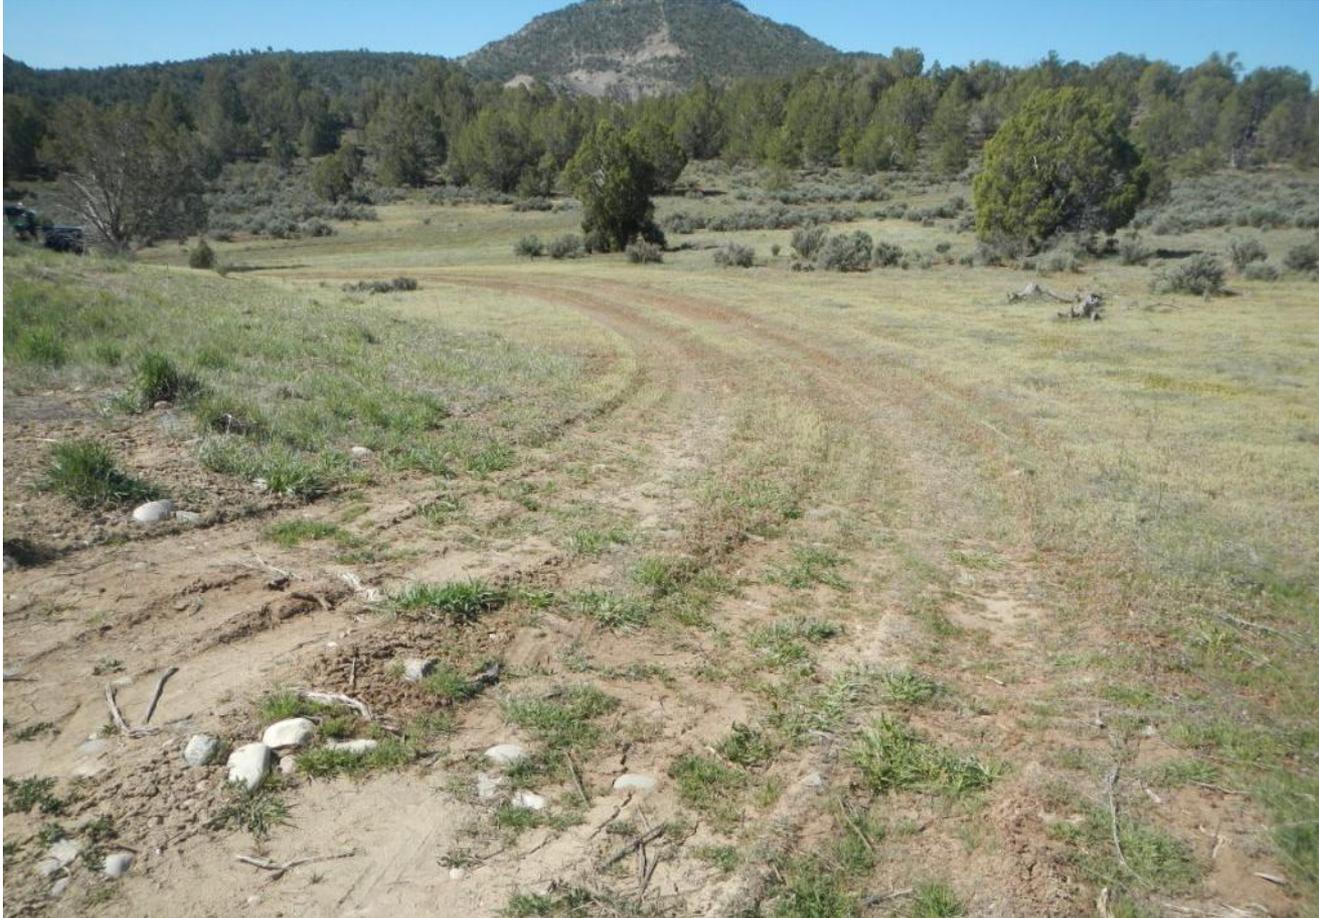
Photo 2. View of two-track road exiting western edge of working area facing southwestward. This road needs to be reclaimed.

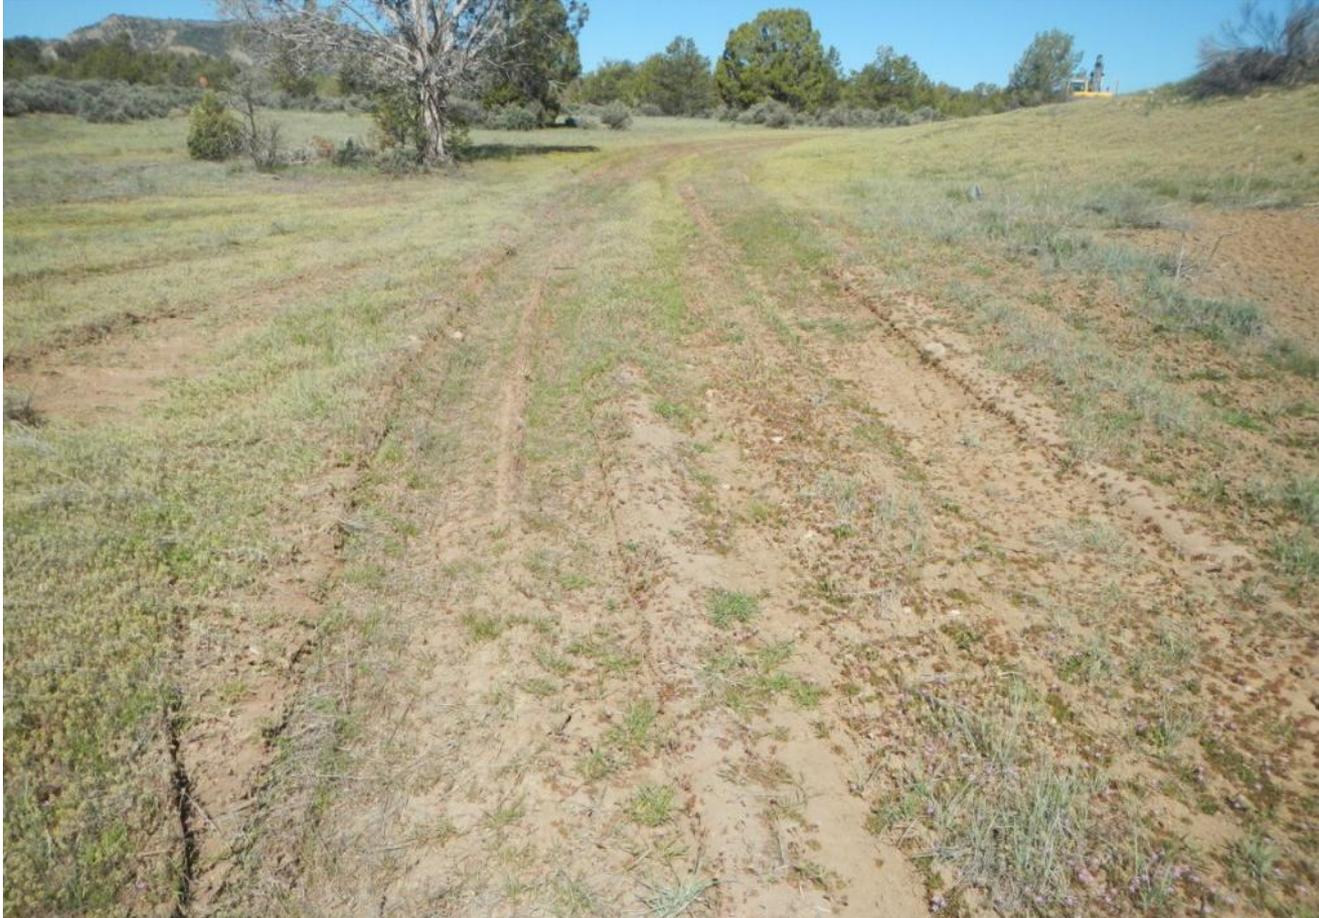
Photo 3. View of two-track road from southern portion facing northward.

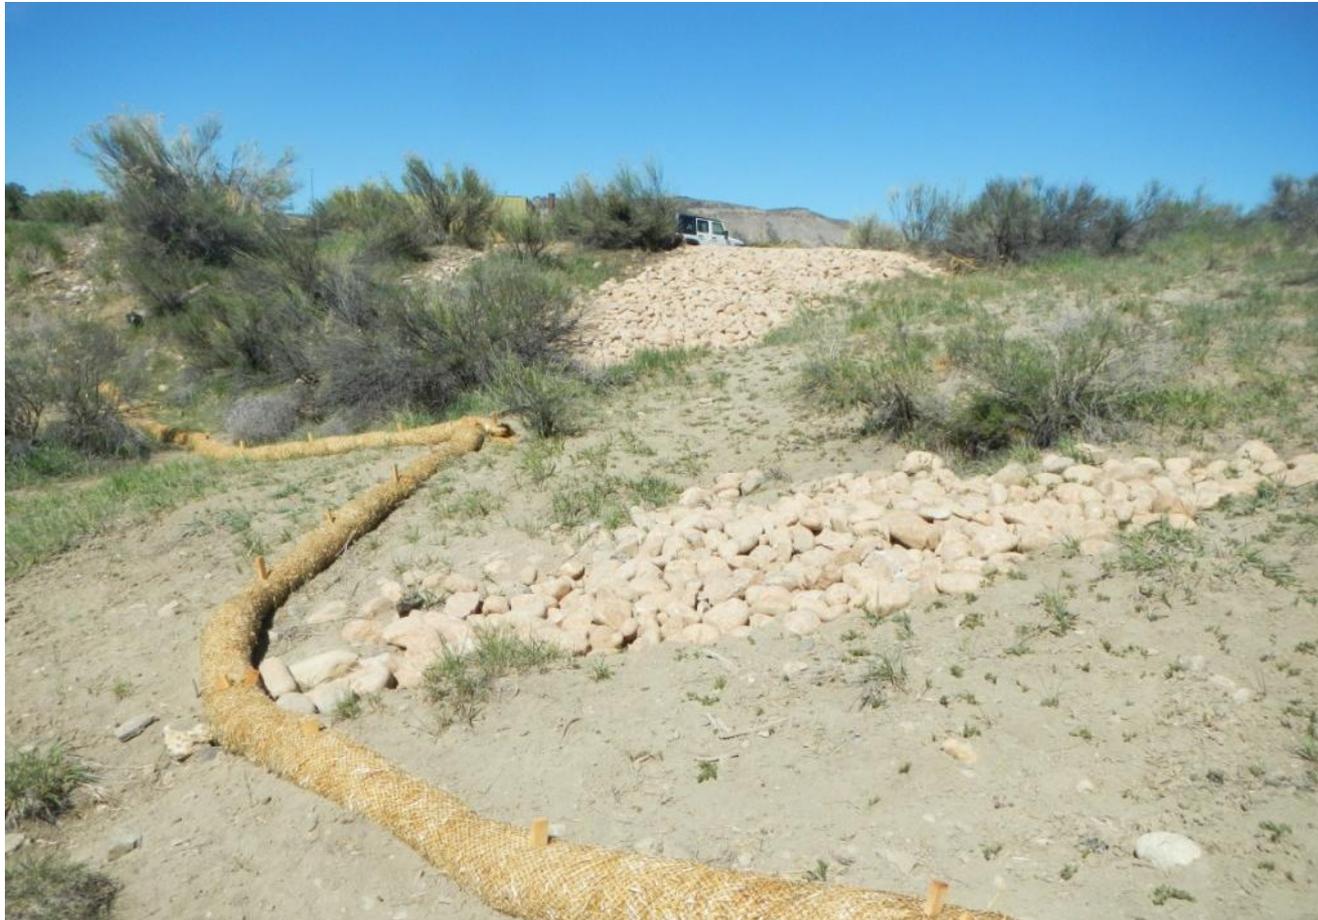
Photo 4. View of new stormwater BMPs installed within the eastern portion of the project area facing northwestward toward the well pad.

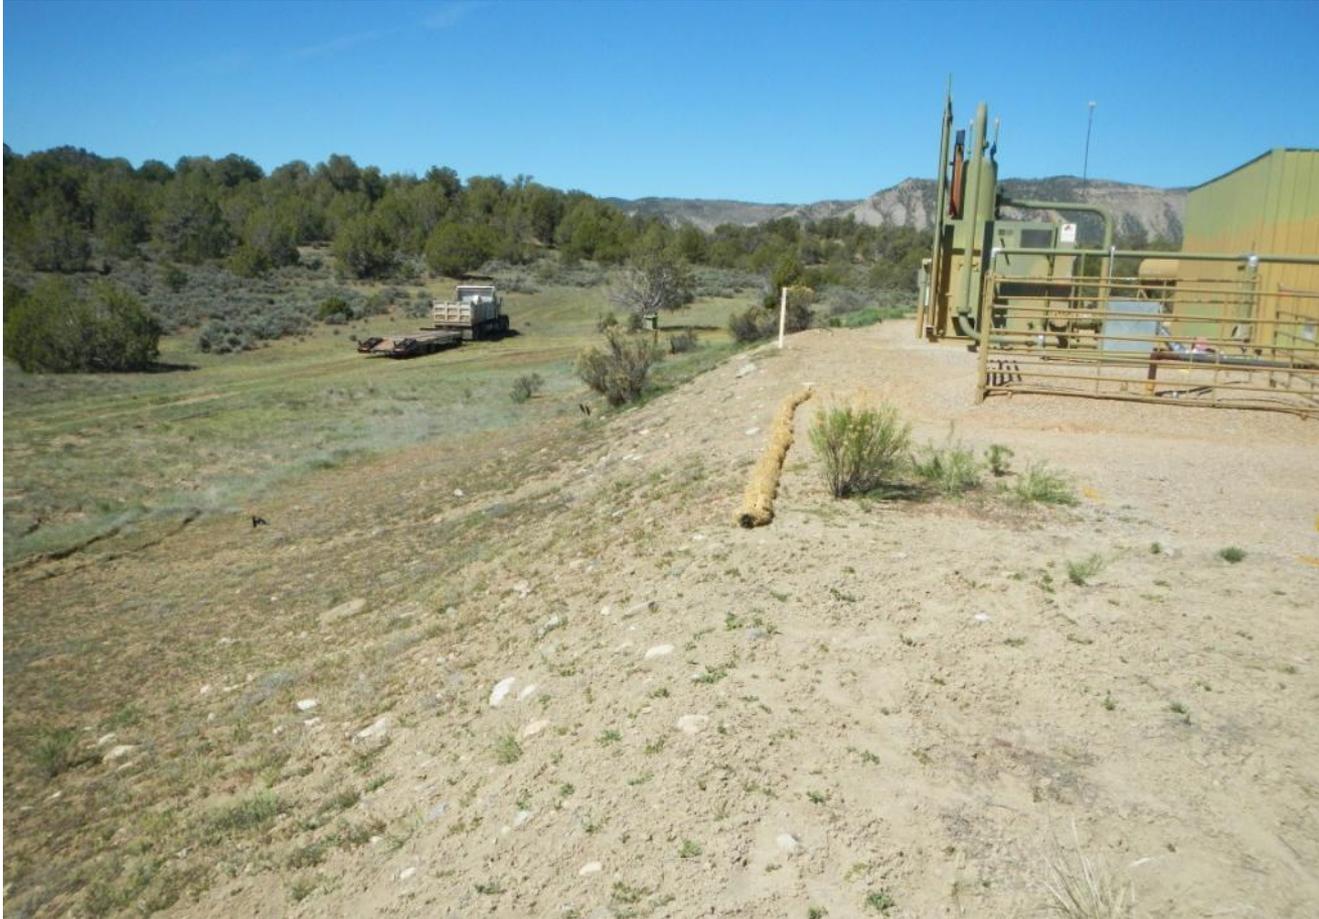
Photo 5. View of new straw wattle installation on southern edge of working area.

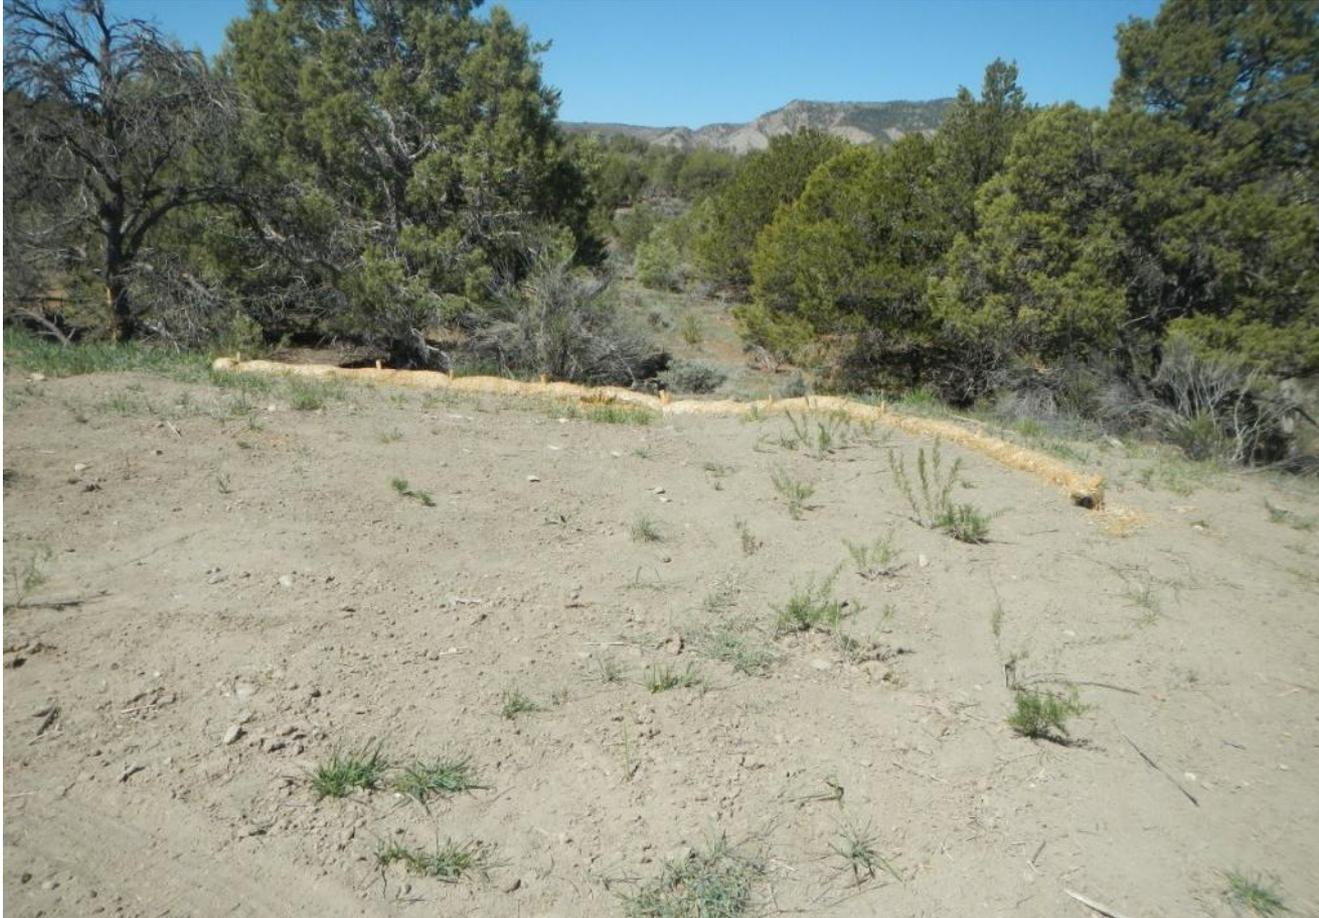
Photo 6. View of new straw wattle installation within northwestern corner of project area.
