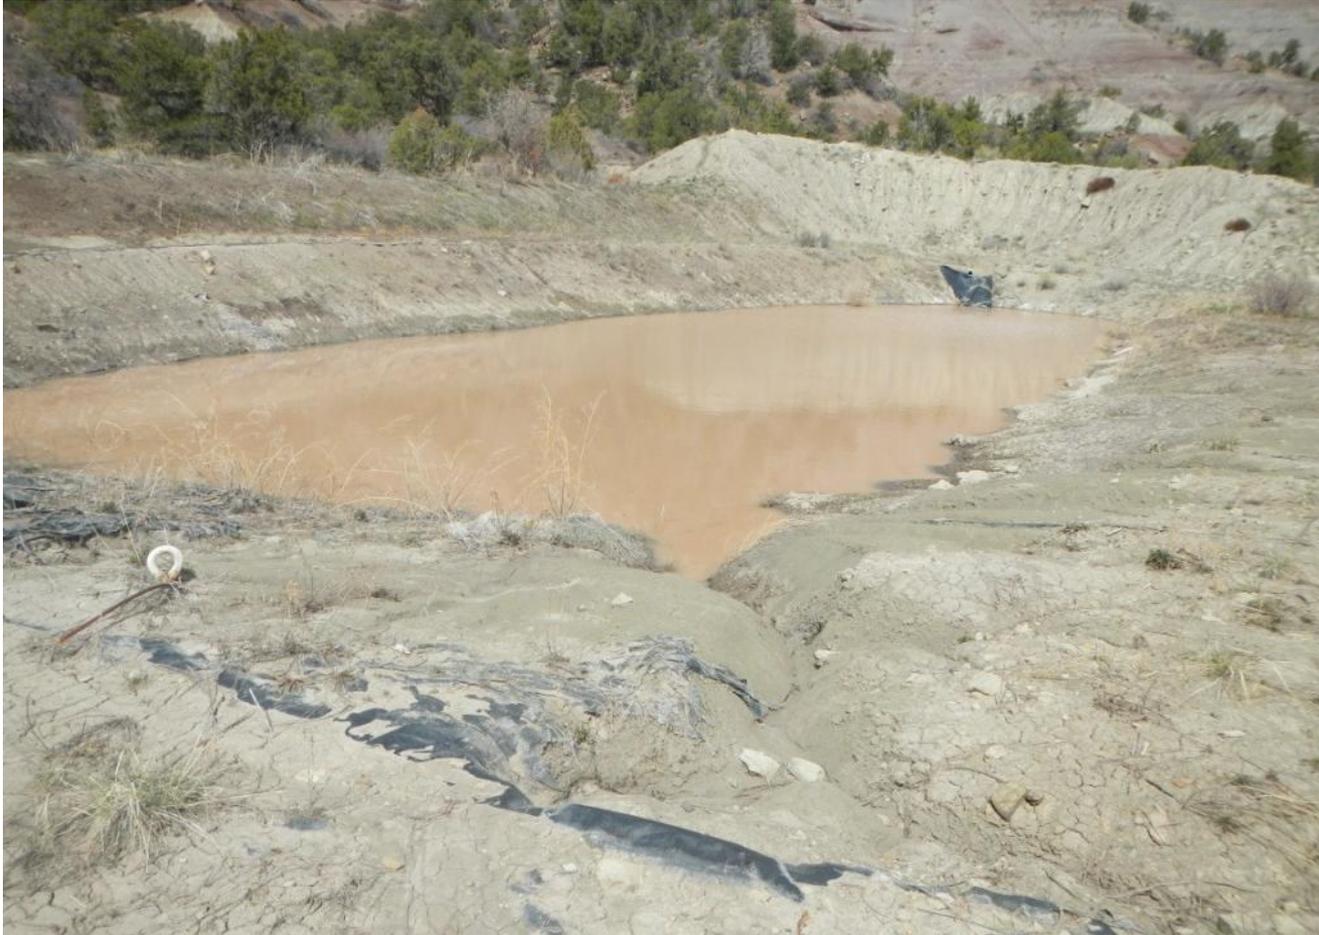
Photo 1. View of existing pit, pit liner, rig anchor, and sediment deposition on the well pad, facing northwestward.

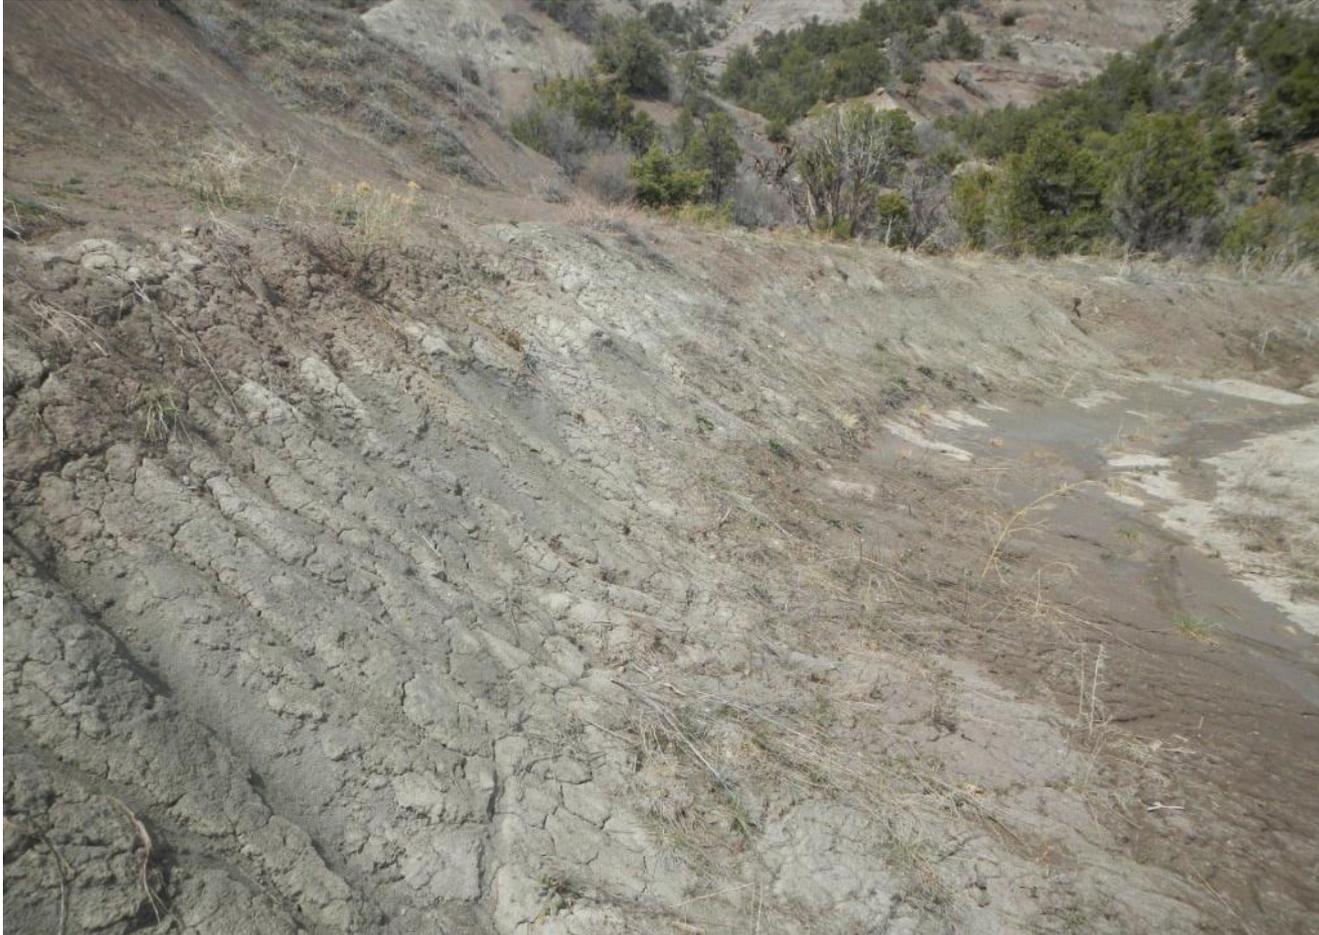
Photo 2. View of erosion along cut-slopes on western edge of project area.

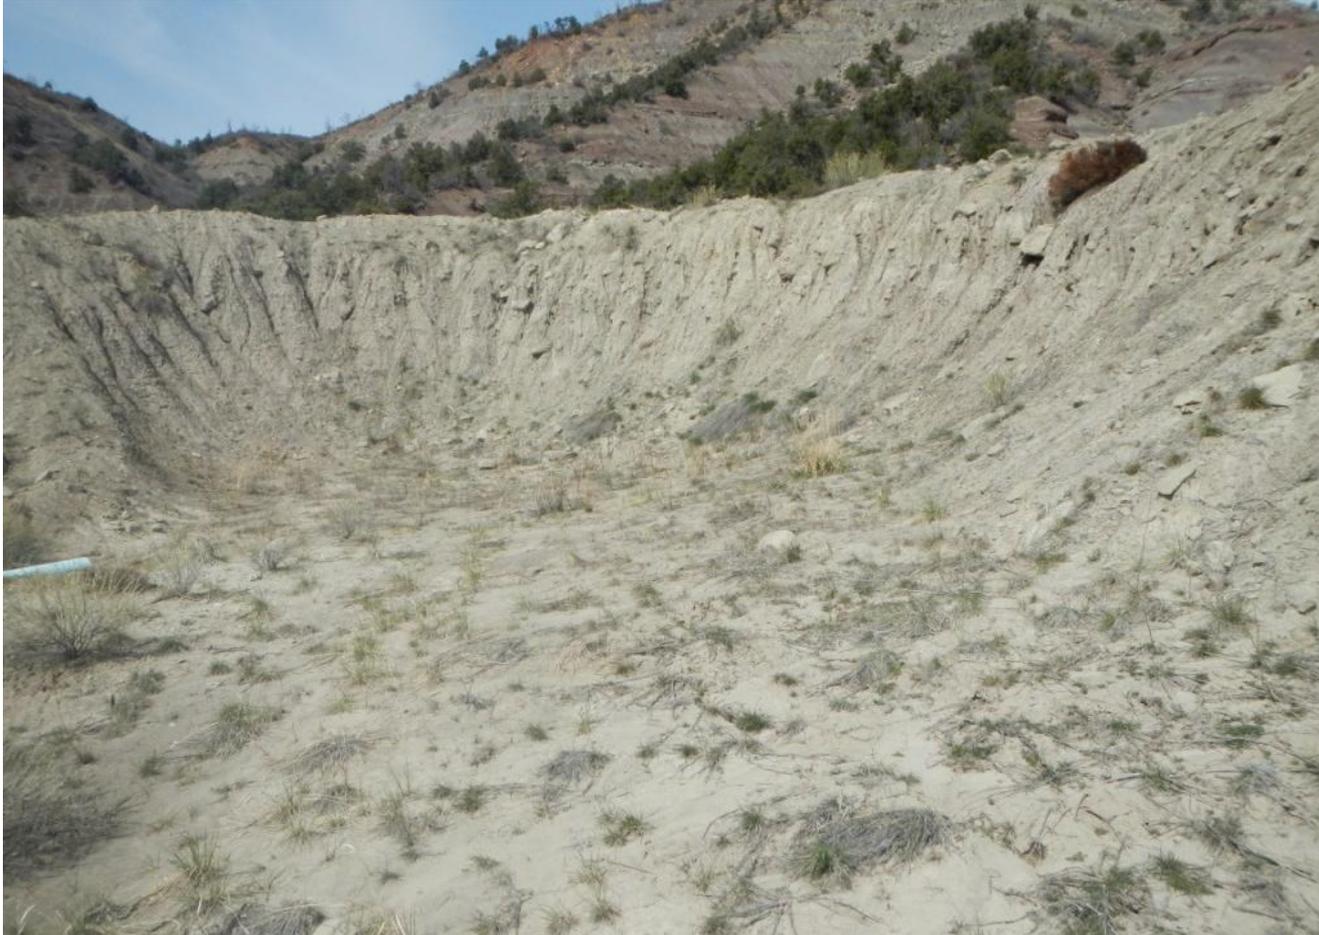
Photo 3. View of erosion of stockpiled soil in northwestern corner of project area.

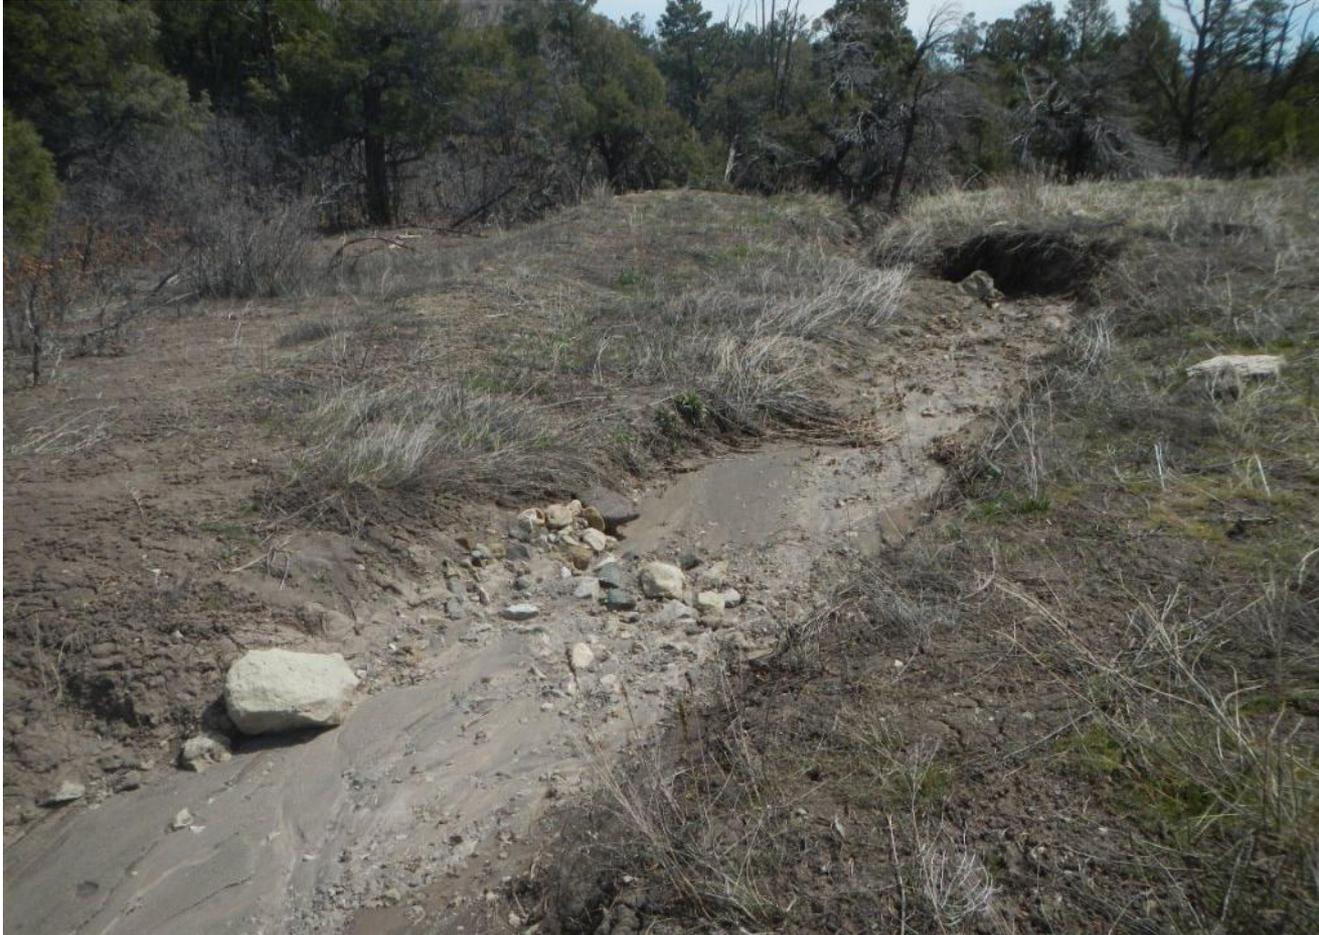
Photo 4. View of stormwater erosion in diverted channel along northern edge of project area.

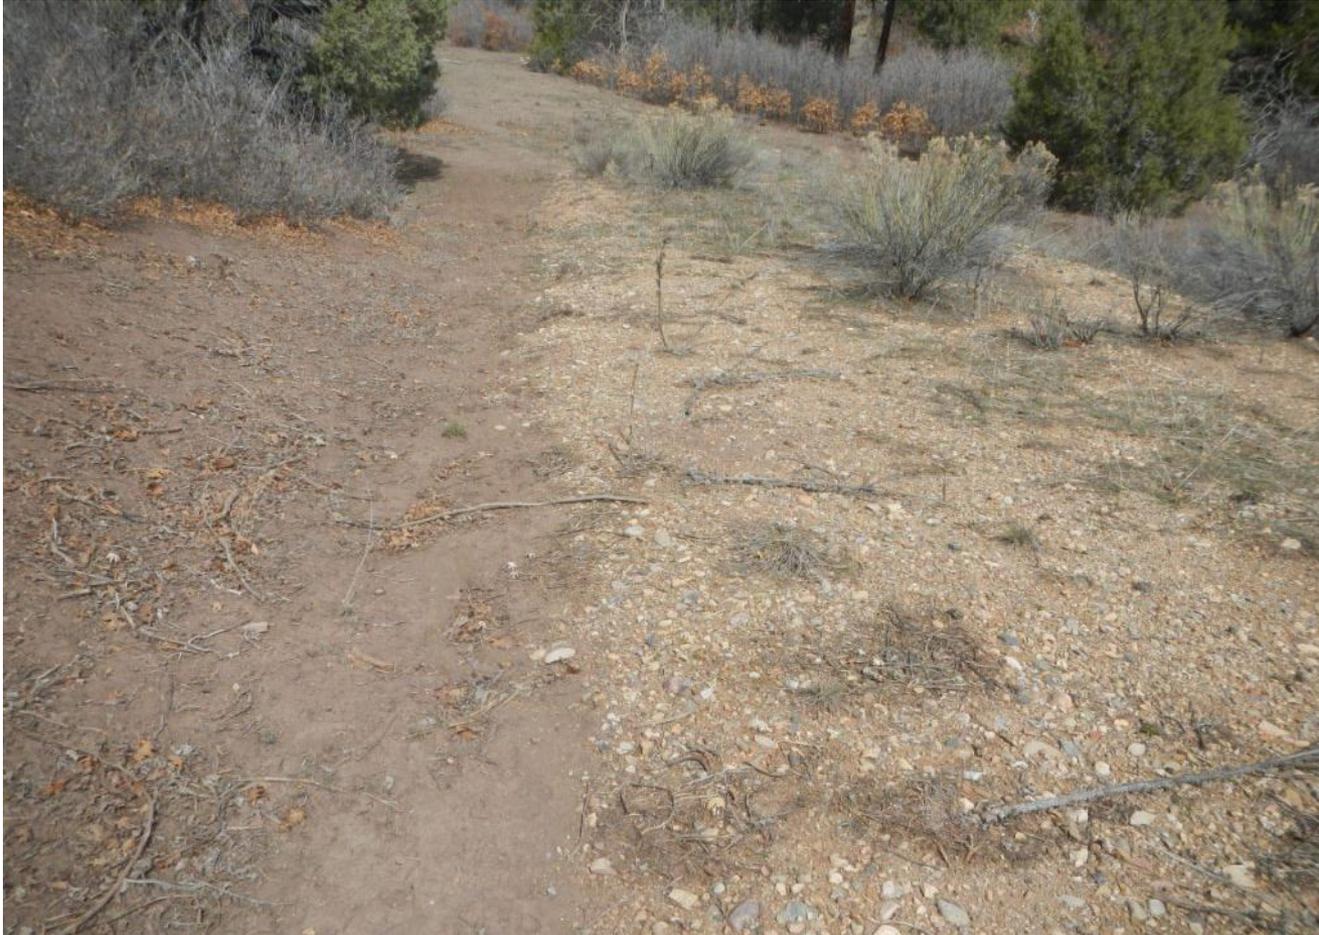
Photo 5. View of gravel on surface of access road.

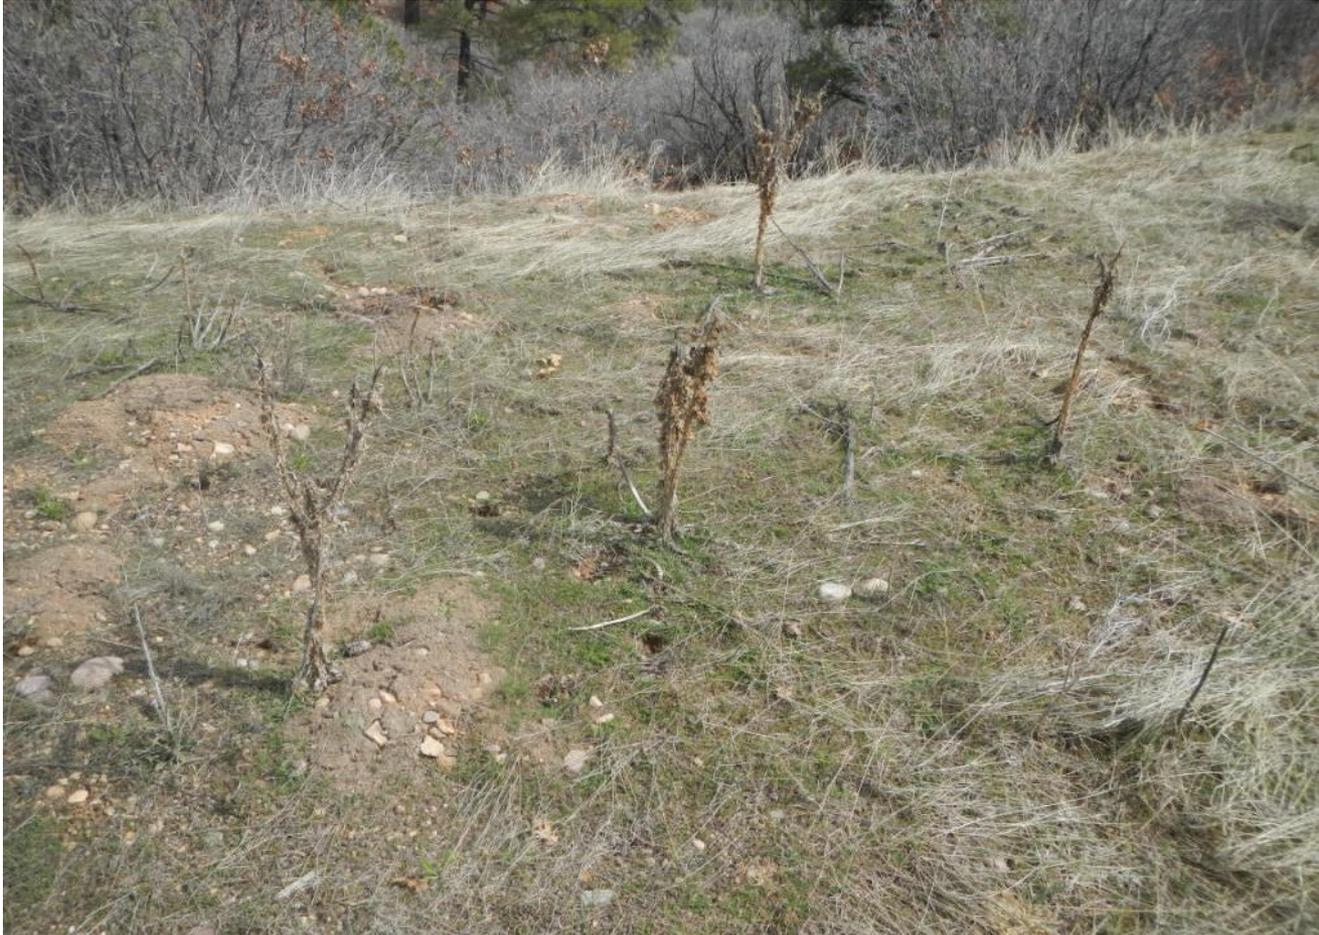
Photo 6. View of musk thistle (*Carduus nutans*) plants from the previous season. These plants have produced seed that will become a new infestation during the 2015 growing season.

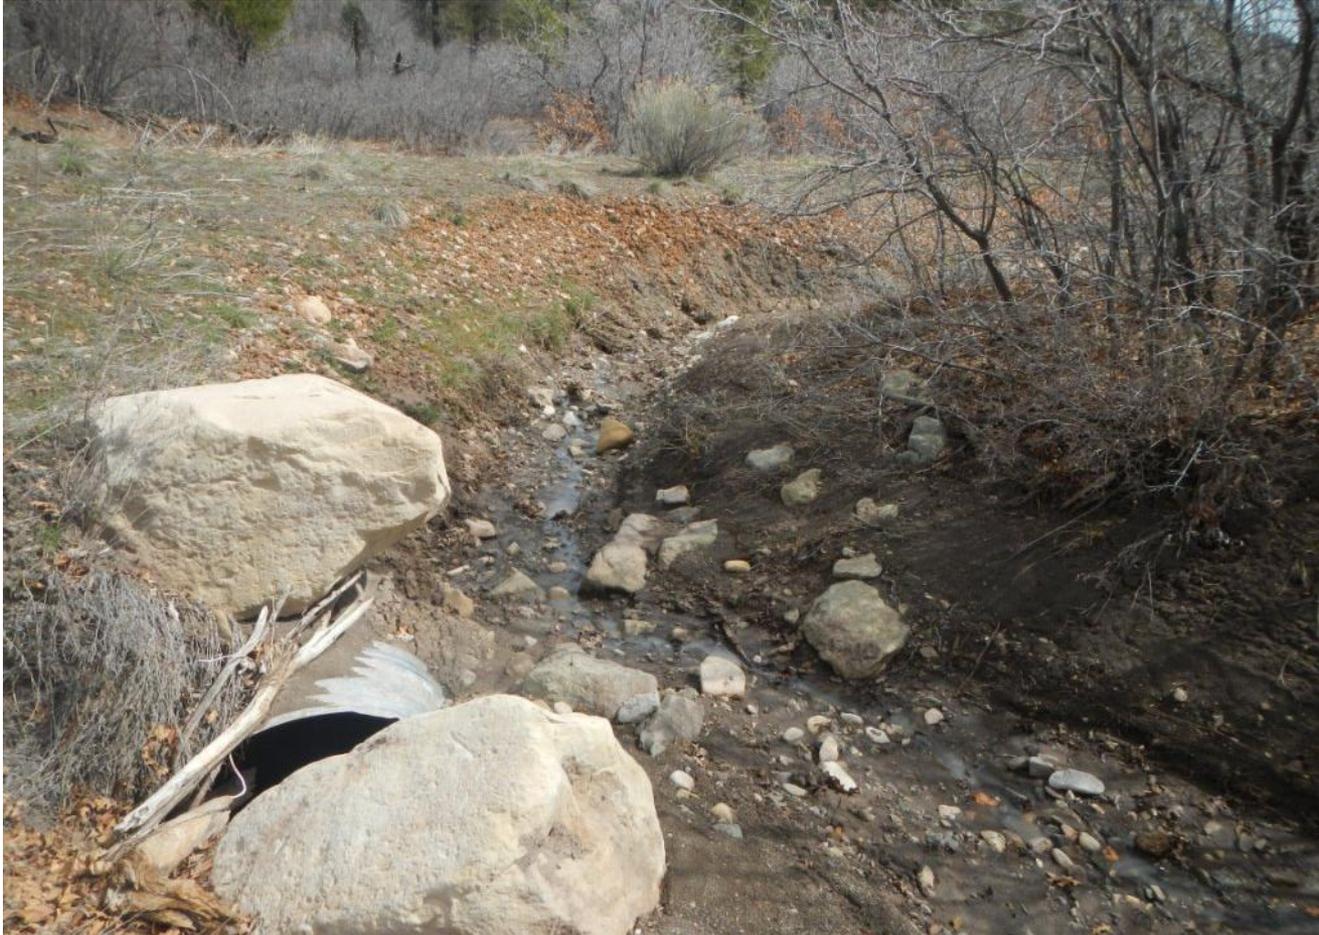
Photo 7. View of culvert inlet near the entrance to the well pad. It appears that a boulder has blocked the culvert and diverted the stream along the access road for approximately 700 feet.

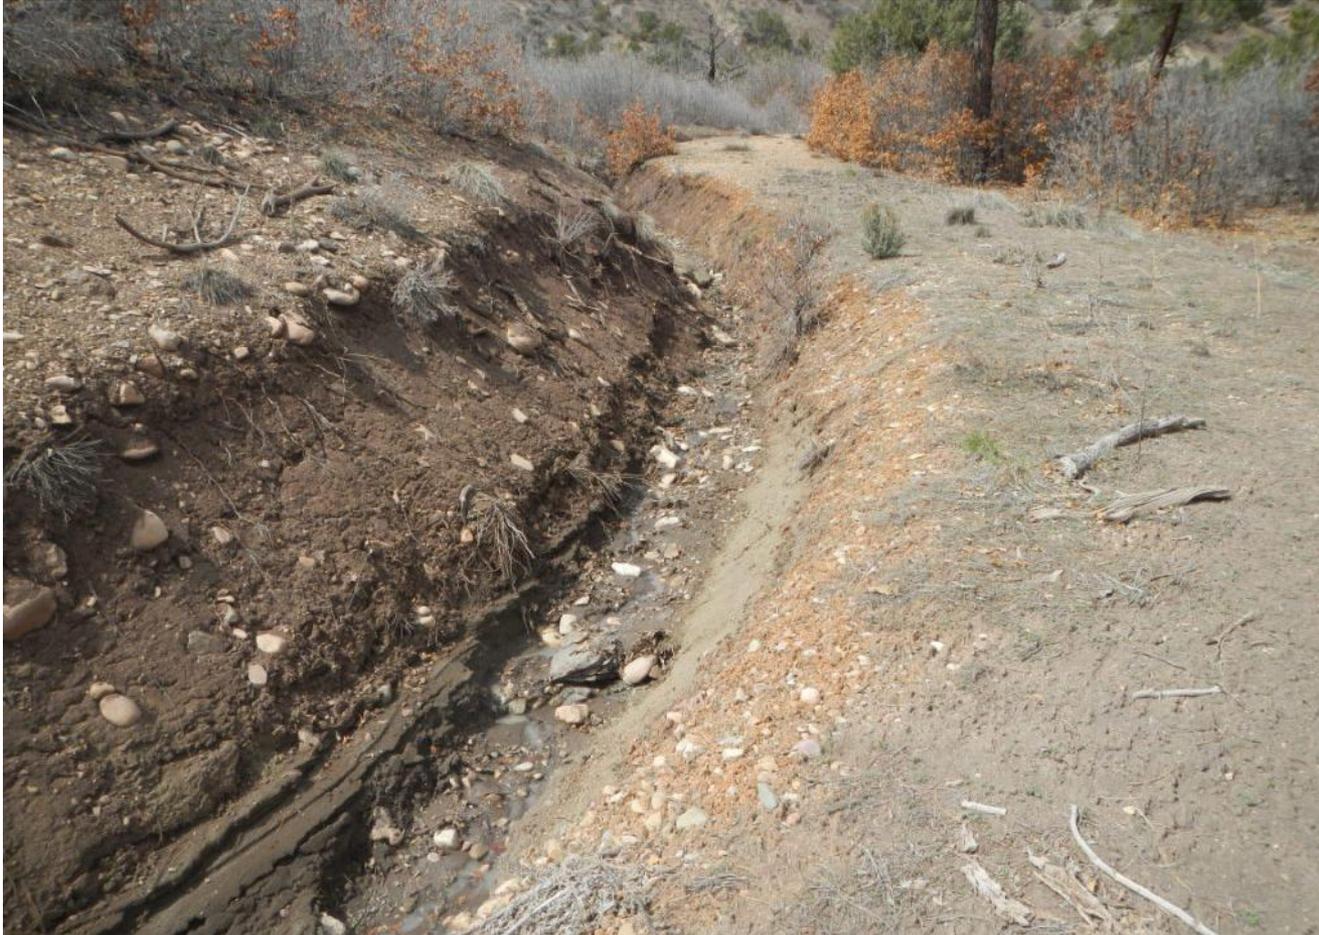
Photo 8. View of erosional channel approximately 3 to 6 feet wide and 2 to 5 feet deep along access road.
