Coal Gulch 15-9

Inspection# 675201478

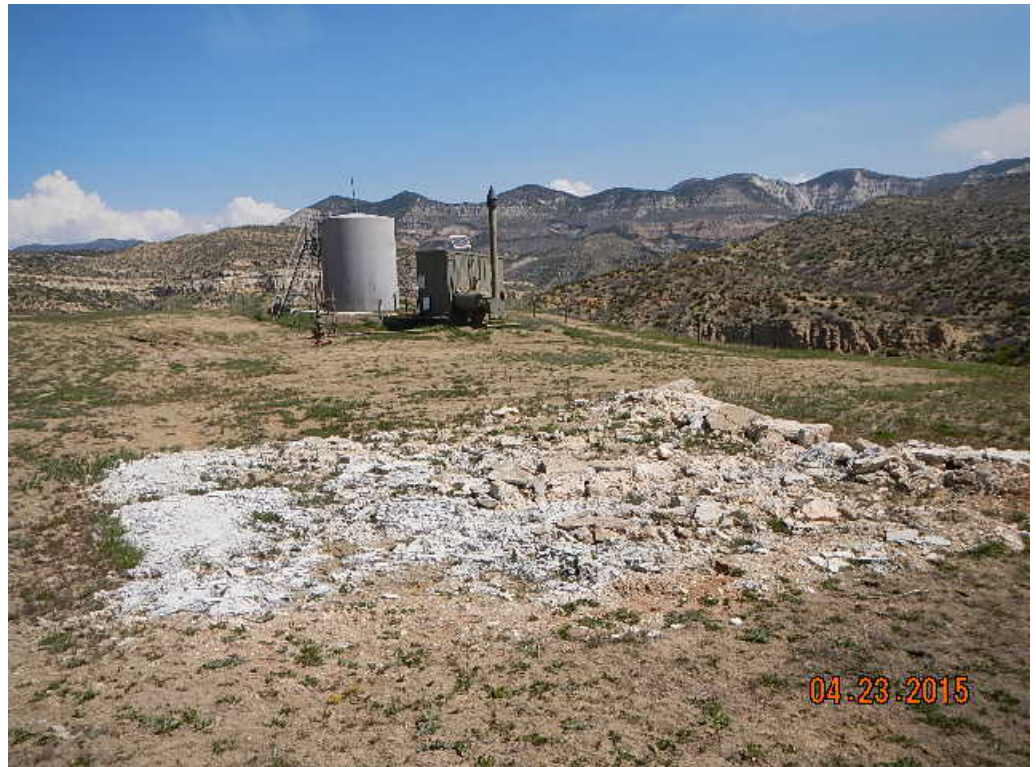
Concrete washout area with
no BMPs.

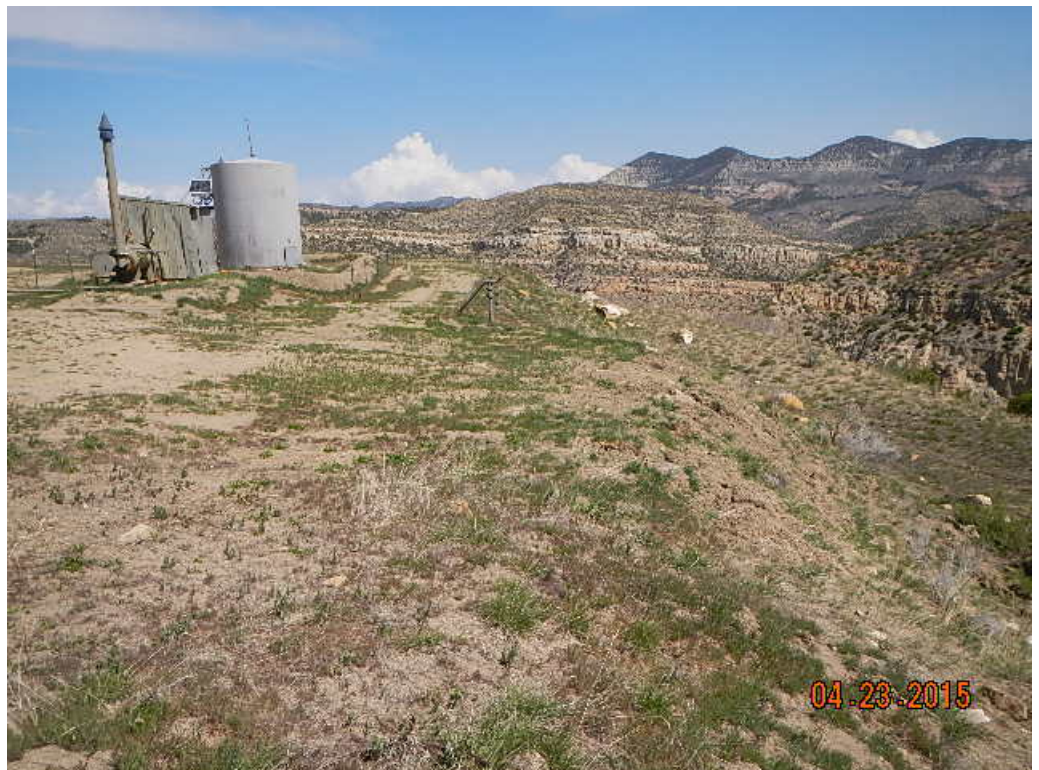
Disturbed area sloping away
from equipment with no
stormwater BMPs.

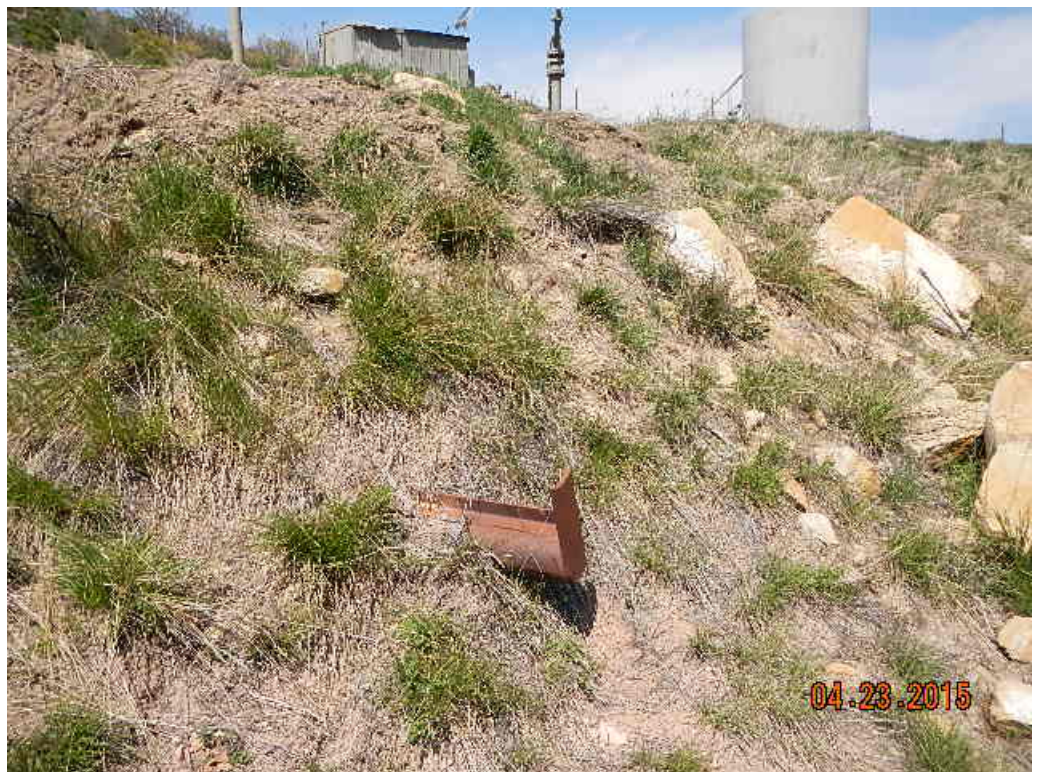
Debris on fill side of location
in disturbed area.

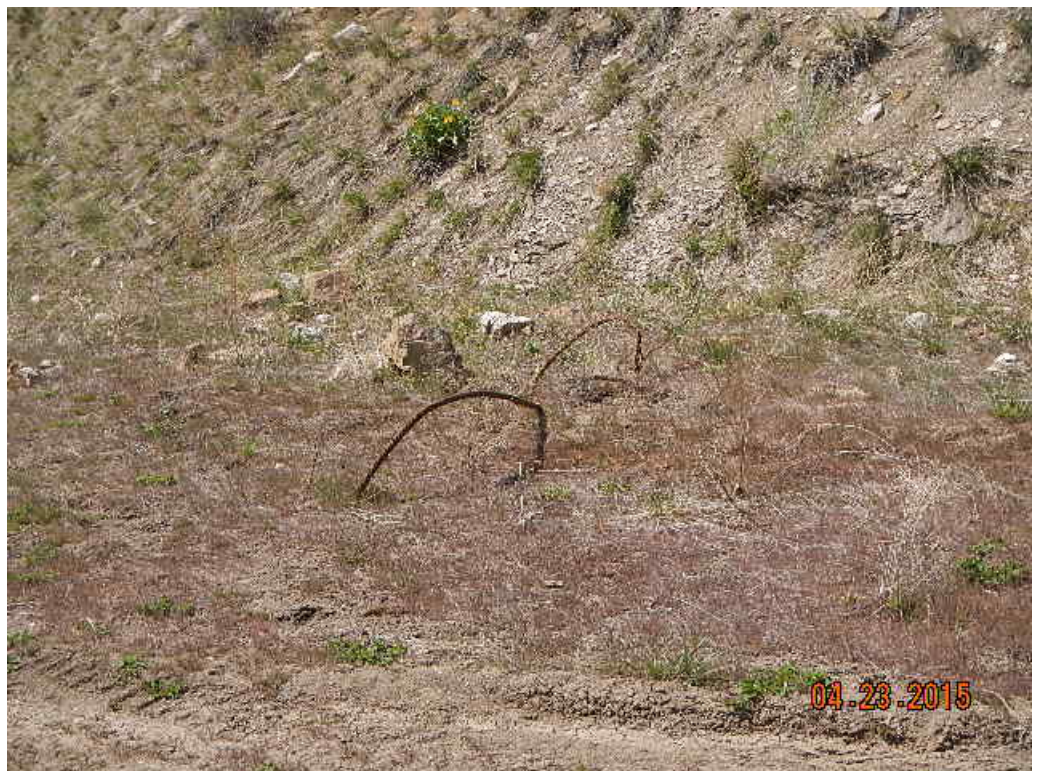
Debris near entrance of
location.

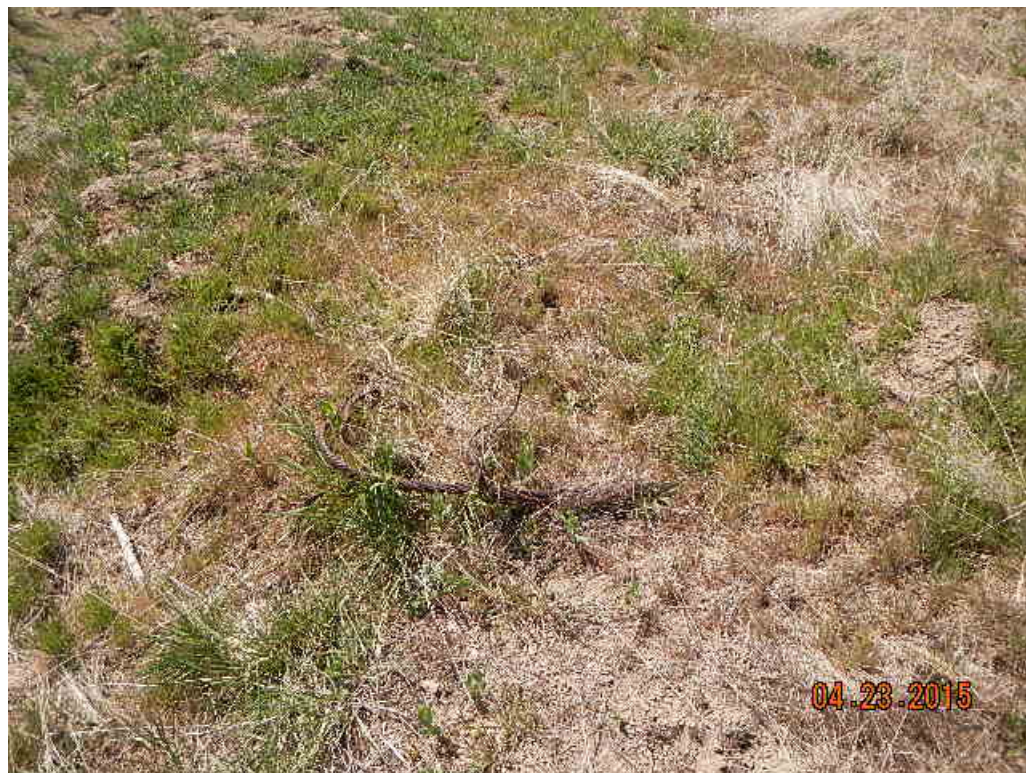
Debris on south east corner
of location.

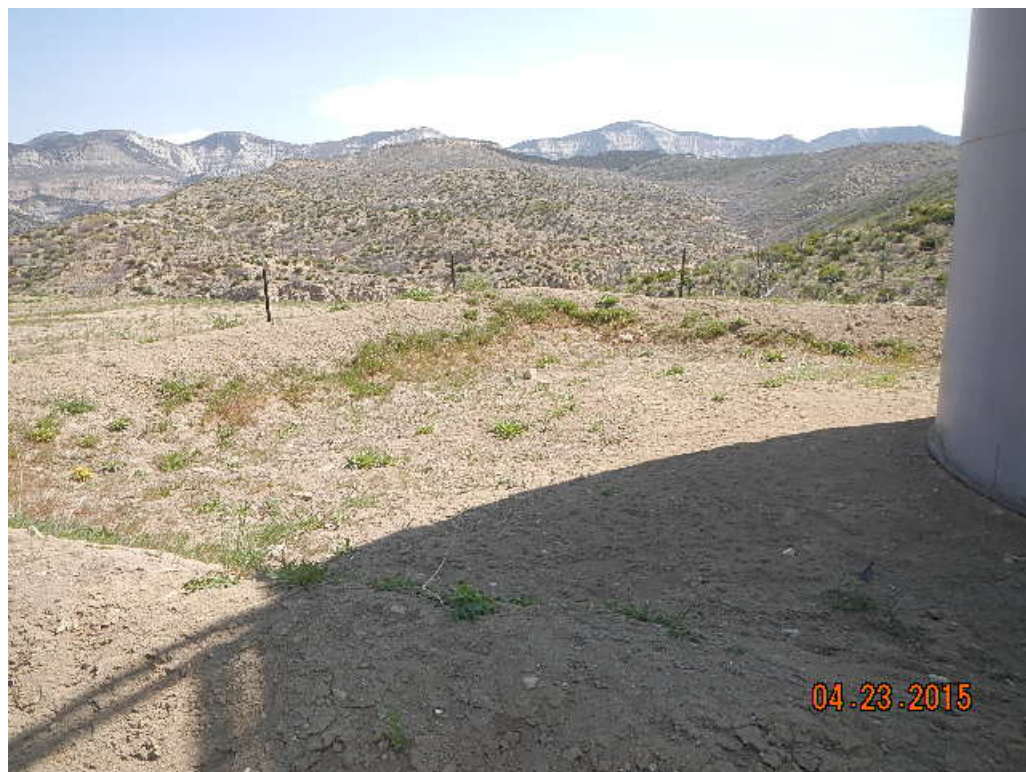
Vegetation growing in tank
containment and on berms.

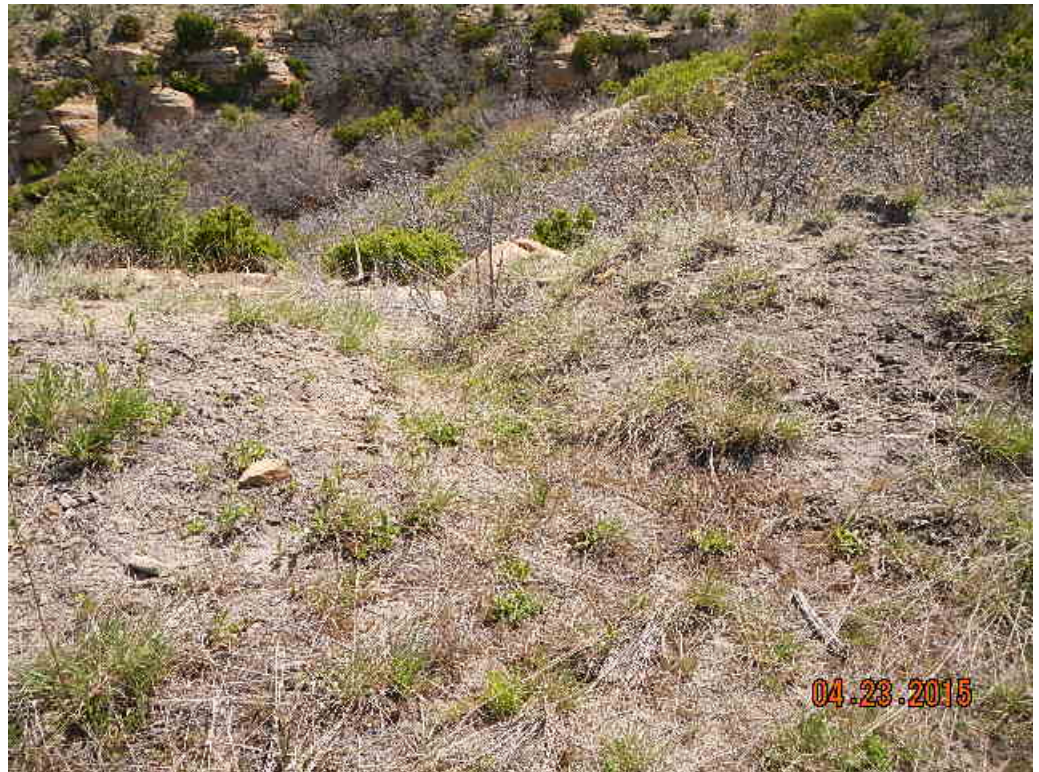
Storm water discharge
point. No BMPs in place.

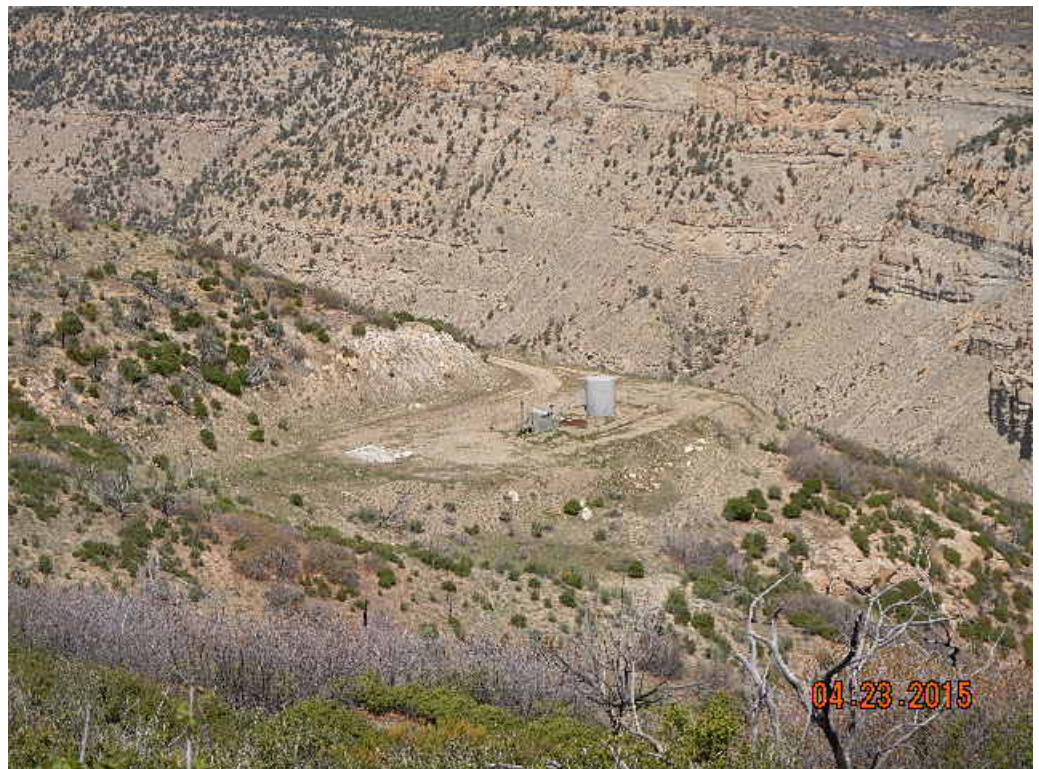
Location: concrete wash out
visible, no stormwater BMPs
in place at time of
inspection.
