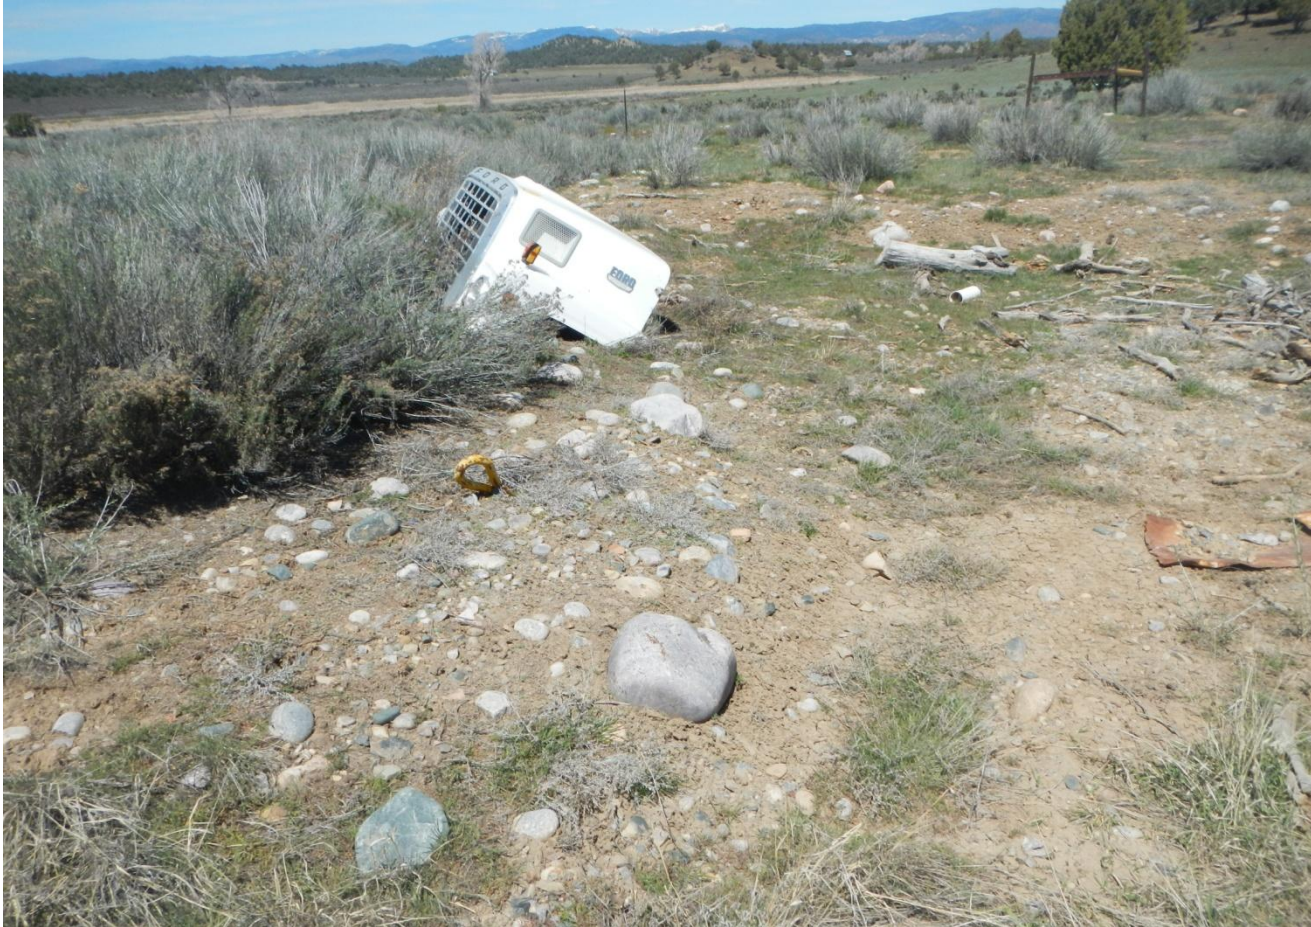
Photo 2. View of junk in northeastern corner of project area.

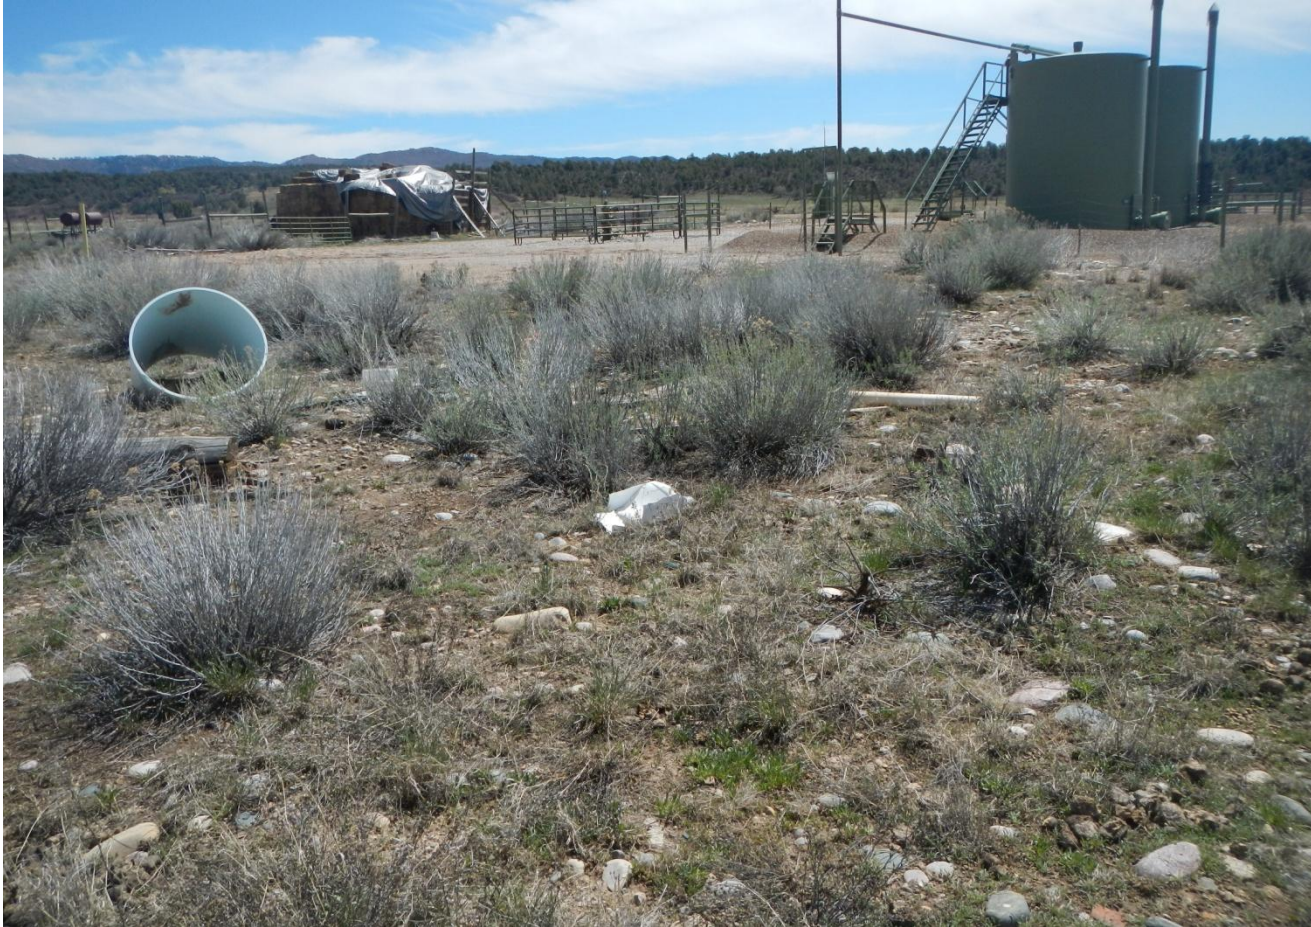
Photo 4. View of scattered junk and debris within project area from northwestern corner facing center.

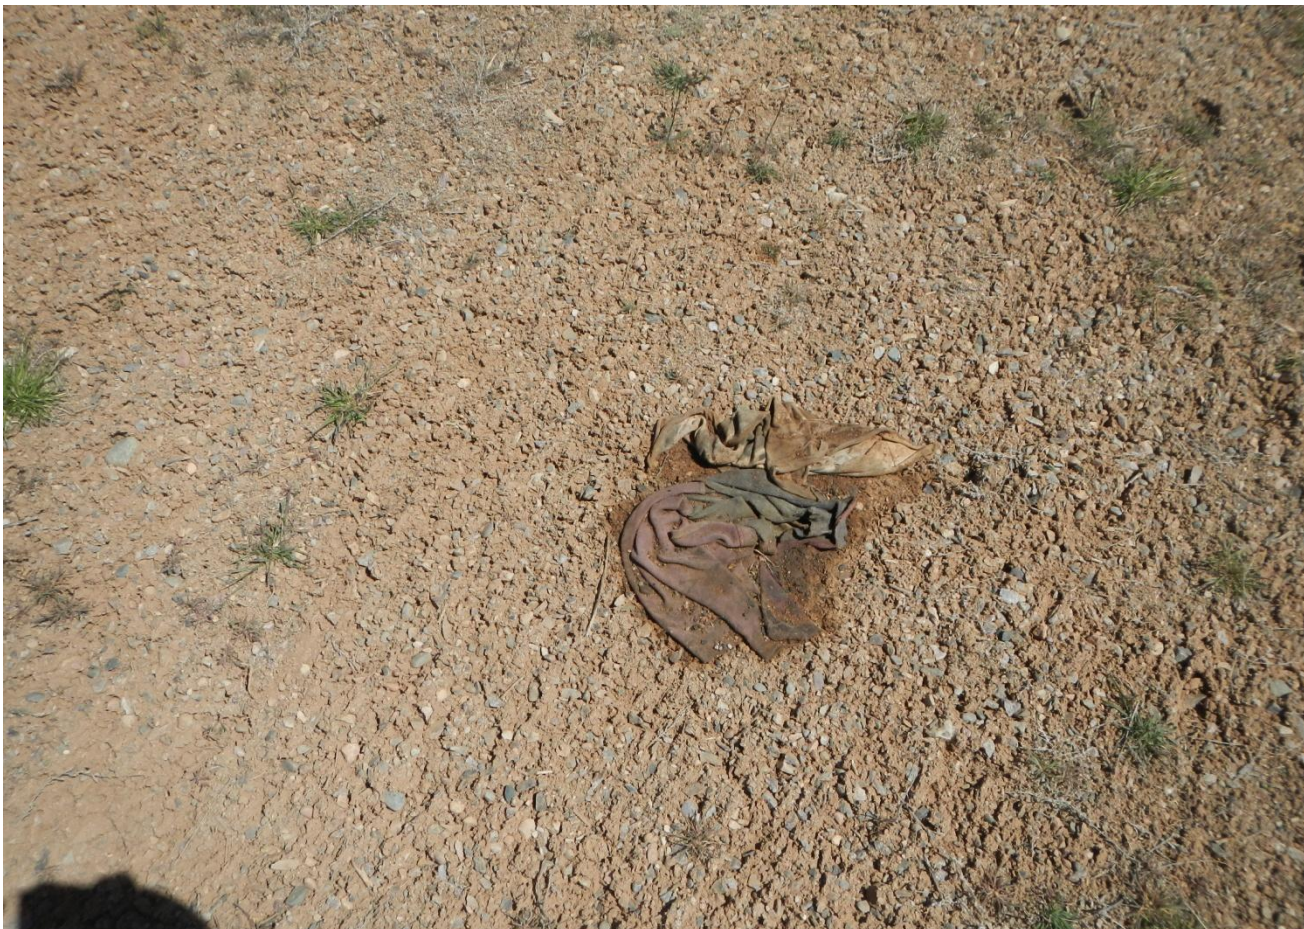
Photo 5. View of what appears to be an oily rag on working surface of well pad.
