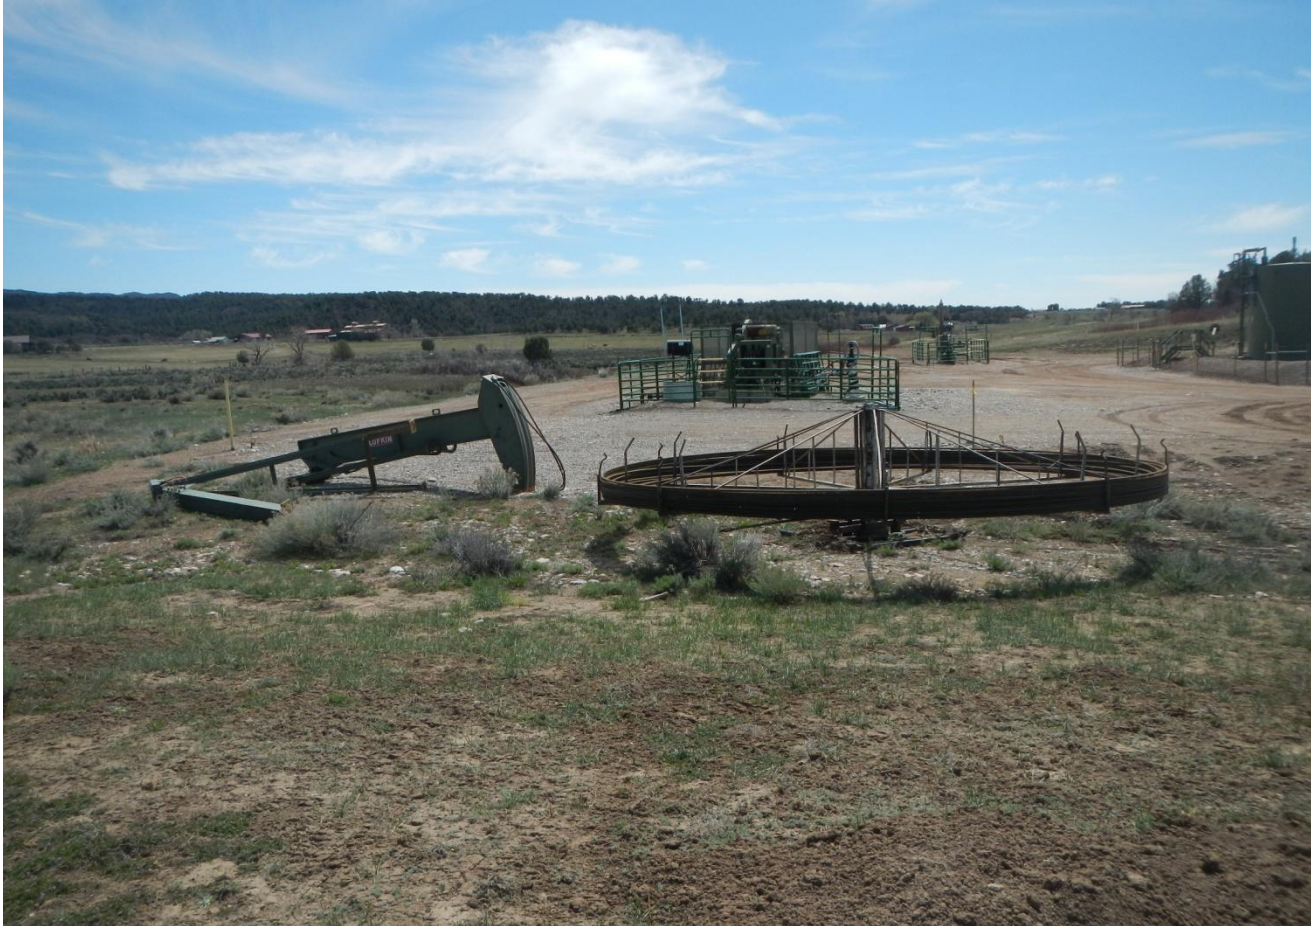
Photo 1. View of unused equipment in northern portion of working area.

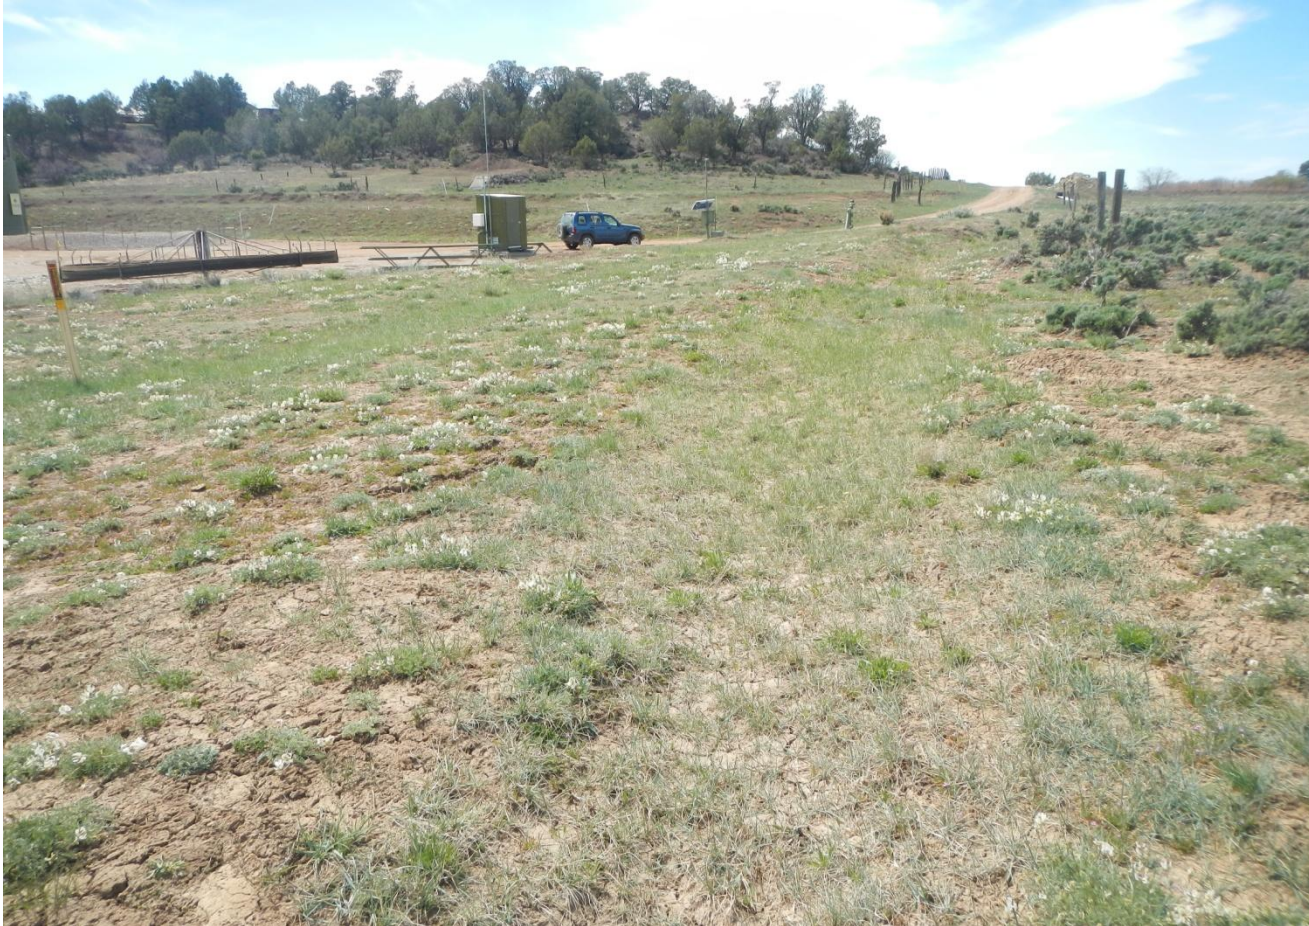
Photo 2. View of good revegetation establishment within northern portion of the interim reclamation area.

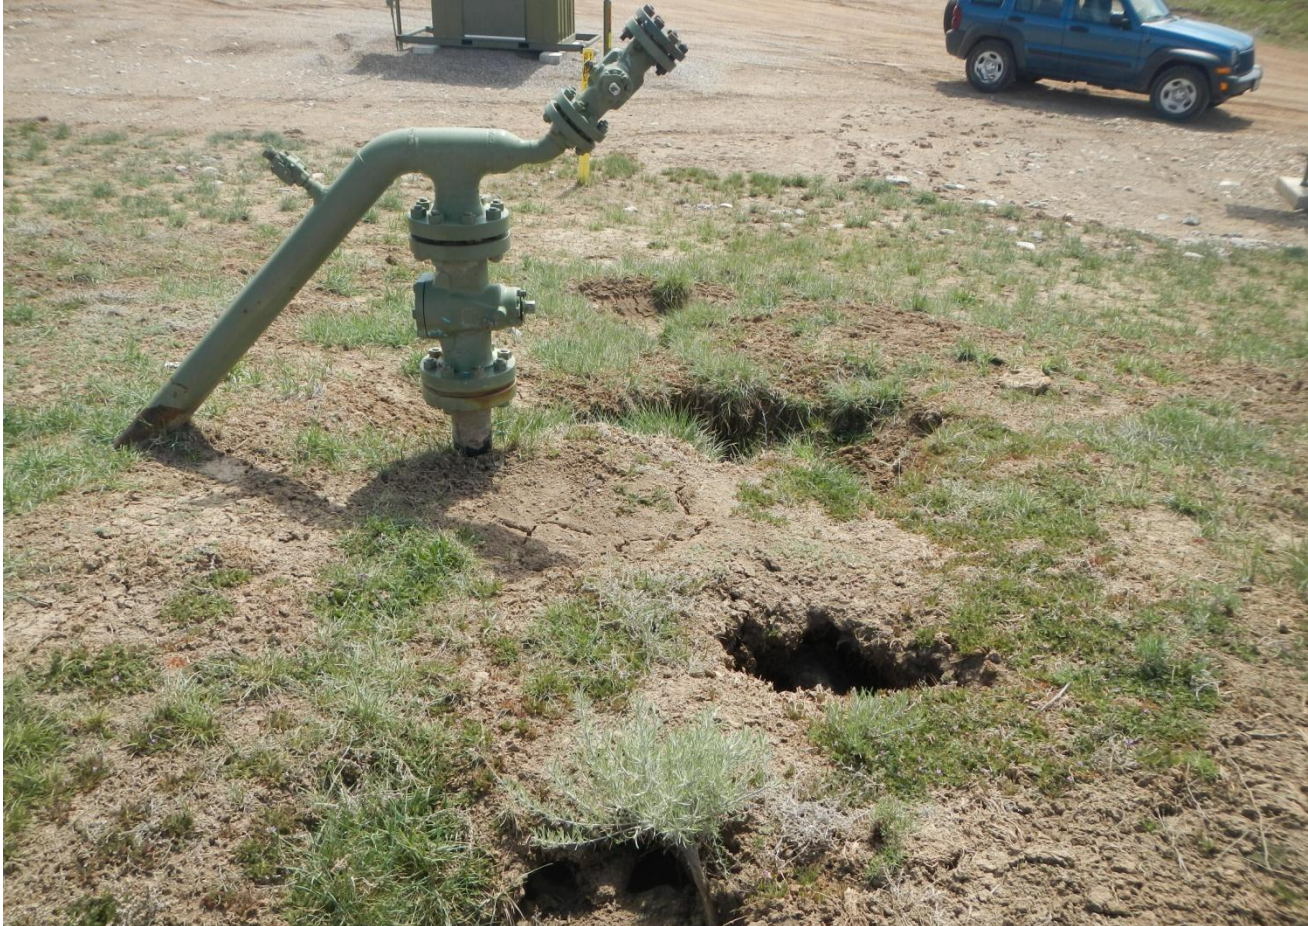
Photo 3. View of erosional channel tunneling beneath the northern portion of the interim reclamation area.

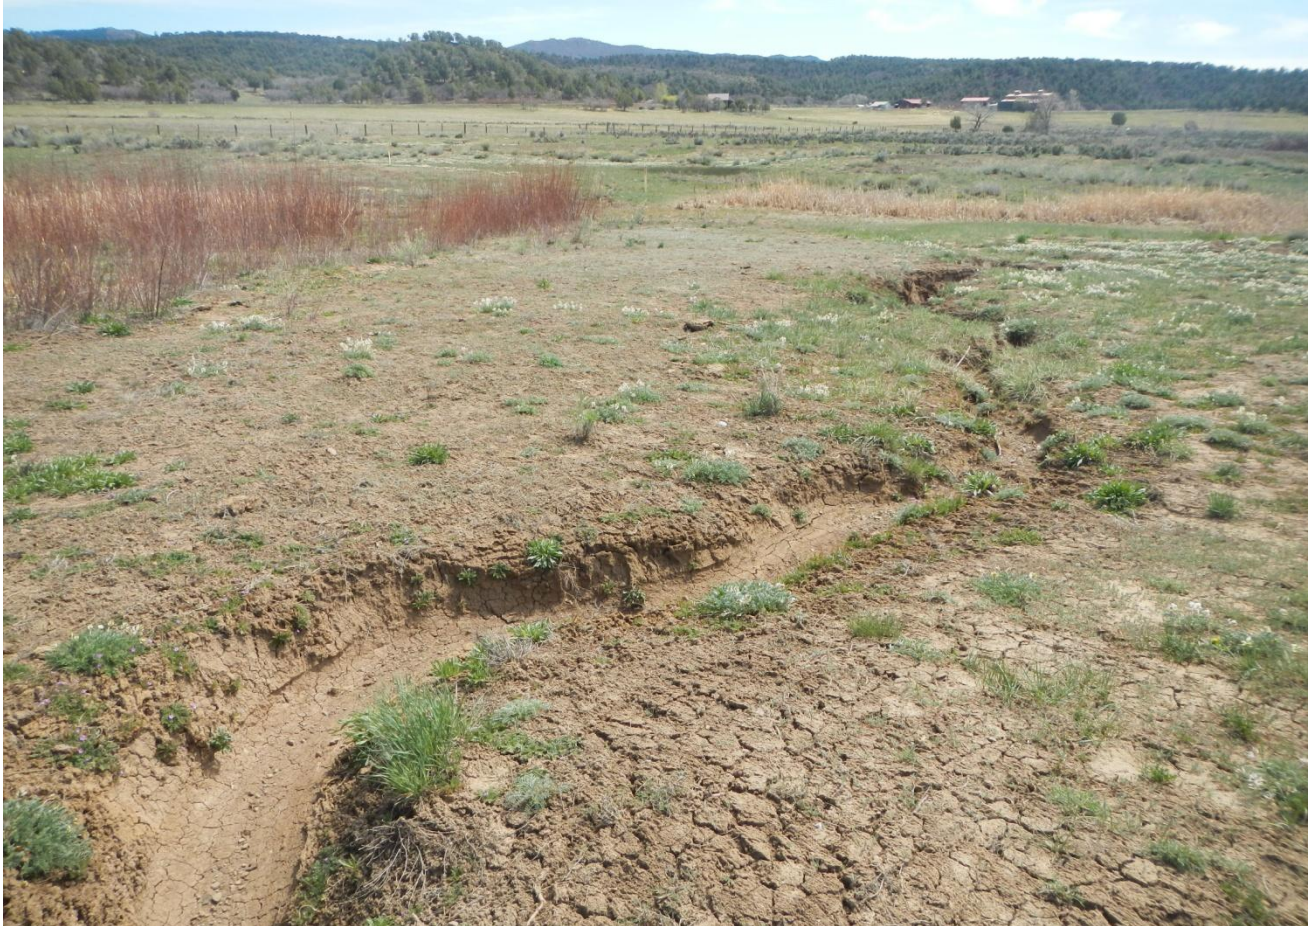
Photo 4. View of erosional channel in northeastern portion of project area, flowing toward a wetland complex.

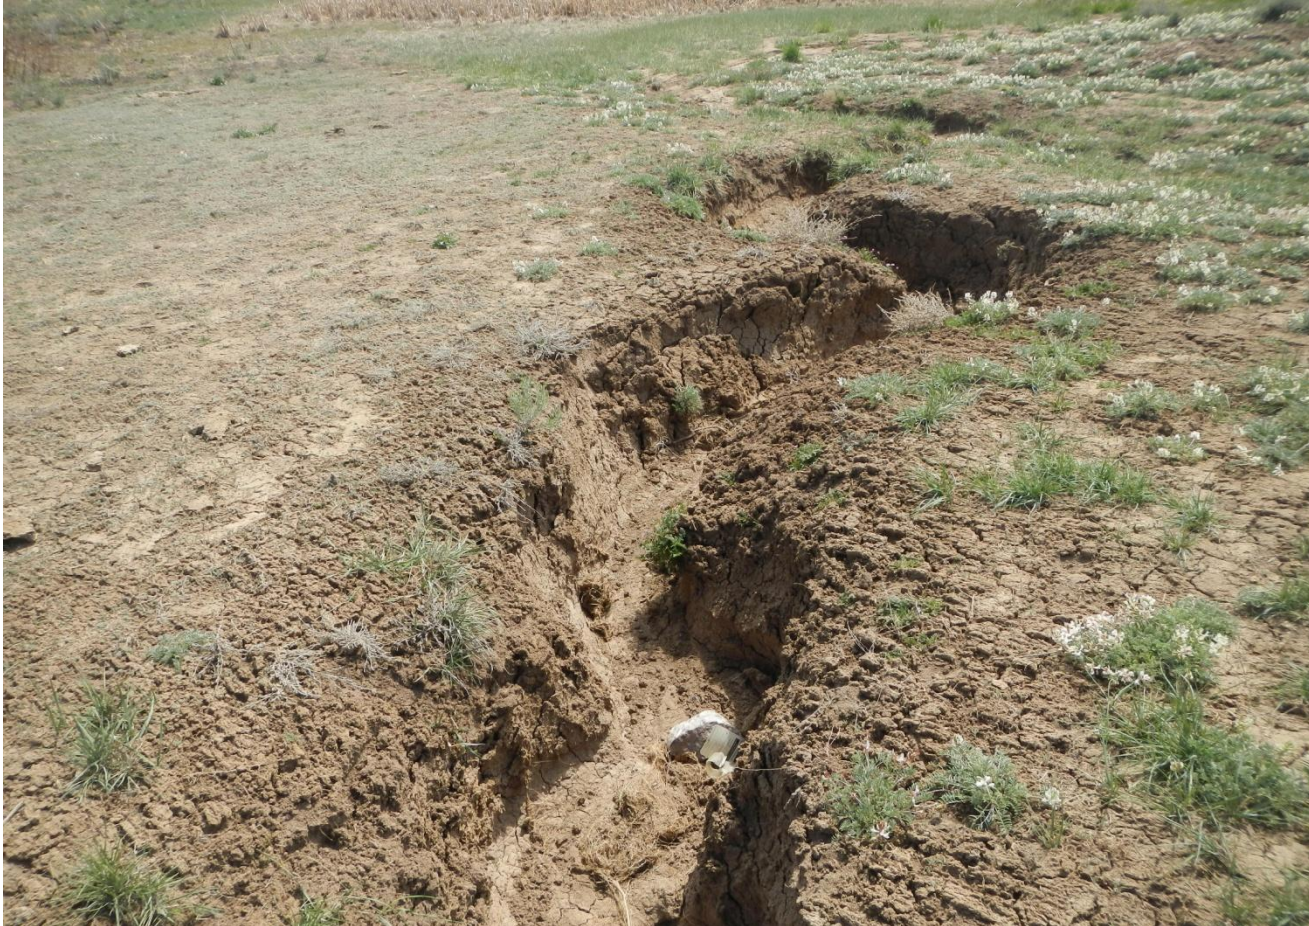
Photo 5. View of erosional channel shown in Photo 4. Stormwater has eroded this channel approximately 2.5 feet wide and 3.5 feet deep.

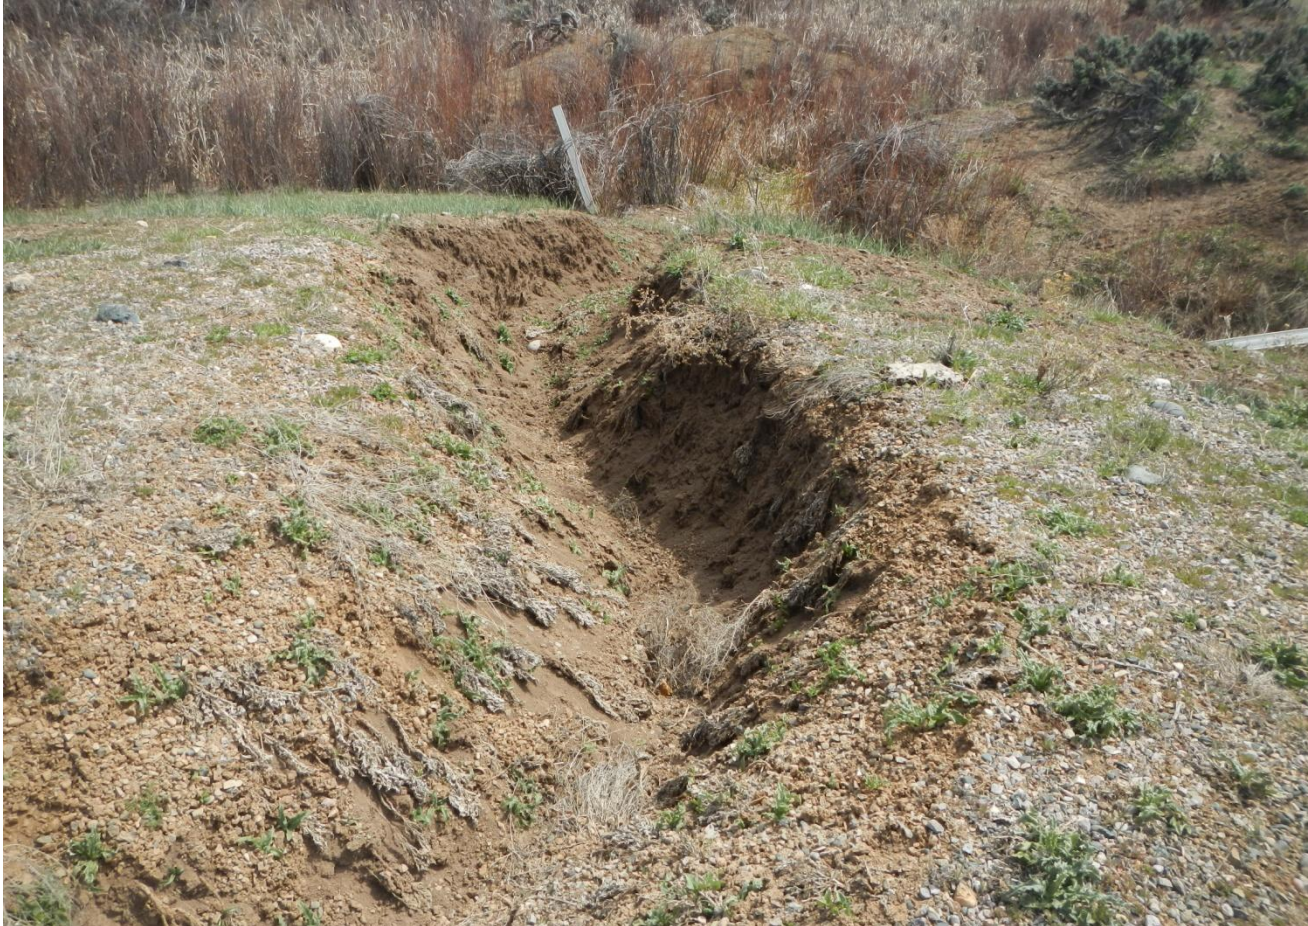
Photo 6. View of an erosional channel in the southeastern corner of the project area flowing toward the eastern wetland complex. This channel is approximately 2 to 3 feet wide and 4 feet deep.

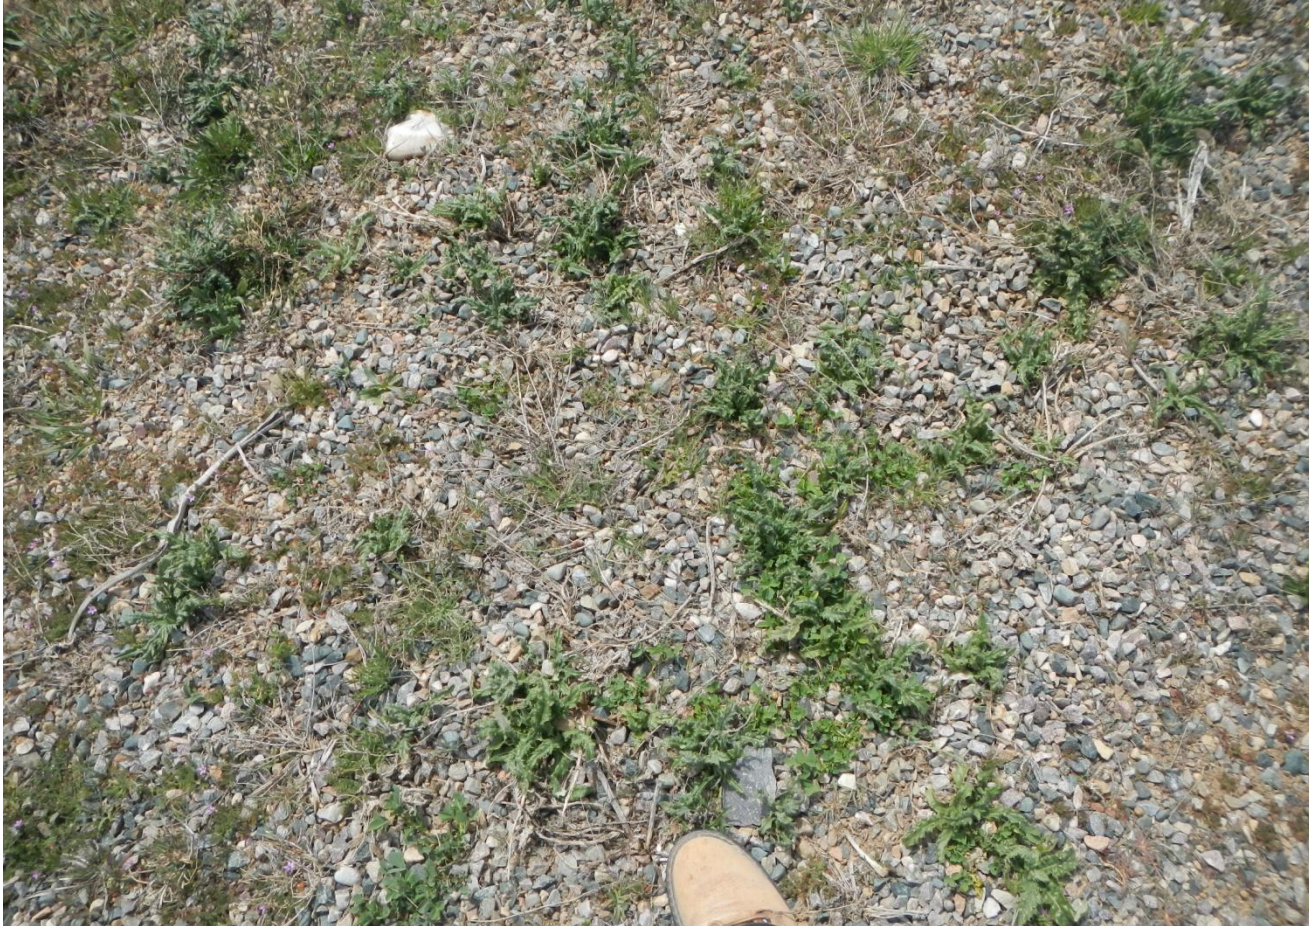
Photo 7. View of several young Canada thistle plants within the interim reclamation area.
