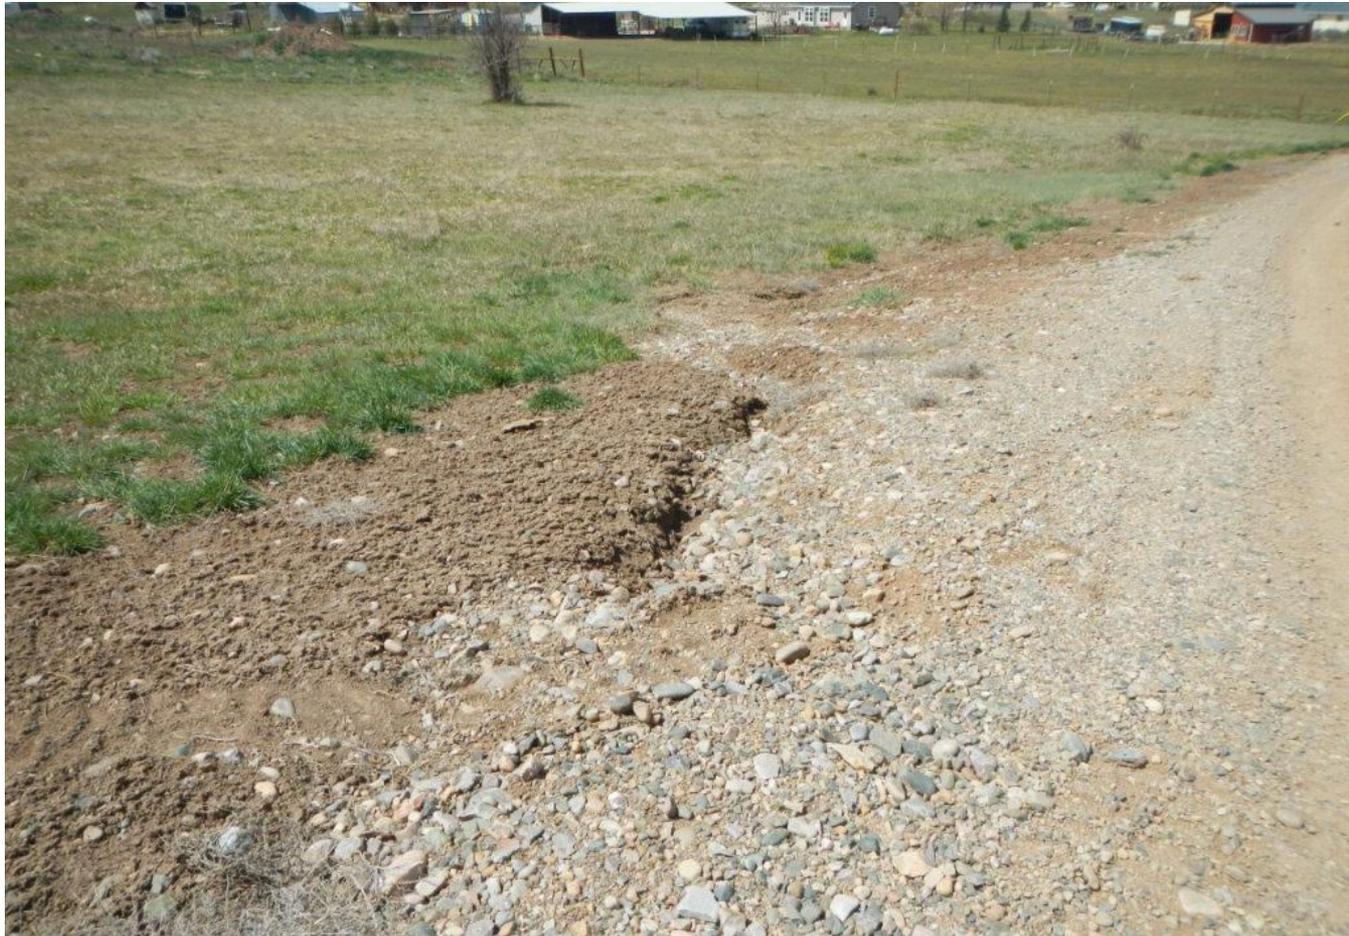
Photo 1. View of rill erosion coming off of access road that needs to be monitored.

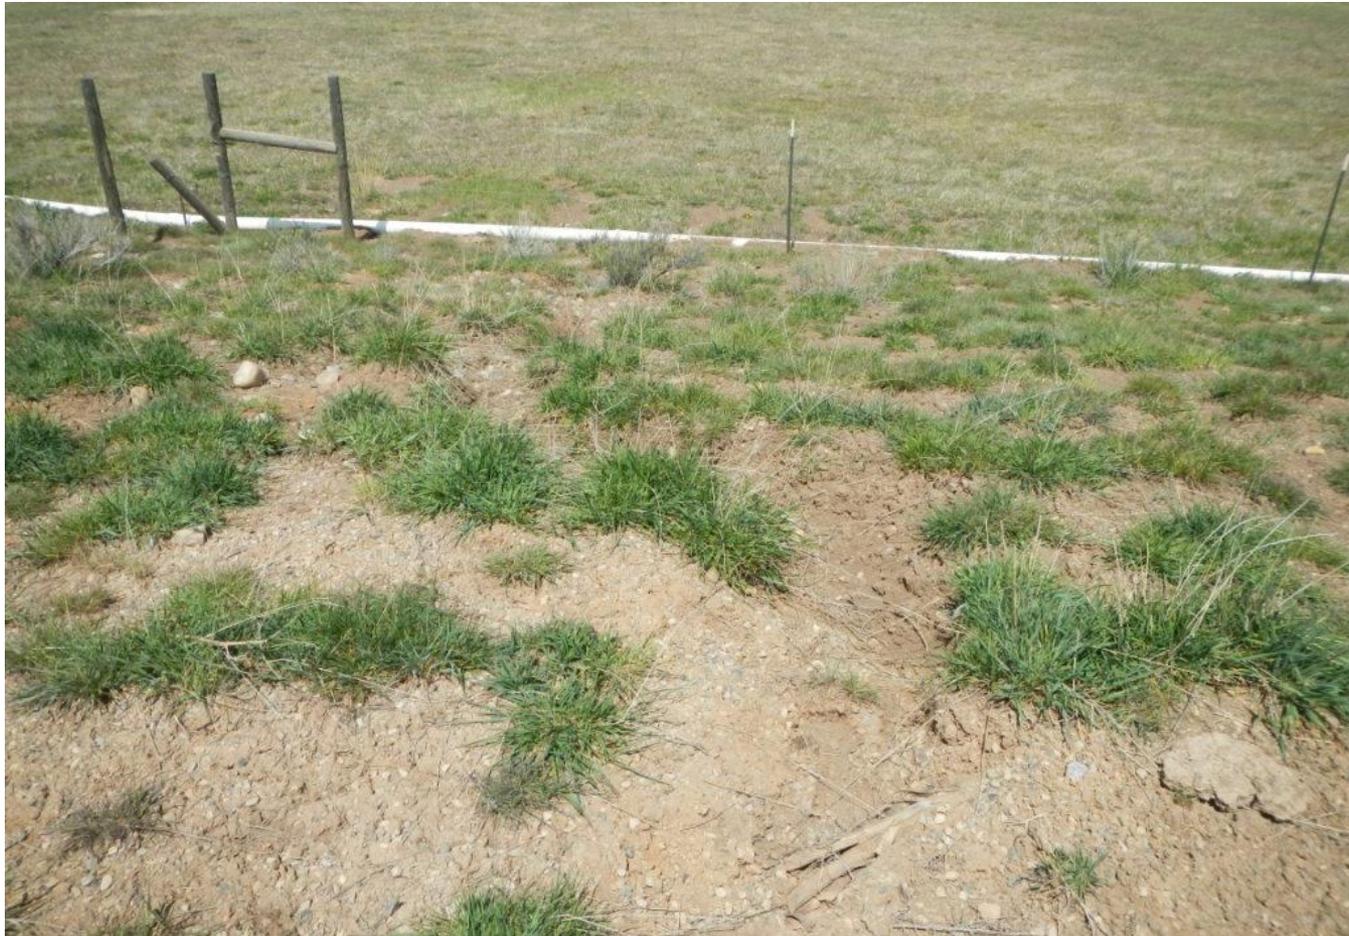
Photo 2. View of erosion that needs to be monitored in northeastern portion of project area.

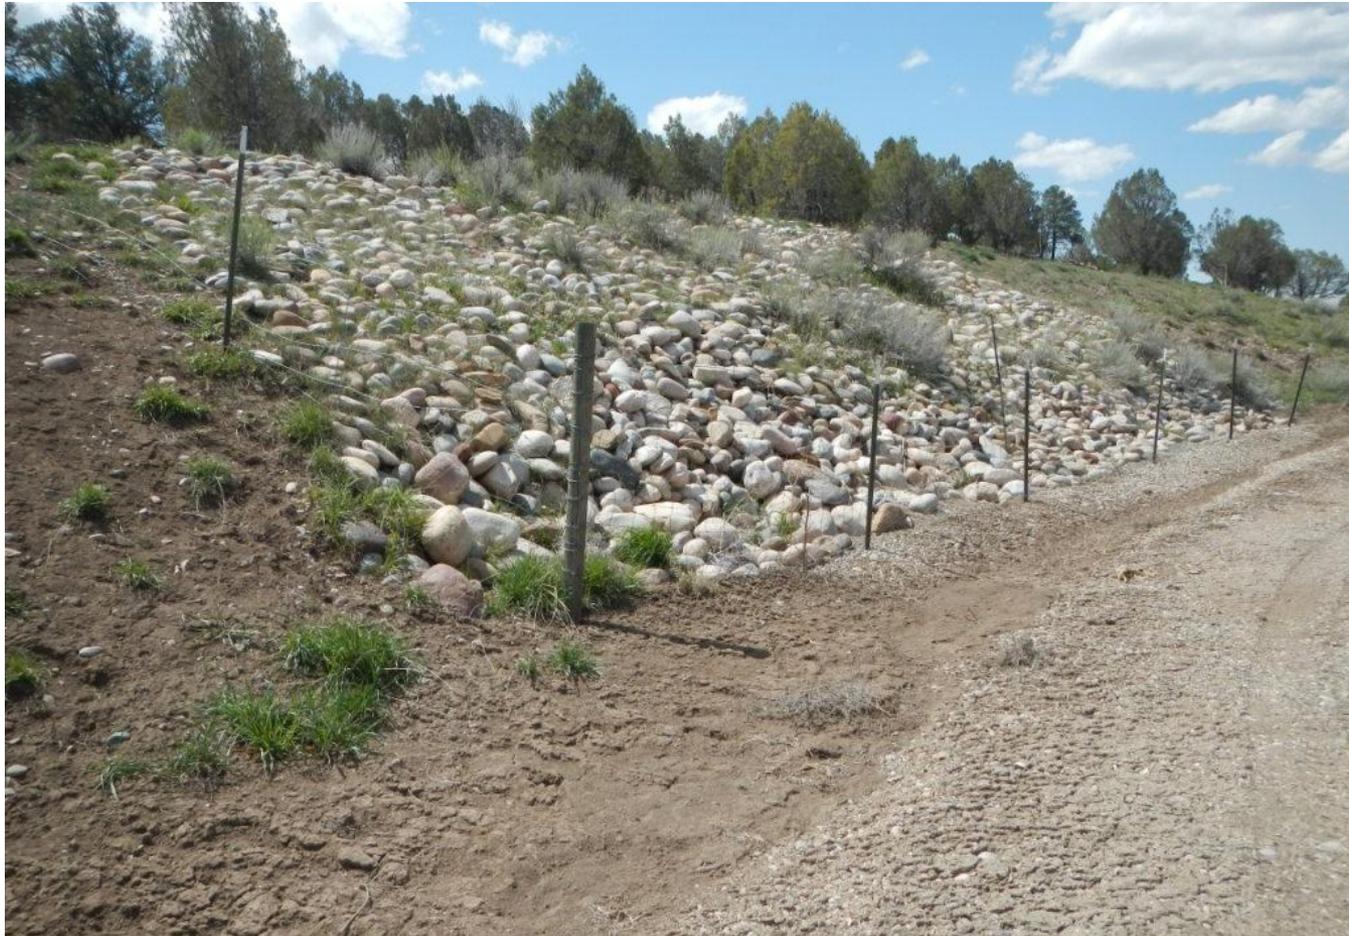
Photo 6. View of cobble armoring BMP on southern portion of project area.
