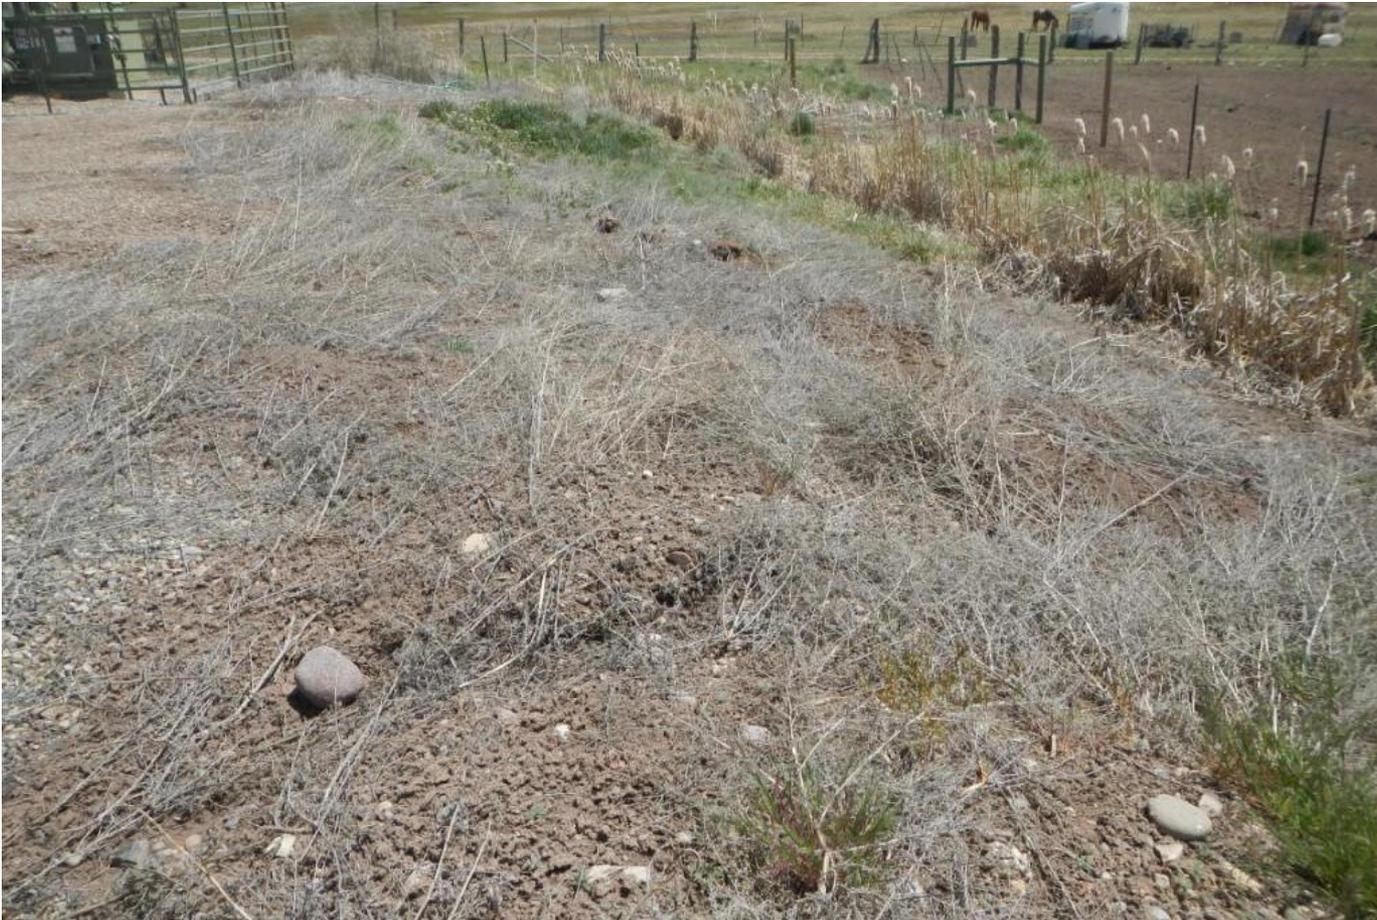
Photo 1. View of kochia debris in southern portion of project area. Kochia appears to be inhibiting revegetation in this area.

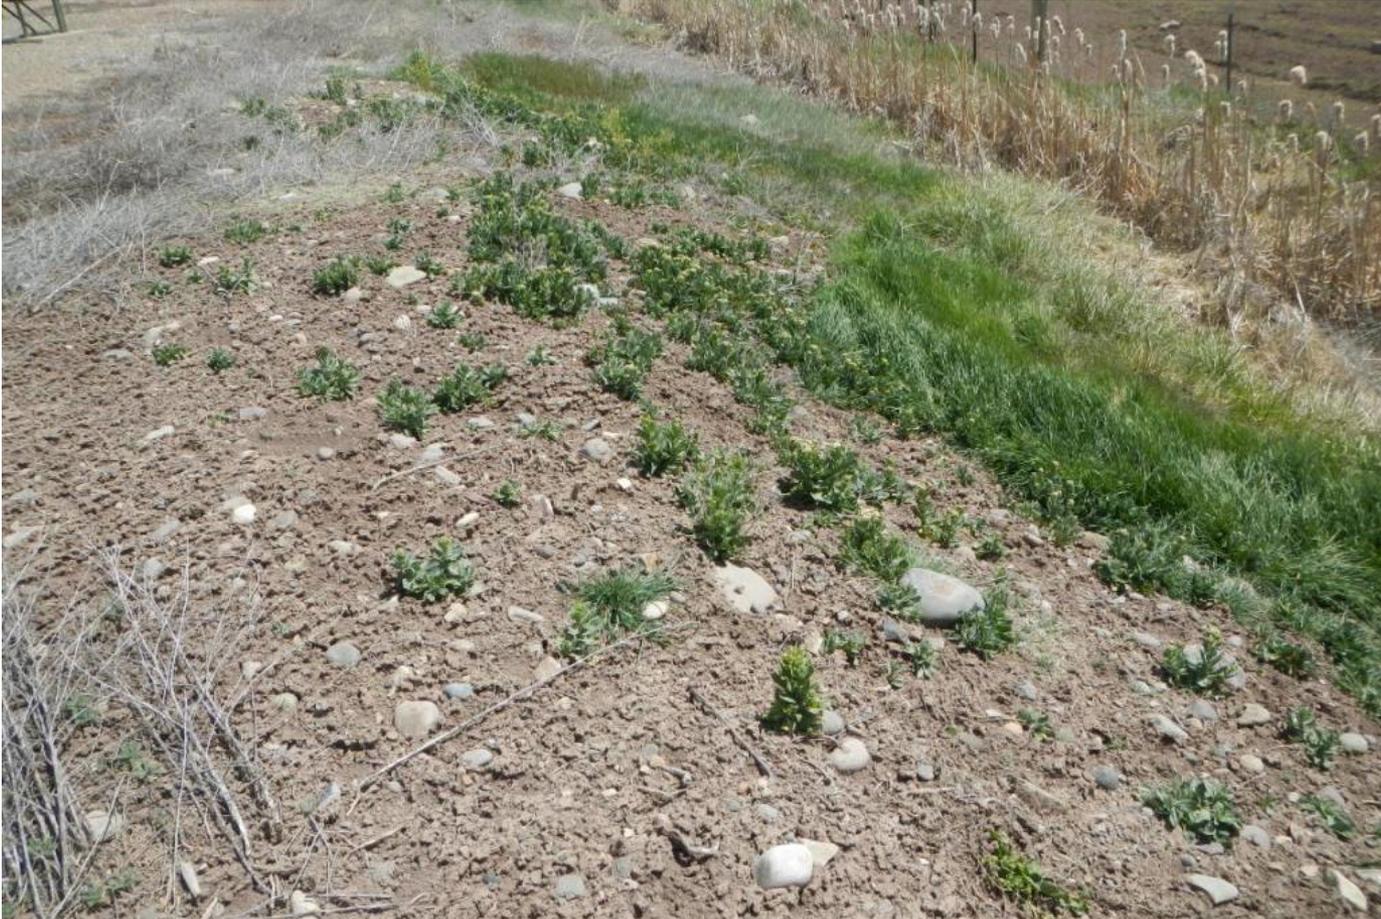
Photo 2. View of hoary cress (*Cardaria draba*) in southern portion of project area.

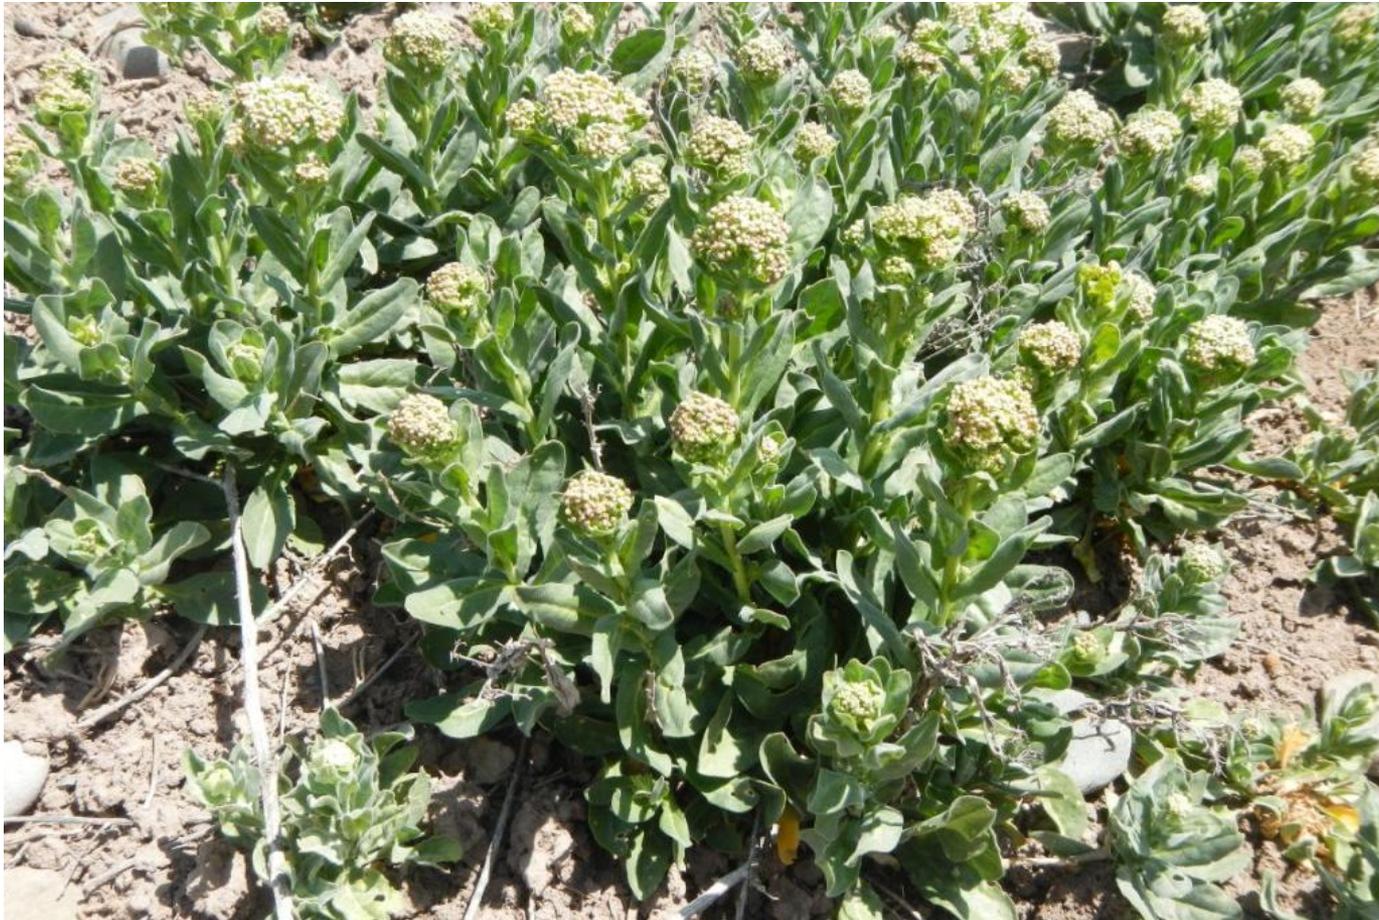
Photo 3. Close up of hoary cress weeds that are close to flowering within southern portion of project area.

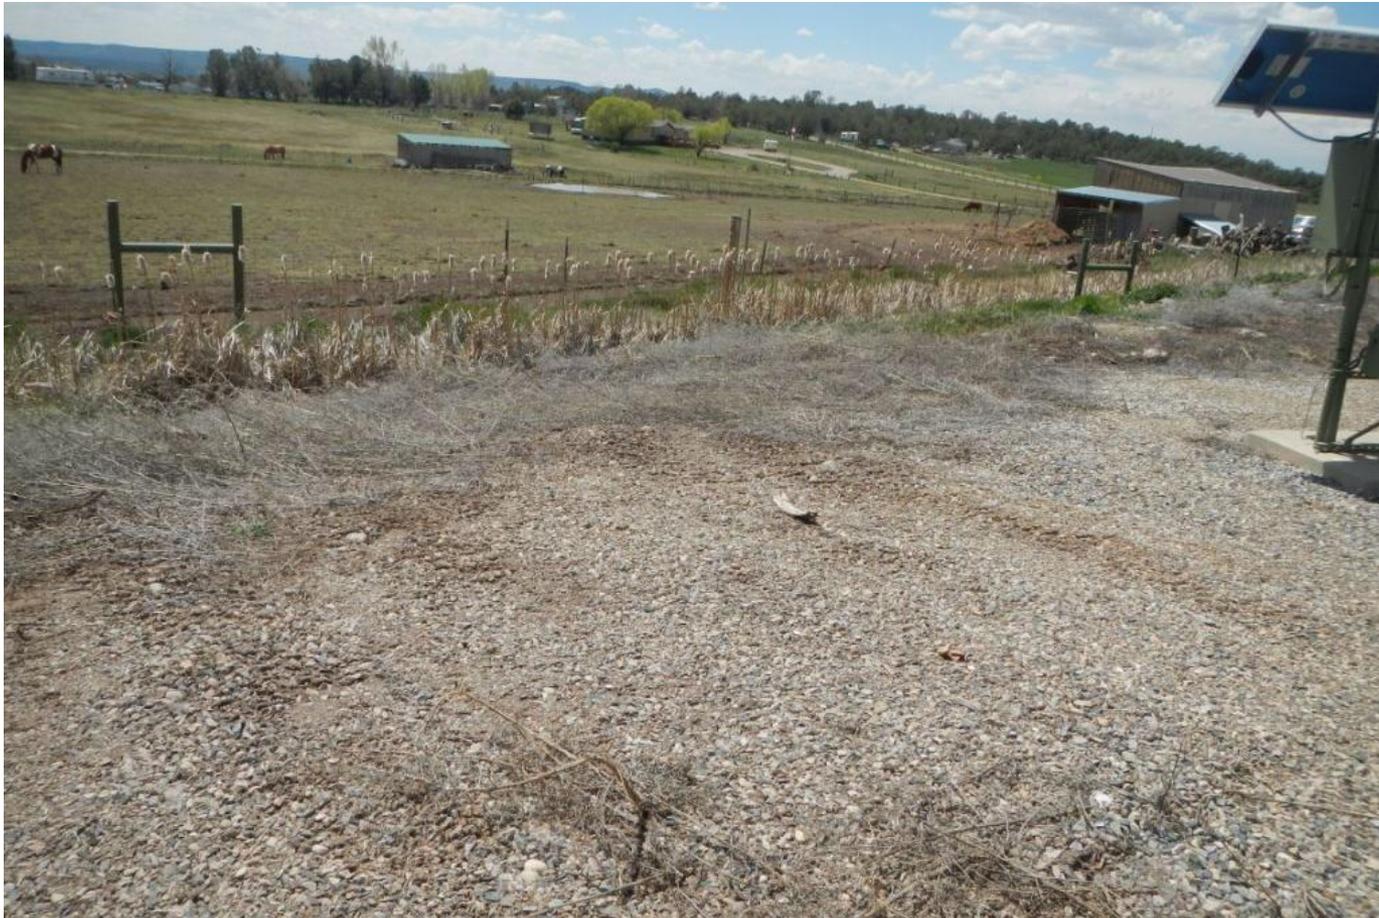
Photo 4. View of rills from stormwater flows in southeastern portion of project area. Little to no desirable vegetation is present on fill slope to filter stormwater flows.
