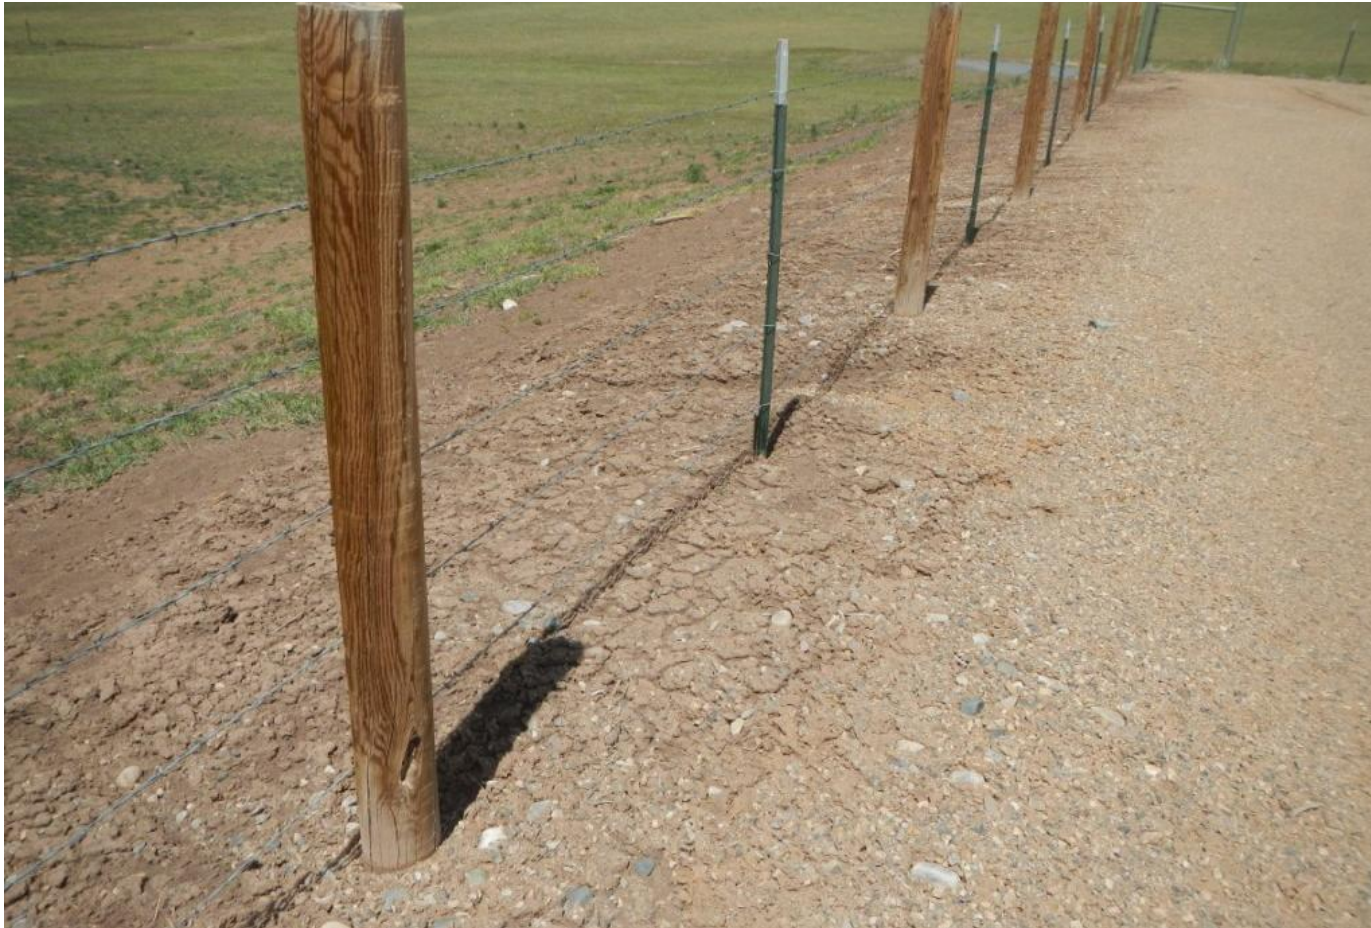
Photo 3. View of rill erosion along western edge of fenceline that needs to be monitored.

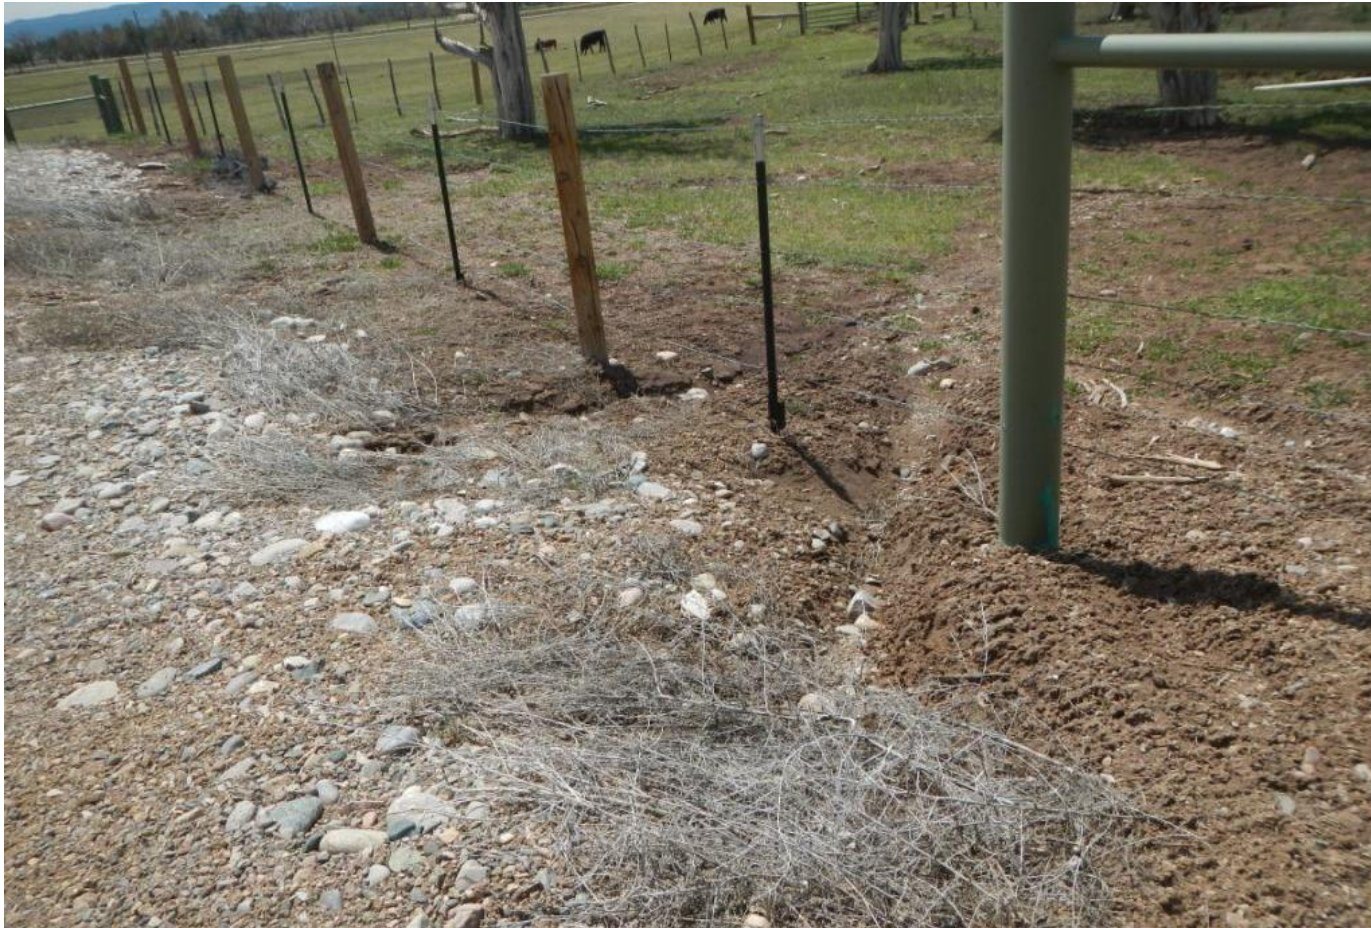
Photo 4. View of rill erosion in southwestern portion of project area that needs to be monitored.
