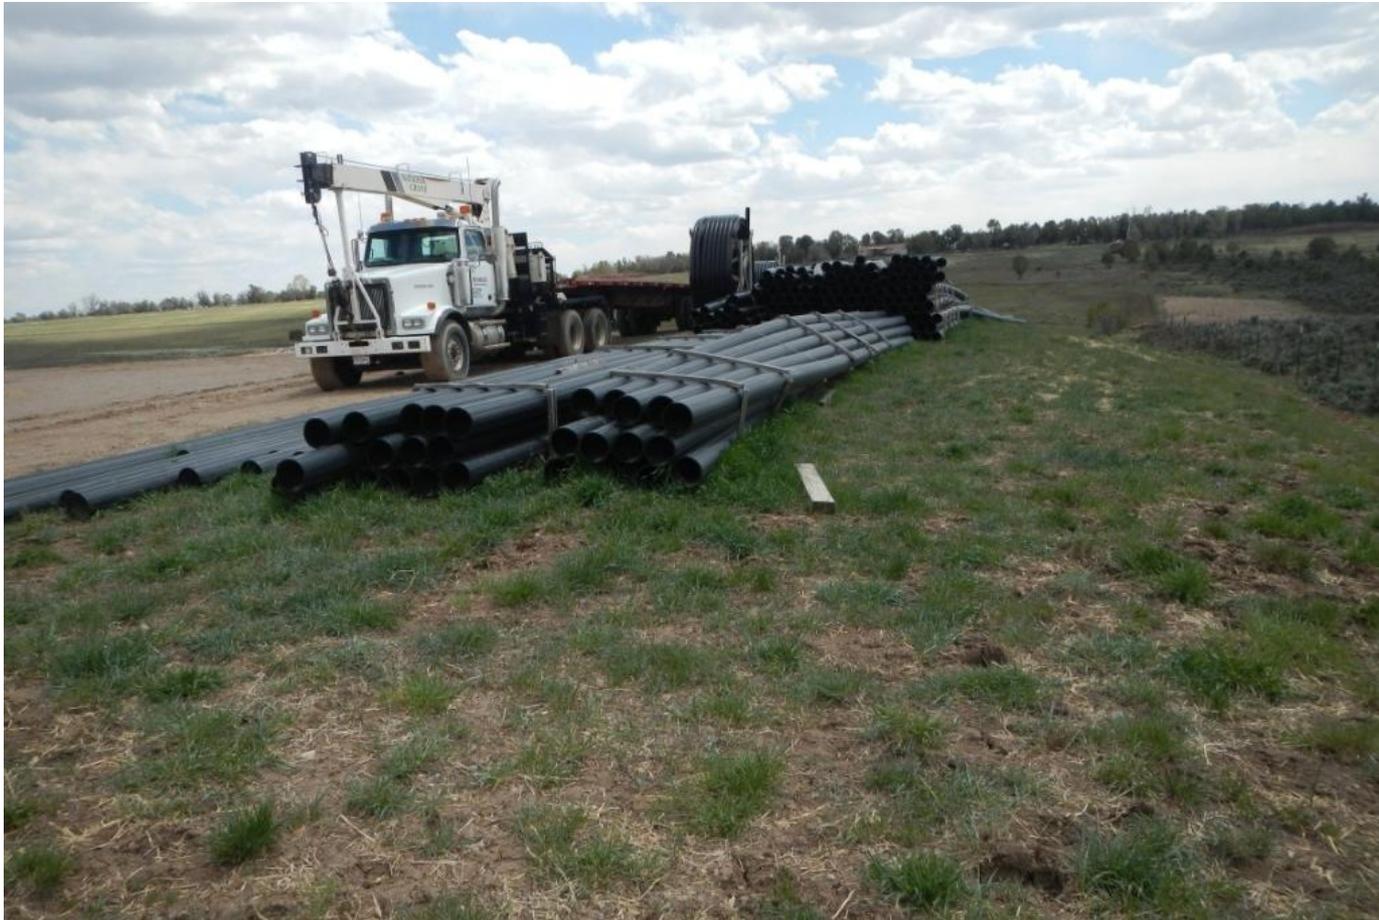
Photo 1. View of unused equipment and vegetation within the southwestern portion of the project area.

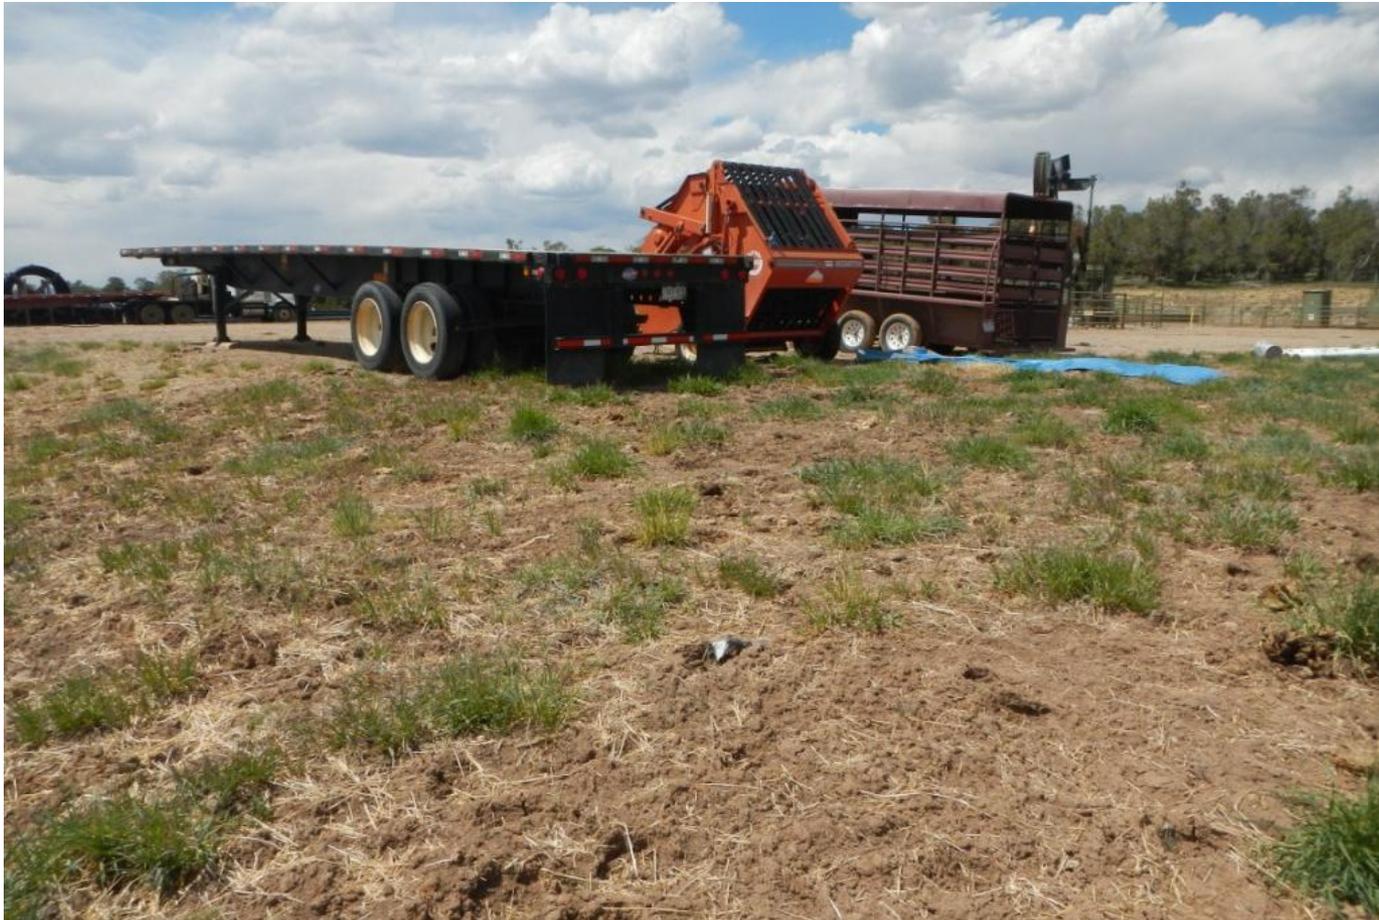
Photo 2. View of unused equipment within the southeastern portion of the project area.

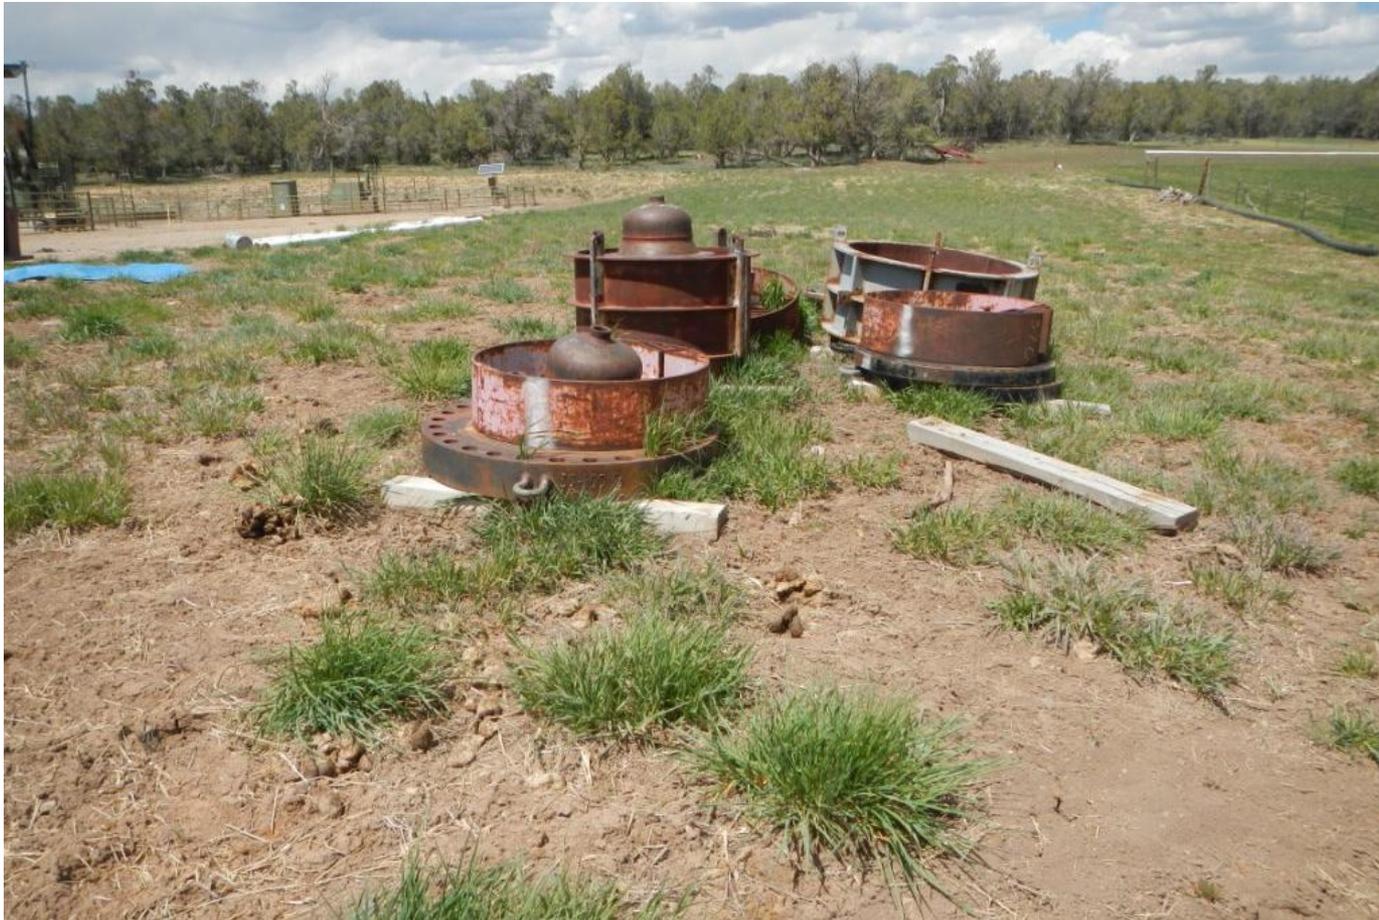
Photo 3. View of more unused equipment within the southeastern portion of the project area.

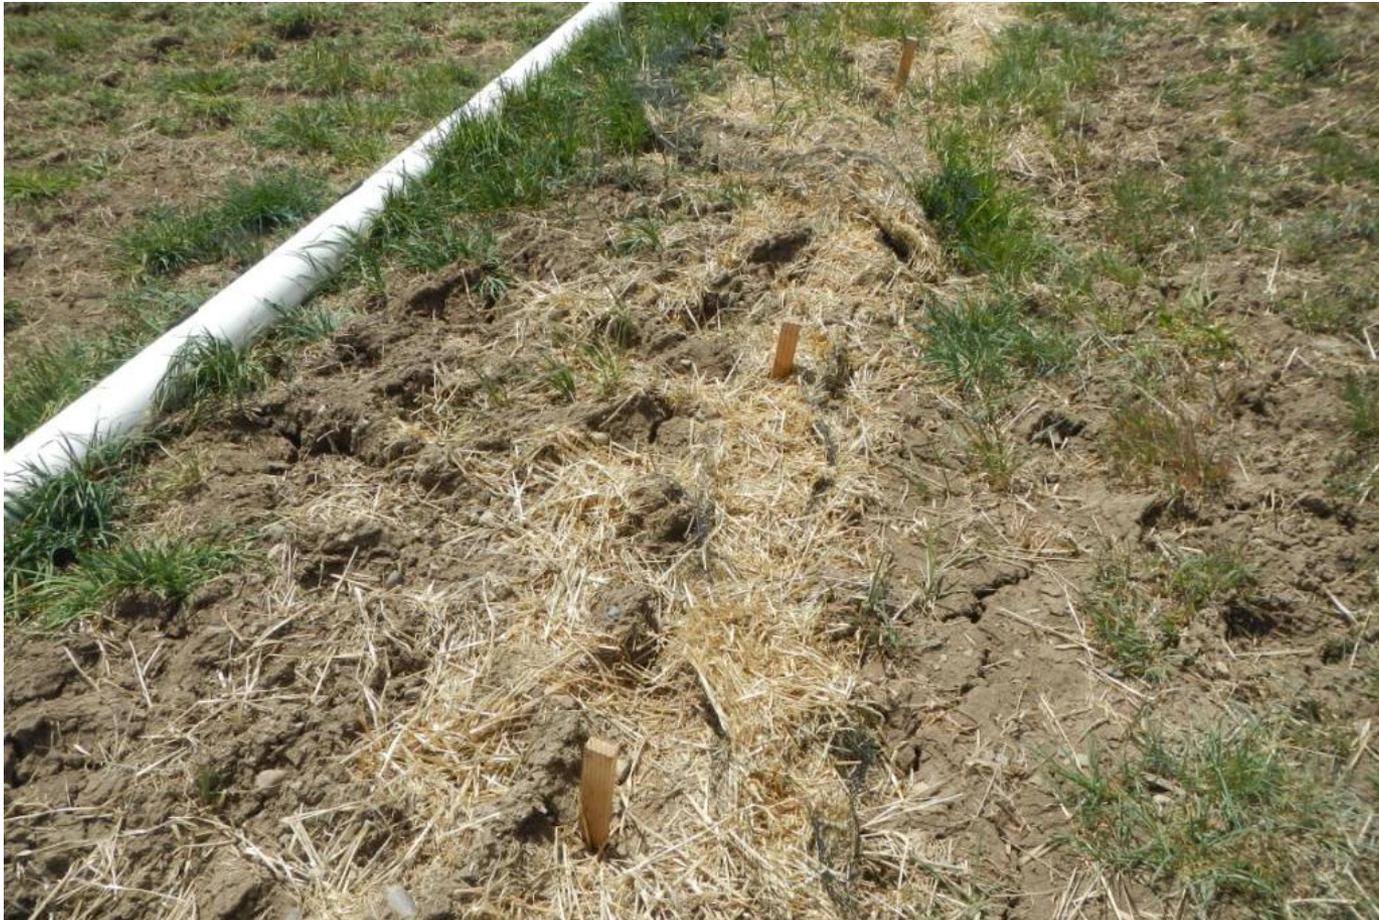
Photo 4. View of straw wattles that appear to have been grazed (see adjacent hoof prints).

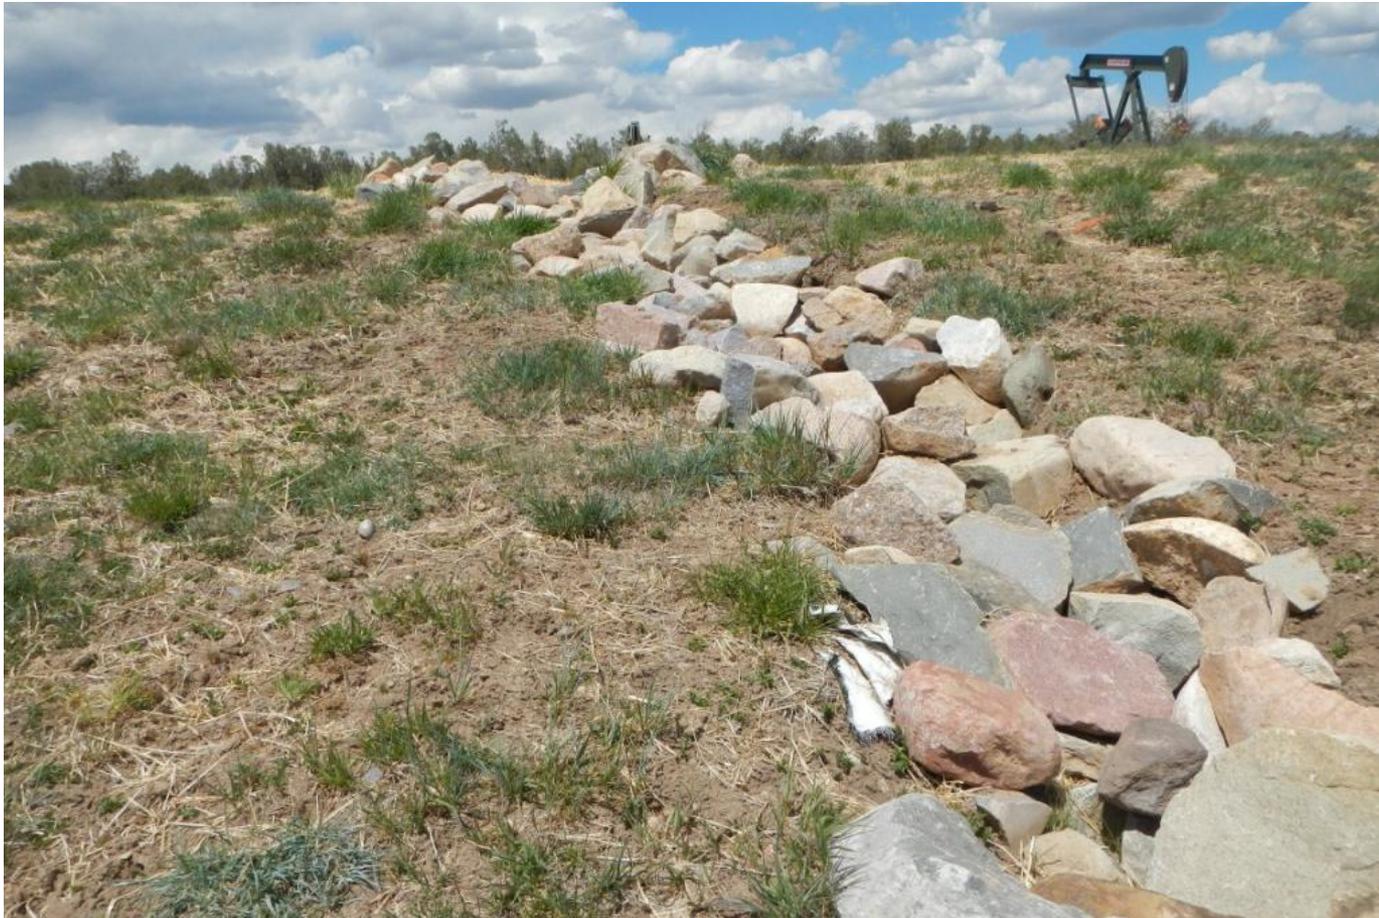
Photo 5. View of stormwater BMP and vegetation along southern slope of project area. These appear to be helping stabilize the location.

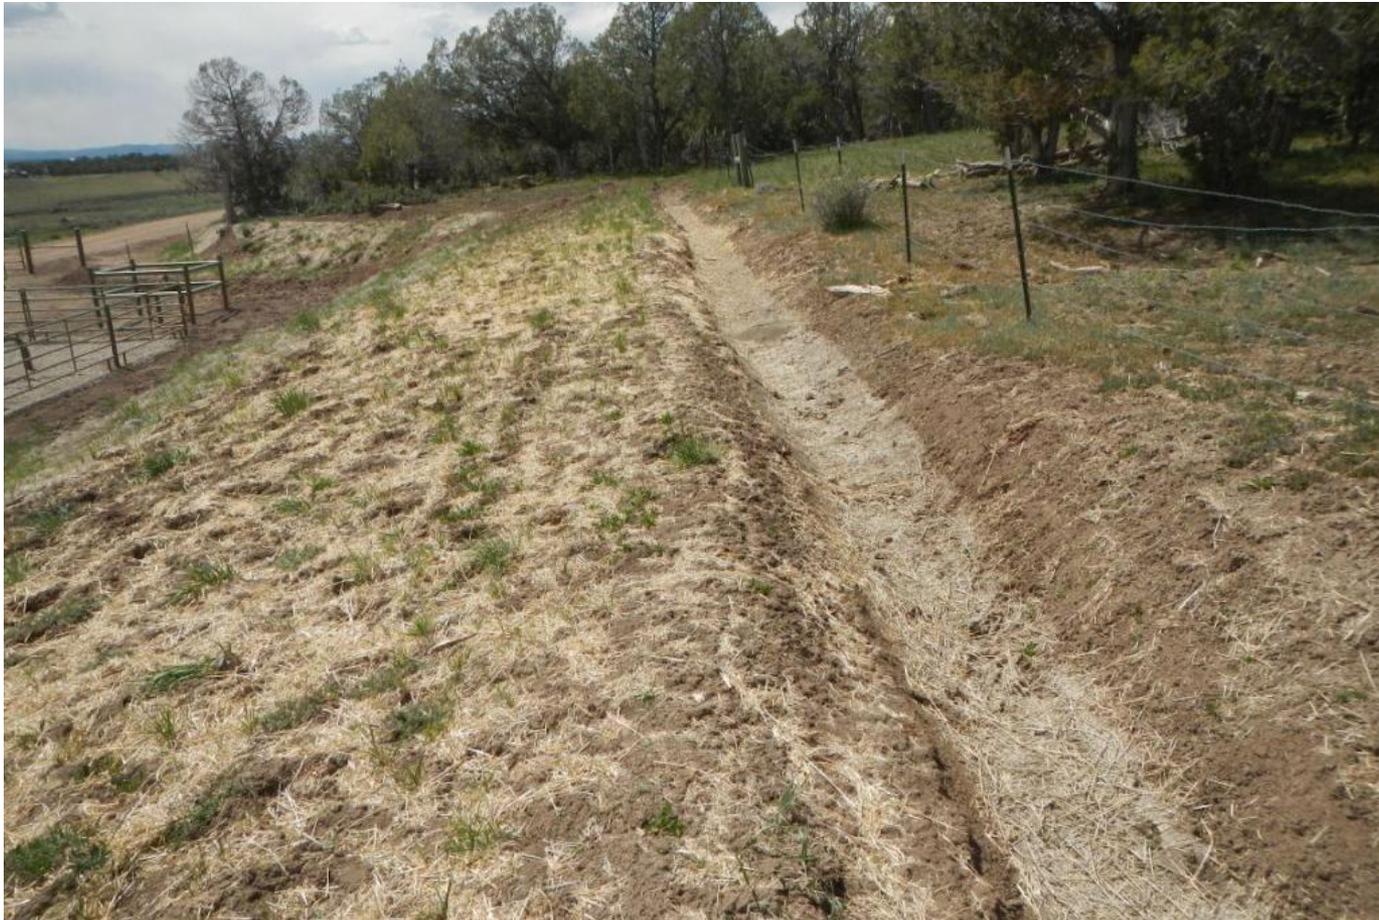
Photo 6. View of stormwater diversion drainage with straw blanket along northern edge of project area facing westward.
