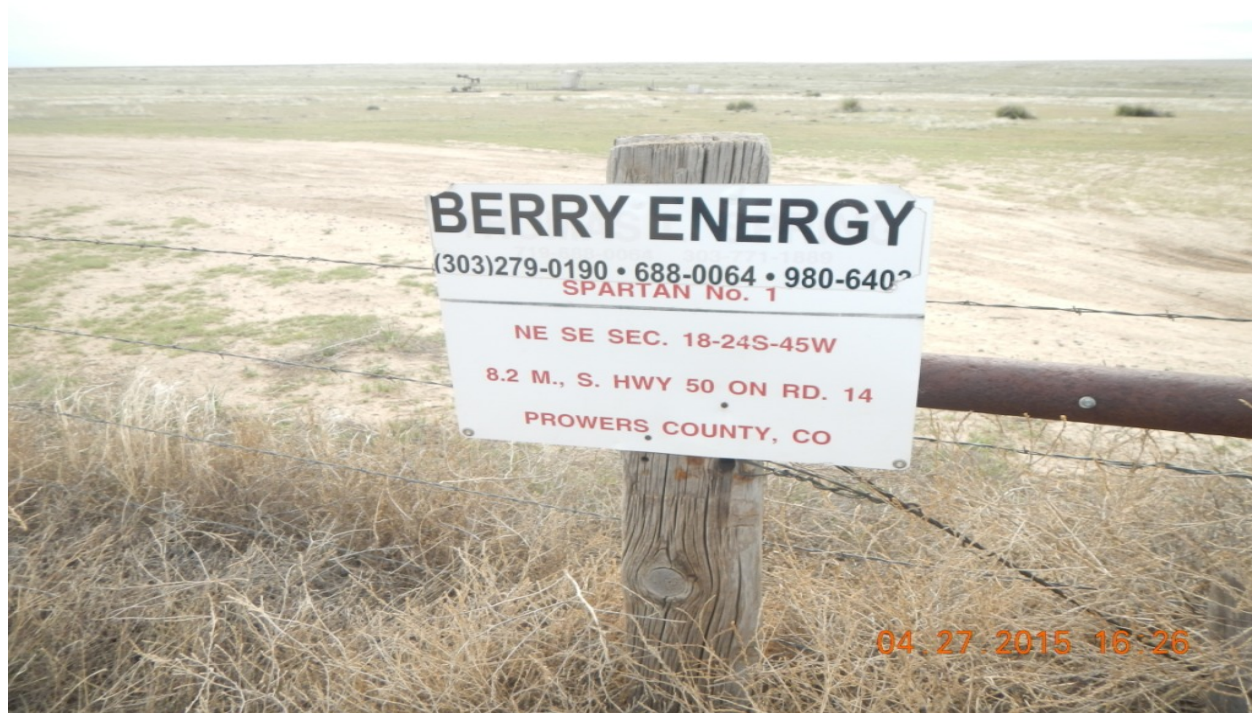
photo 1: Well sign at the beginning of the access road

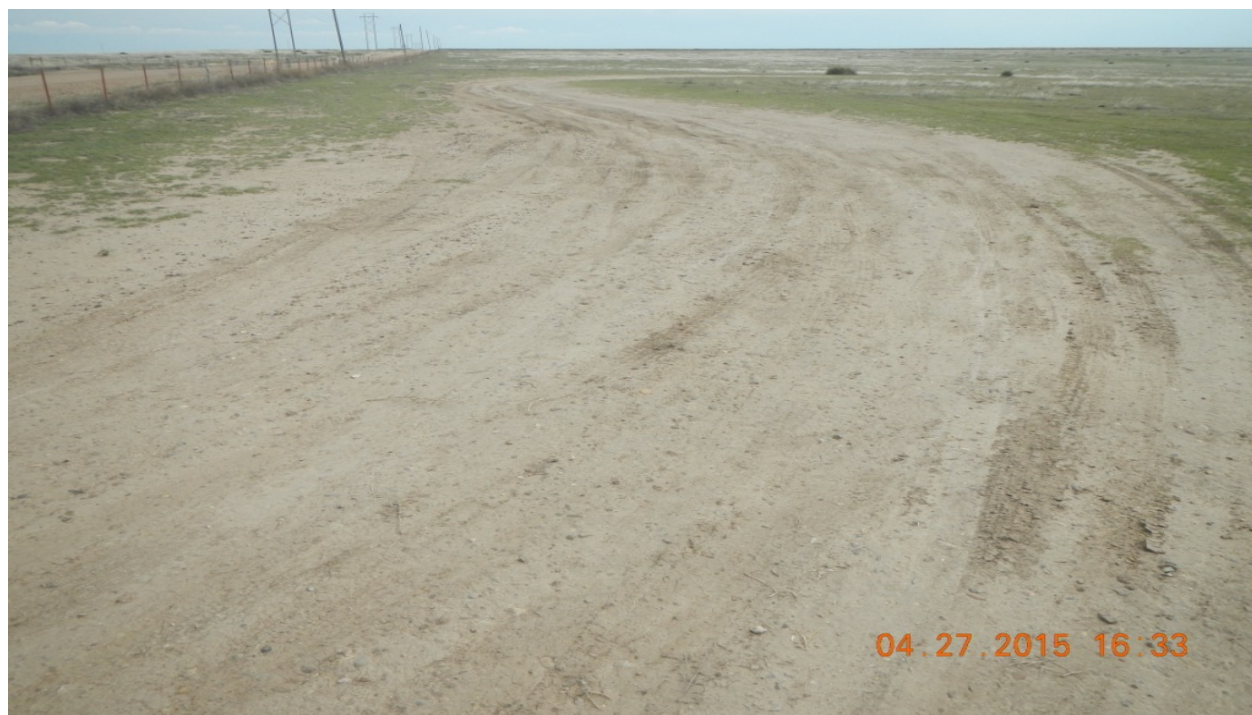
photo 2: Access road to the location has been widened to approximately 50 ft.

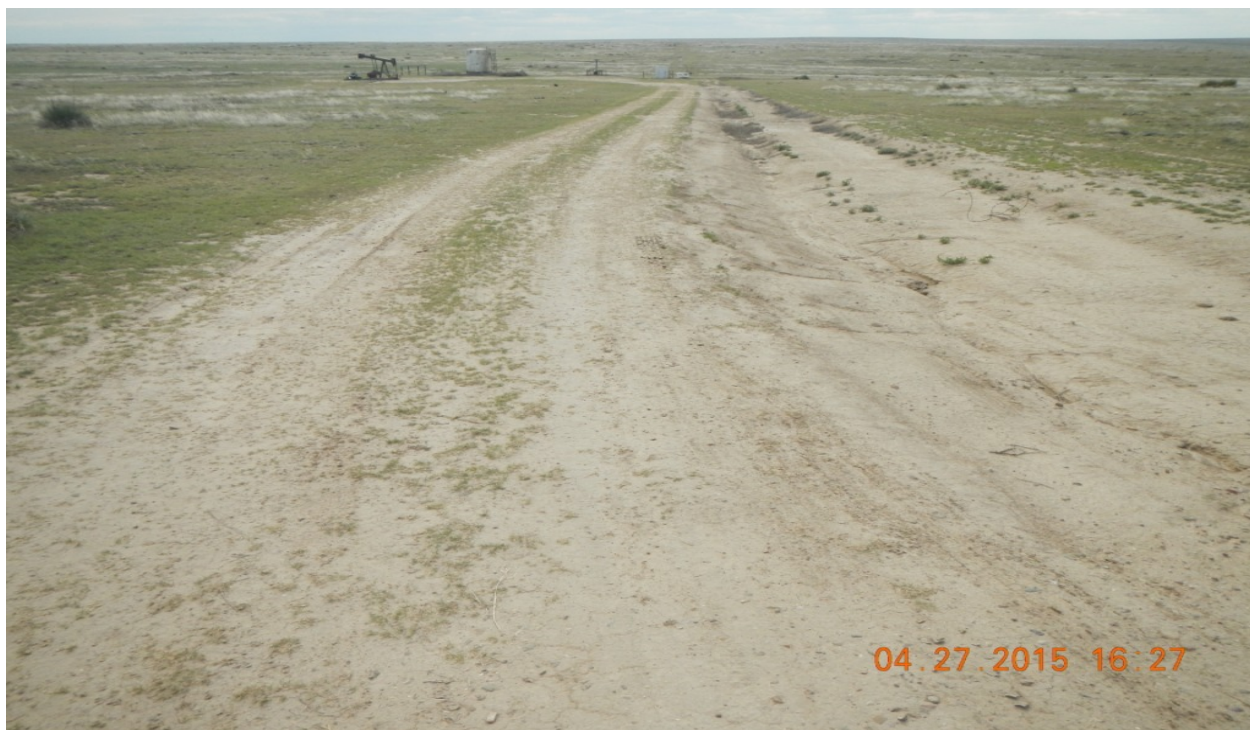
photo 3: Access road west to the location has been routed around the original access road.

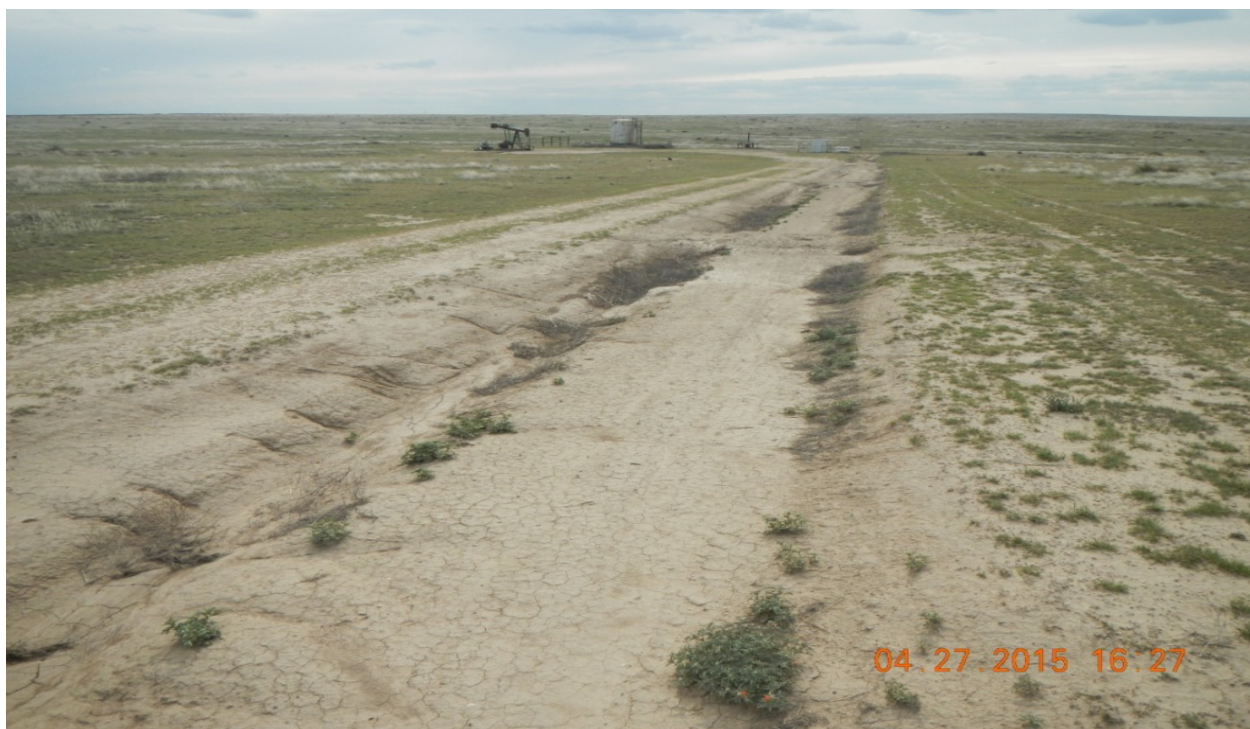
photo 4: Erosion along the old access road has caused vehicle traffic to widen the road to approx. 50 ft.

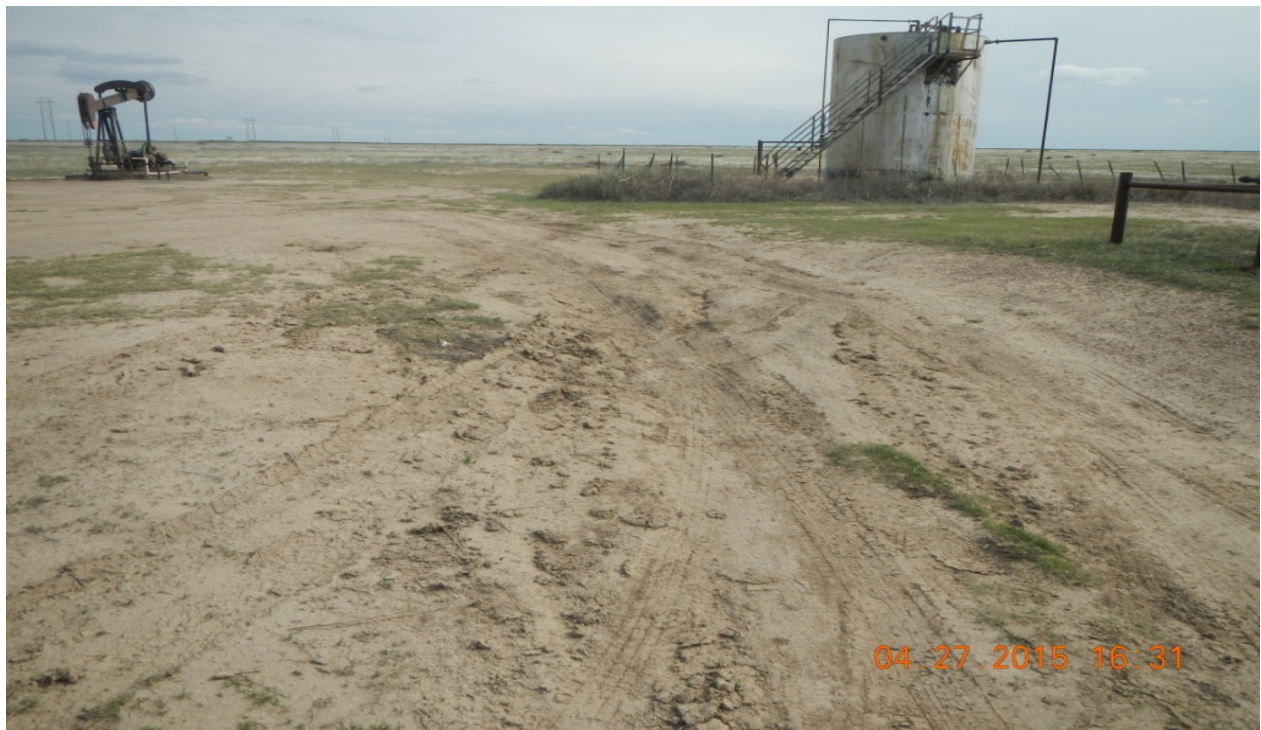
photo 5: Center of the location facing south towards the production equipment.

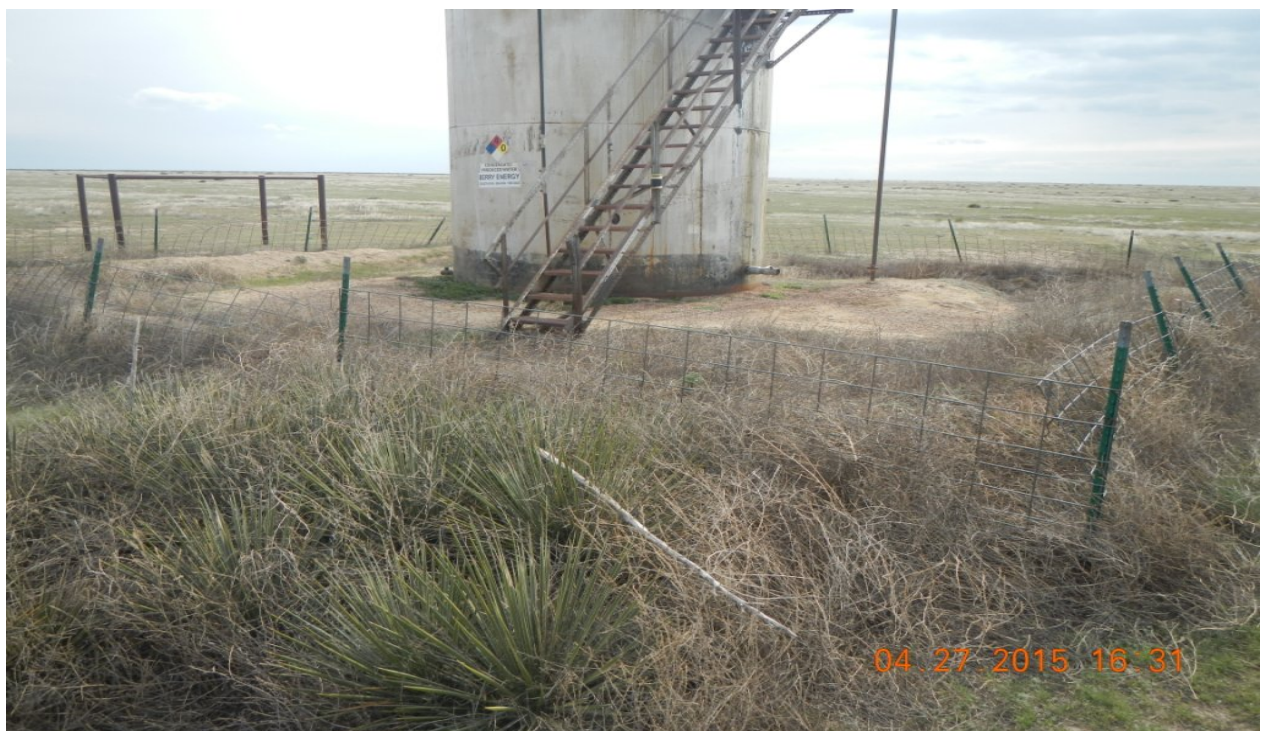
photo 6: Tank battery at the location.

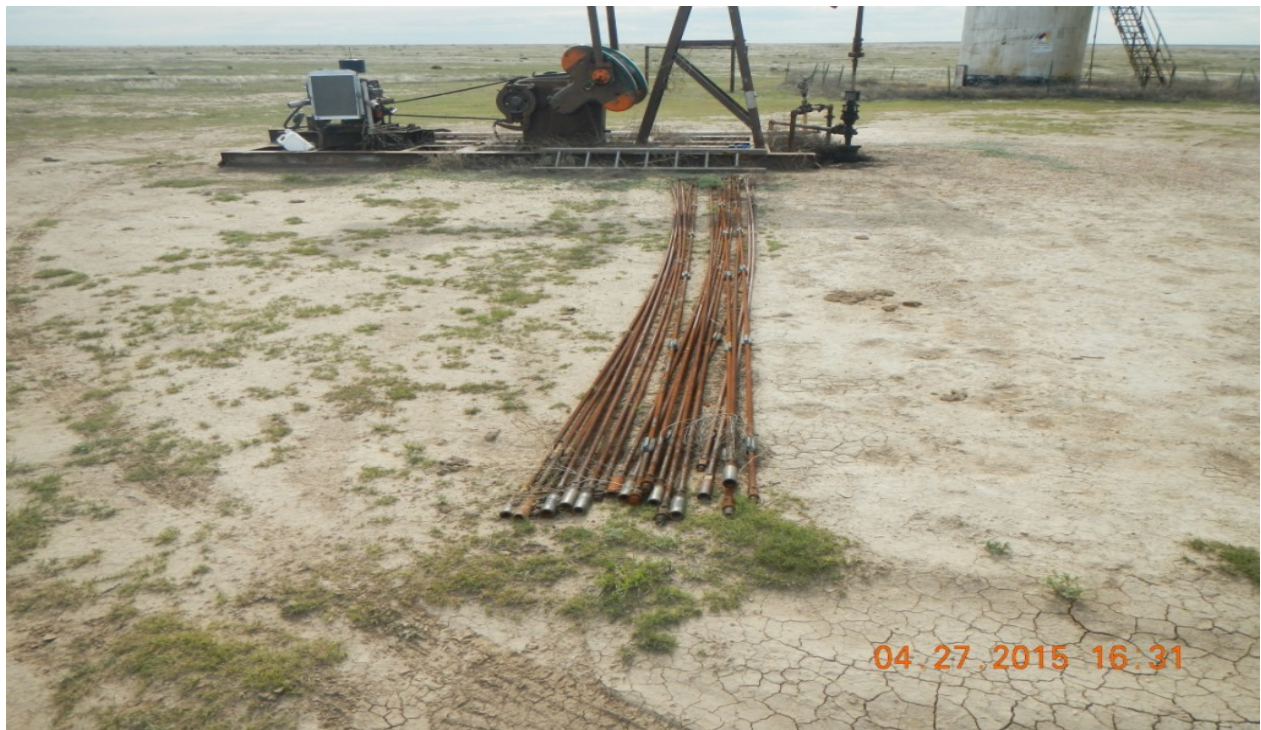
photo 7: Unused pipe near the pumpjack.

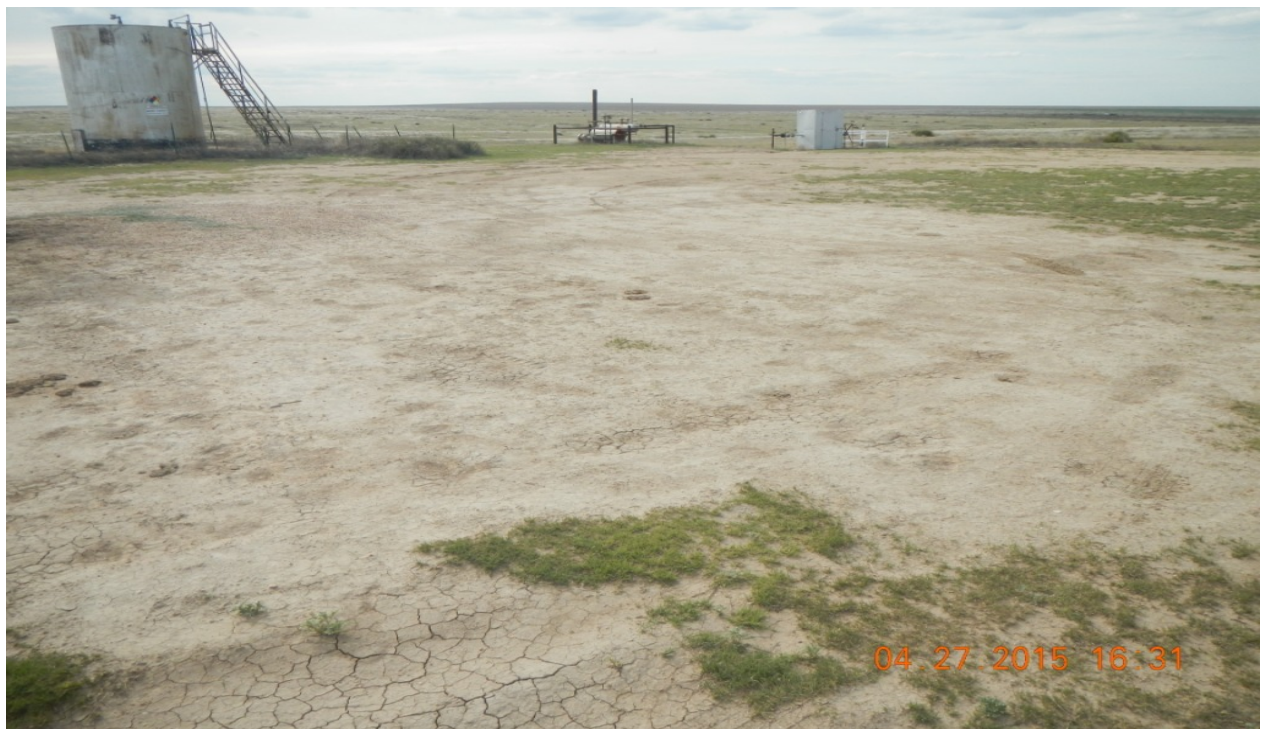
photo 8: Facing north at the location.
