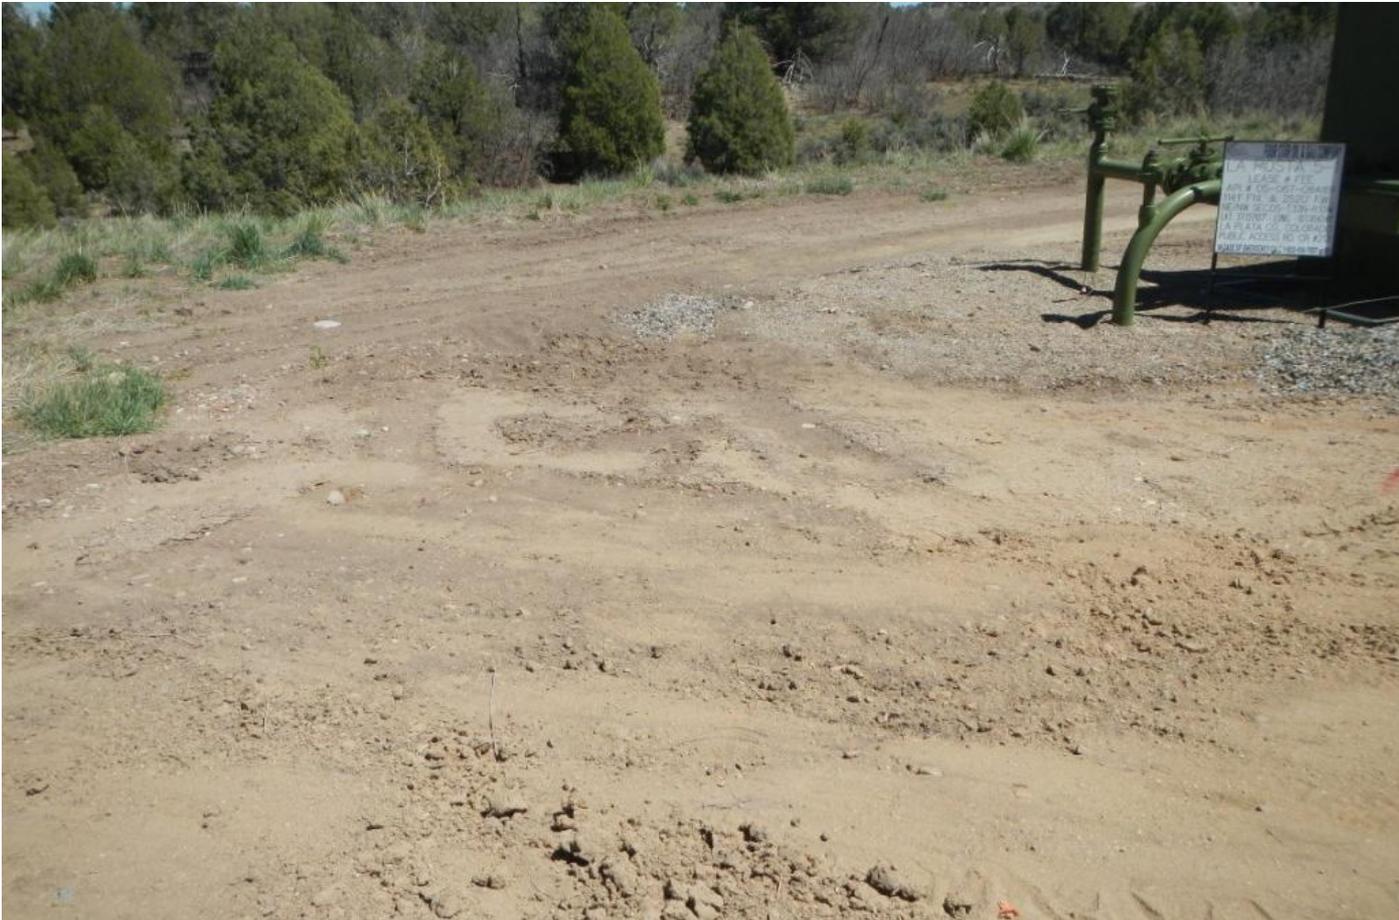
Photo 1. View of erosional feature that has been re-graded in northern portion of project area.

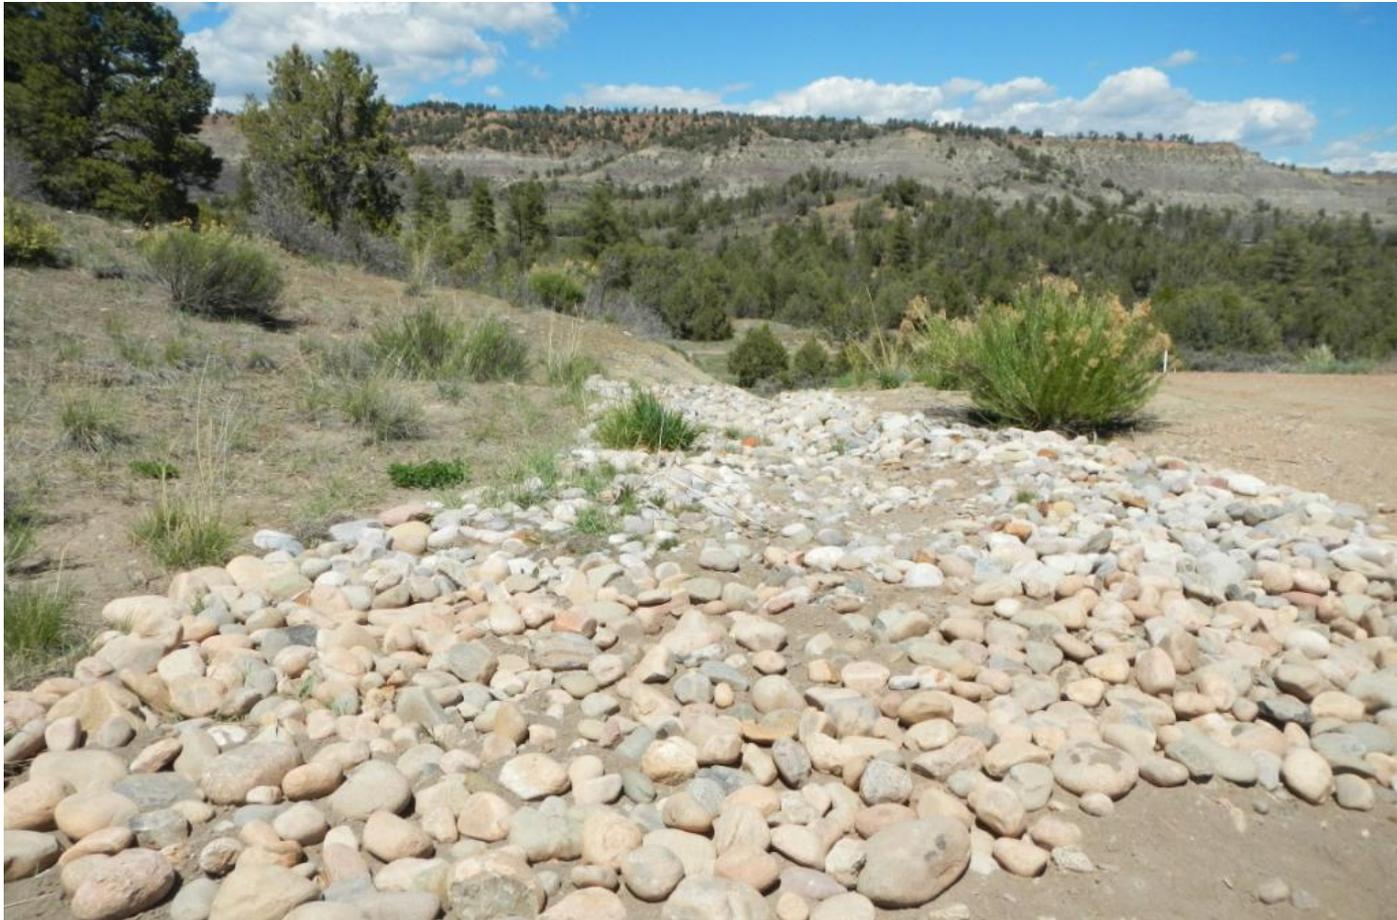
Photo 2. View of cobble on well pad surface where it appears that concentrated stormwater flows exit the project area.

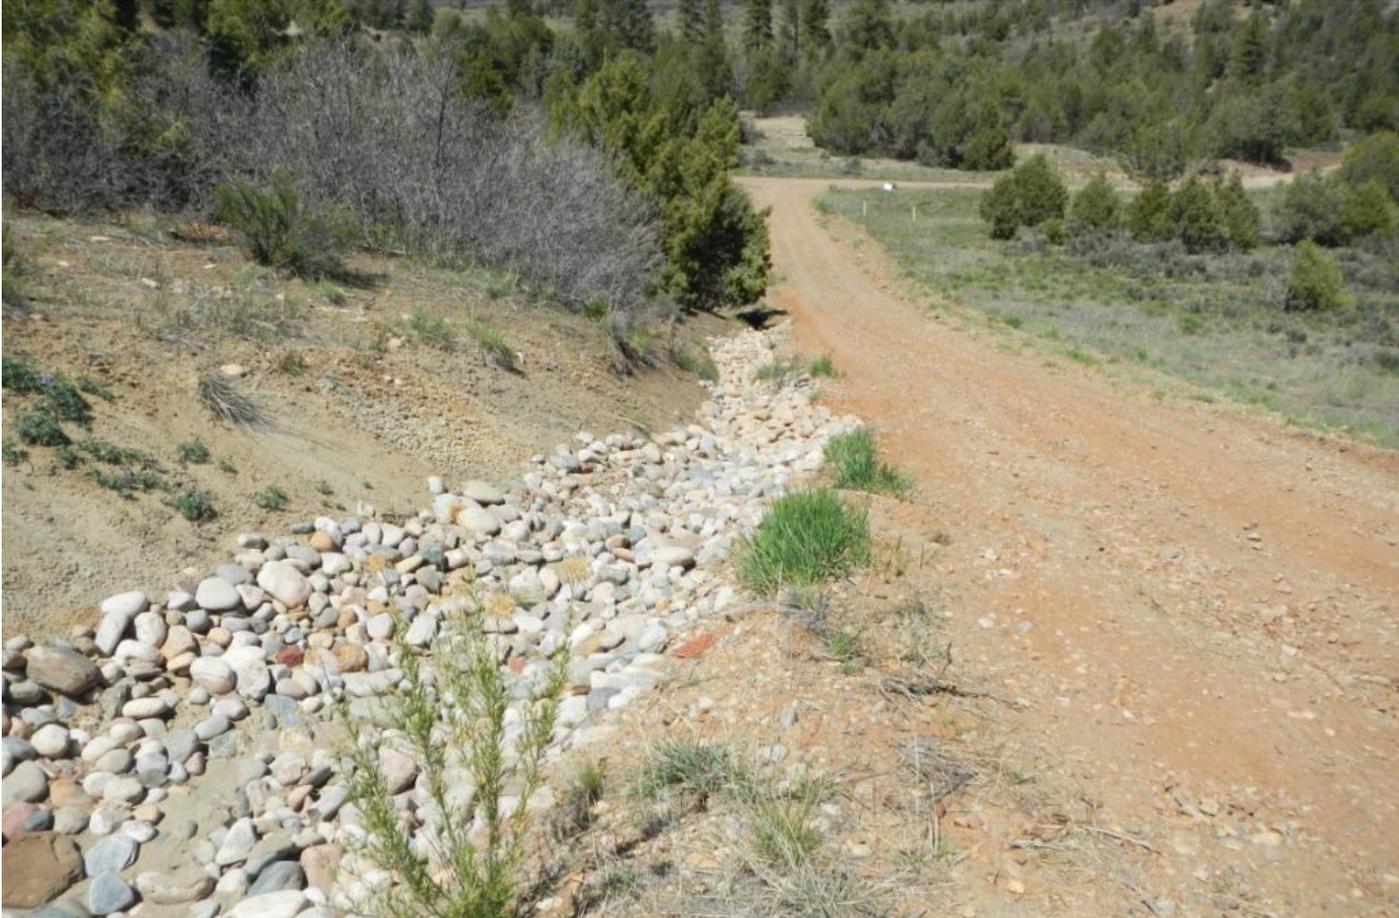
Photo 3. View of cobble lining along drainage adjacent to access road.

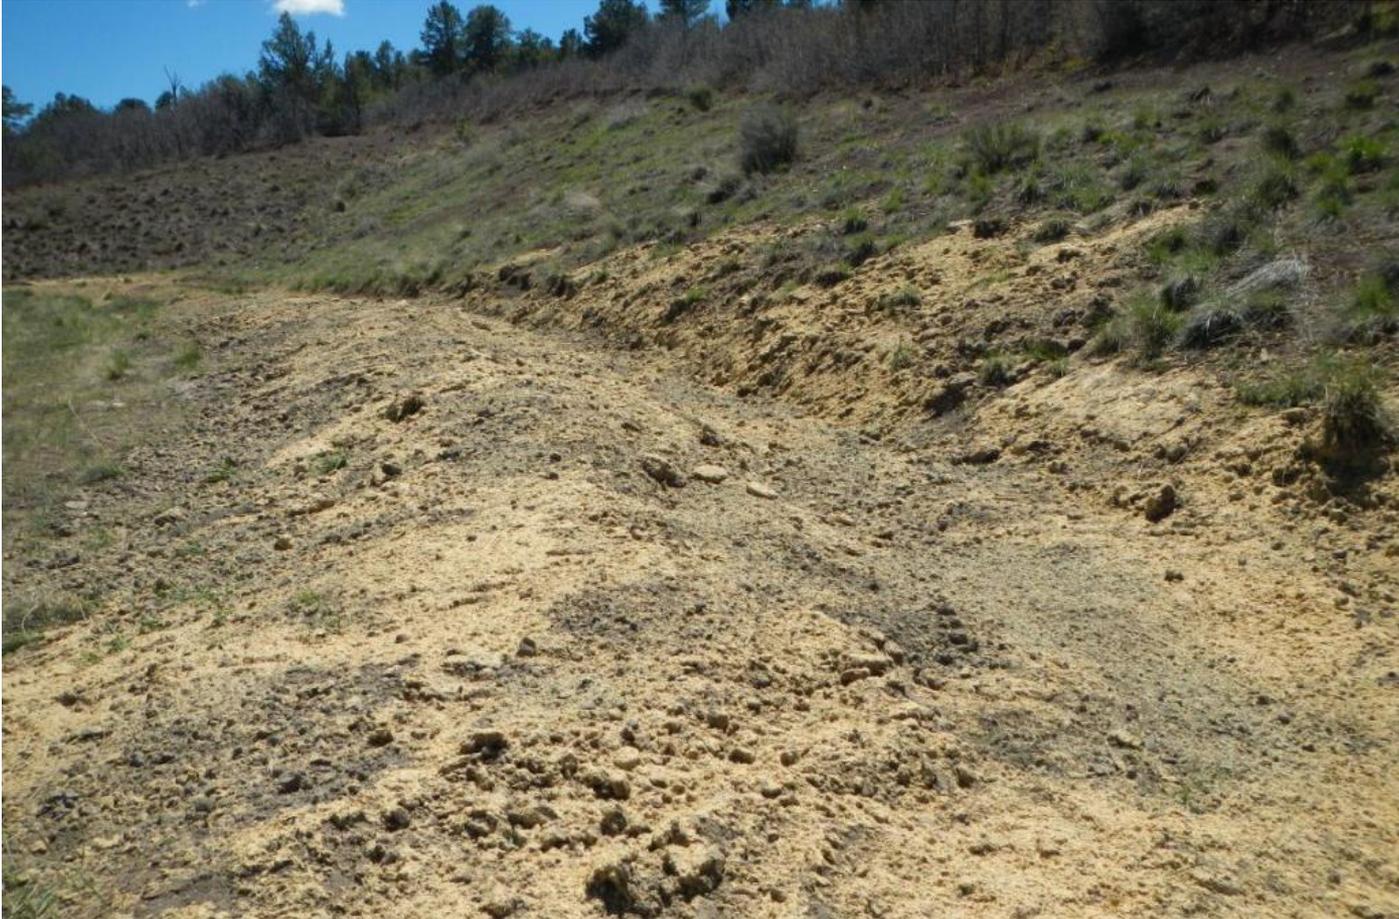
Photo 4. View of hydromulch on southern stormwater diversion channel and berm.
