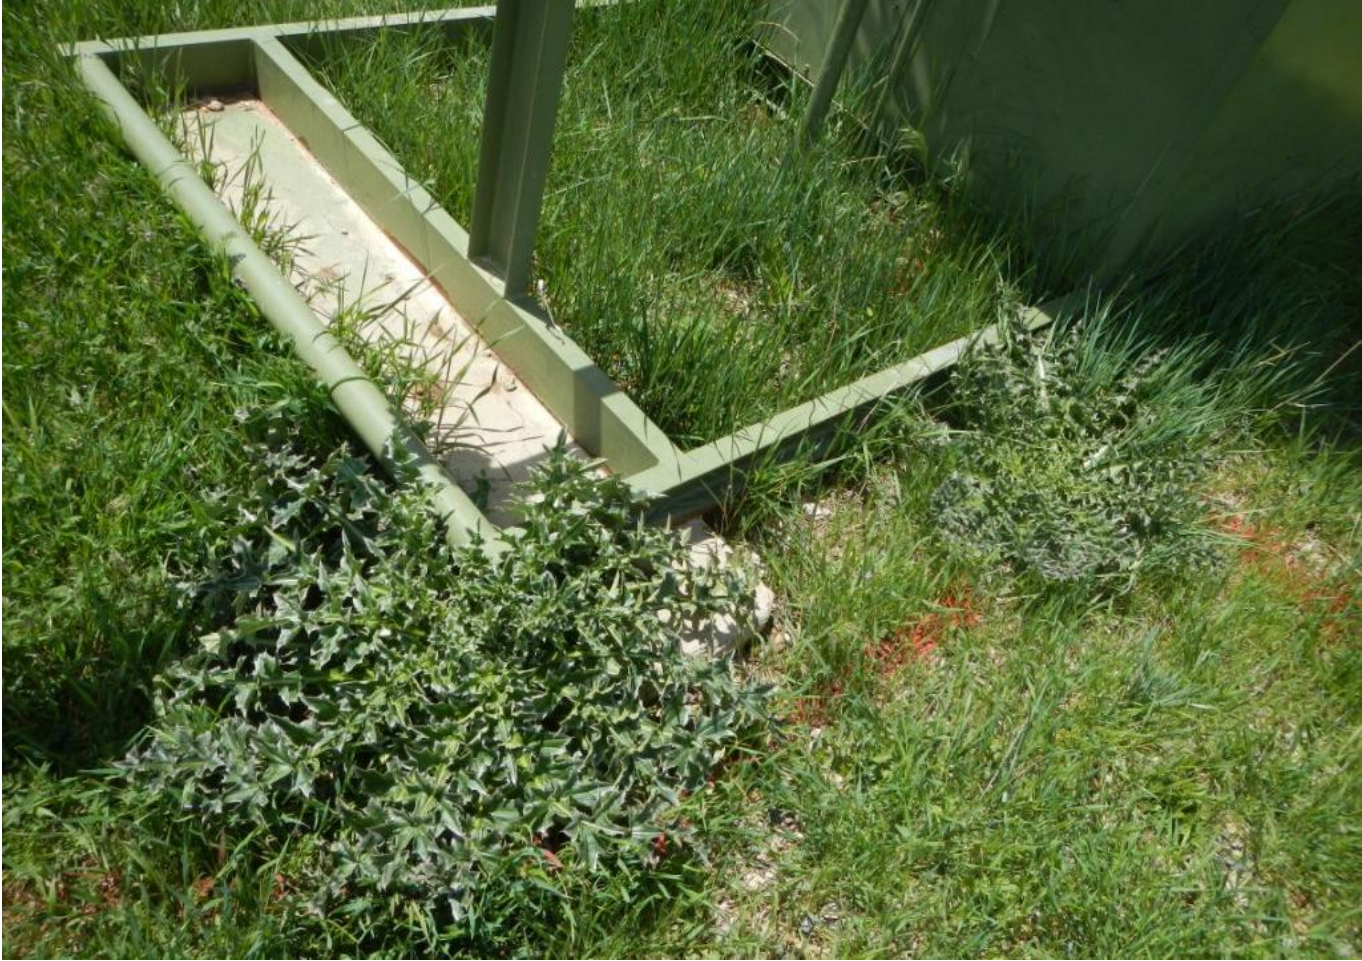
Photo 1. View of musk thistle (*Carduus nutans*) within the project area.

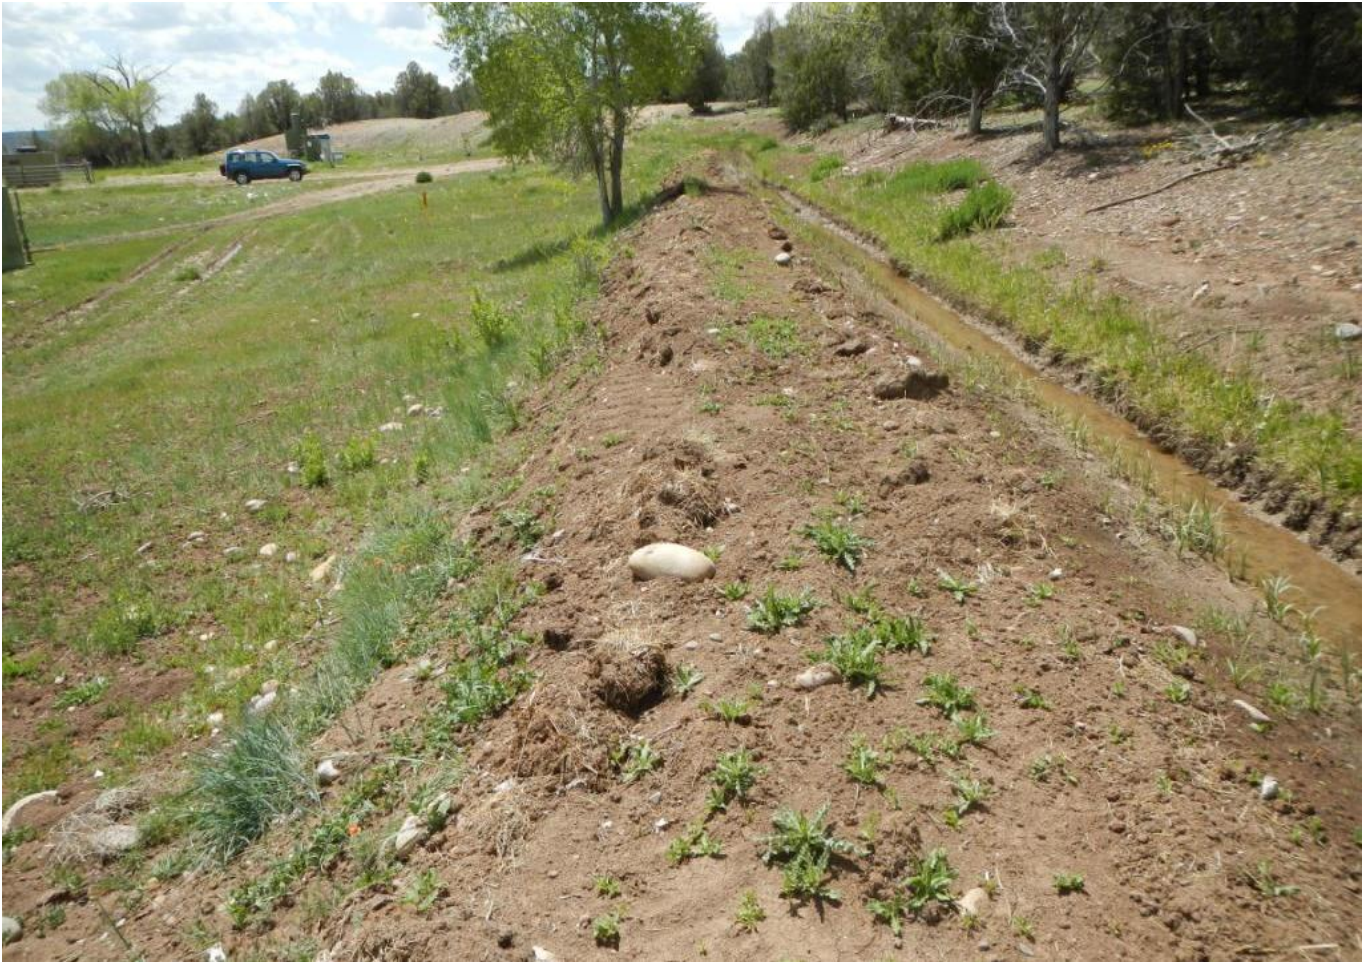
Photo 2. View of Canada thistle (*Cirsium arvense*) along the western ditch bank.

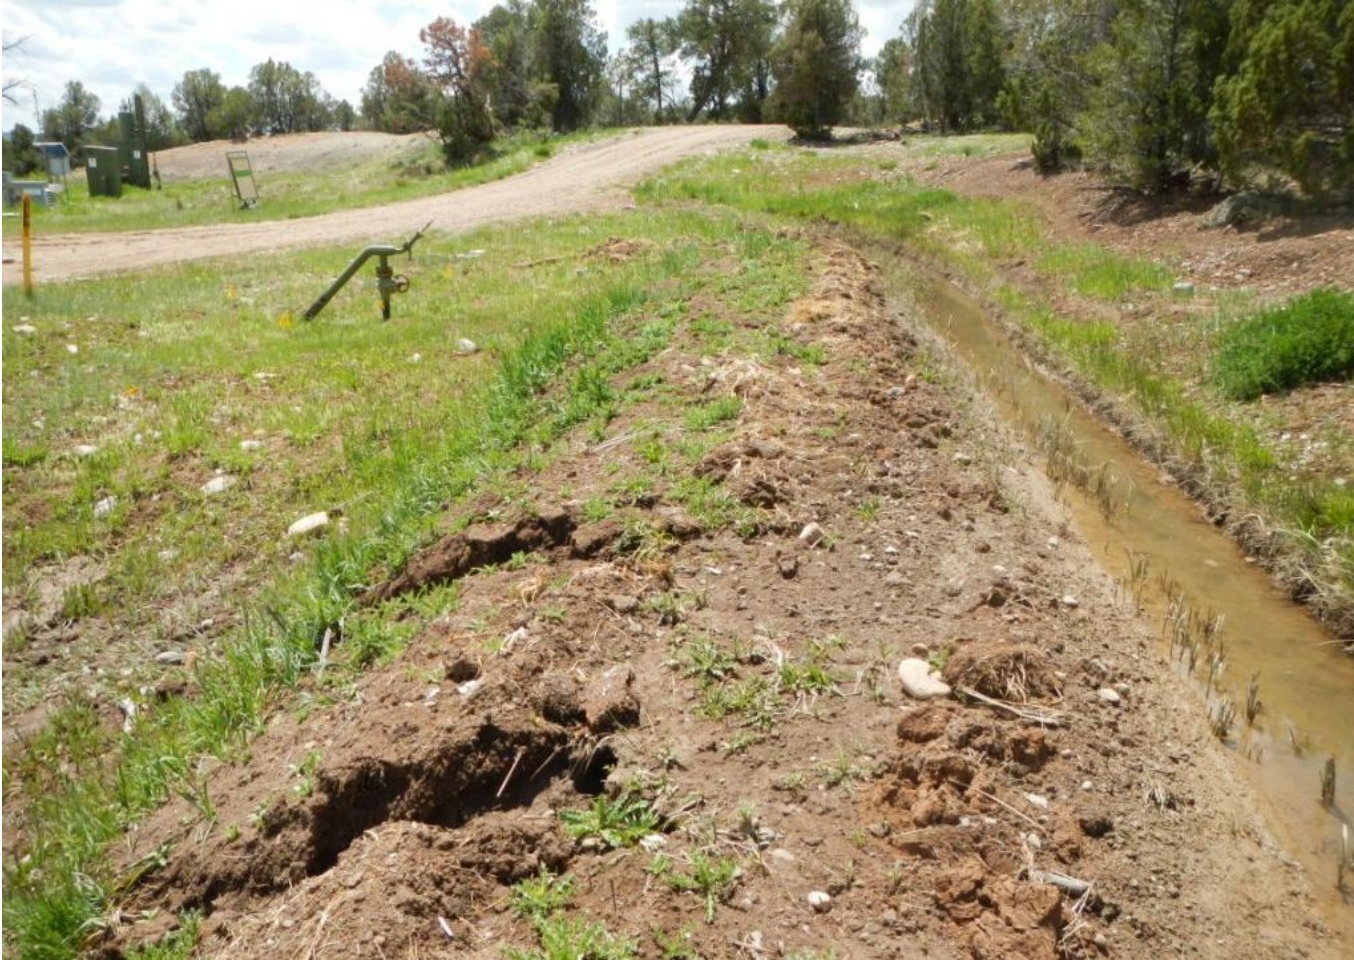
Photo 3. View of erosion where it appears ditch bank has breached along western edge of project area.

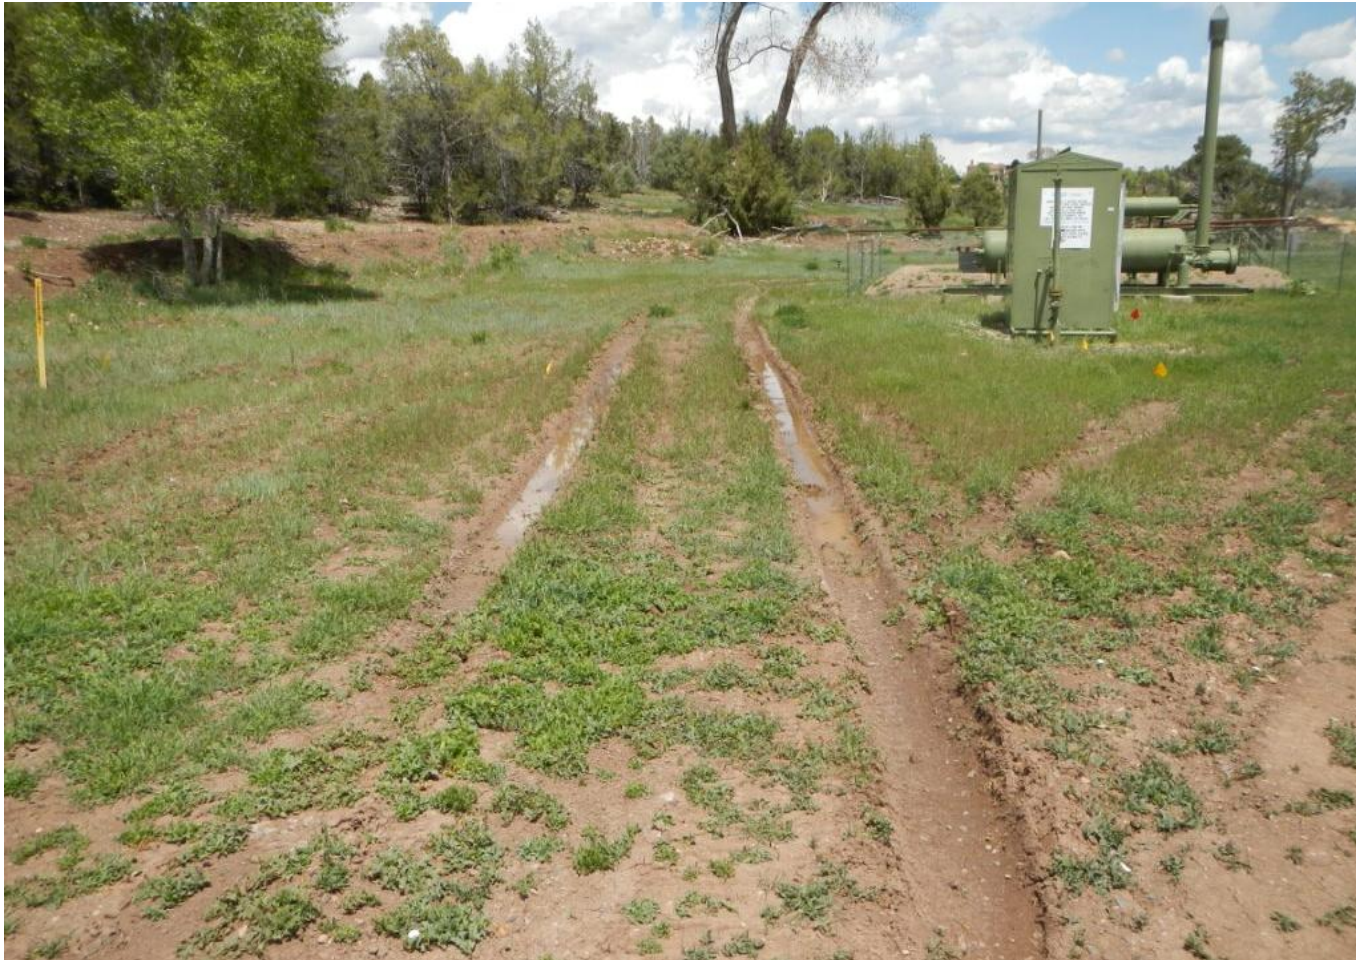
Photo 4. View of standing water in driving surface of well pad.
