## Arroyo Project

Inspection# 6752010562

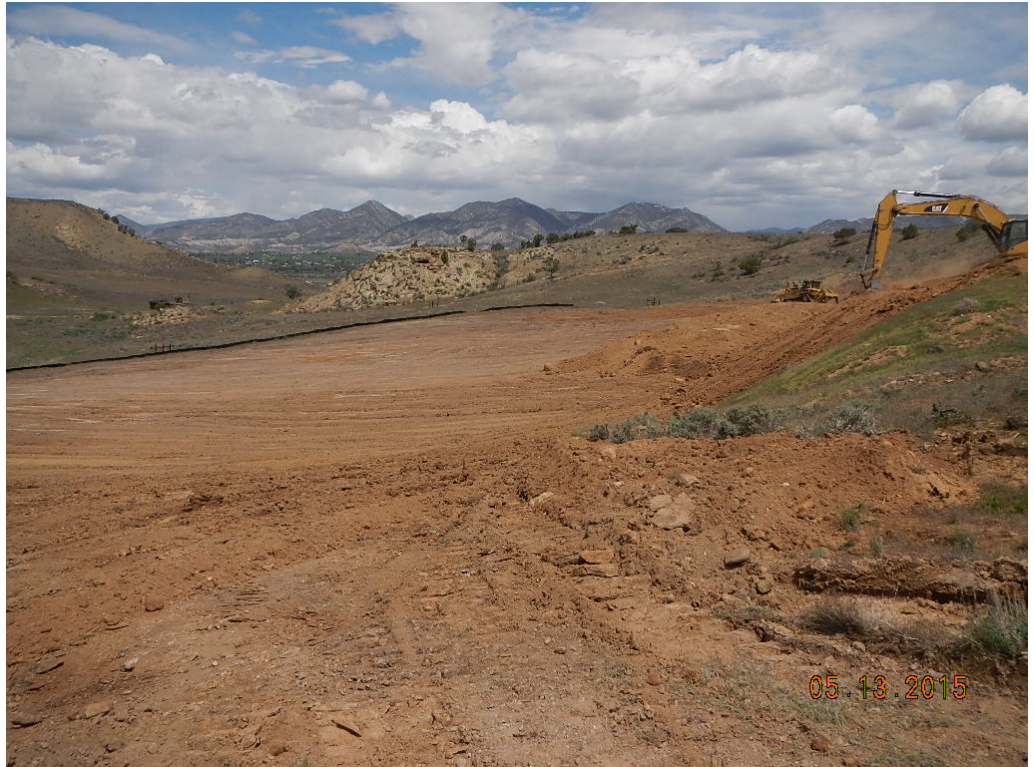
Location from SE corner. Top  
soil in process.

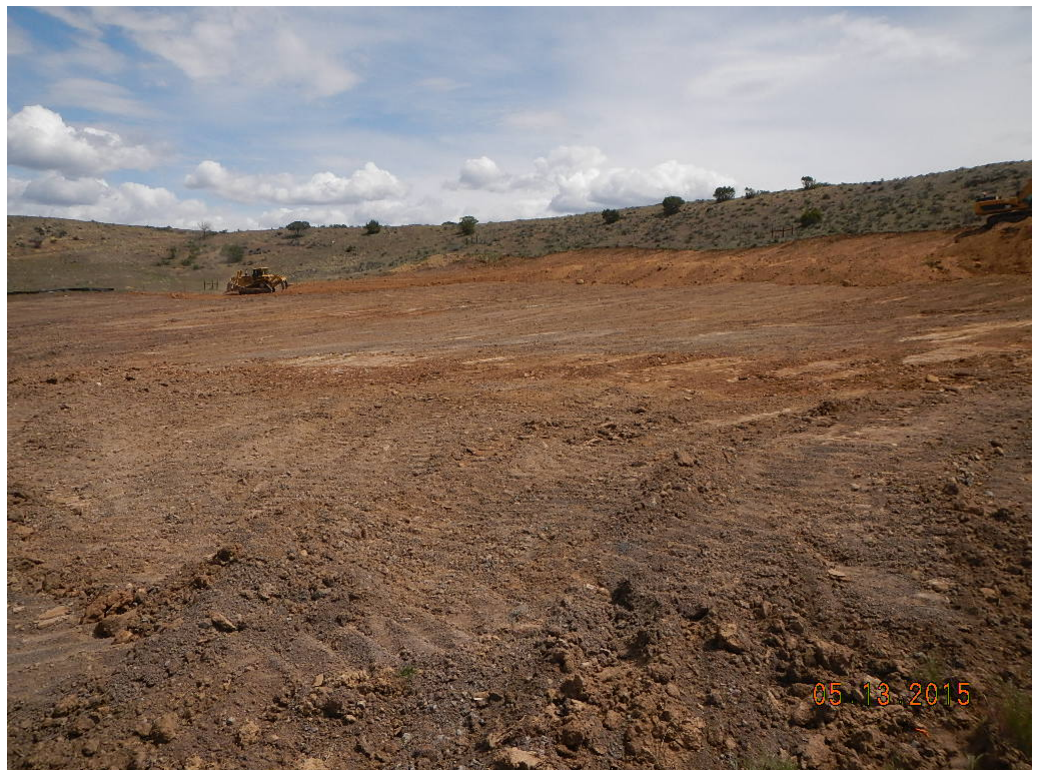
Location from SW corner.  
Top soil in process.

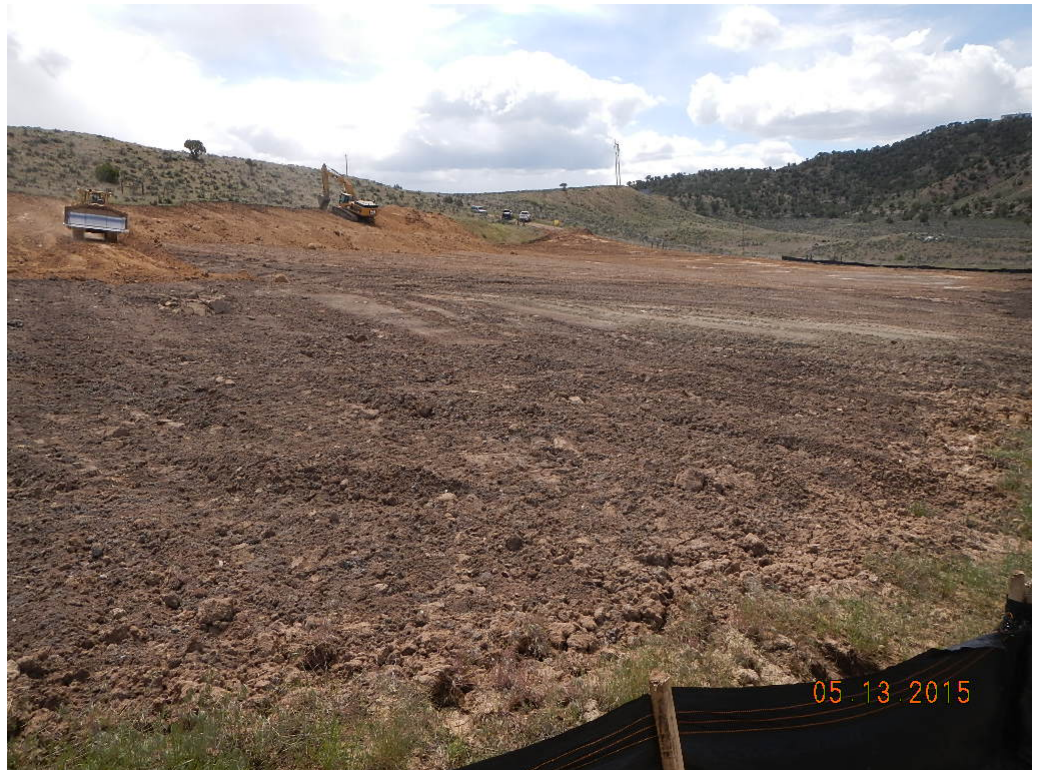
Location from NW corner.  
Top soil in process.

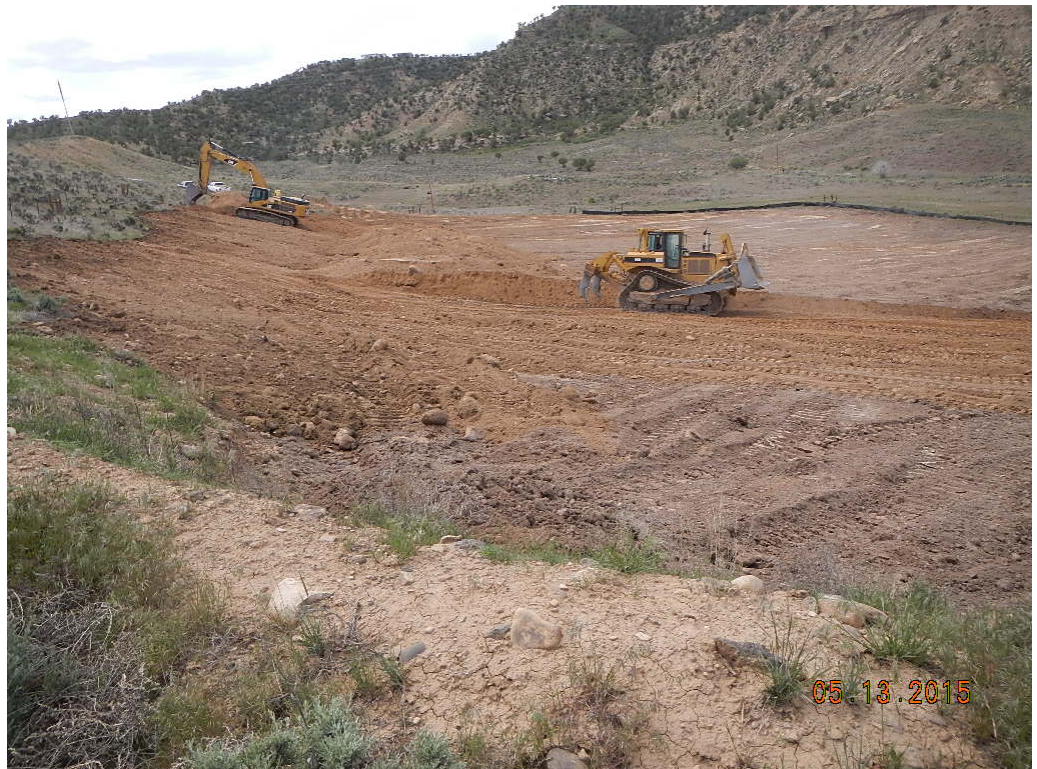
Location from NE corner.  
Top soil in process.

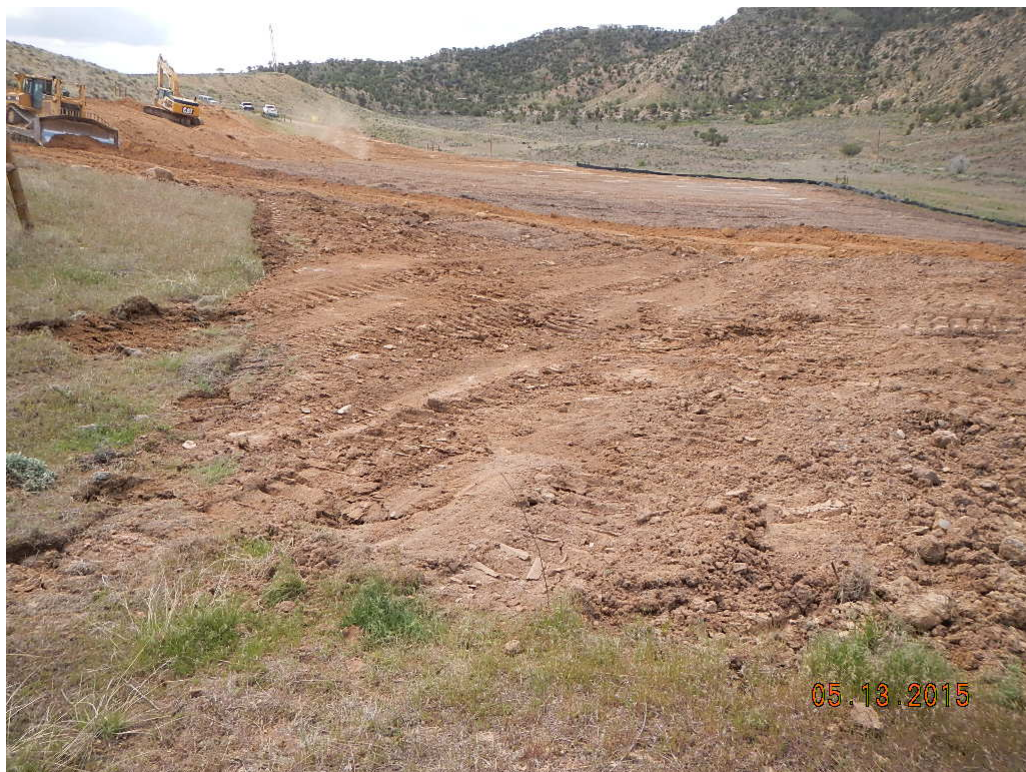
Drainage area on north side  
of location with depression  
for sediment retention.
