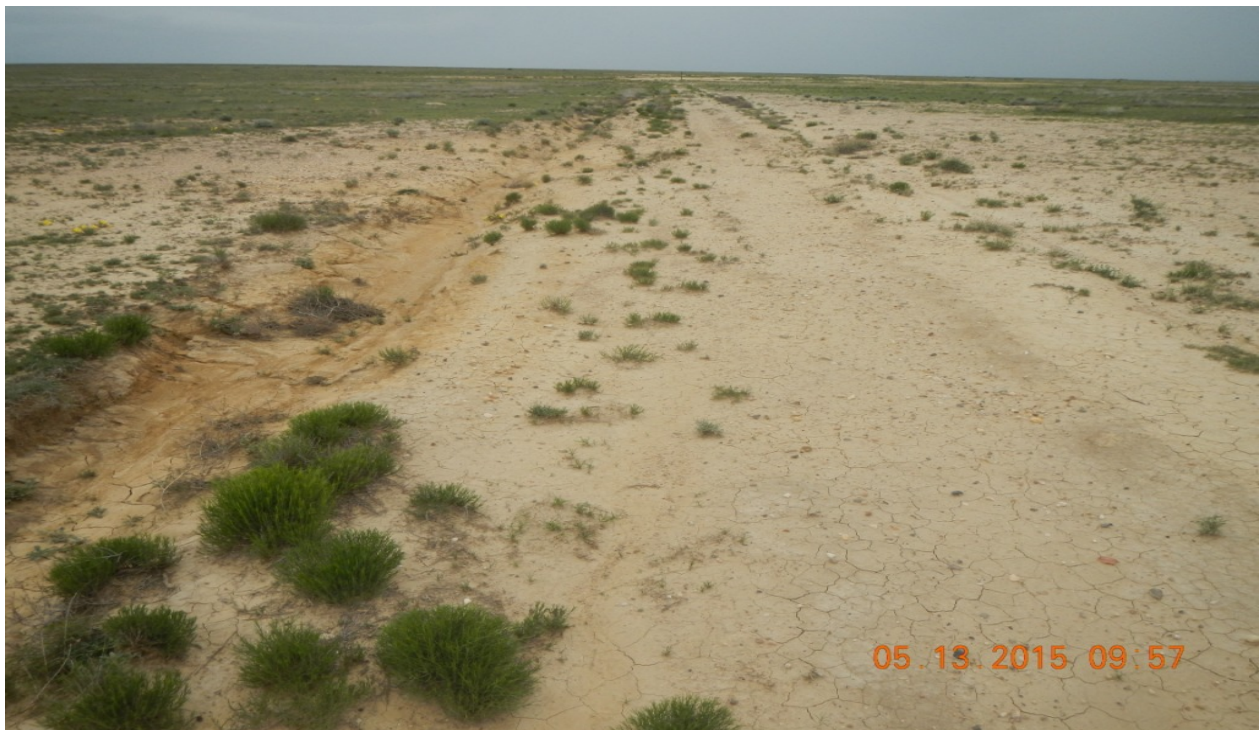
photo 2: Facing south along the access road. Erosion channel along the access road.

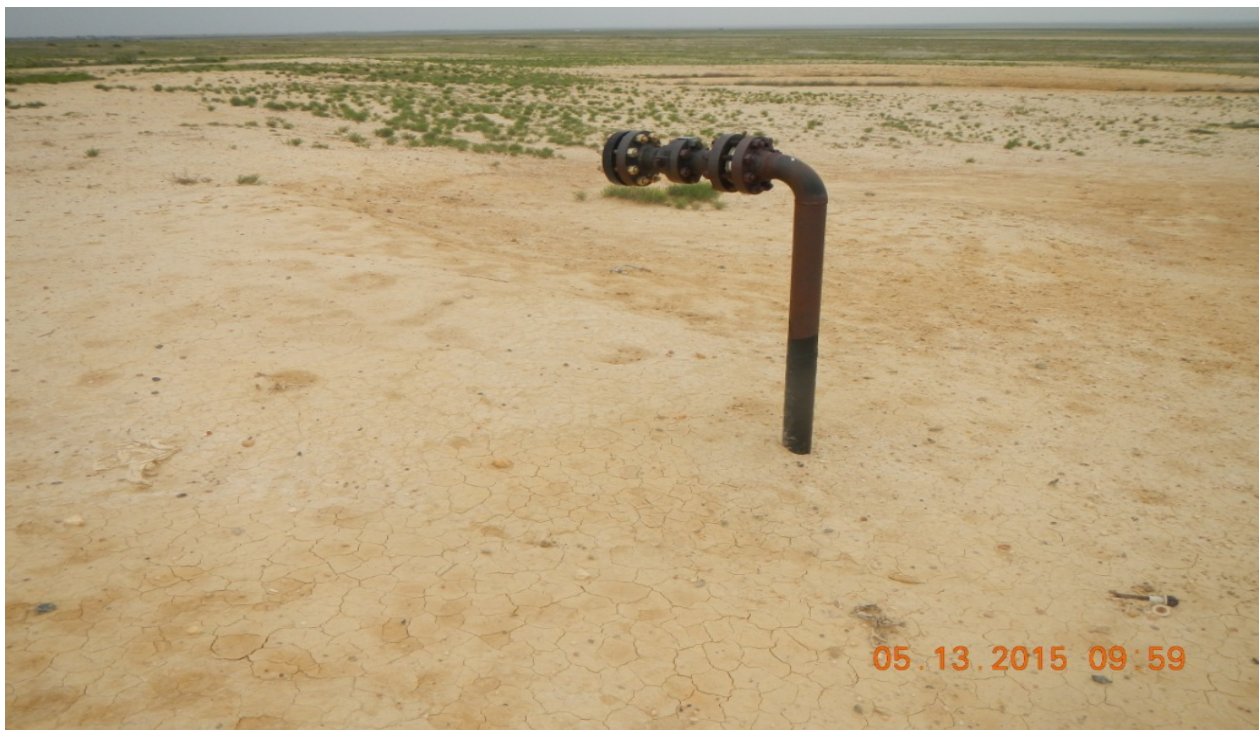
photo 4: Pipe riser remains on the location (Lat/Long: 38.38077, -102.69541).

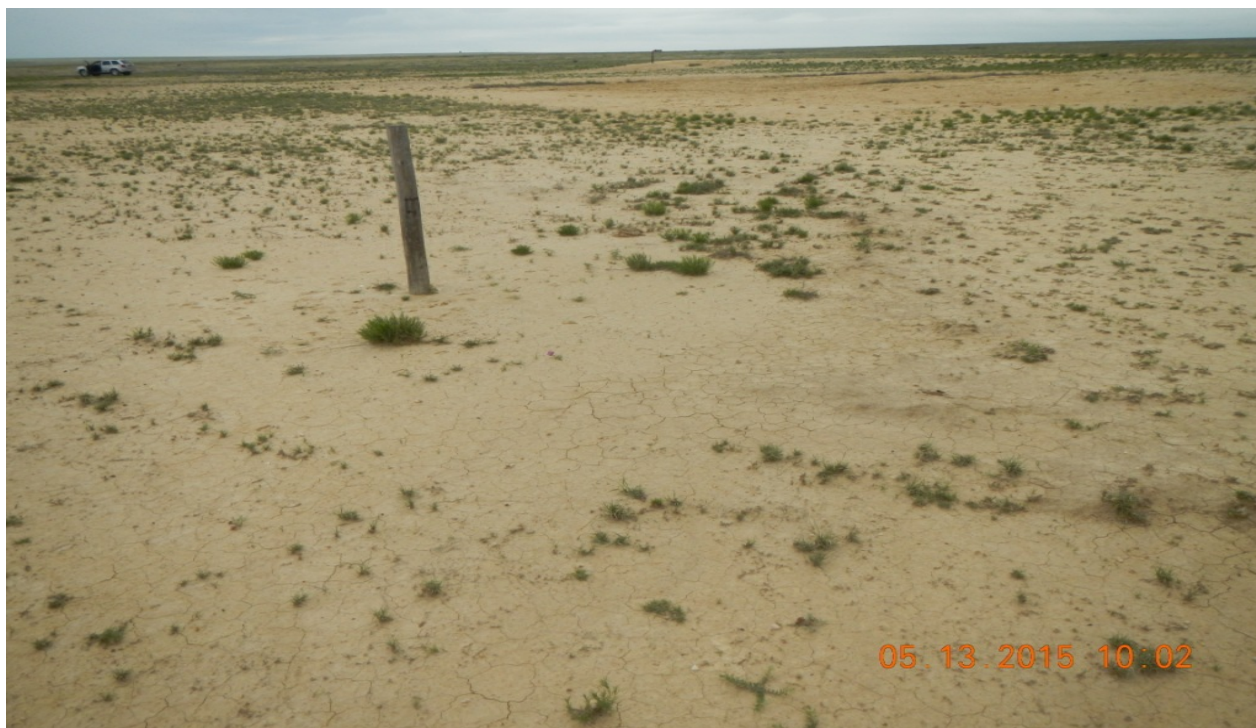
photo 11: Northwest of the location facing southeast towards the location. Wood post remains.
