photo 1: Well sign, Valdez 44-6V

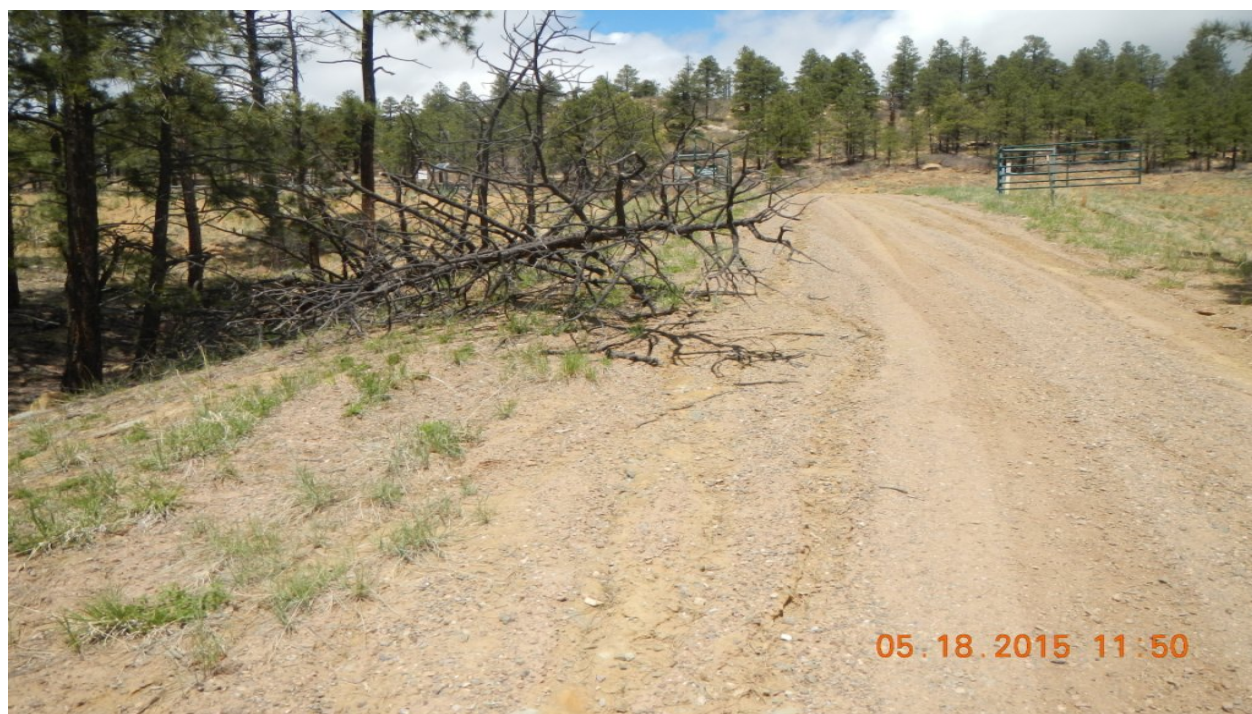
photo 2: Facing south along the access towards the location. Dead tree fell into roadway.

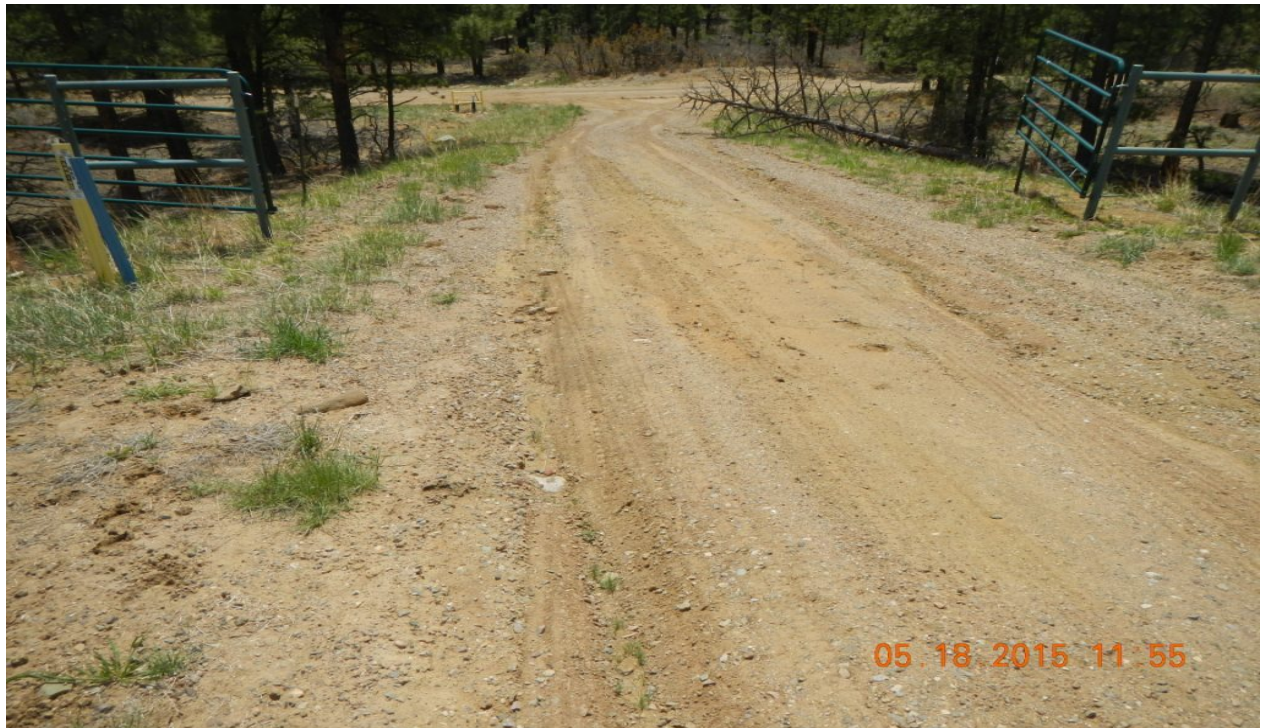
photo 3: Facing north towards the access road. Erosion channels are developing down the roadway.

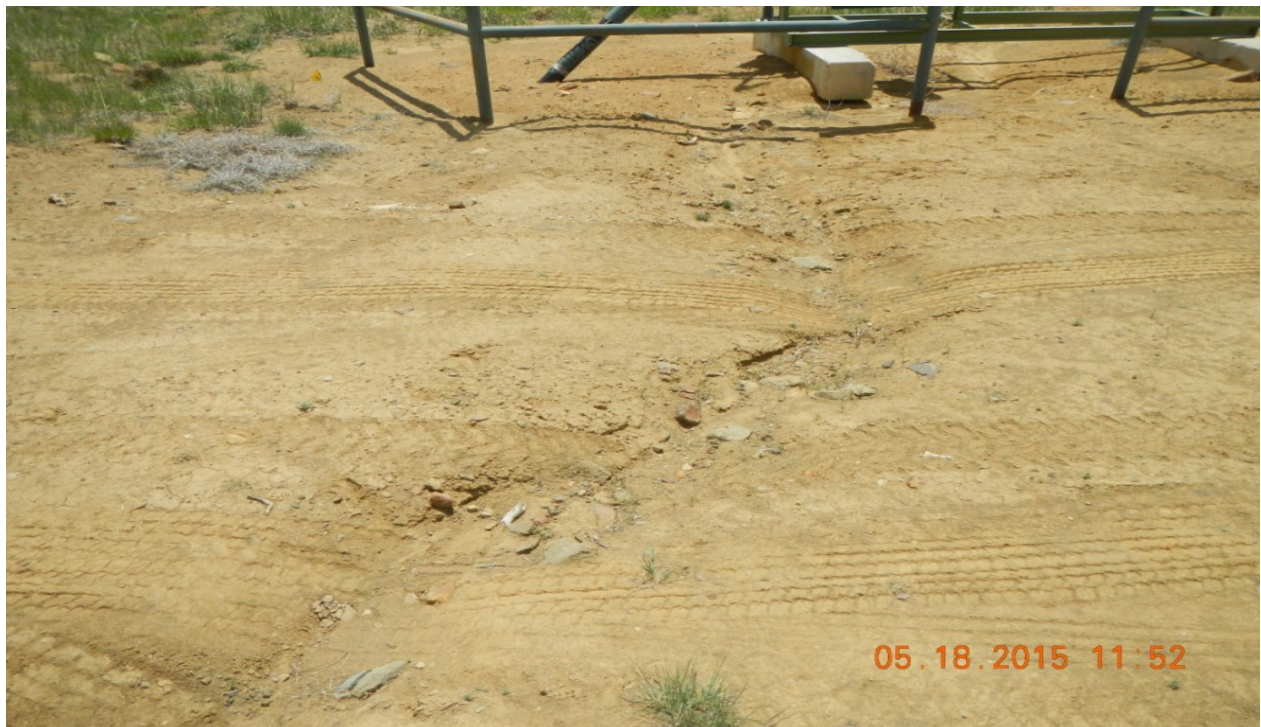
photo 4: Erosion channel developing near the pipe risers at the south side of the location.
