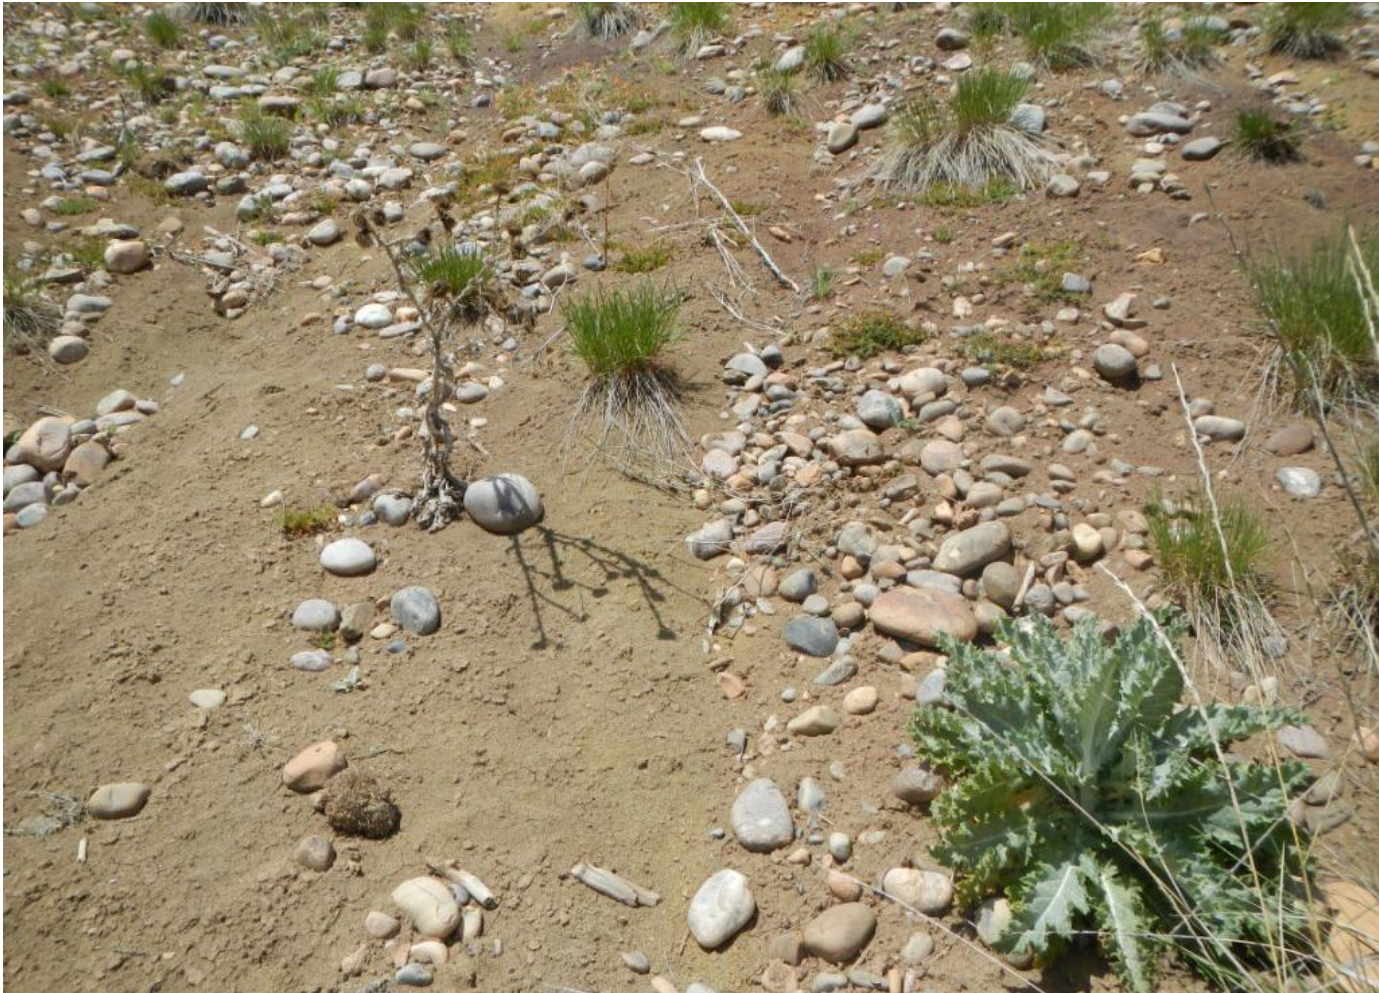
Photo 1. View of Scotch thistle (*Onopordum acanthium*) rosette within the interim reclamation area.

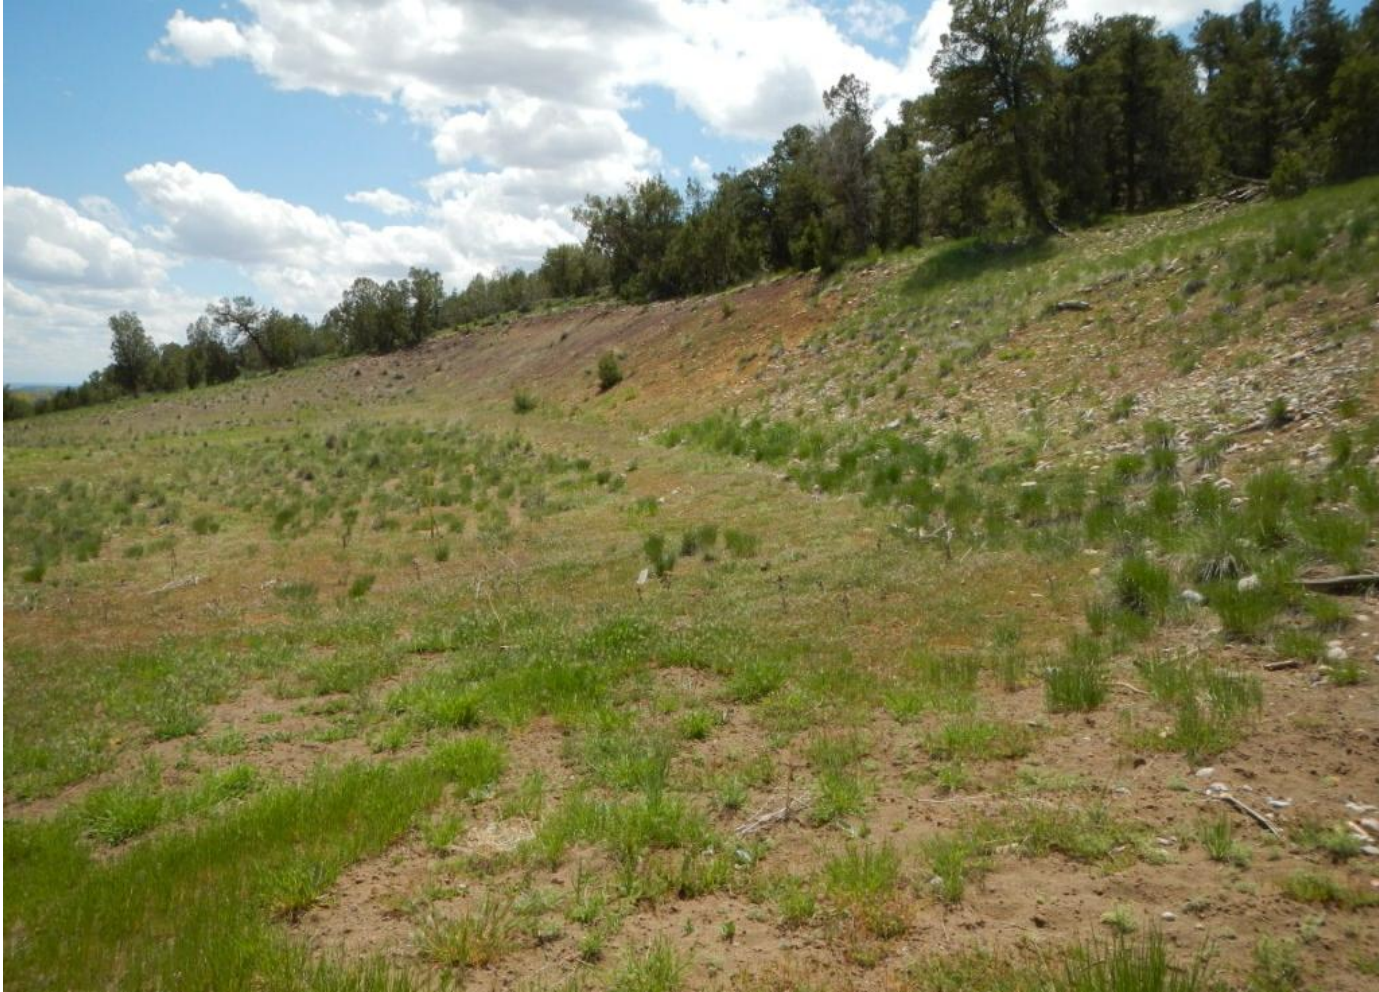
Photo 2. View of western portion of project area from northwestern corner facing southward.

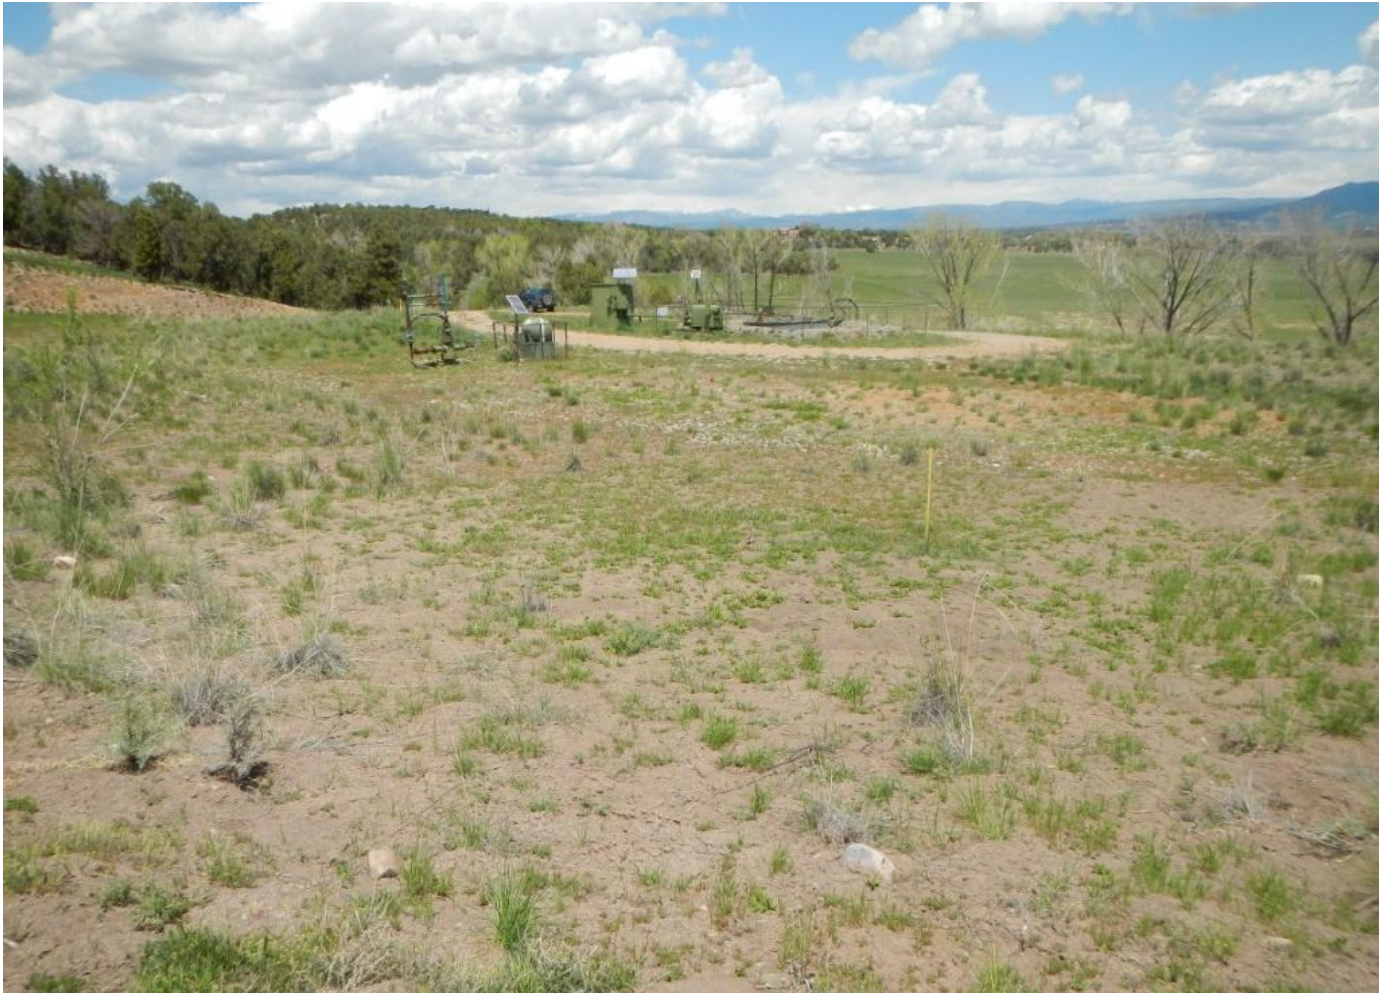
Photo 3. View from southwestern corner of well pad facing center. Revegetation of areas no longer in use appears to be progressing.

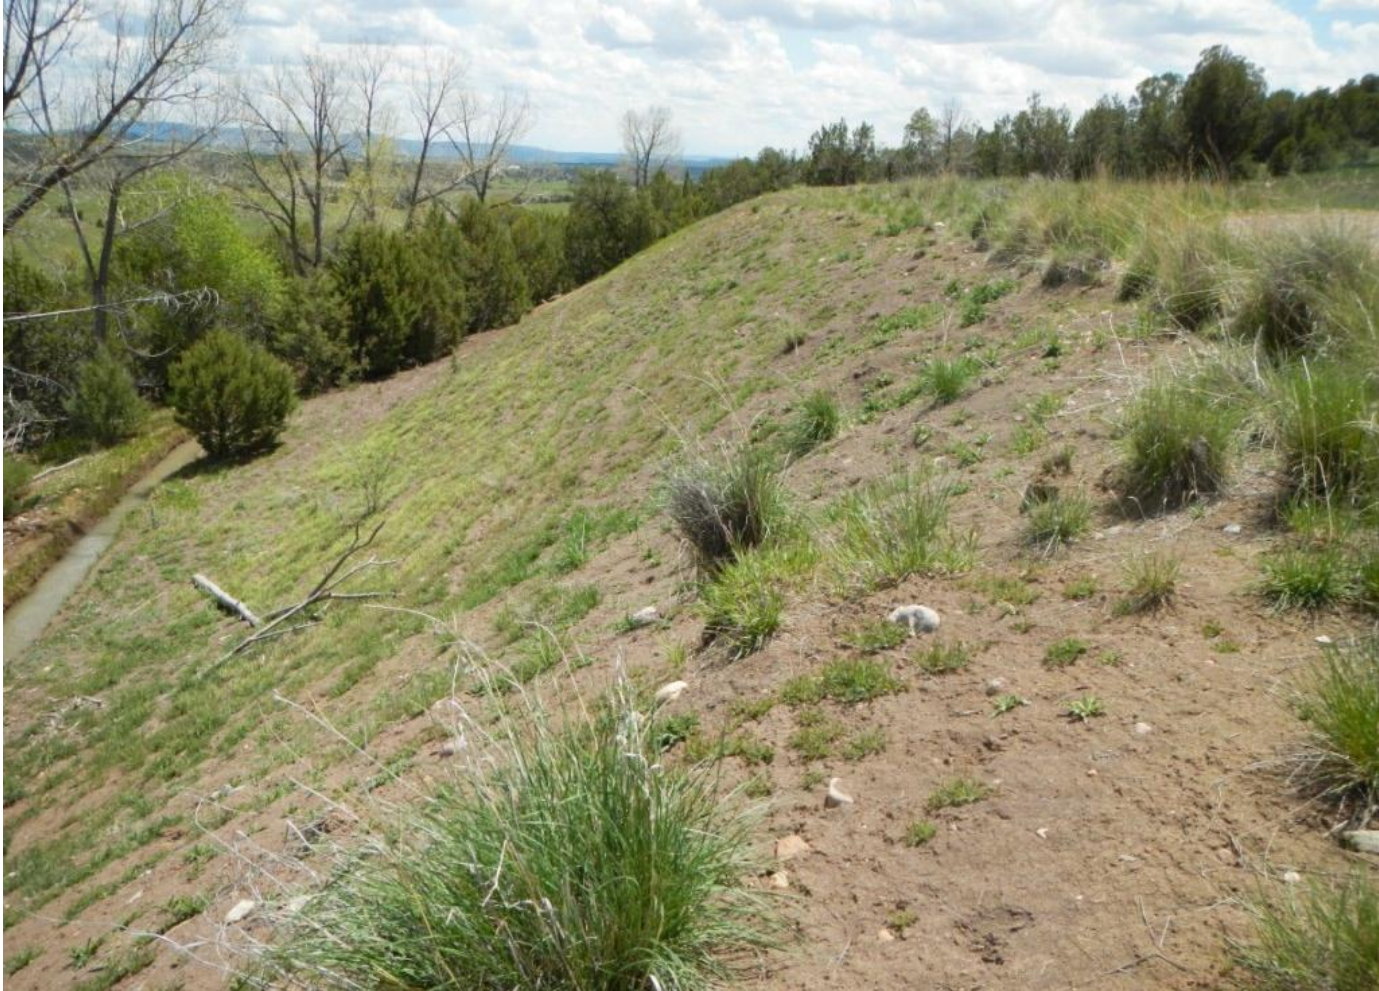
Photo 4. View of eastern portion of project area from northeastern edge of working area facing southward.
