SG 31-32 Pad

Inspection# 675201573

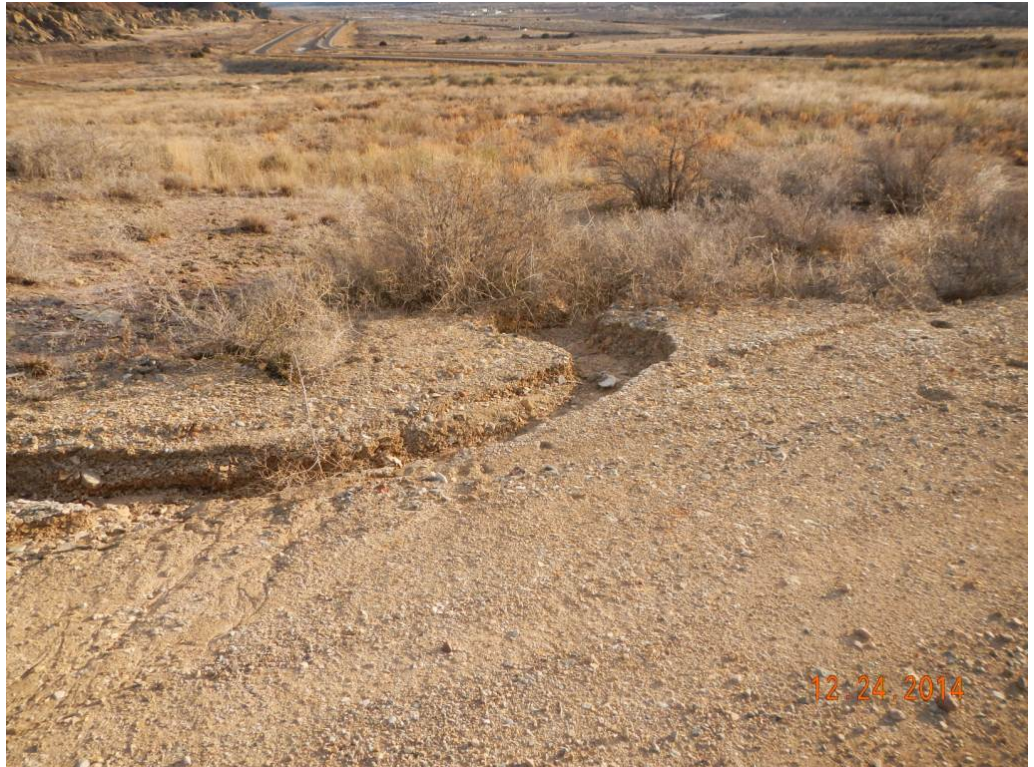
Erosion at entrance at
previous inspection.
(39.39341/-108.12961)

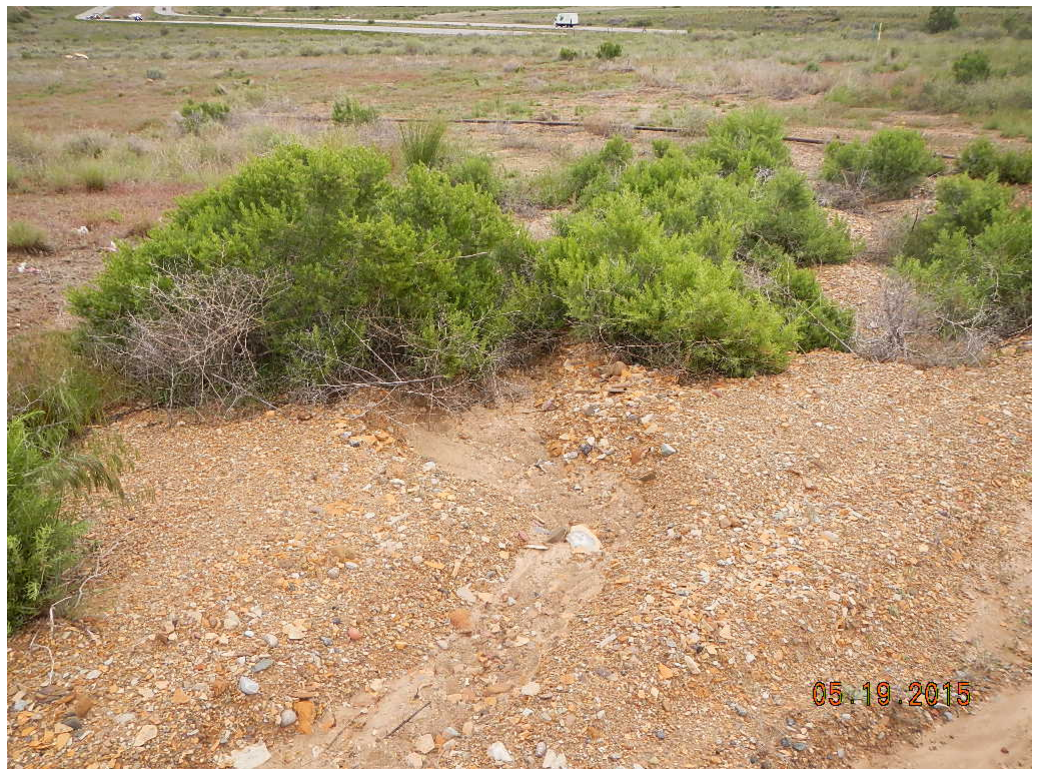
Erosion at entrance at follow
up inspection. (39.39341/-
108.12961)

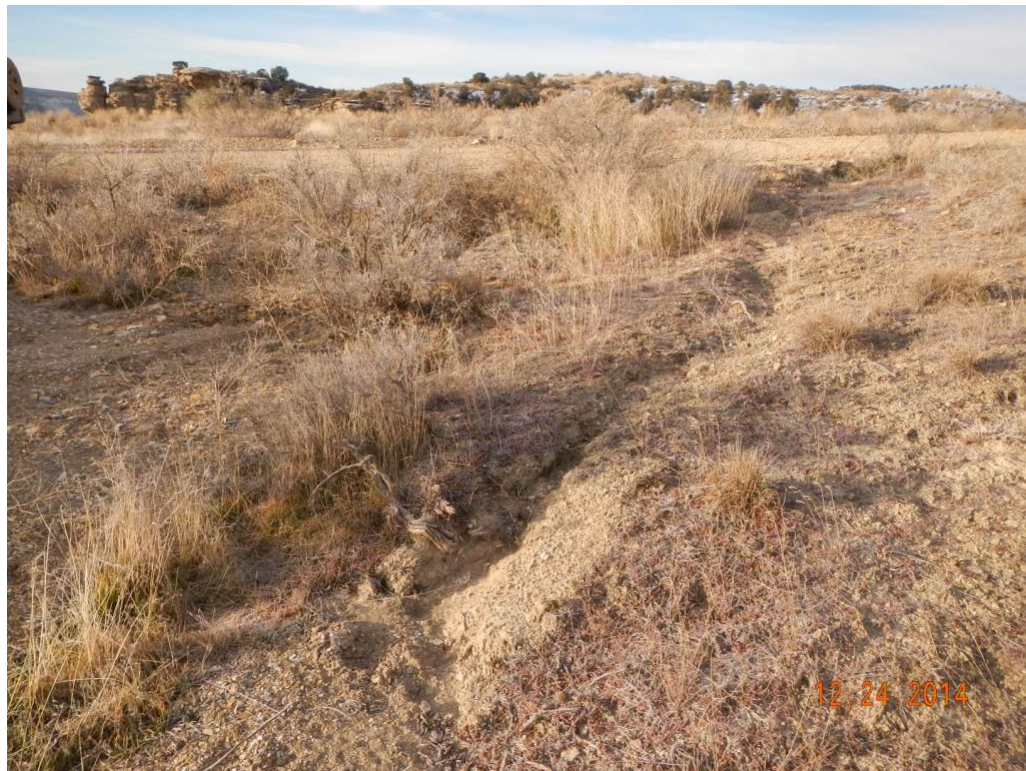
Sediment migration into
vegetation at previous
inspection.

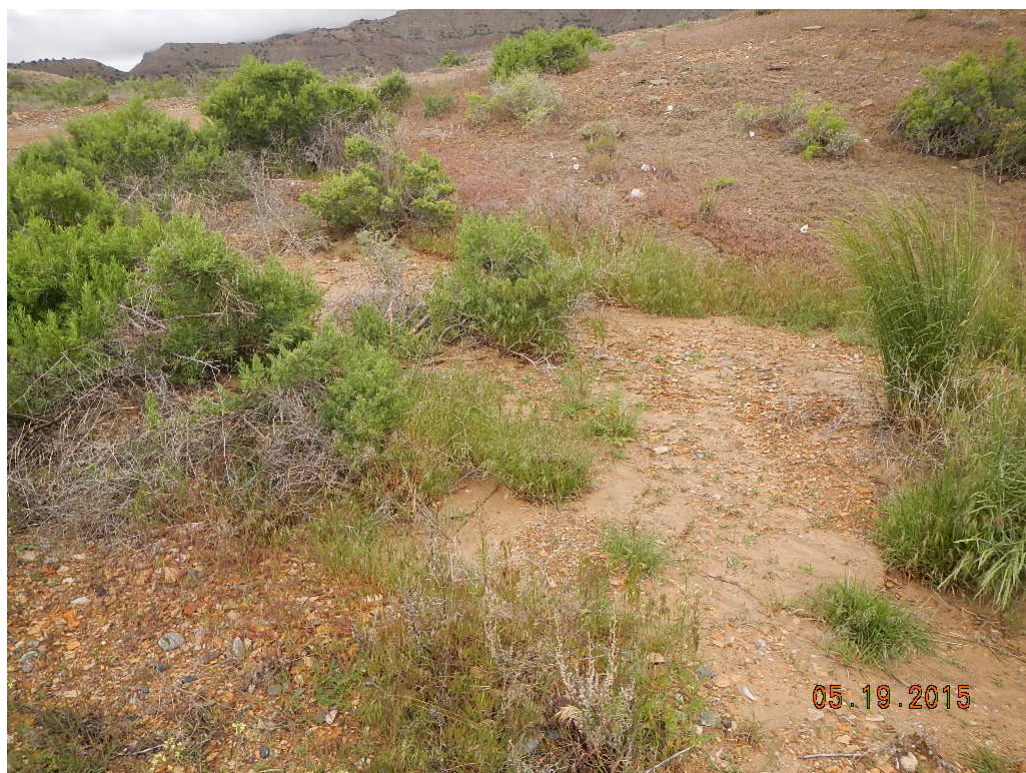
Sediment migration into
vegetation at follow up
inspection

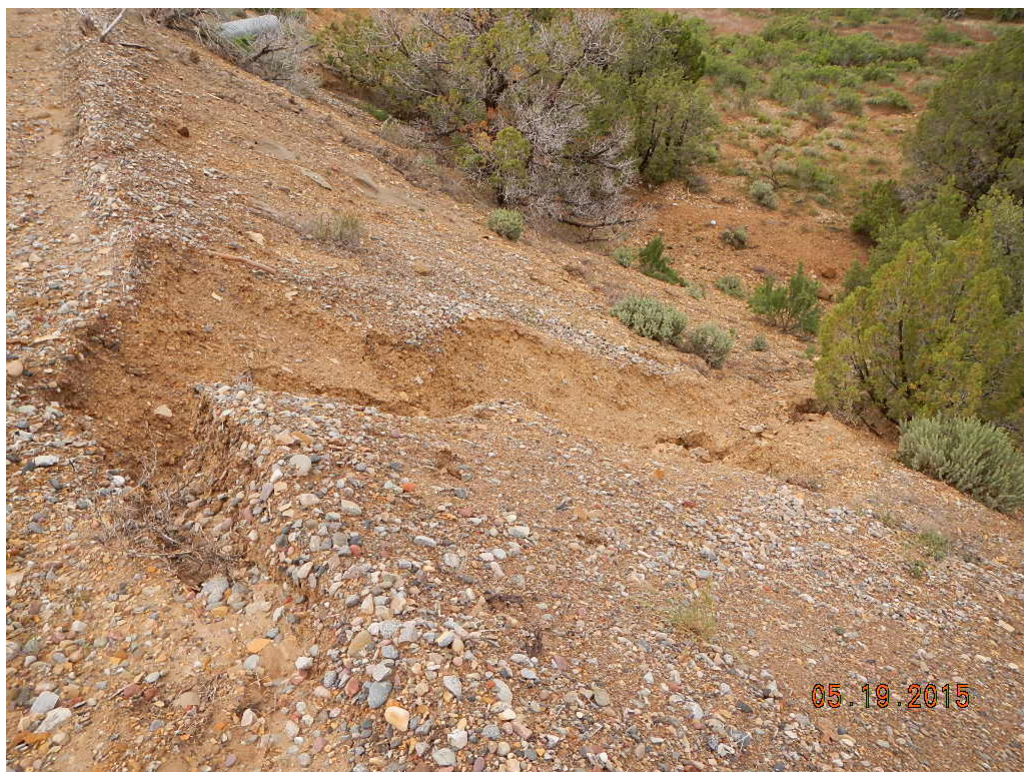
Erosion on side of access
road.

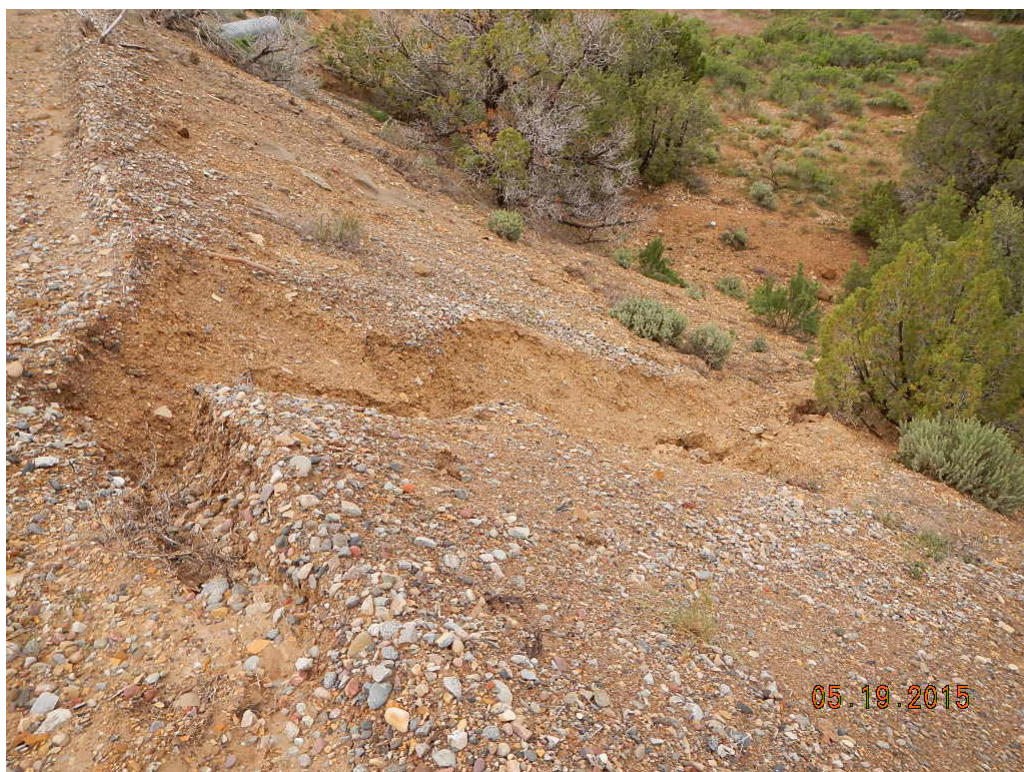
Erosion on side of access
road.
