photo 1: Well sign, Lorencito 1-20-34-66

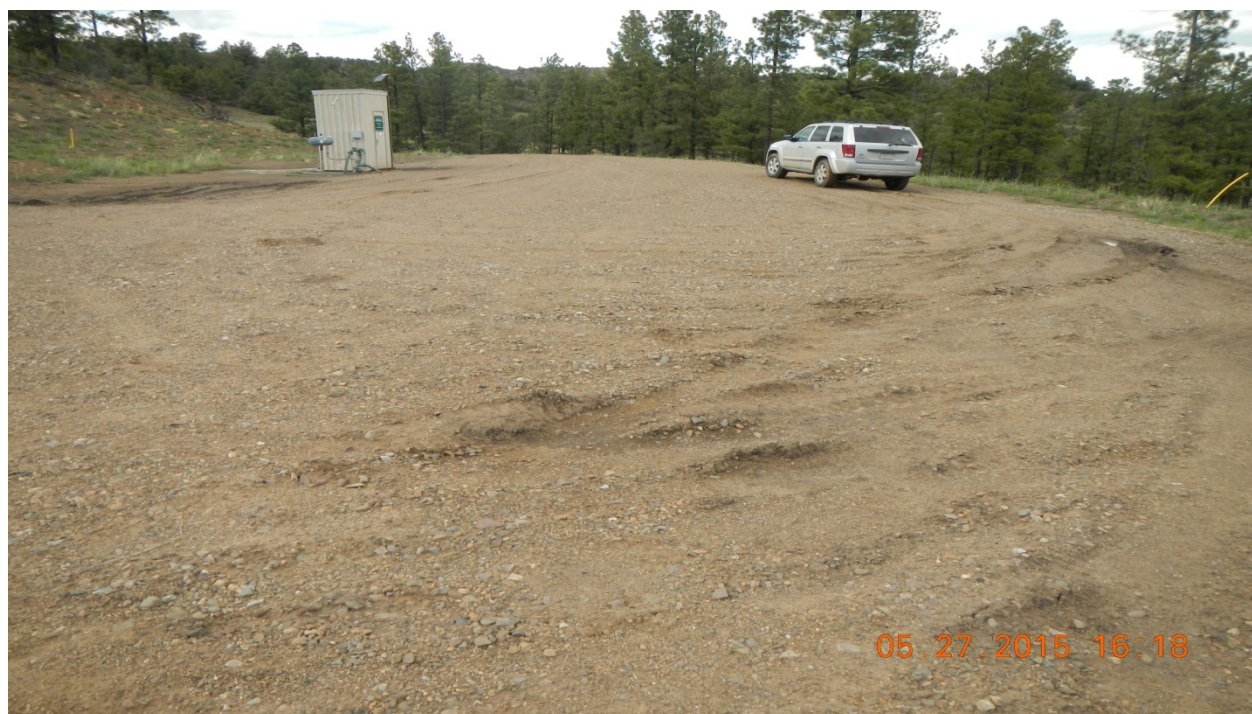
photo 2: Southeast corner of the location facing northwest.

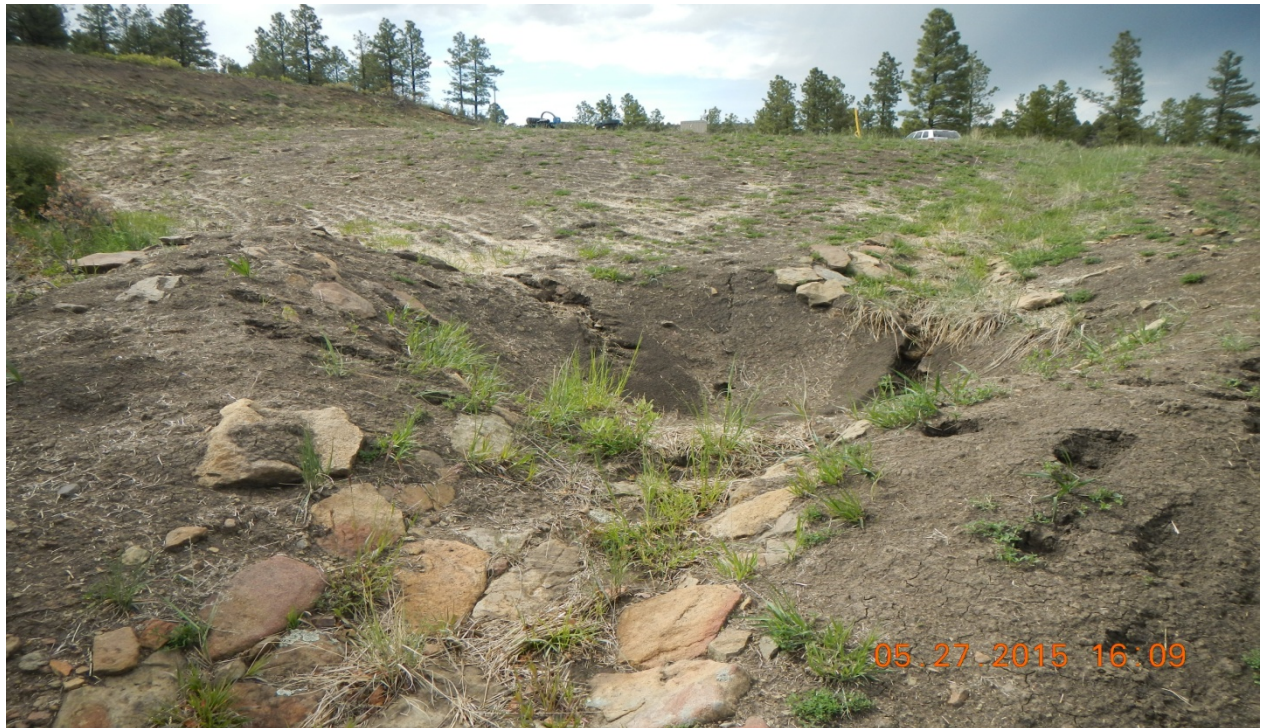
photo 3: Southeast corner of the location facing northwest.

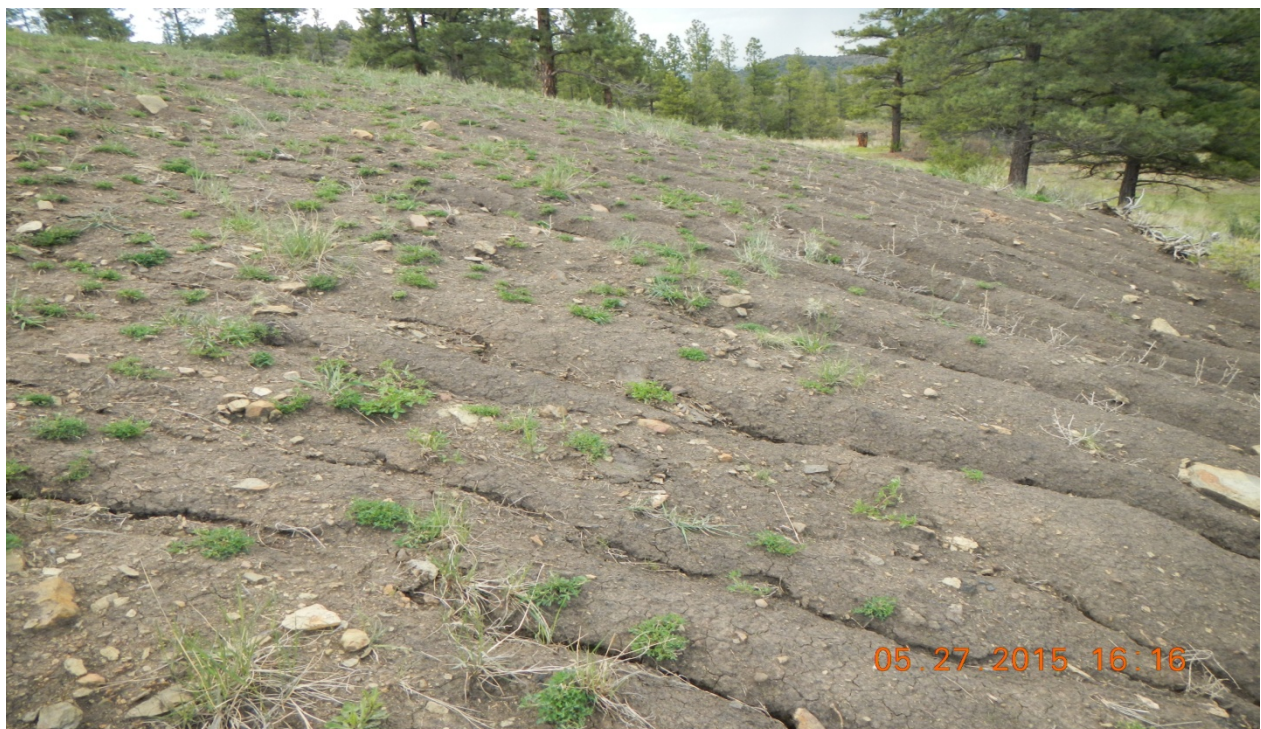
photo 4: Facing north along the east side of the location. Erosion channels have developed off the pad.

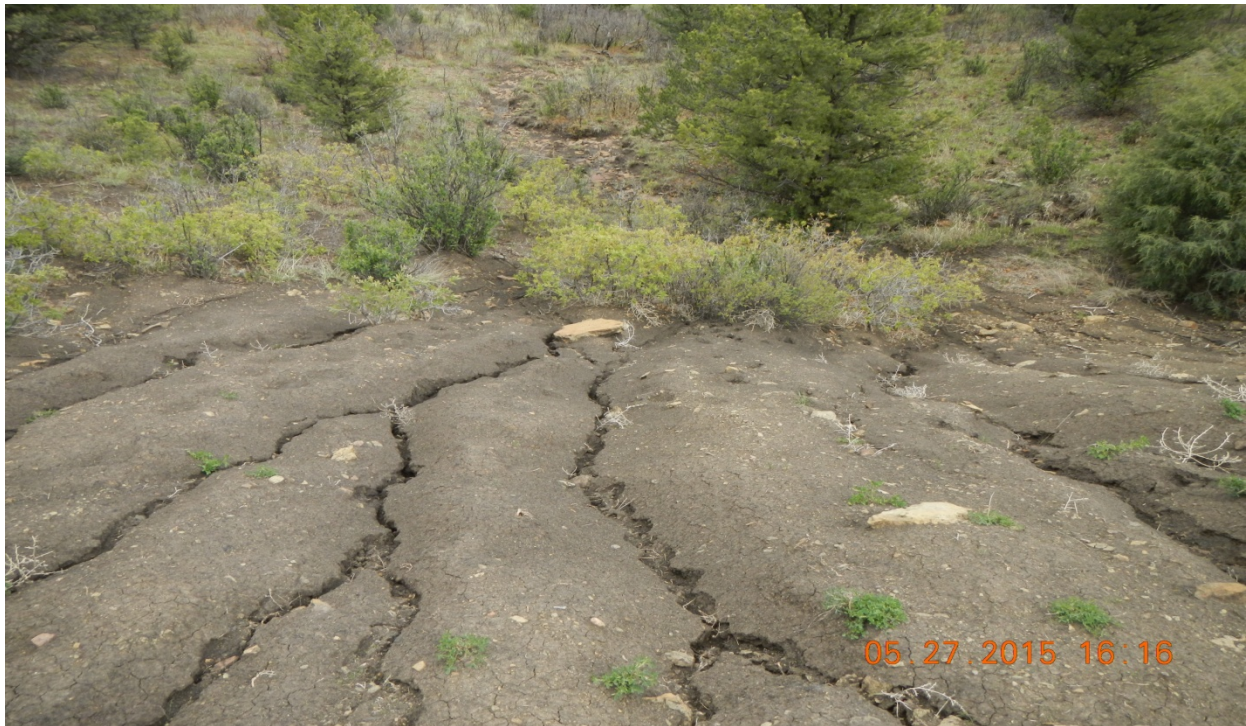
photo 5: Erosion rills have formed transporting sediment off the pad at the east side of the location.

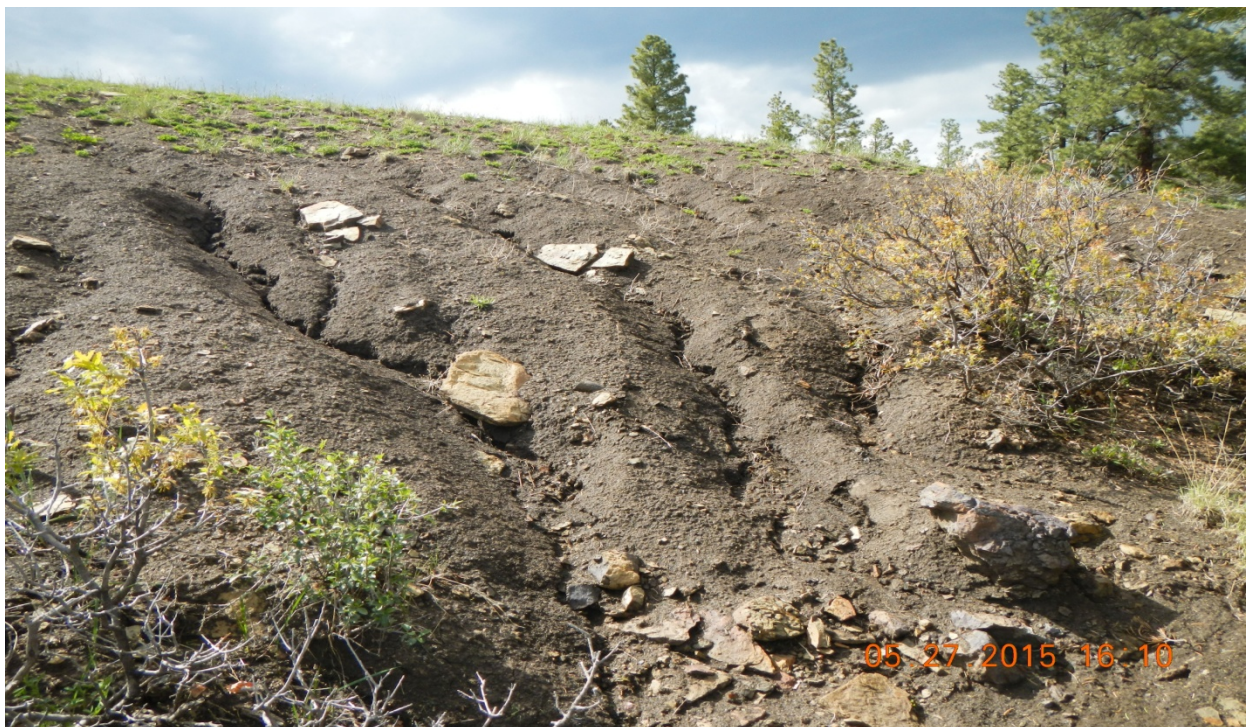
photo 6: The base of the pad where erosion is occurring.

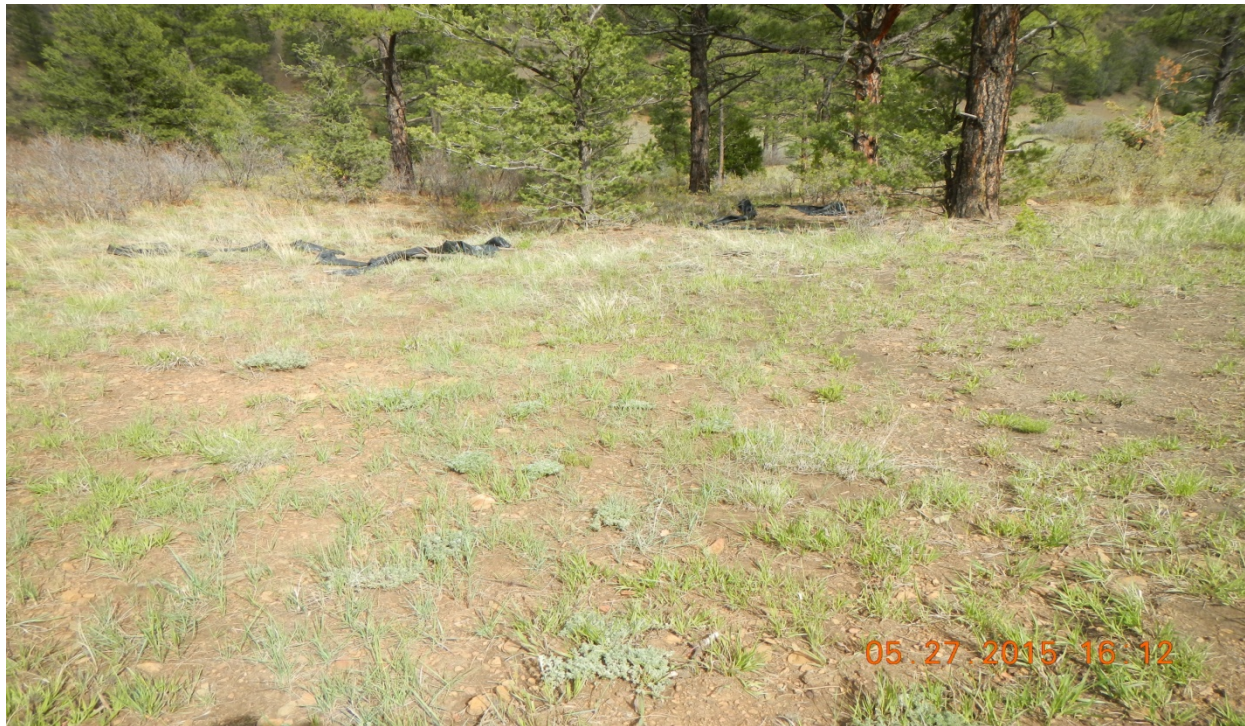
photo 7: Approximately 200ft. east of the location silt fence debris remains.

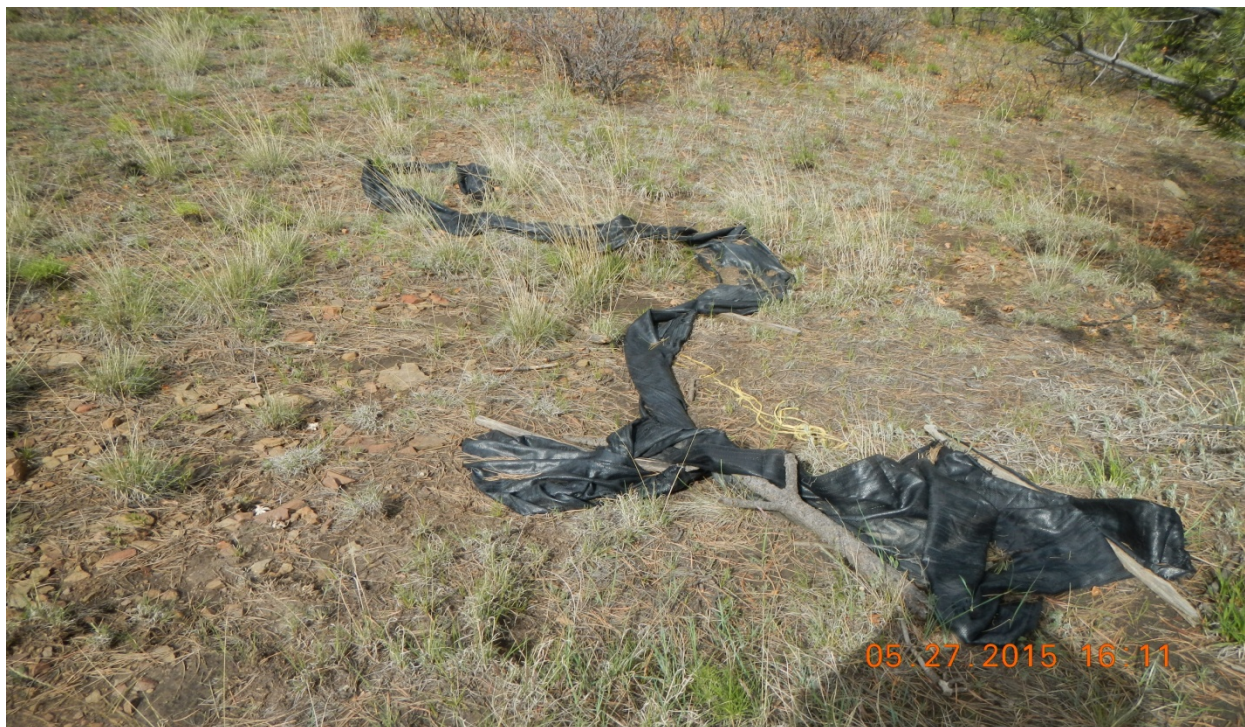
photo 8: Approximately 200ft. east of the location, silt fence debris remains.
