photo 1: Facing north towards the offsite pit #258380.

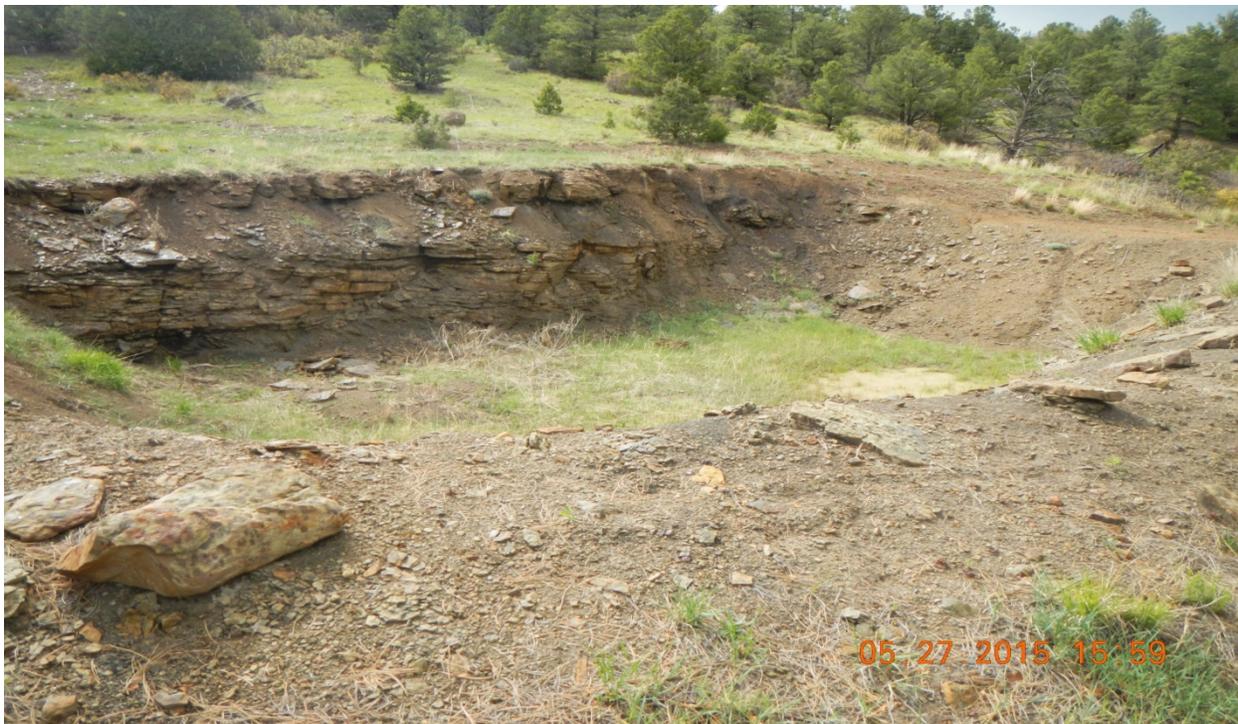
photo 2: Facing northwest towards the offsite pit #258380.

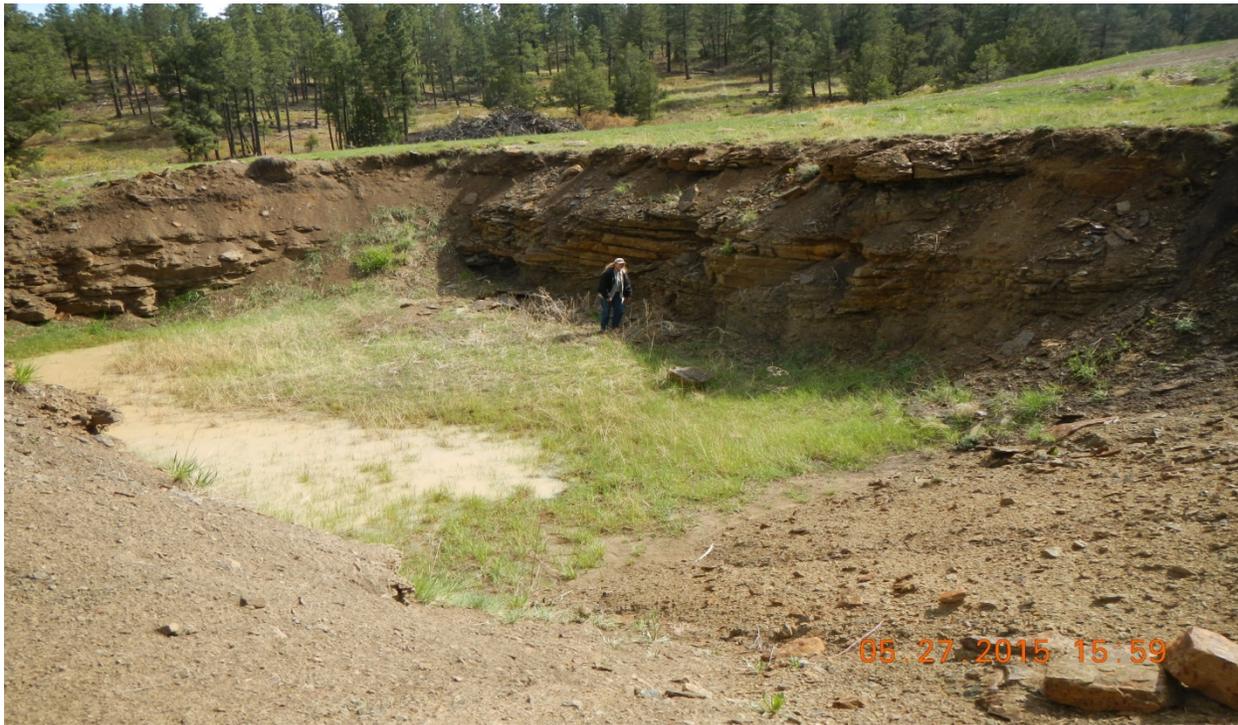
photo 3: Facing south towards the offsite pit. Three of the sides have unstable vertical cuts.

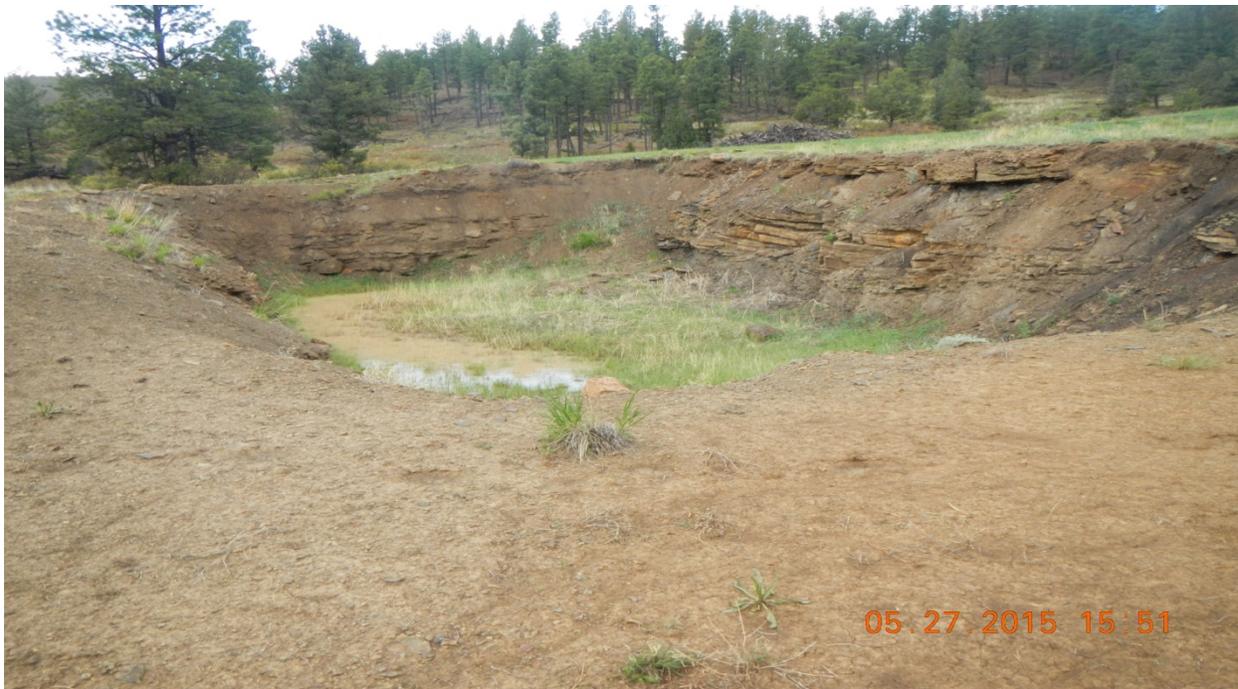
photo 4: Facing south towards the offsite pit. After significant recent precipitation events, there is very little water in the pit.

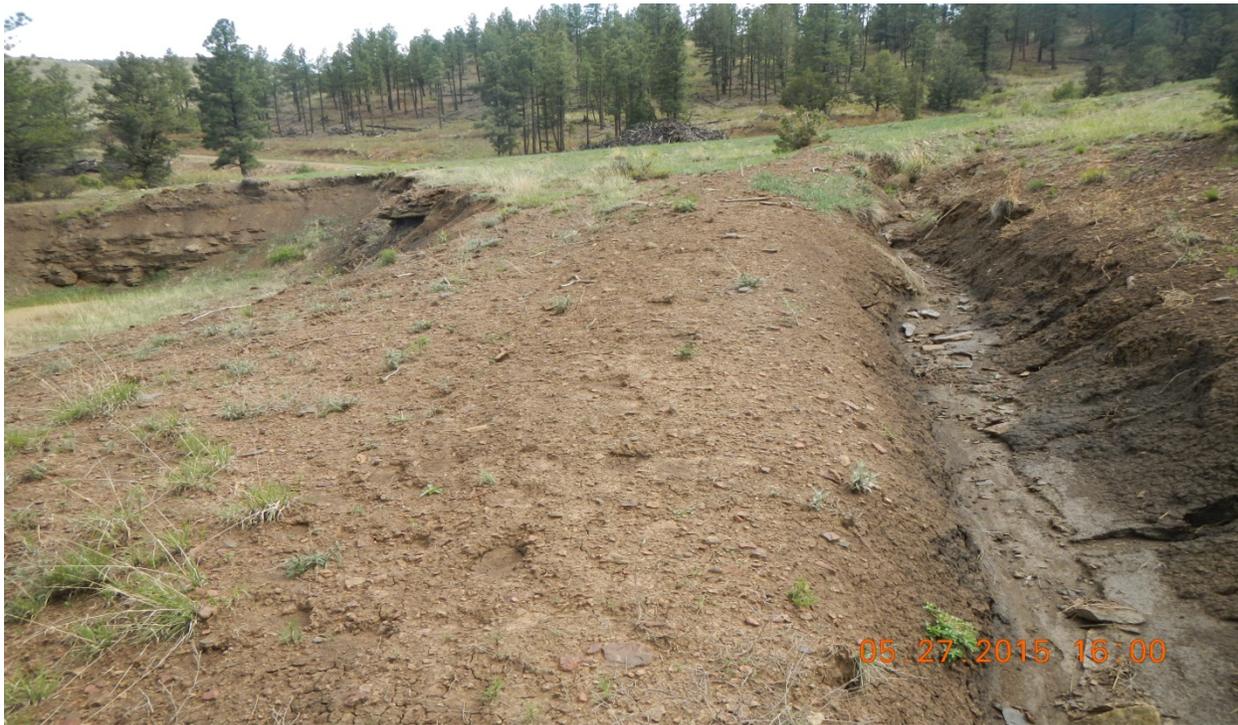
photo 5: Facing south. A diversion ditch from the access road diverts water around the west side of pit.

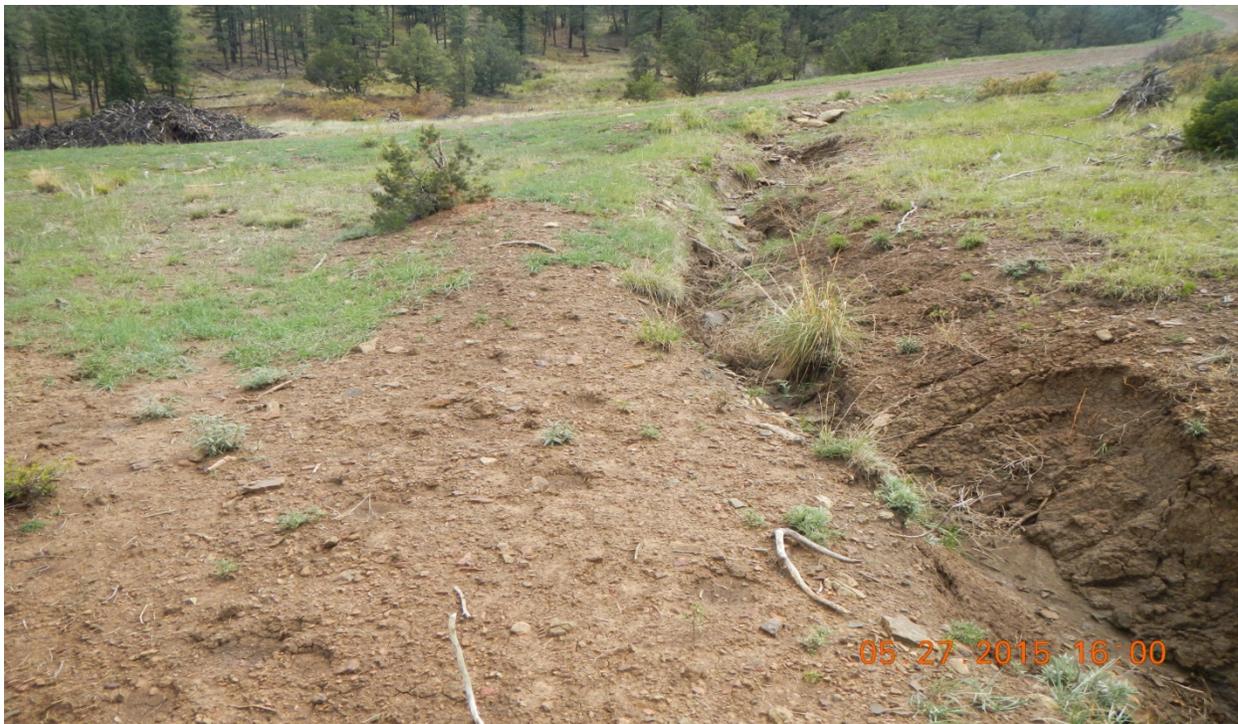
photo 6: The diversion ditch from the access road is being incised and needs BMP's installed to prevent erosion.

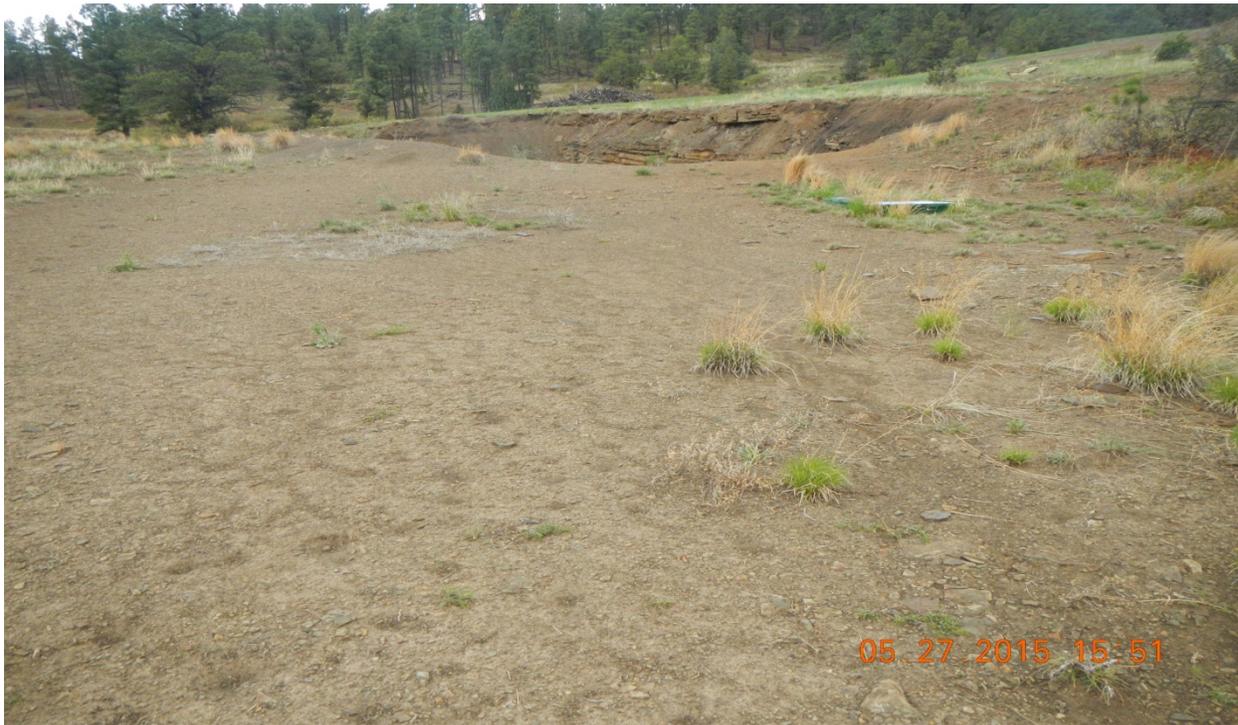
photo 7: Northeast side of pit disturbance area which has minimal to no vegetation growth.

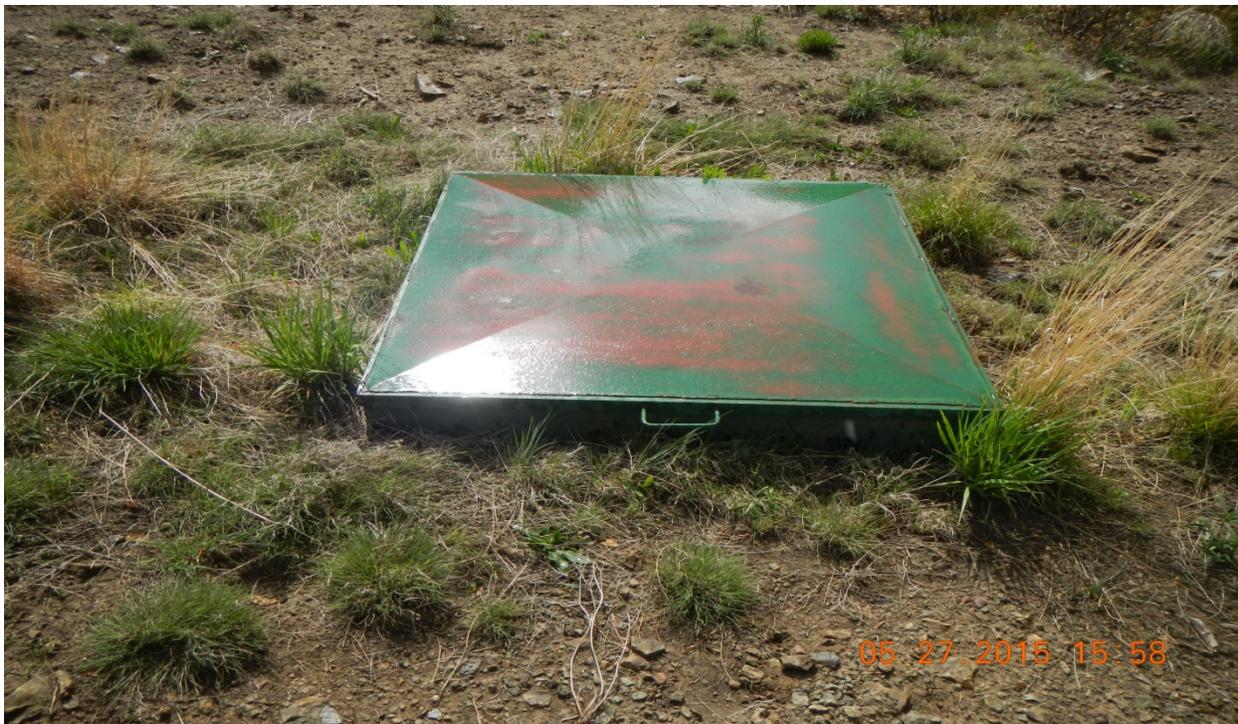
photo 8: Metal box remains at the north side of the pit.

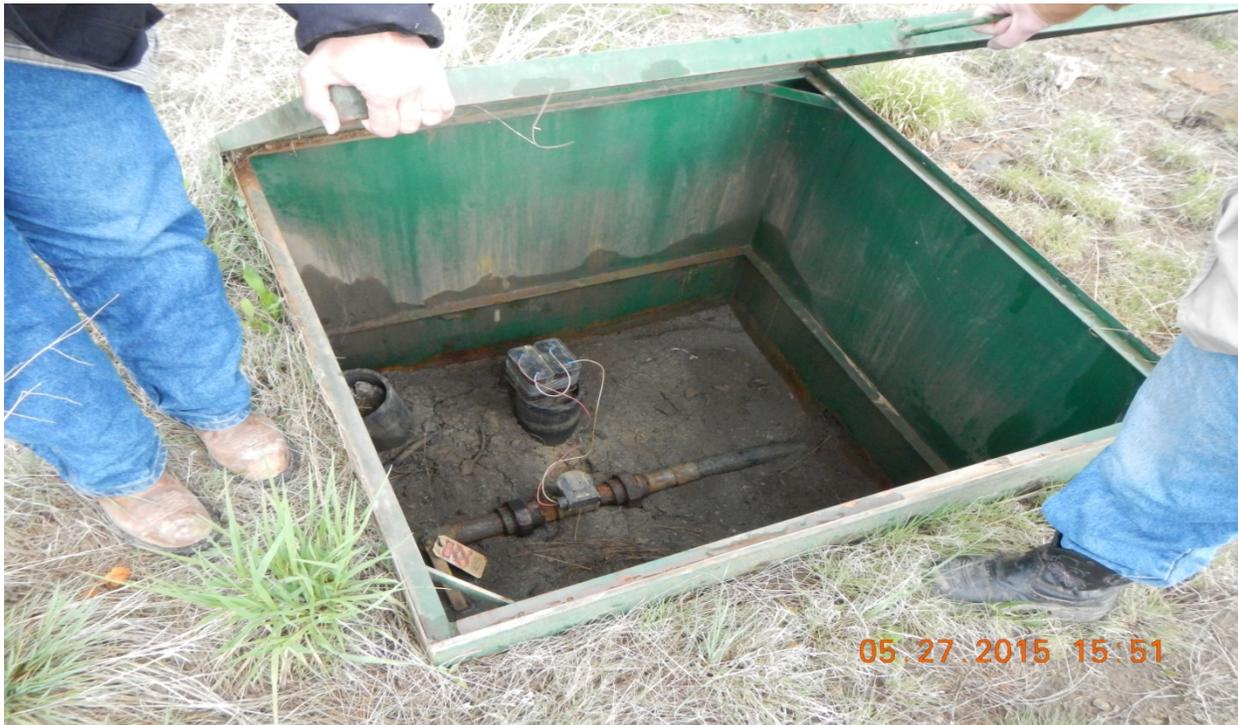
photo 9: Inside of the metal box.

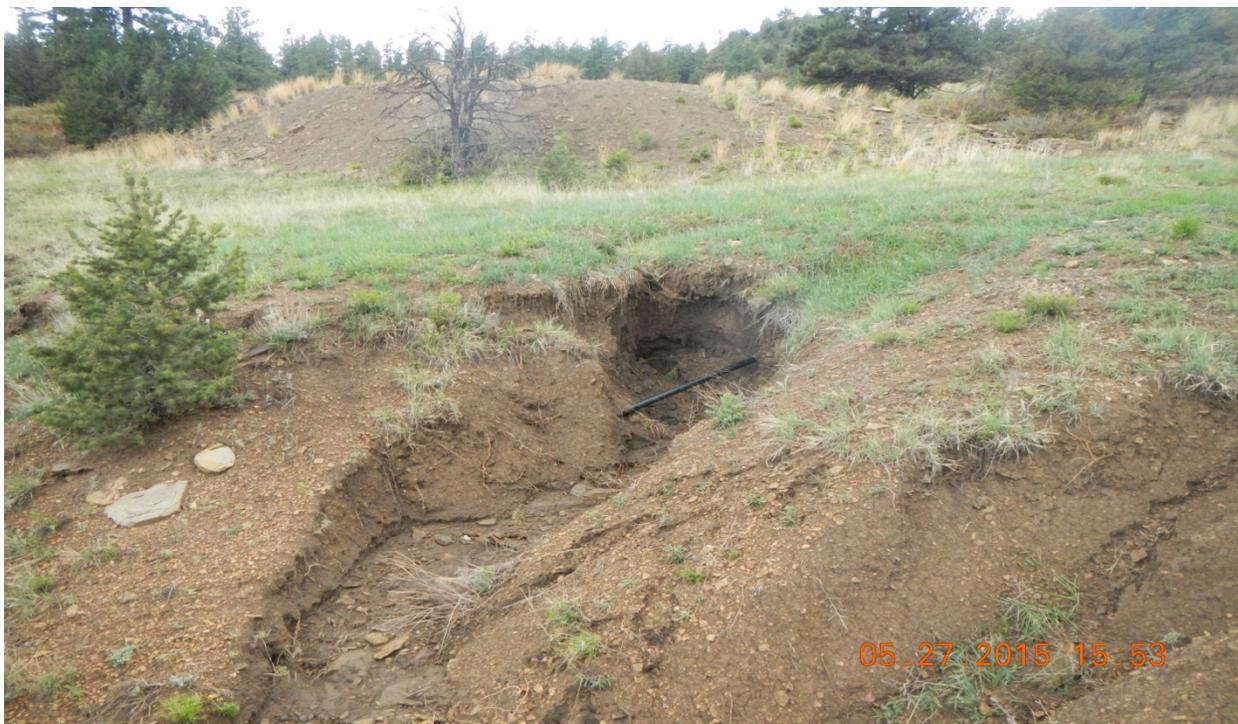
photo 10: Erosion occurring northeast of the pit area where water enters from the access road diversion ditch and pit disturbance area.

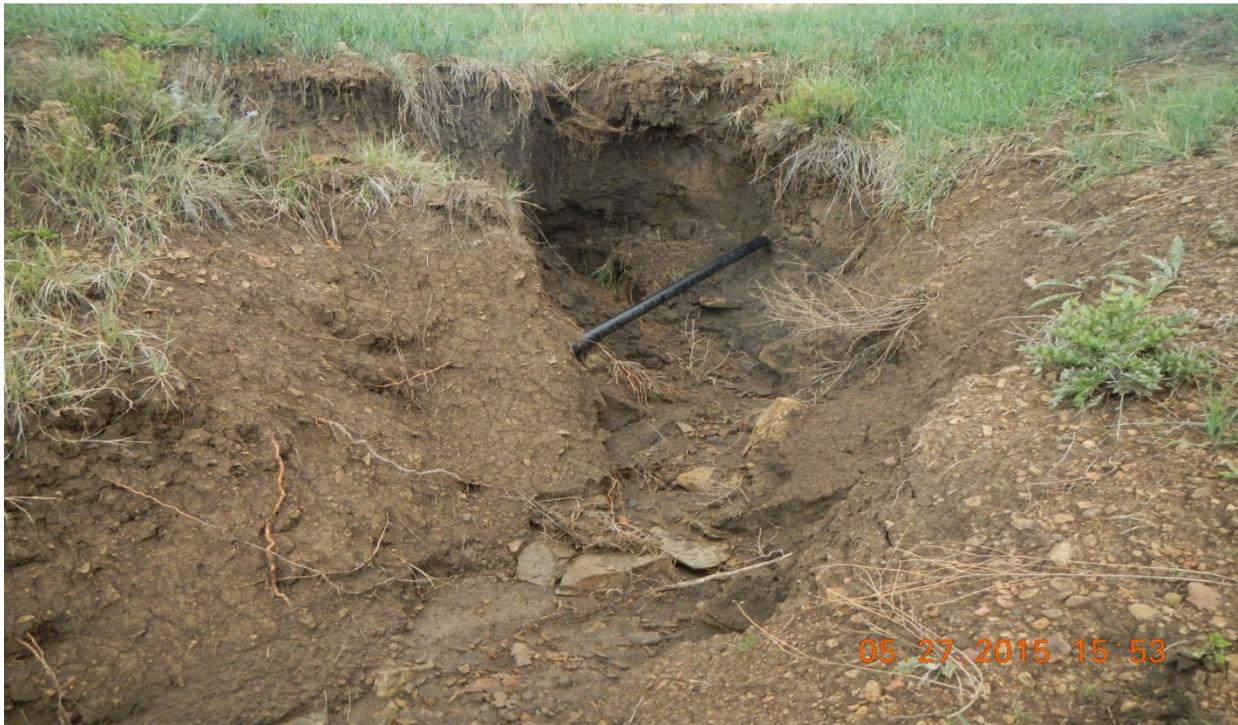
photo 11: Plastic pipe is exposed as a result of erosion which has occurred.

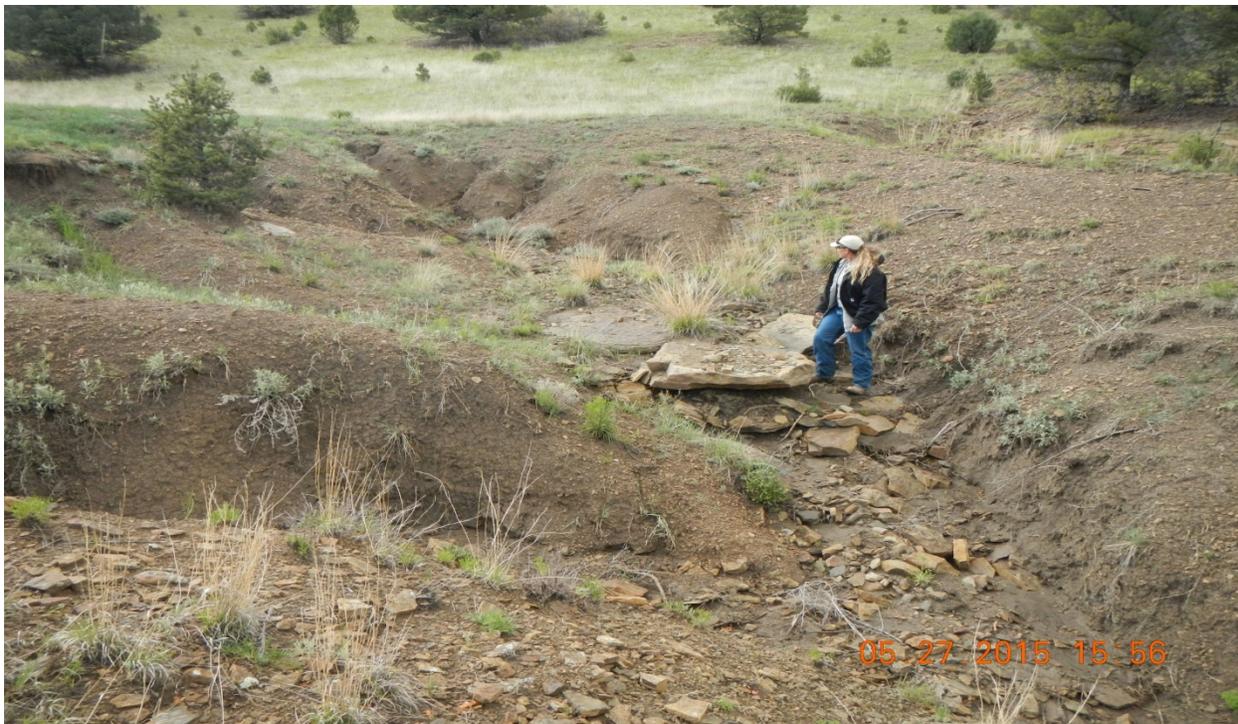
photo 12: Erosion gullies where water enters from the access road diversion ditch and pit disturbance area.
