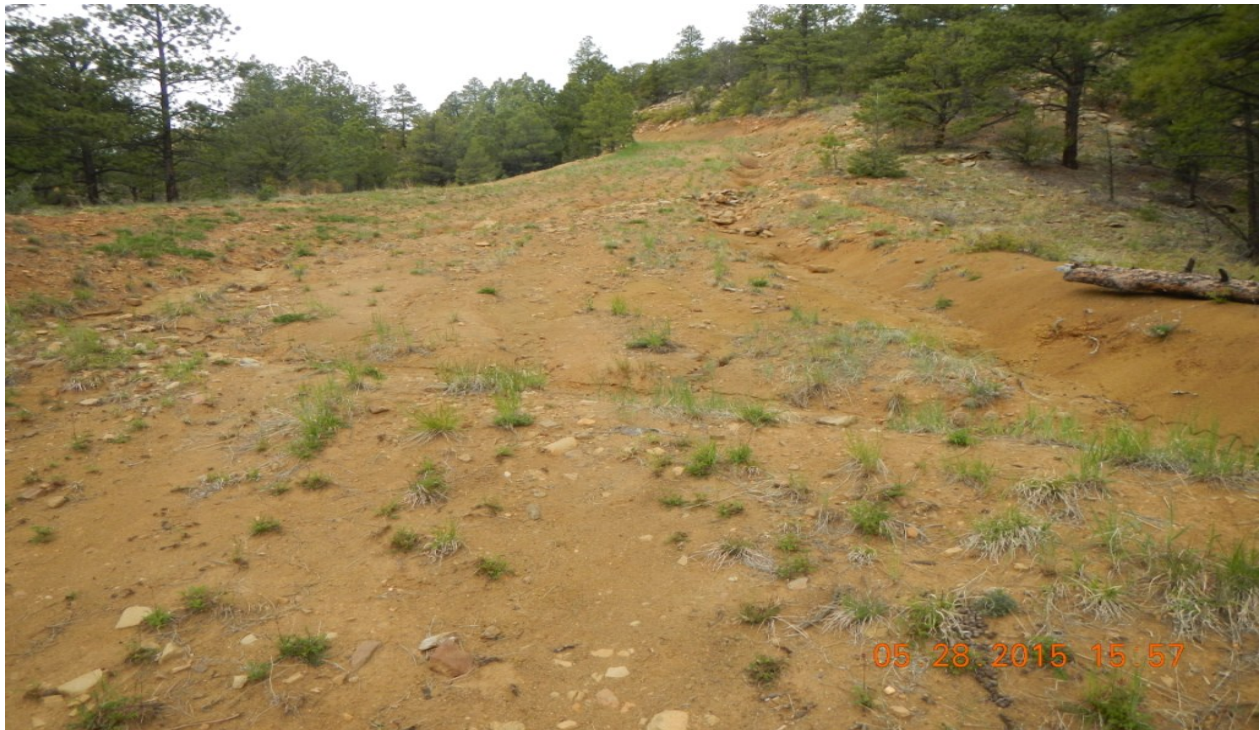
photo 1: Access road west towards the location.

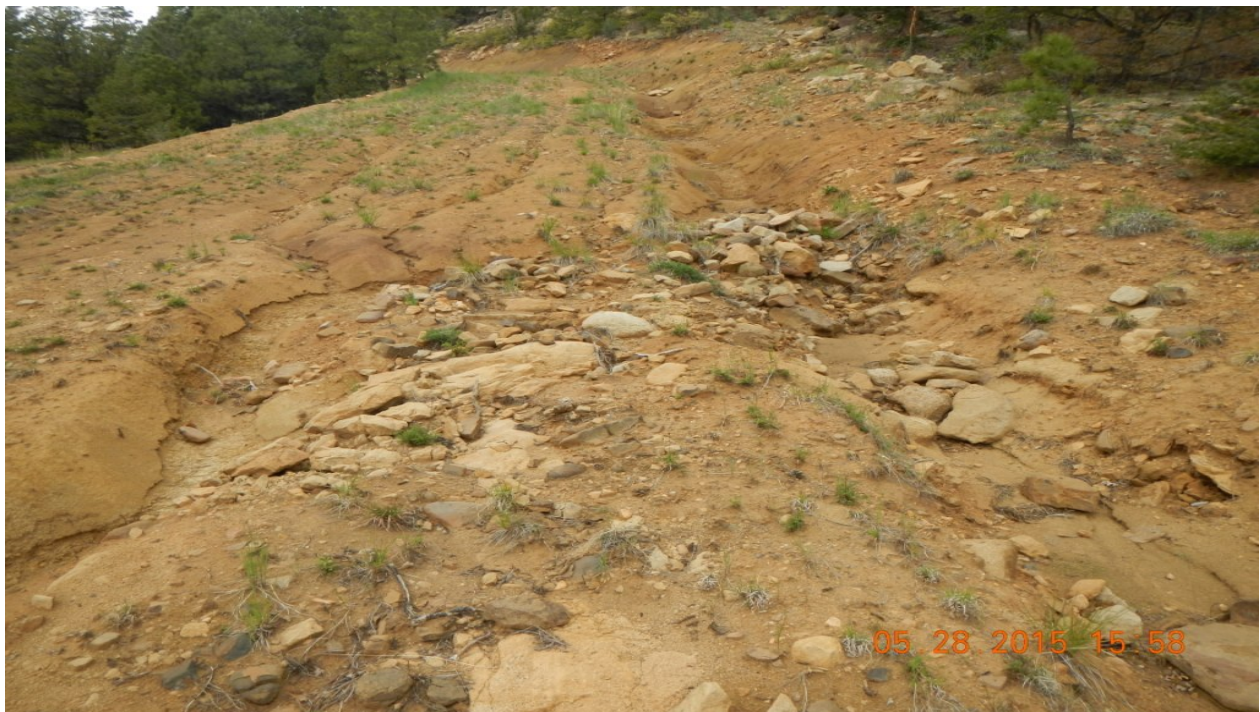
photo 2: Erosion rills/channels have formed transporting sediment and eroding the access road.

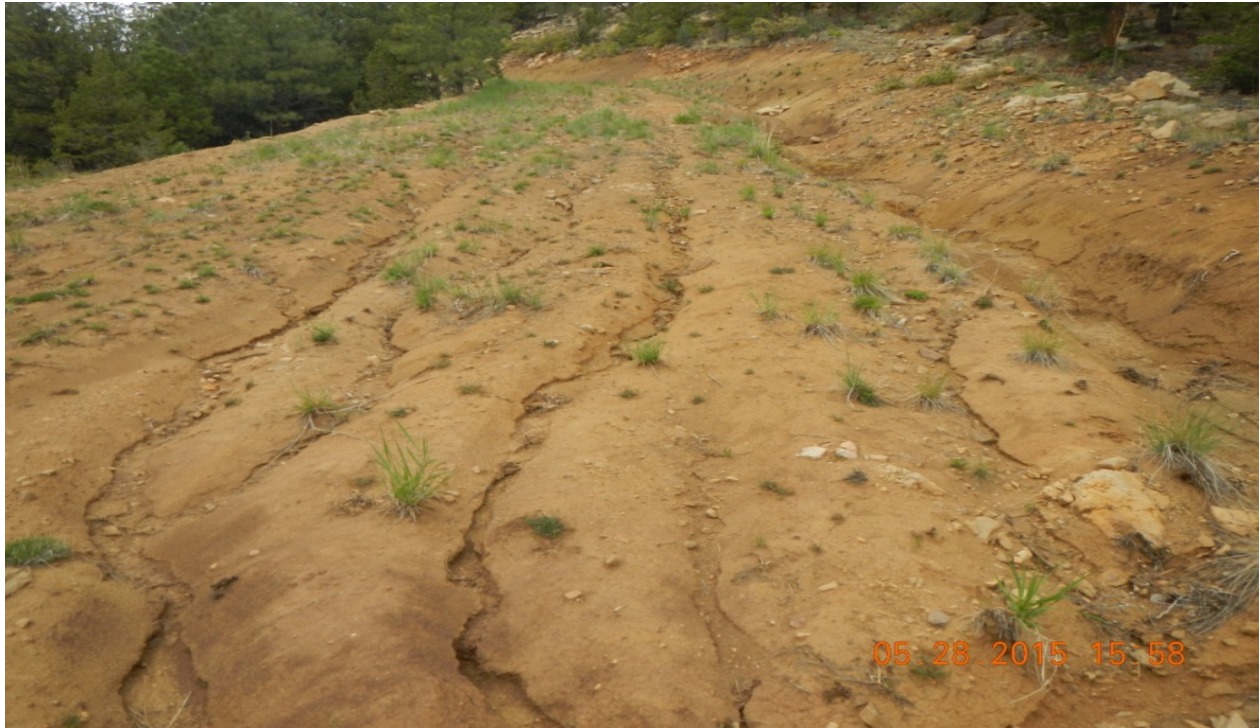
photo 3: No BMP's have been installed along the access road to prevent erosion from worsening.

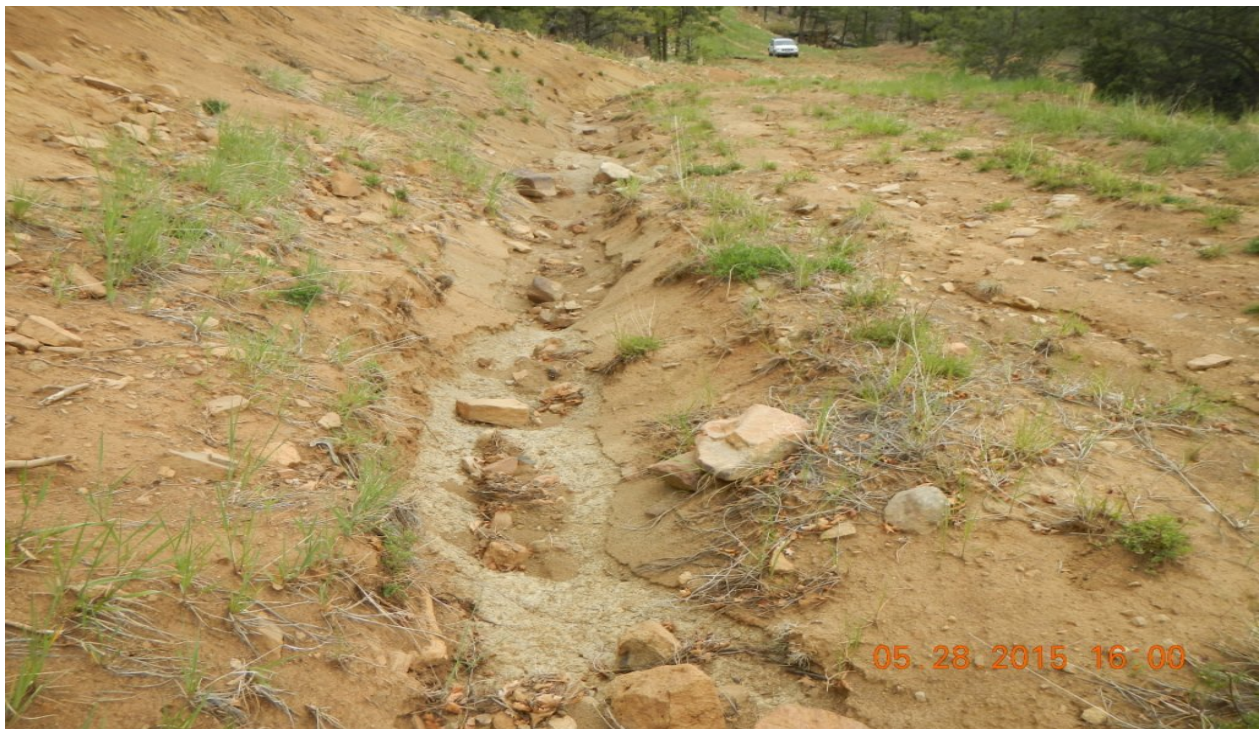
photo 4: Facing east. Erosion channels running down the access road.

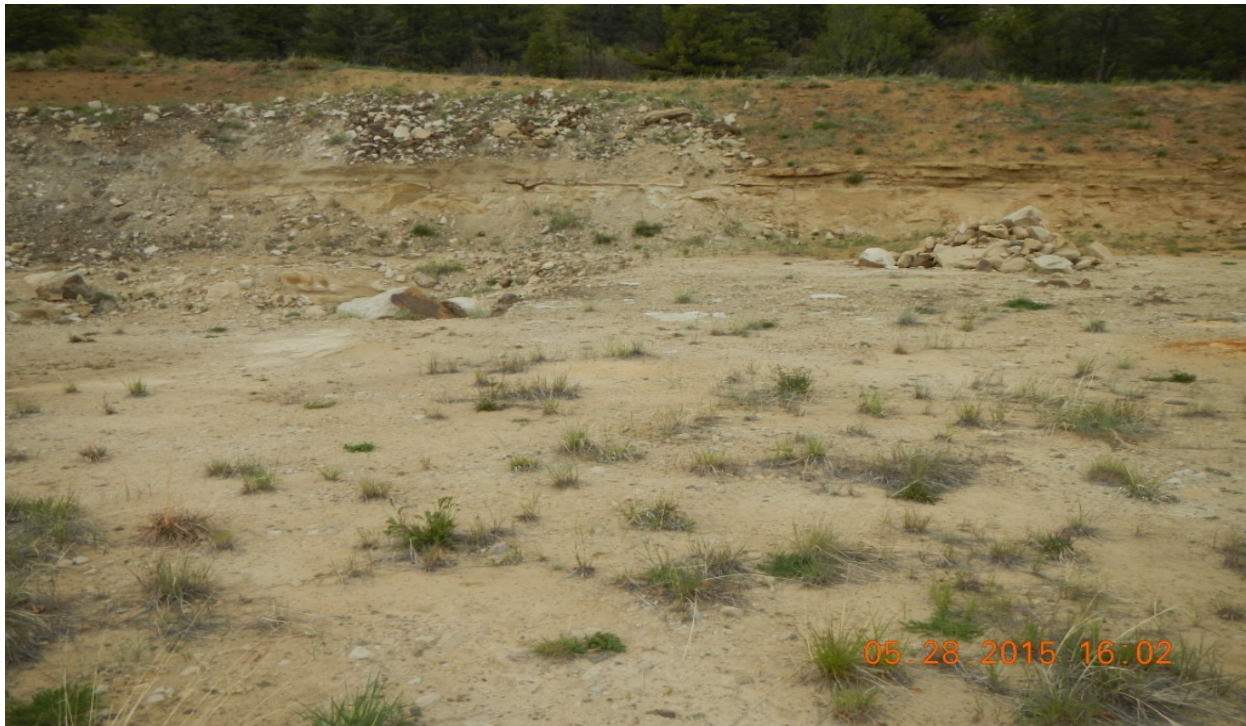
photo 5: Center of the location facing north.

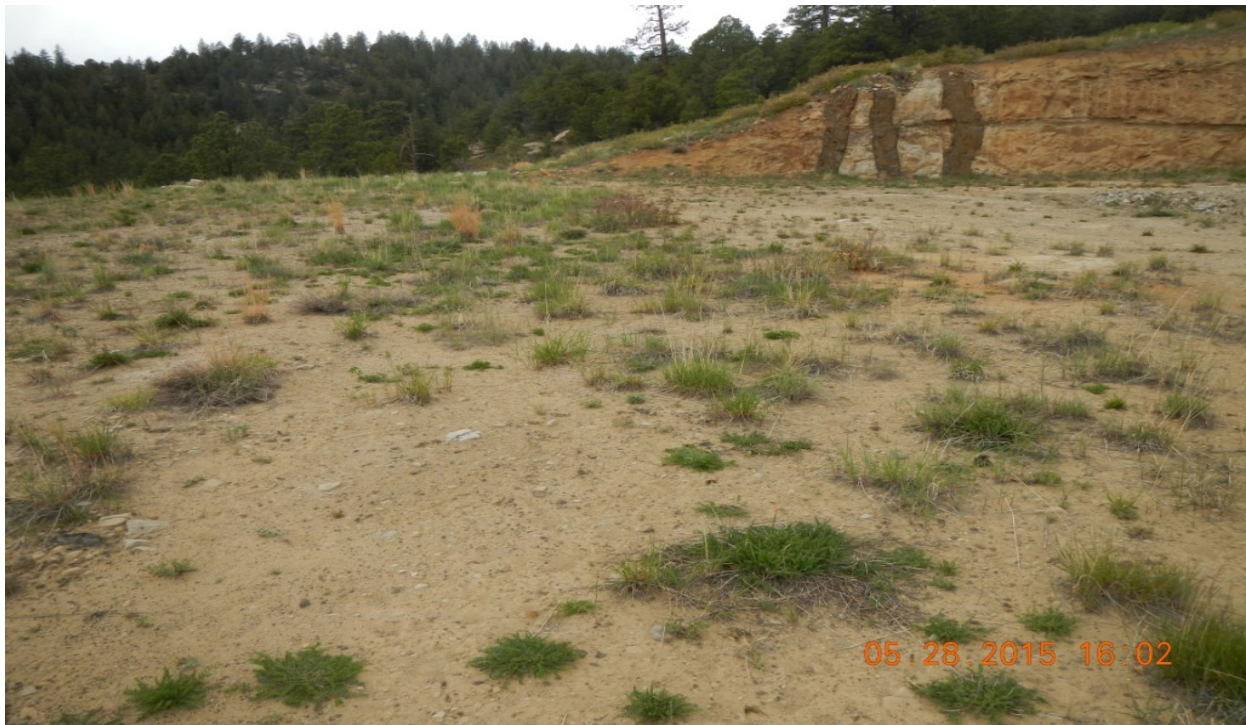
photo 6: Center of the location facing west.

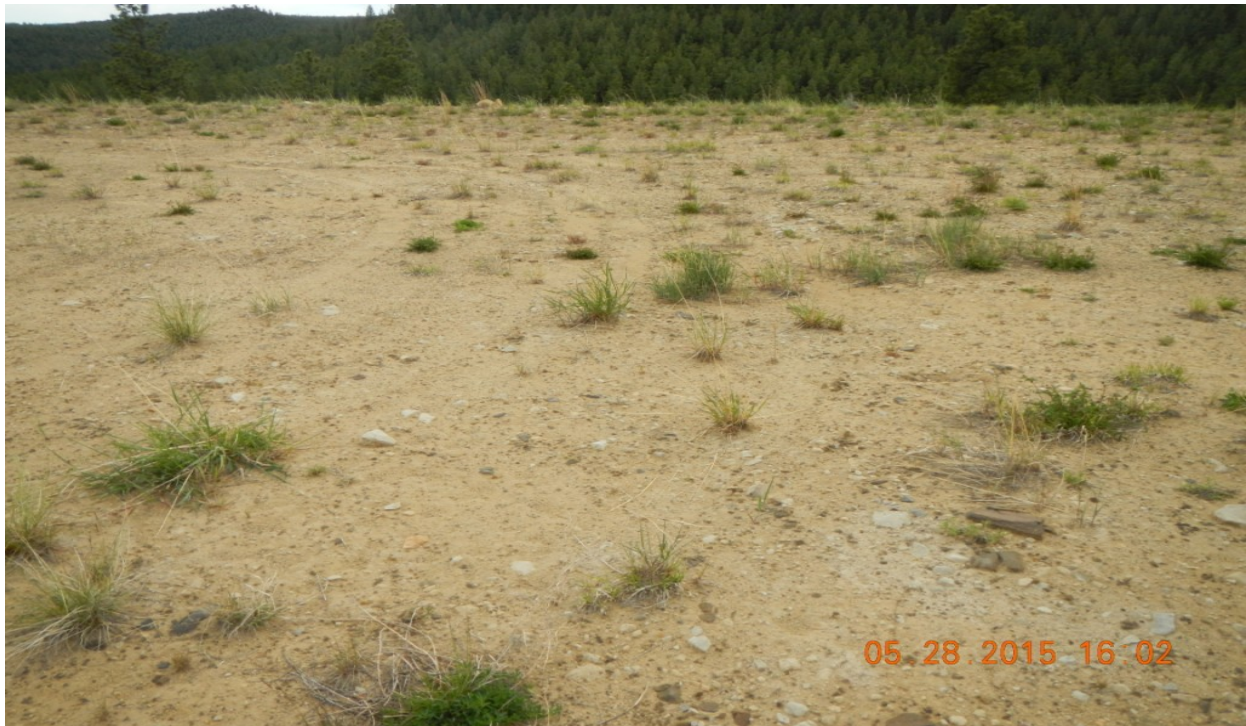
photo 7: Center of the location facing south.

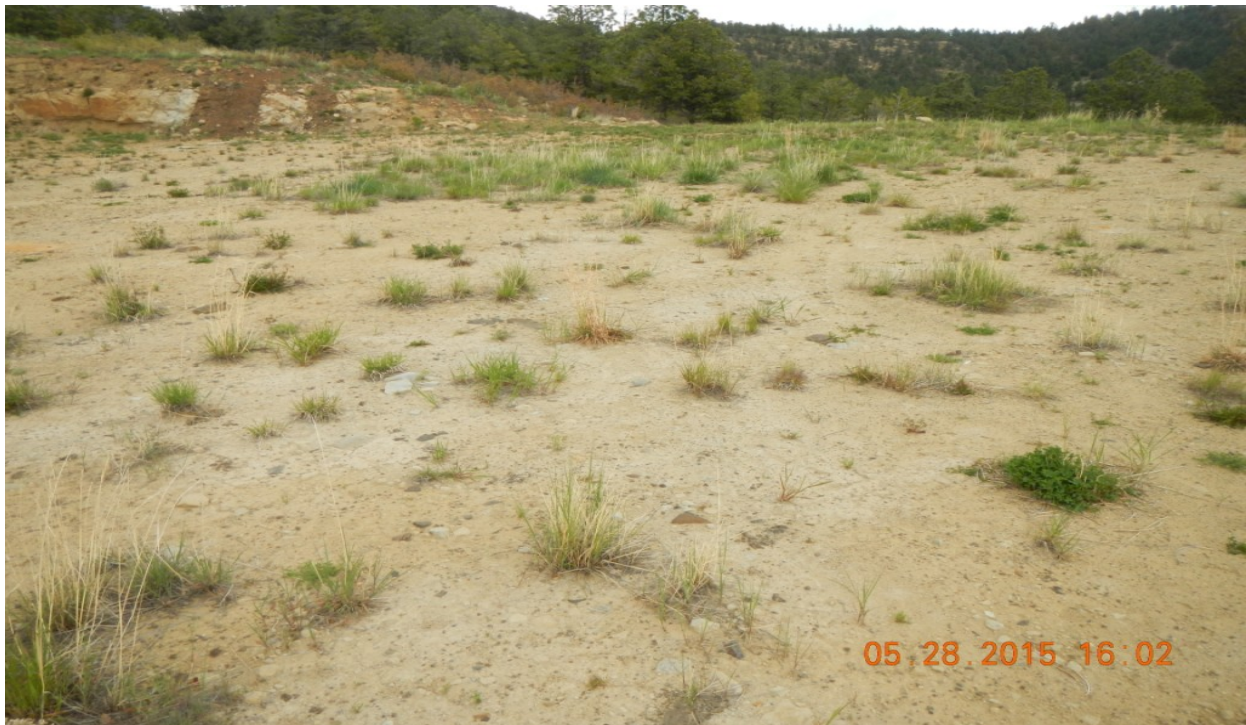
photo 8: Center of the location facing east.

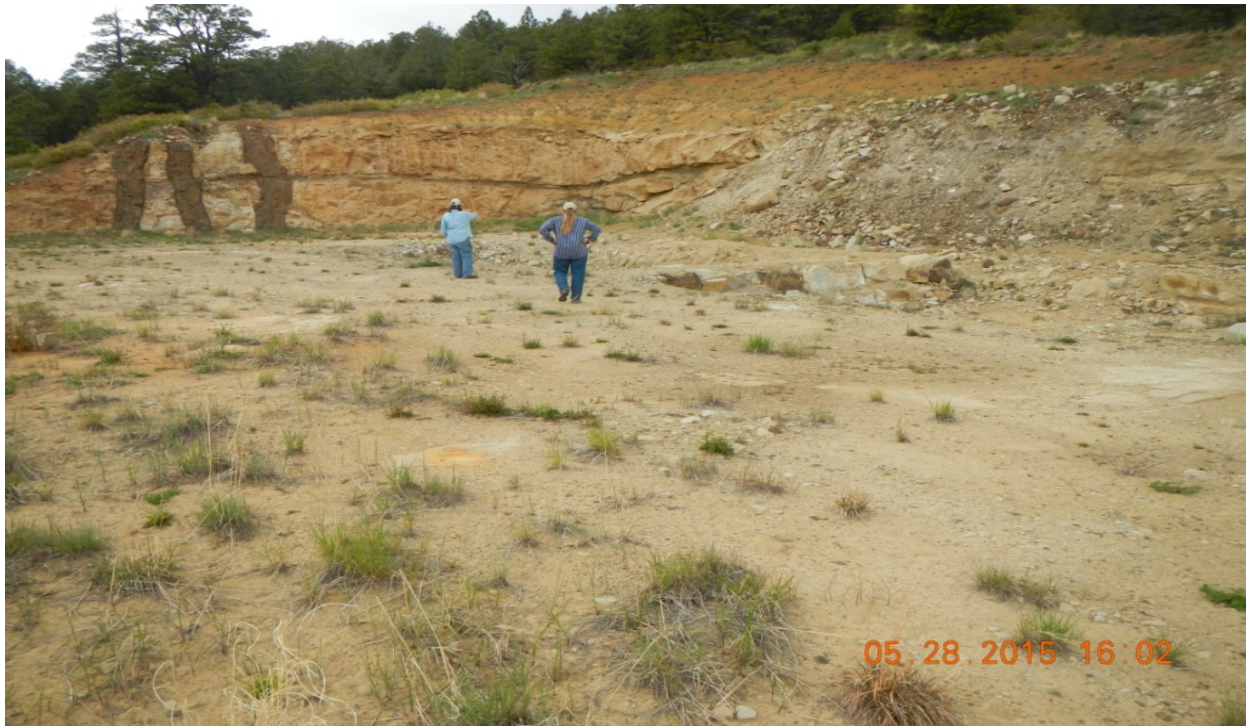
photo 9: Center of the location facing northwest towards the unstable cut of the pad.

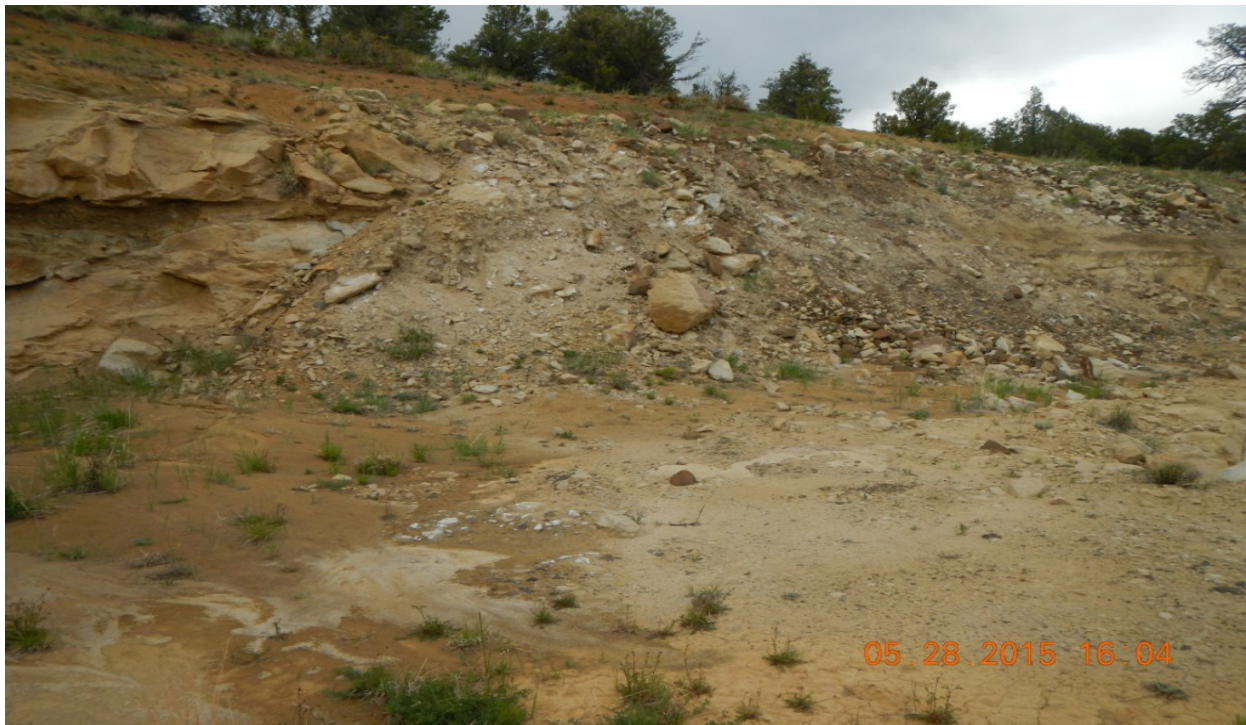
photo 10: North side of the location. Unstable cut with material falling onto the pad.

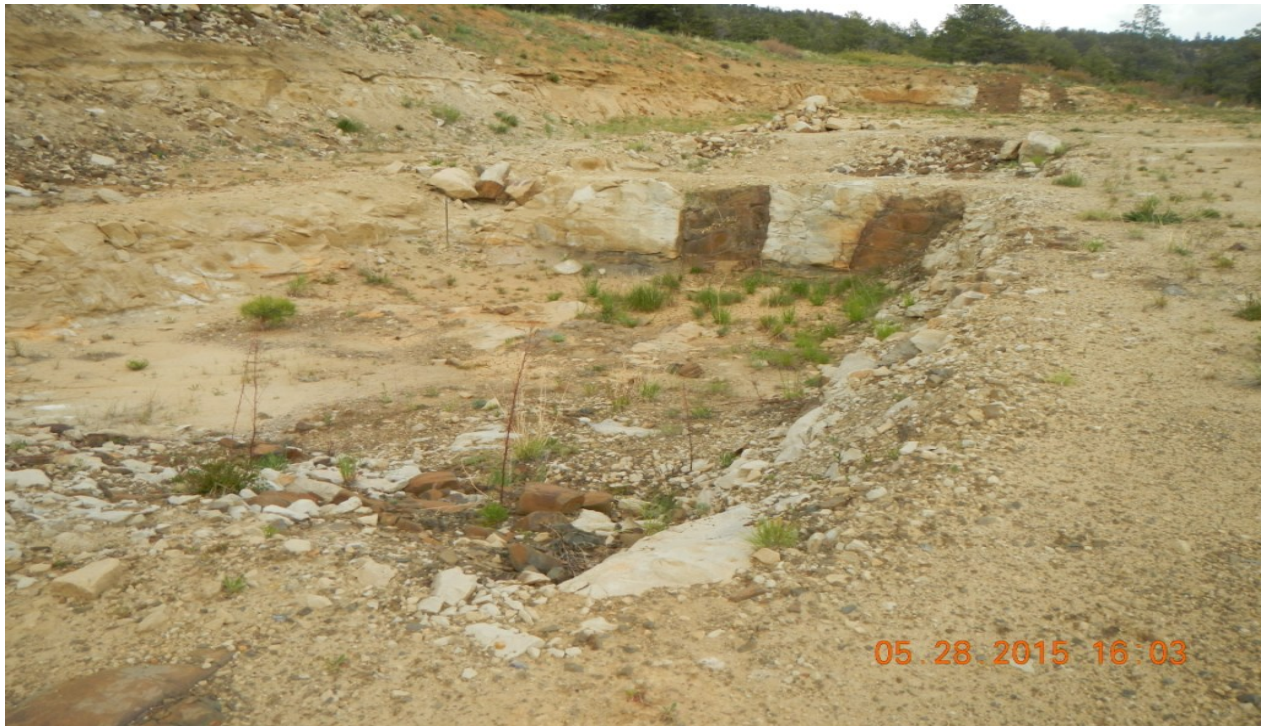
photo 11: The pits remain open on the location.

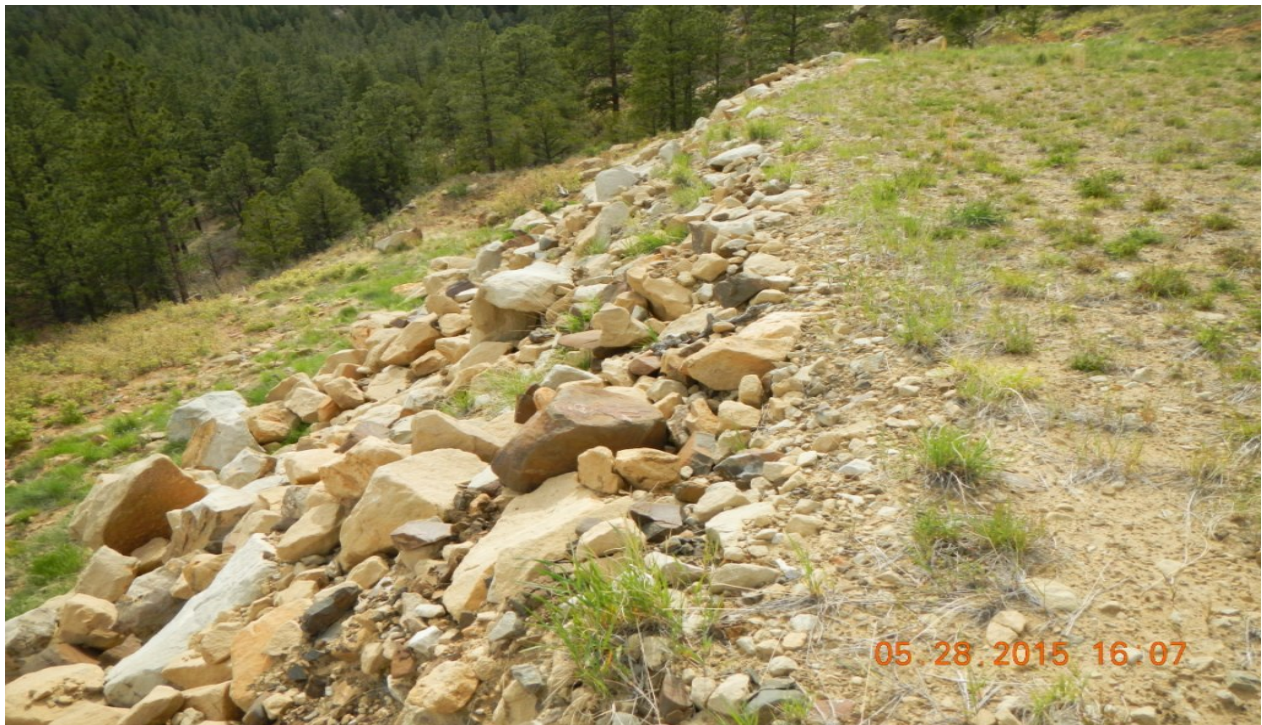
photo 12: South side of the pad area has a steep rock base.
