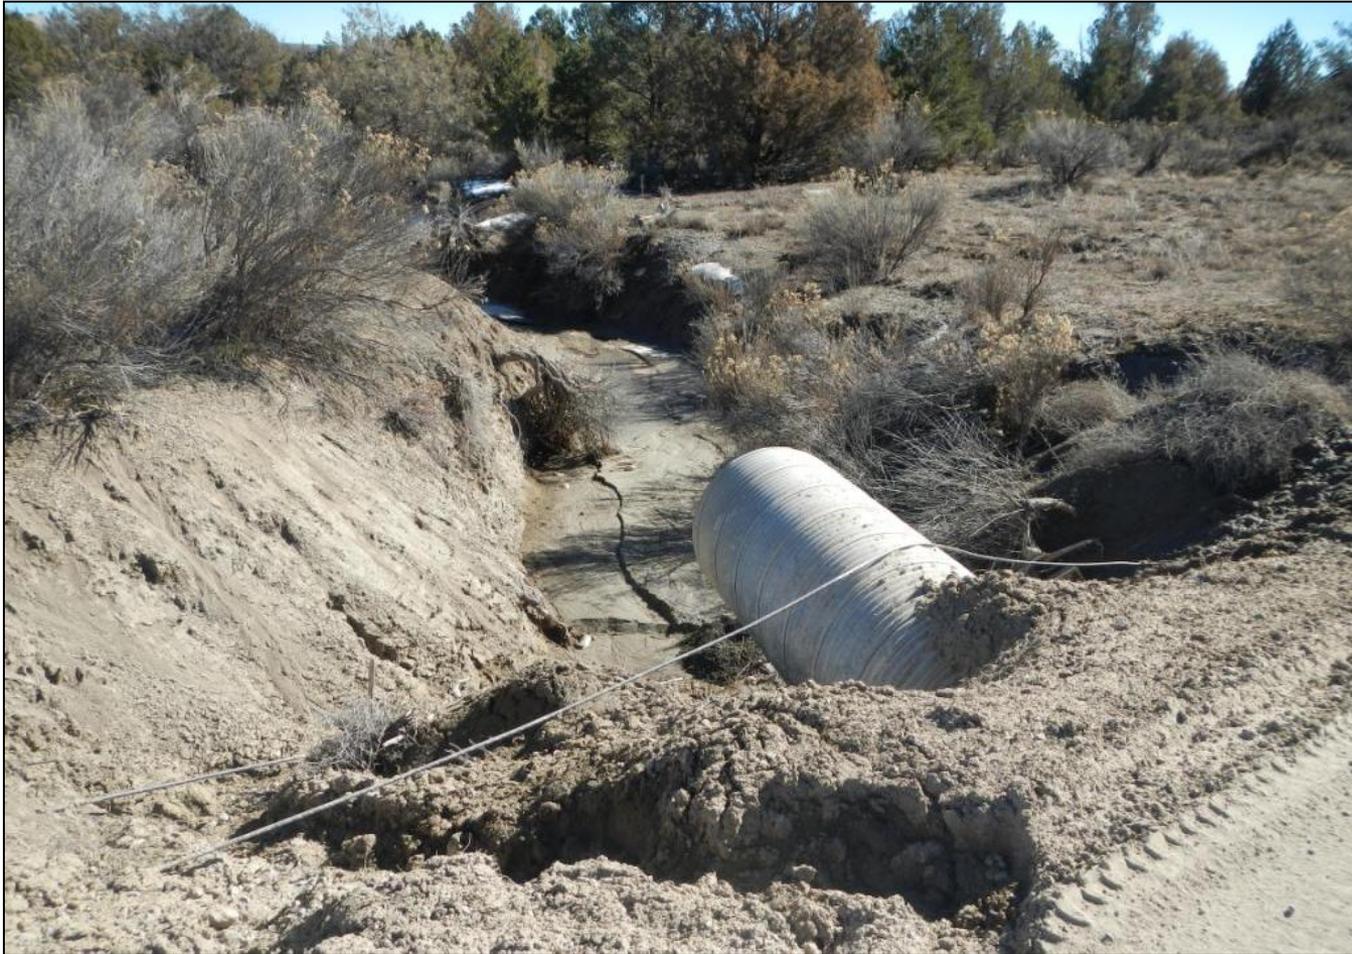
Photo 1. Culvert outlet at 0.5 mile on La Posta Road

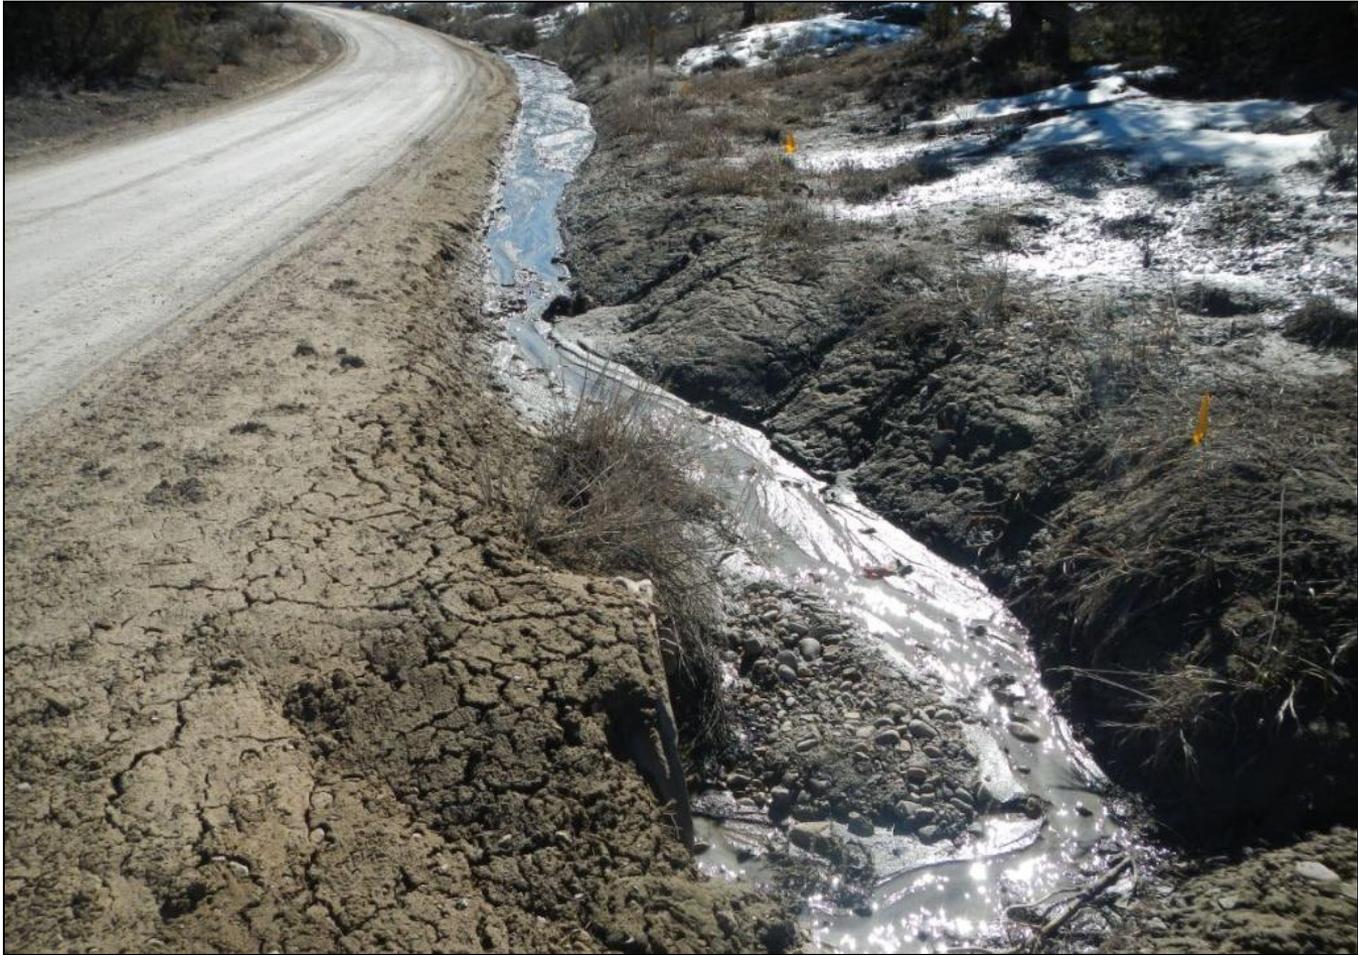
Photo 2. Culvert inlet at 0.9 mile on La Posta Road

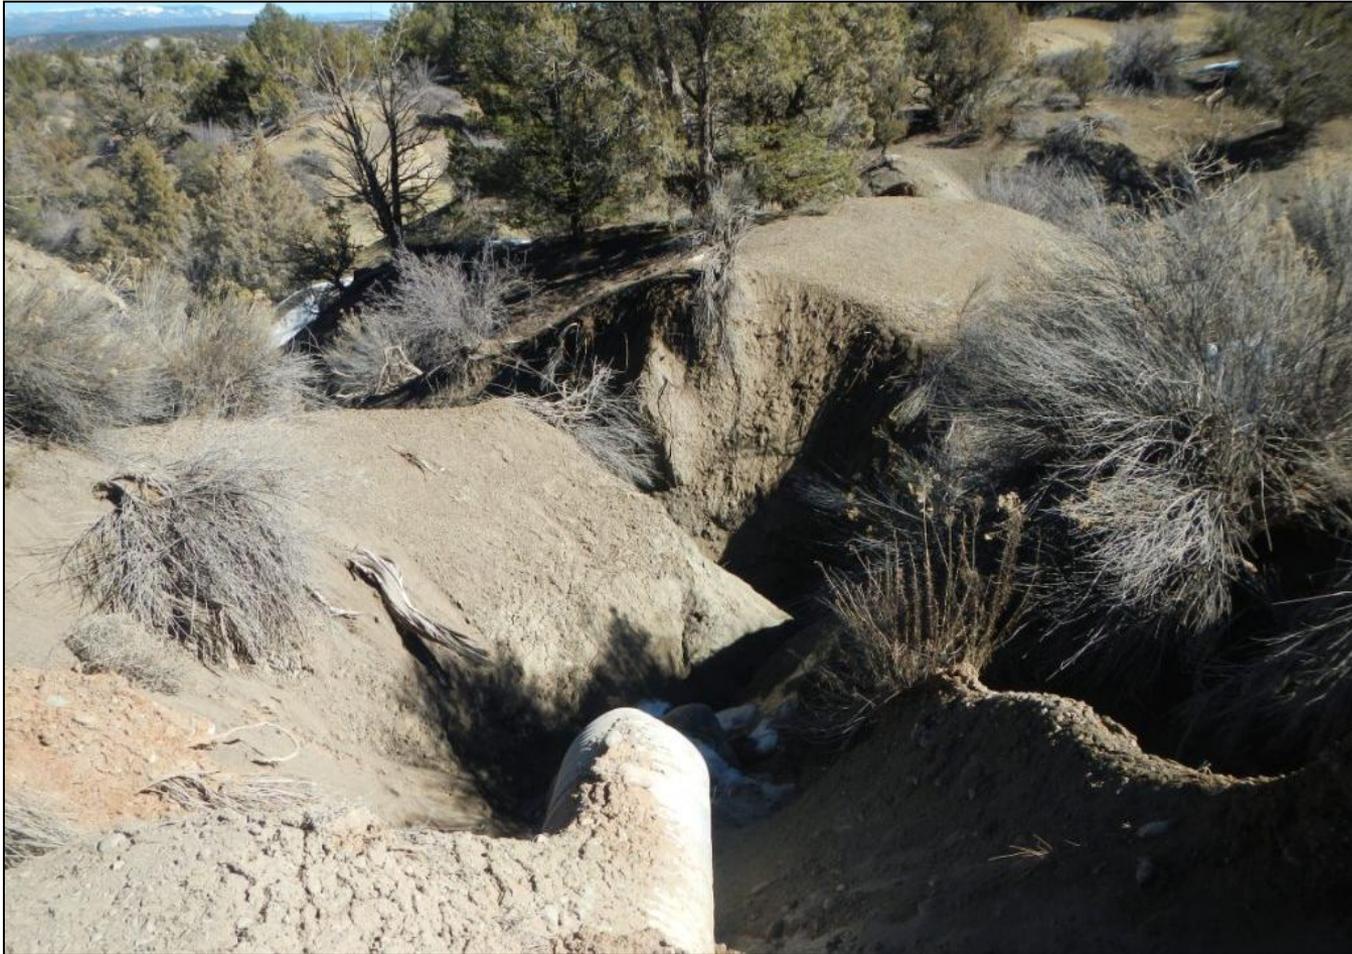
Photo 3. Culvert outlet at 0.9 mile on La Posta Road

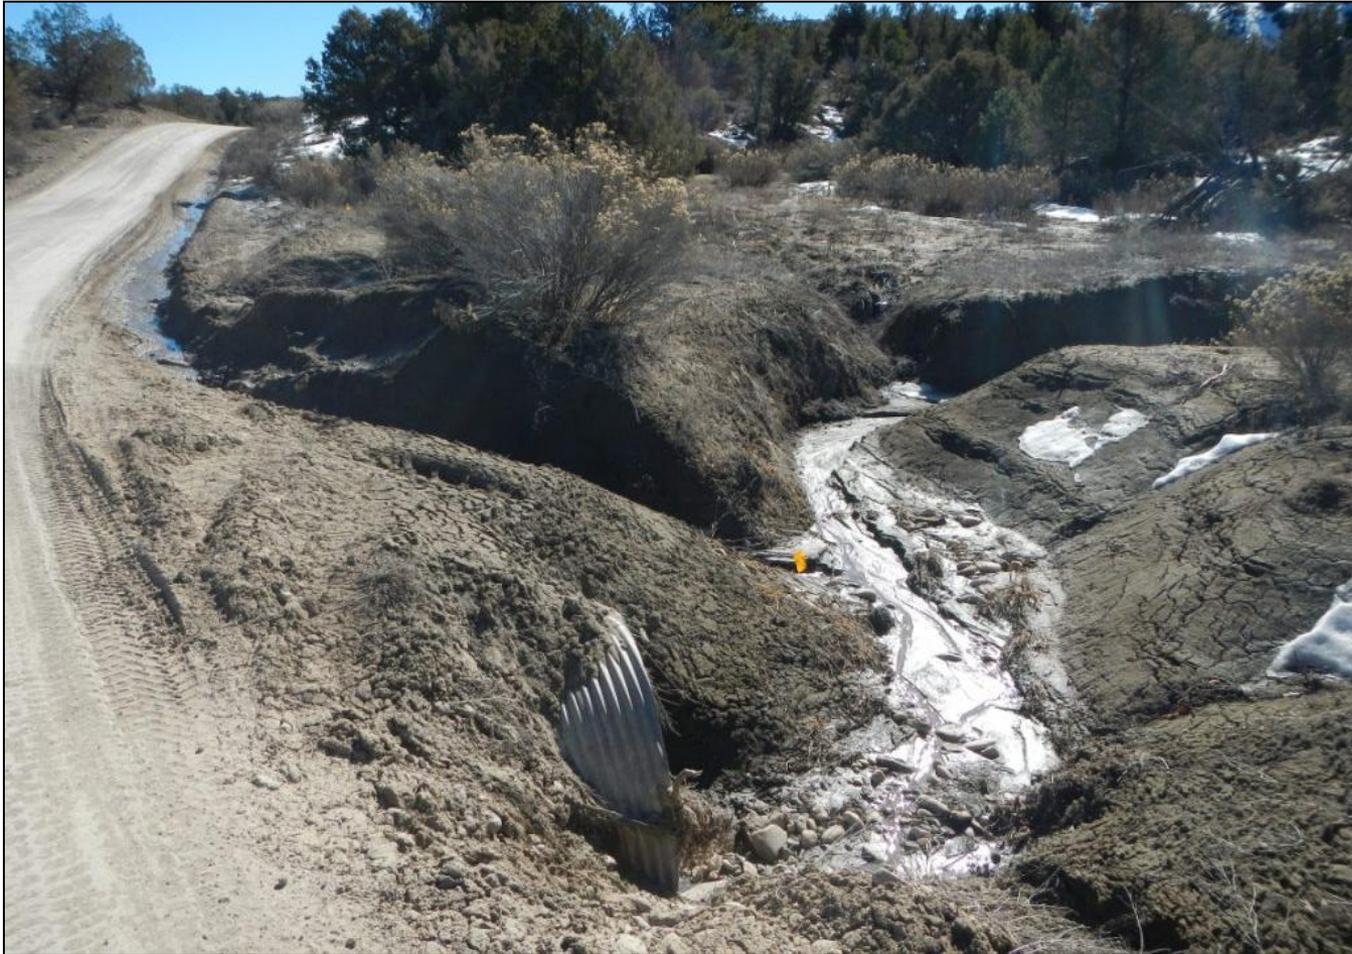
Photo 4. Culvert inlet at 0.95 mile on La Posta Road

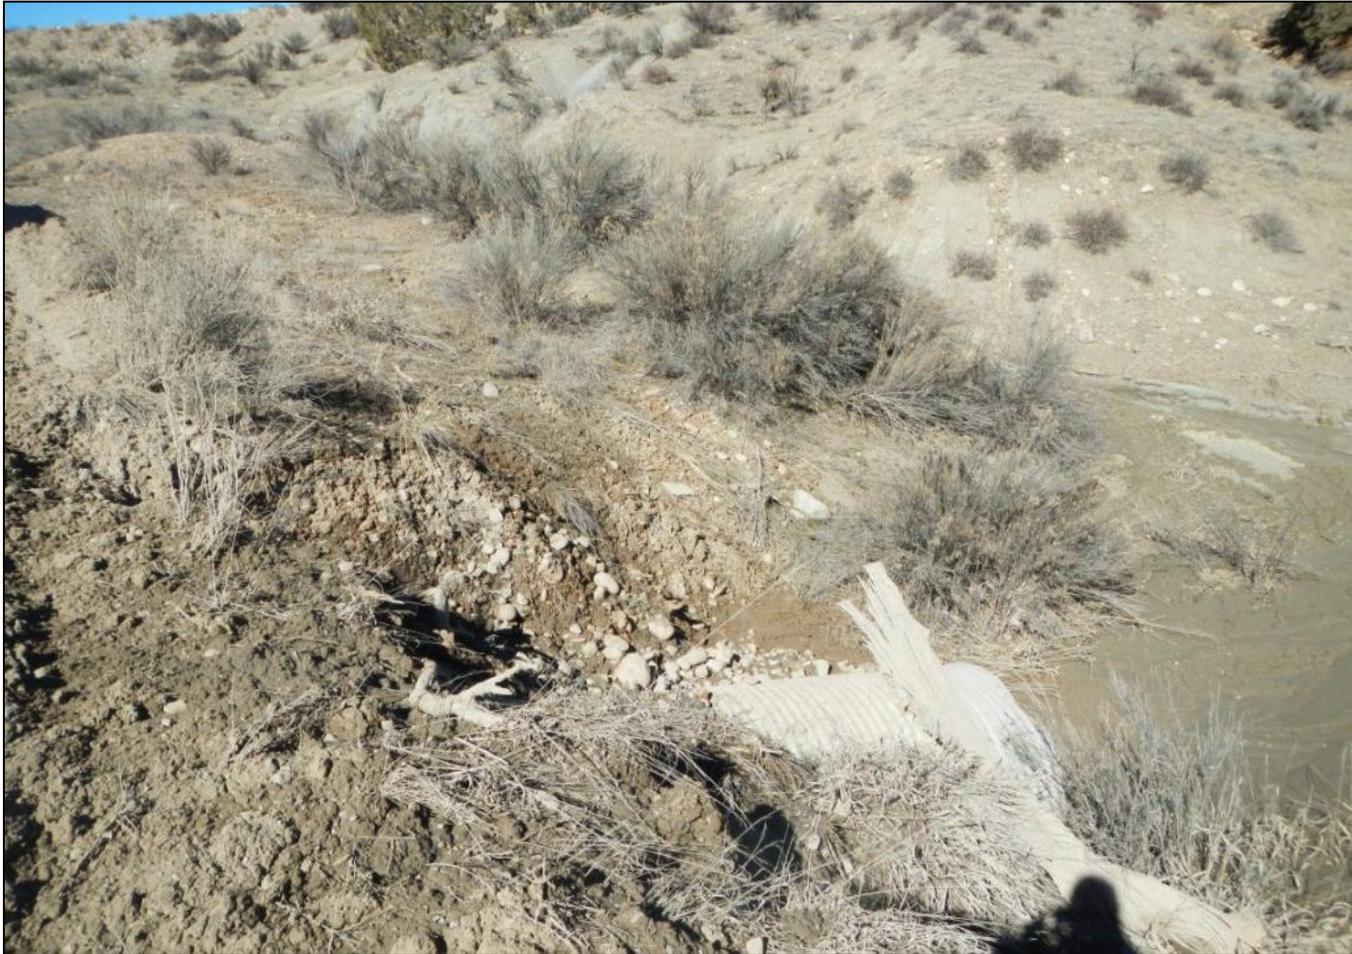
Photo 5. Culvert outlet at 0.95 mile on La Posta Road

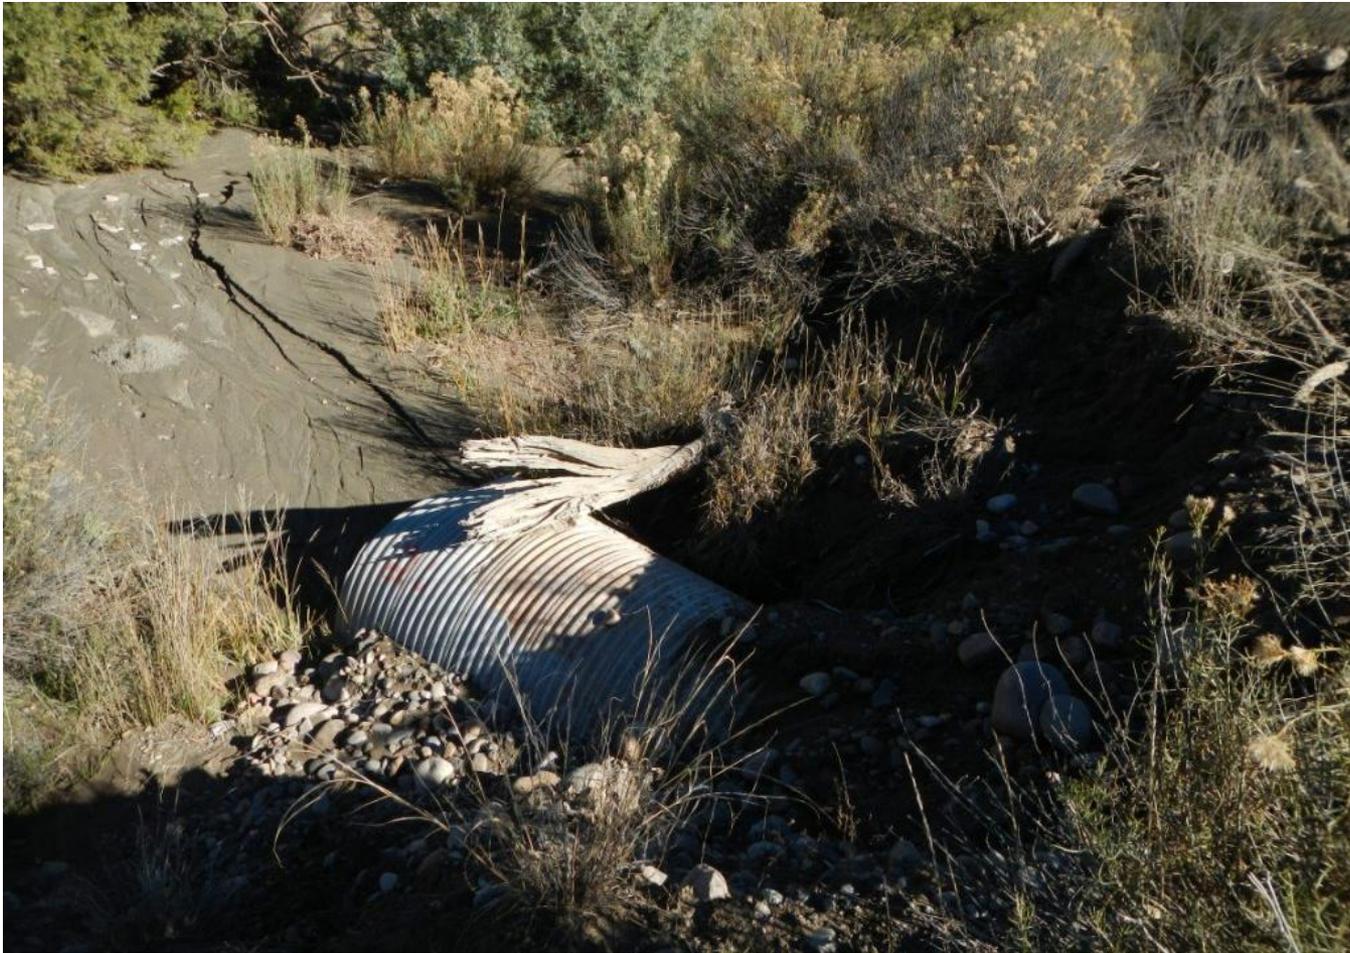
Photo 6. Culvert outlet at 0.95 mile on La Posta Road

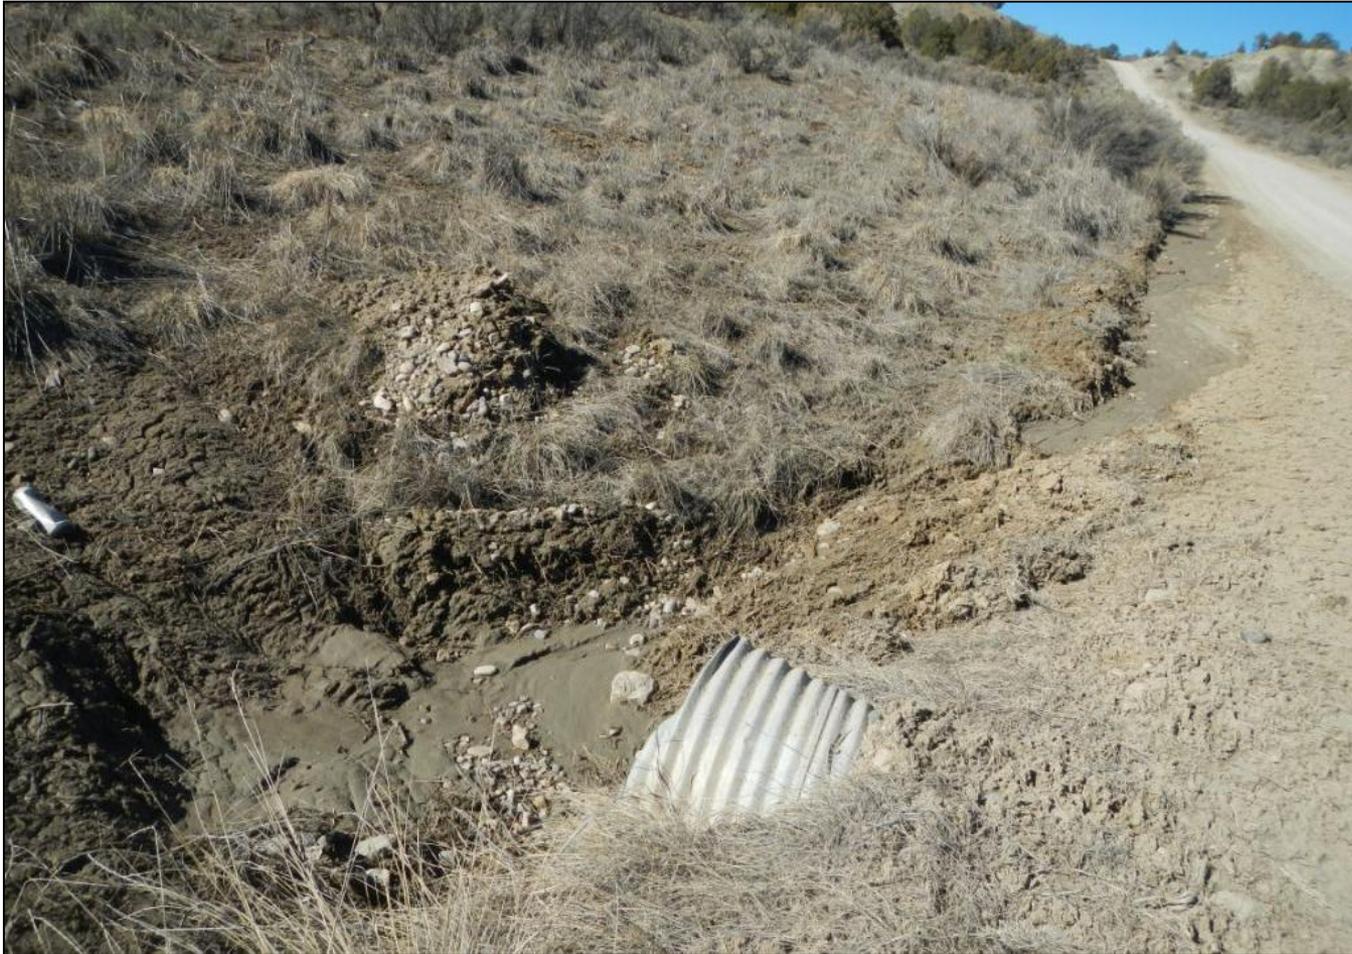
Photo 7. Culvert inlet at 1.1 mile on La Posta Road

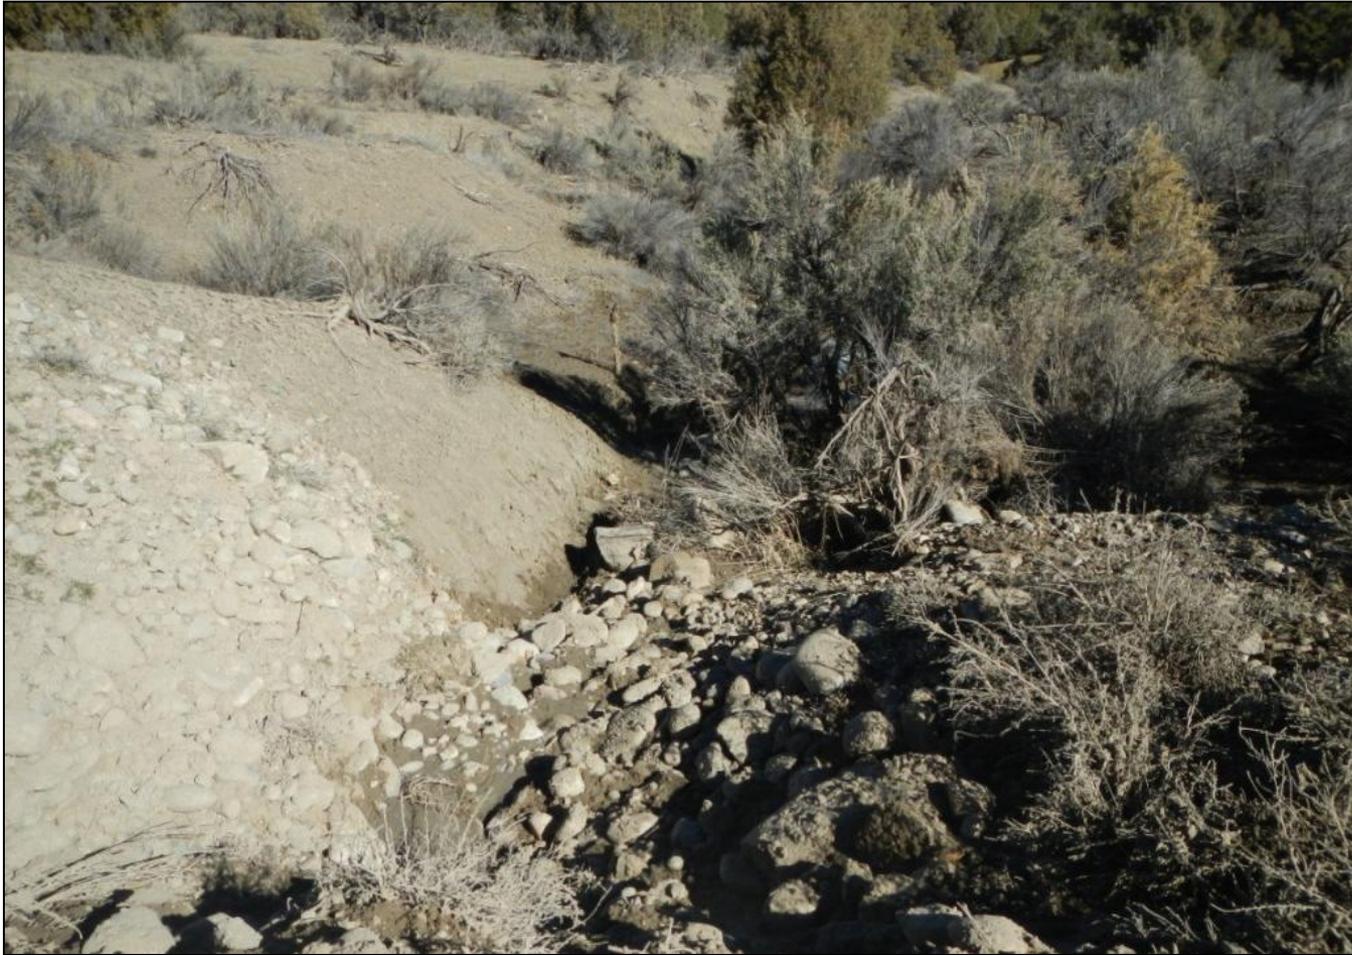
Photo 8. Culvert outlet at 1.1 mile on La Posta Road

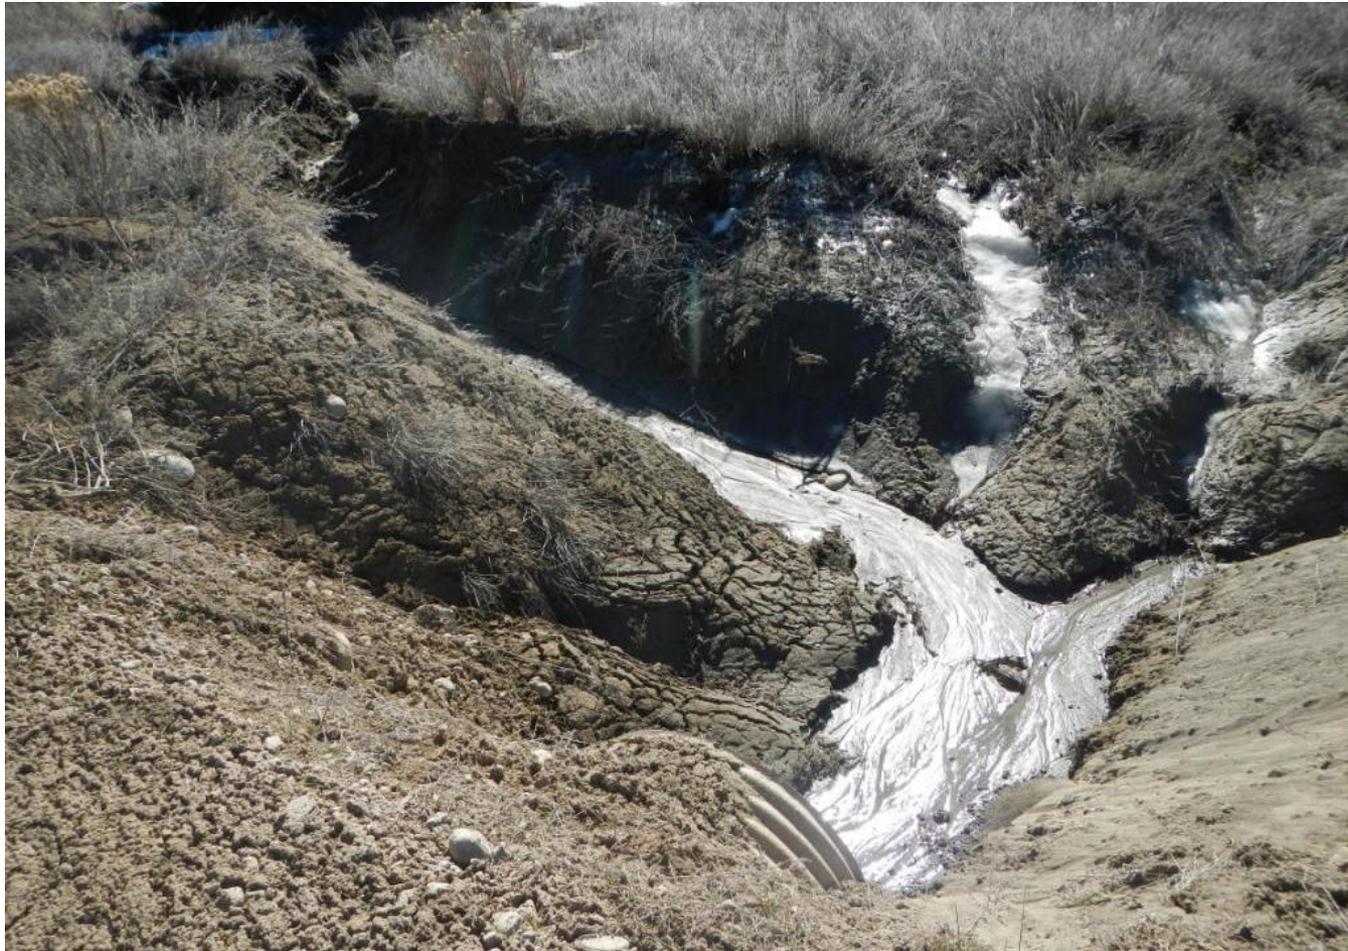
Photo 9. Culvert inlet at 1.4 mile on La Posta Road

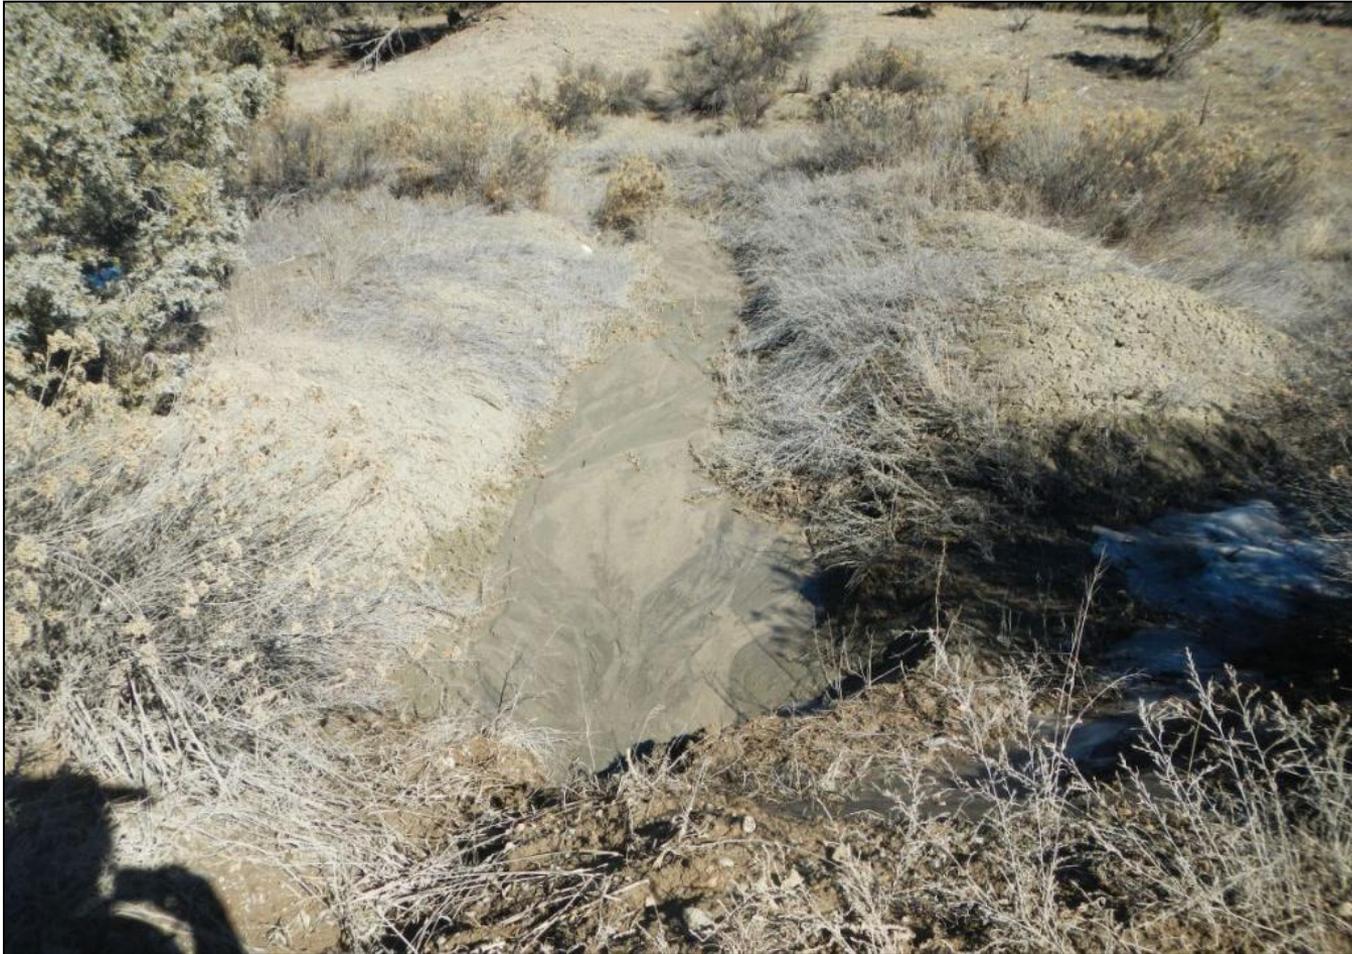
Photo 10. Culvert outlet at 1.4 mile on La Posta Road. Outlet nearly 100 percent blocked by sediment.

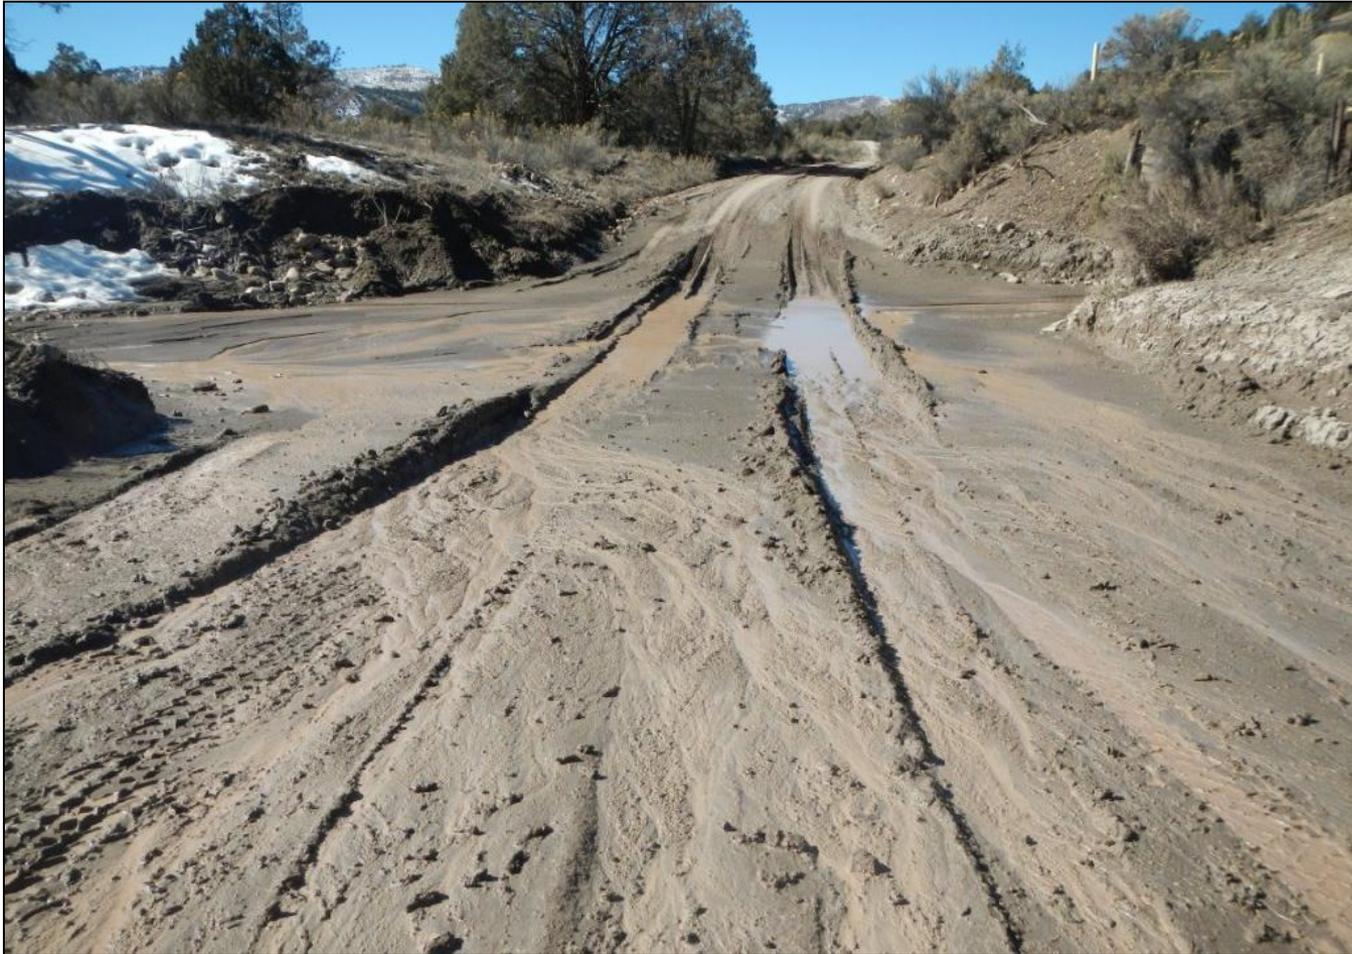
Photo 11. View of low water crossing (mile 1.9 on La Posta Road).

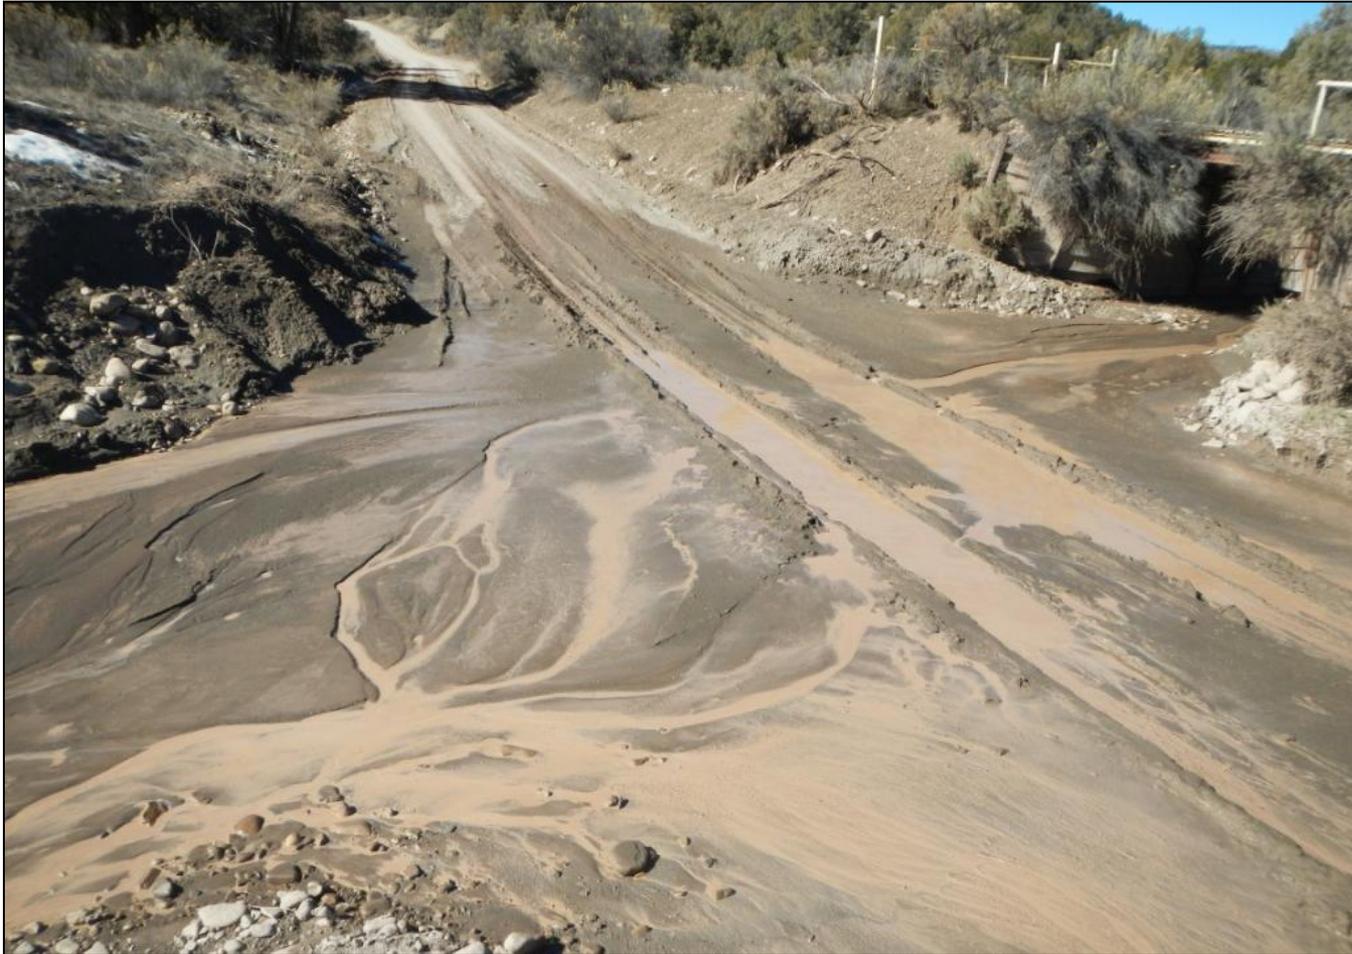
Photo 12. Another view of low water crossing (mile 1.9 on La Posta Road).

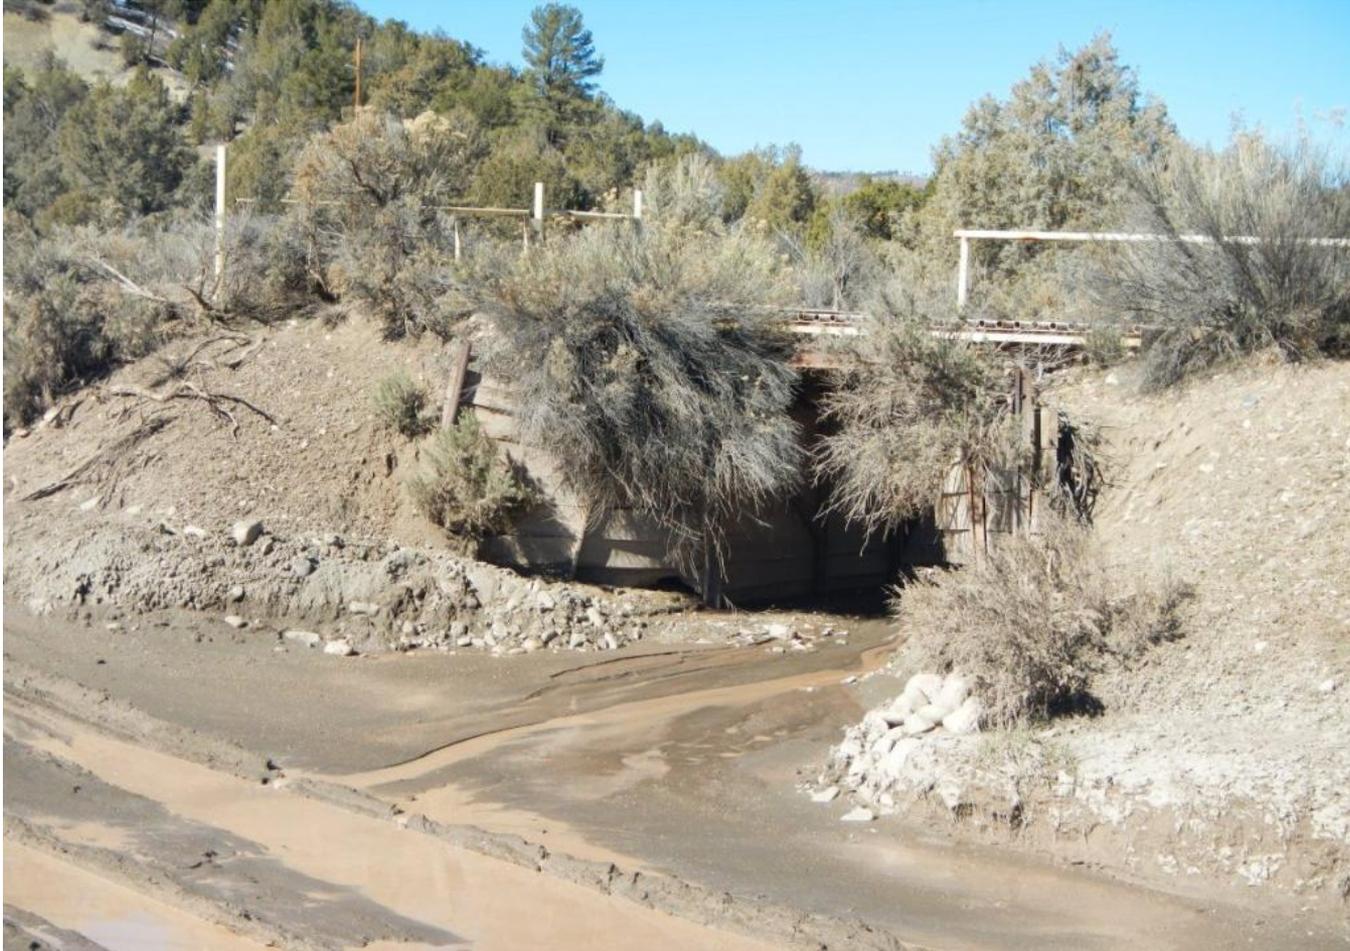
Photo 13. View of old bridge at low water crossing.

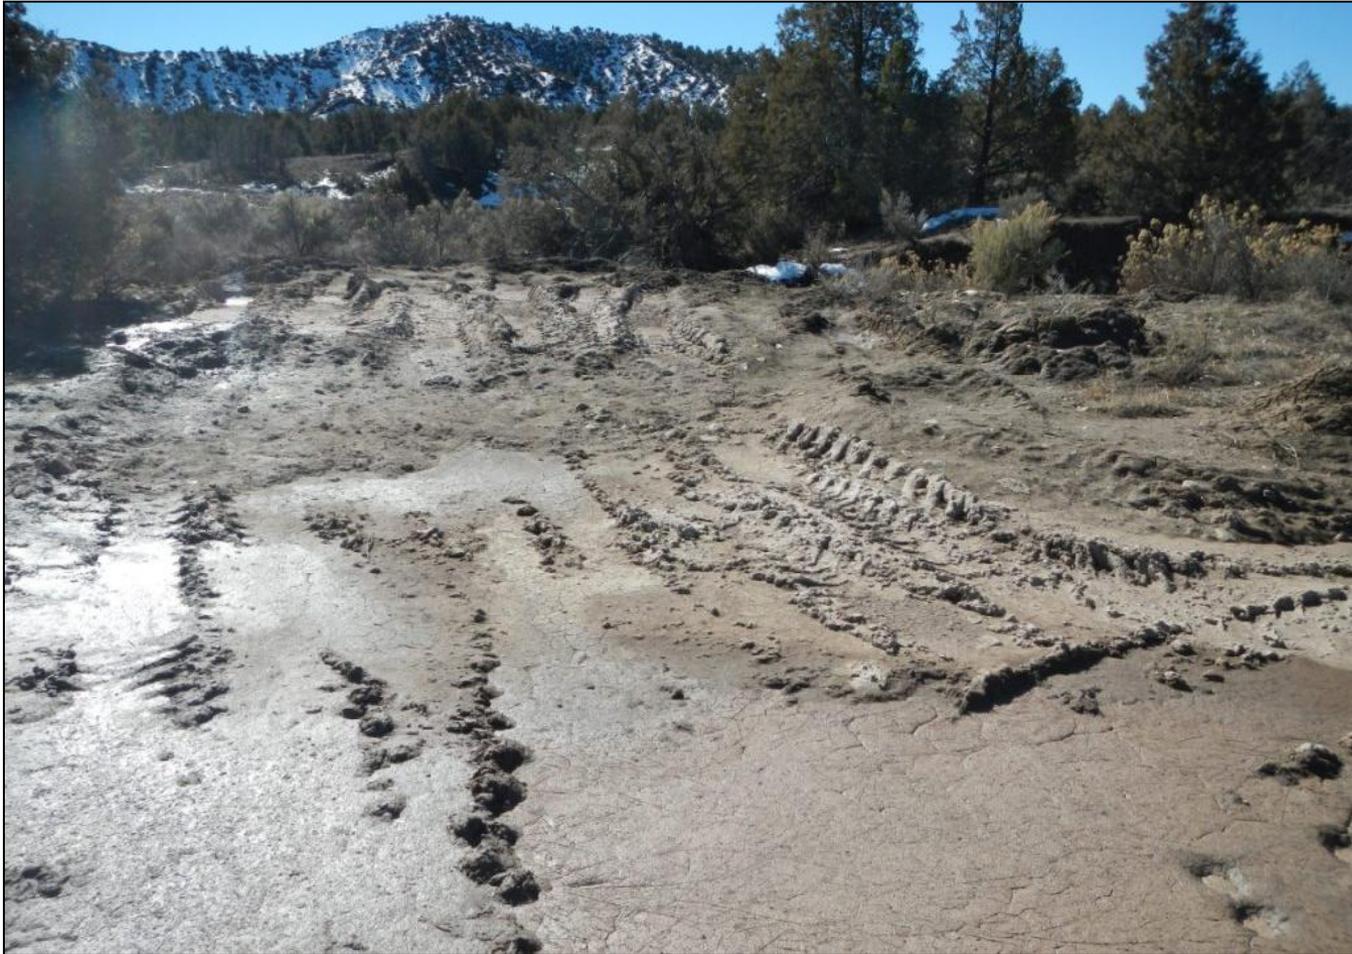
Photo 14. View of sediment stockpiling area at low water crossing (mile 1.9 on La Posta Road).

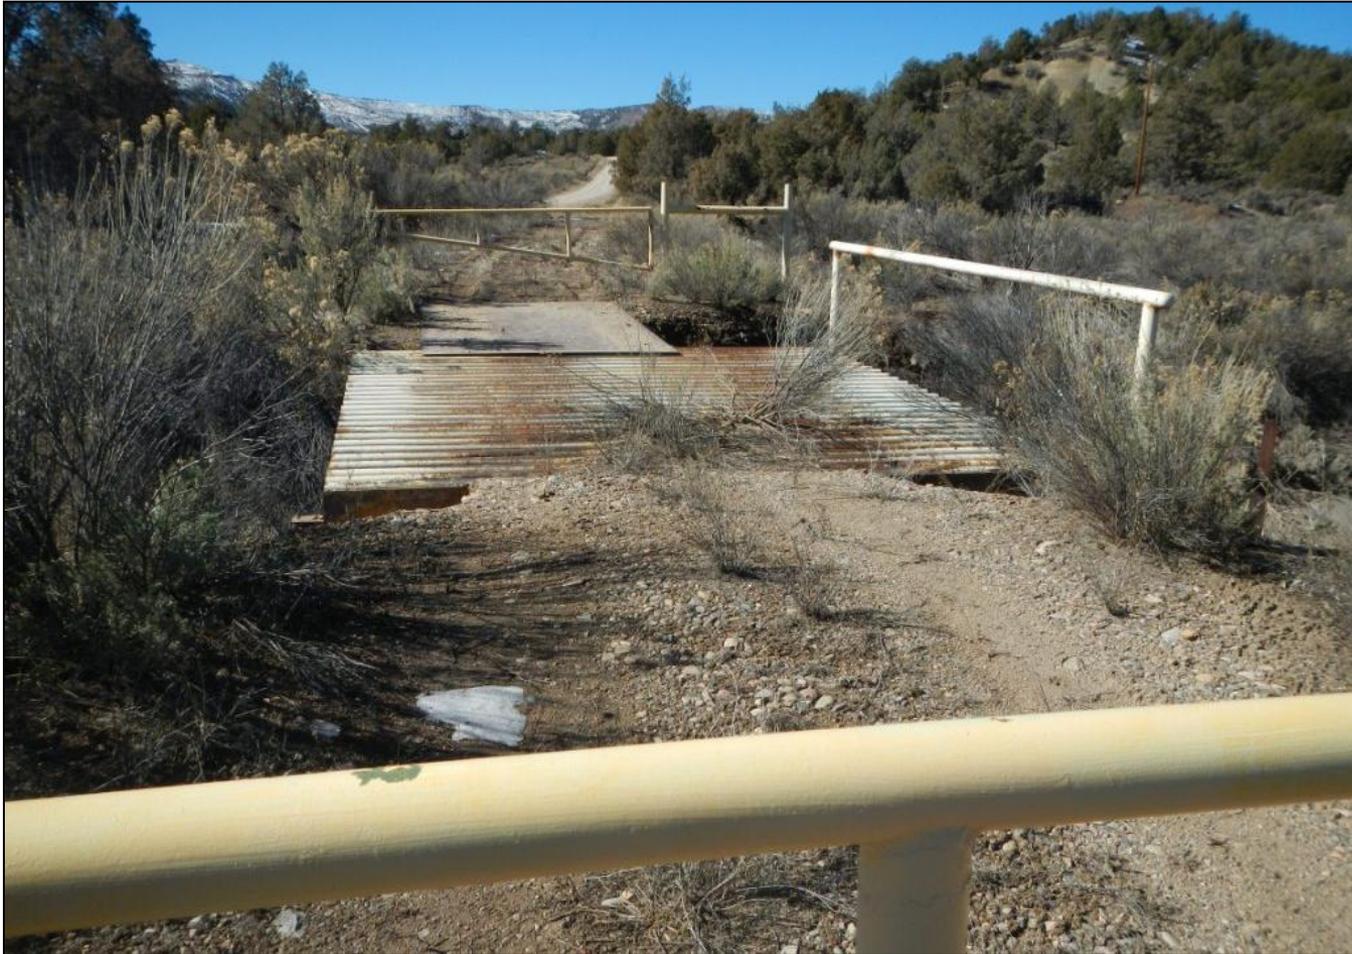
Photo 15. View of driving surface of old bridge at low water crossing.

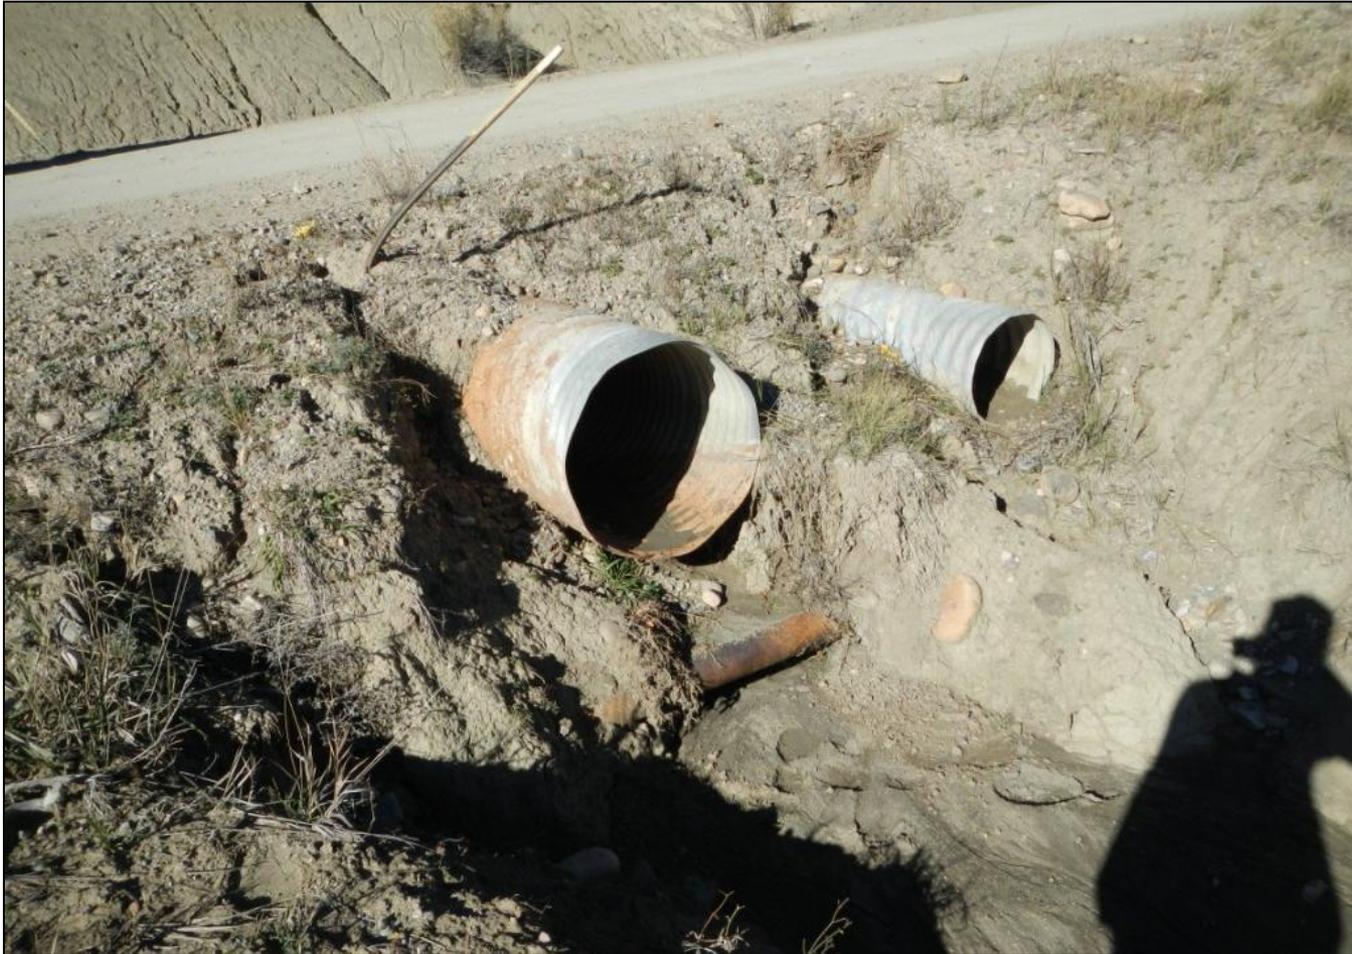
Photo 16. View of exposed pipeline at culvert outlet (approximately 2.5 miles on La Posta Road).

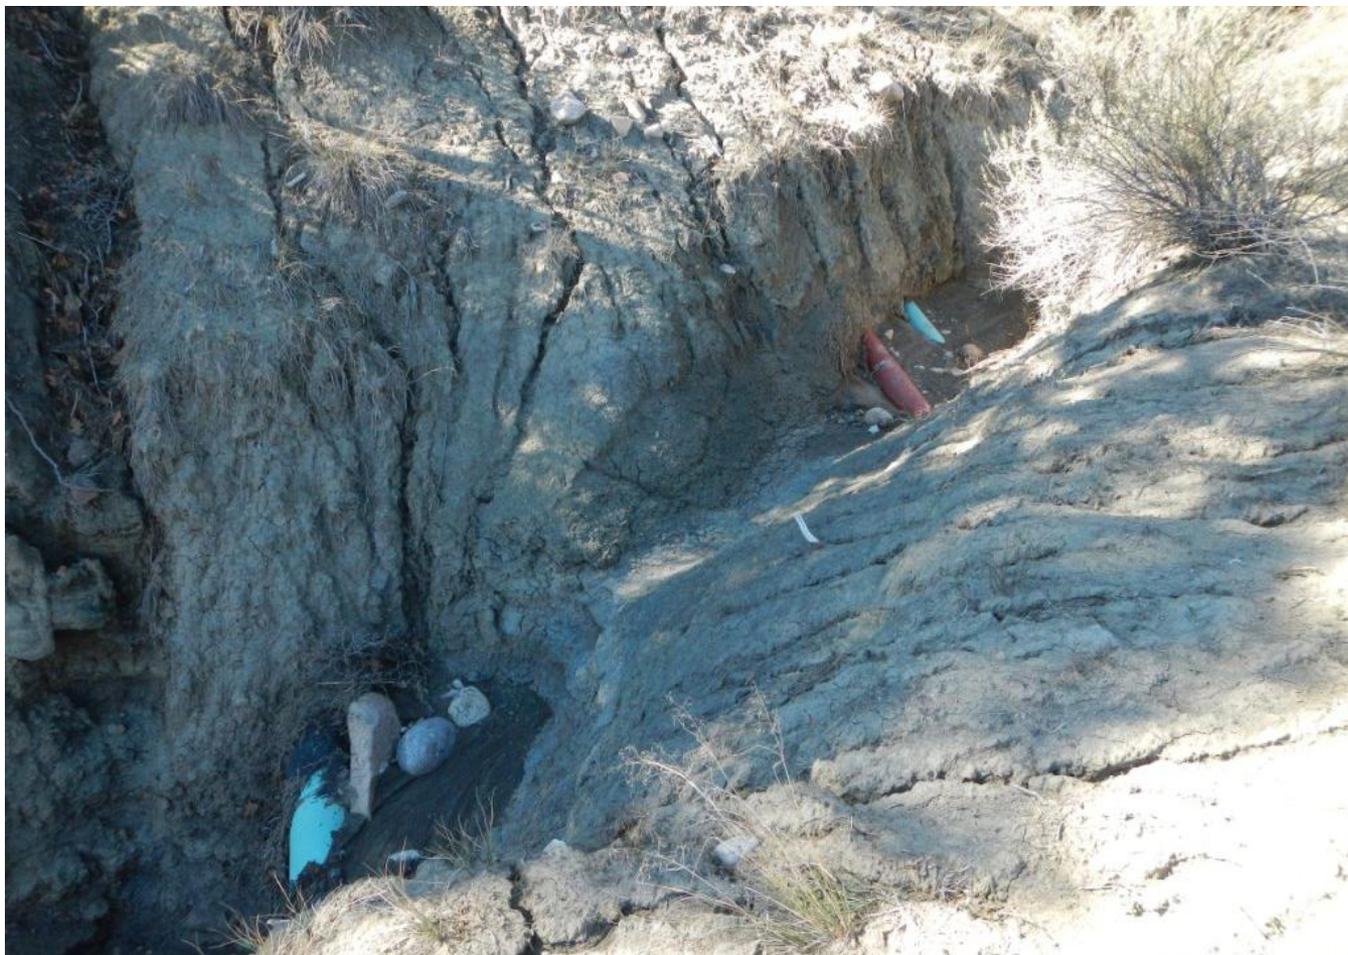
Photo 17. View of exposed pipeline below culvert outlet (approximately 2.5 miles on La Posta Road).
