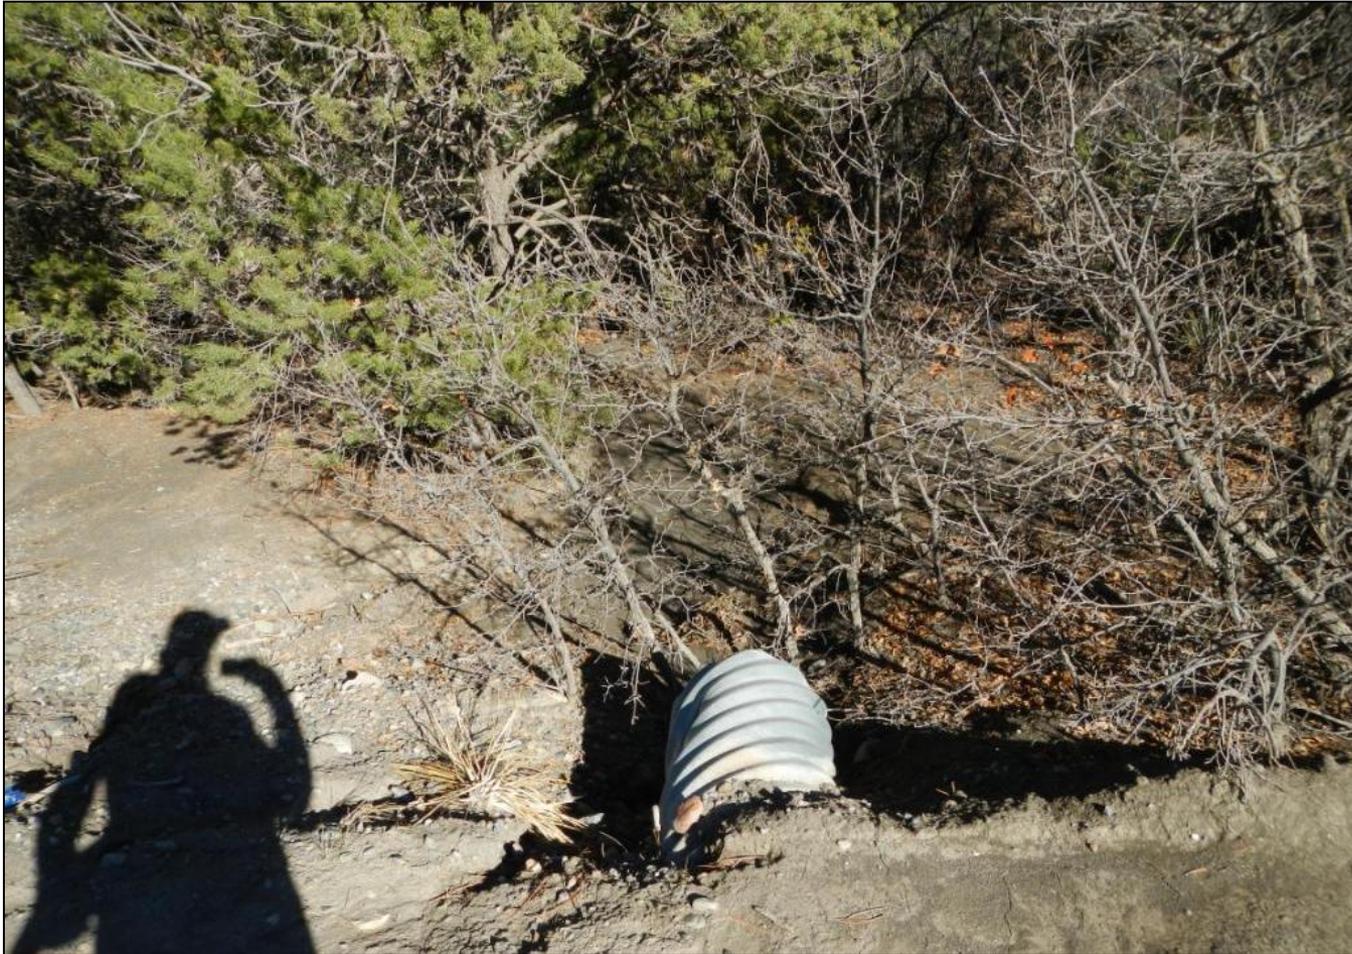
Photo 18. View of culvert outlet directing flows onto private property outside of normal flow pattern at approximately 3.0 miles on La Posta Road.

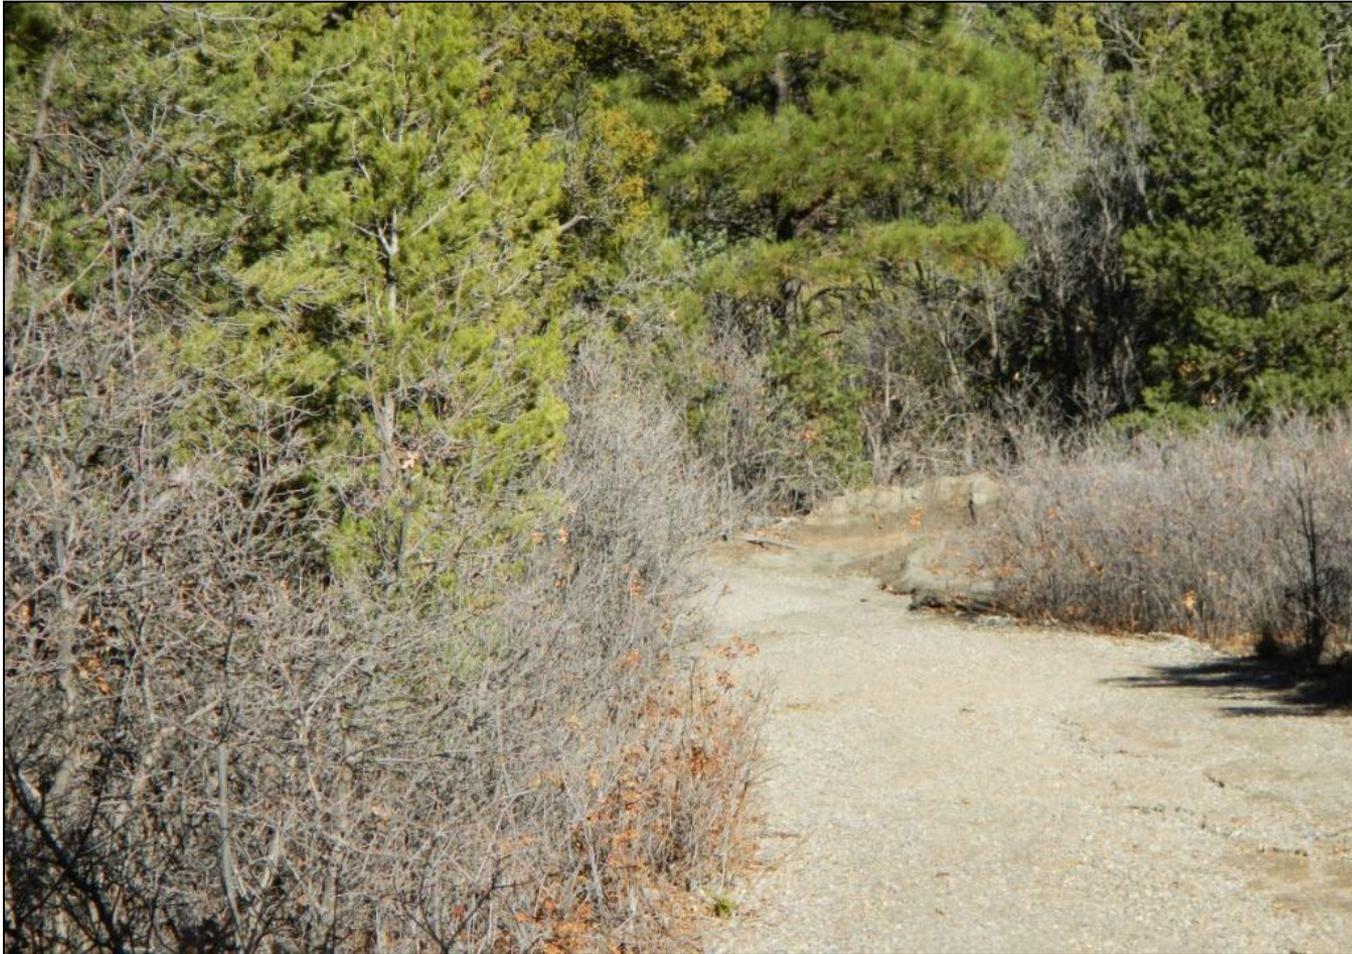
Photo 19. Downstream from Photo 4, sediment discharge from culvert outlet diversion outside of normal flow pattern.

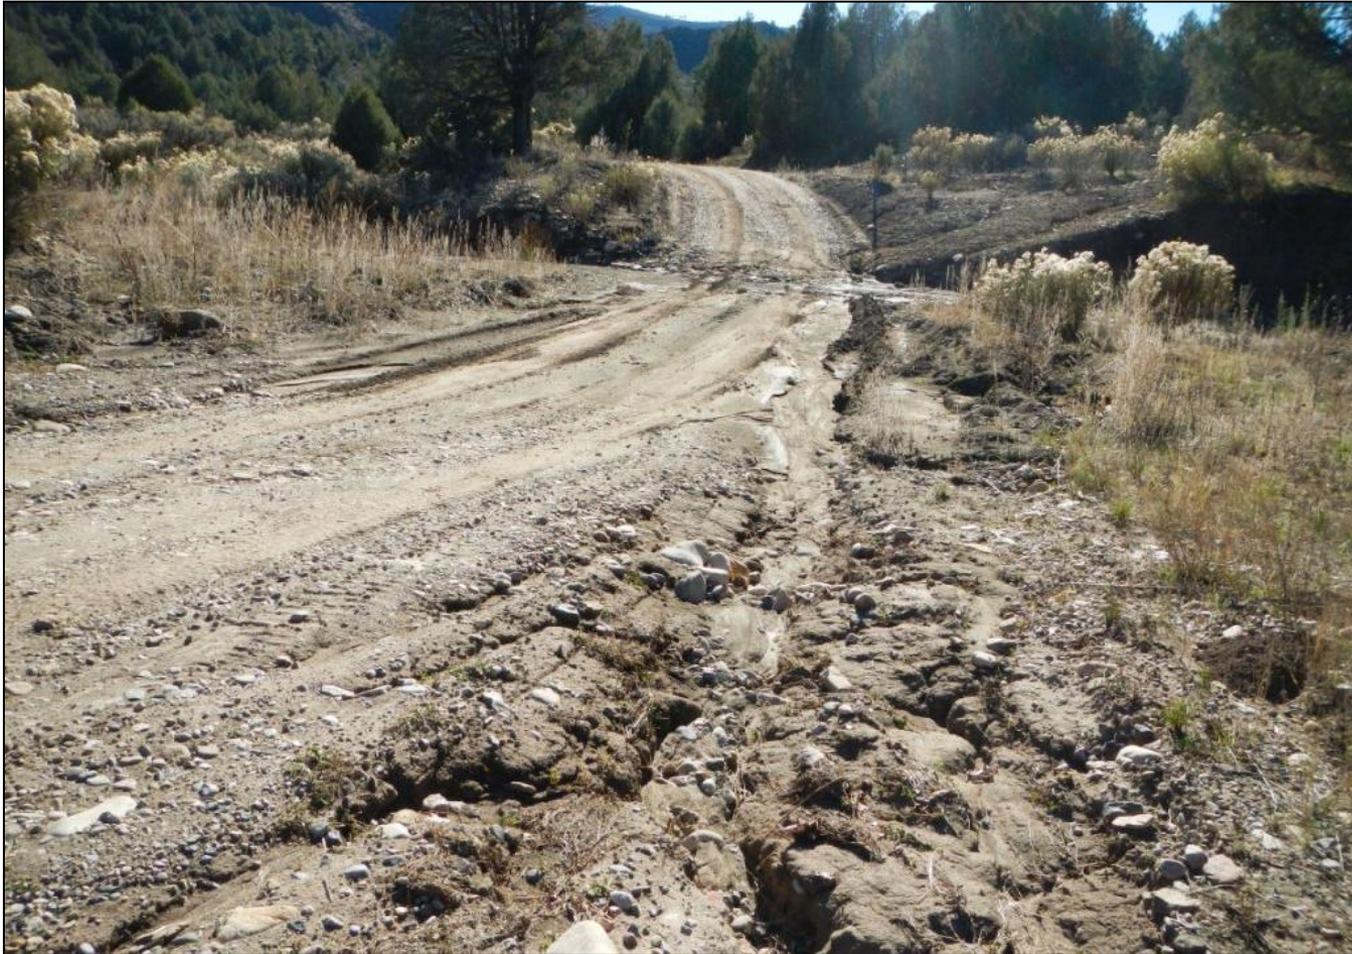
Photo 20. View of erosion on Hermit Haven Road flowing toward low water crossing. Turn off for Hermit Haven Road is approximately 3.4 miles on La Posta Road.

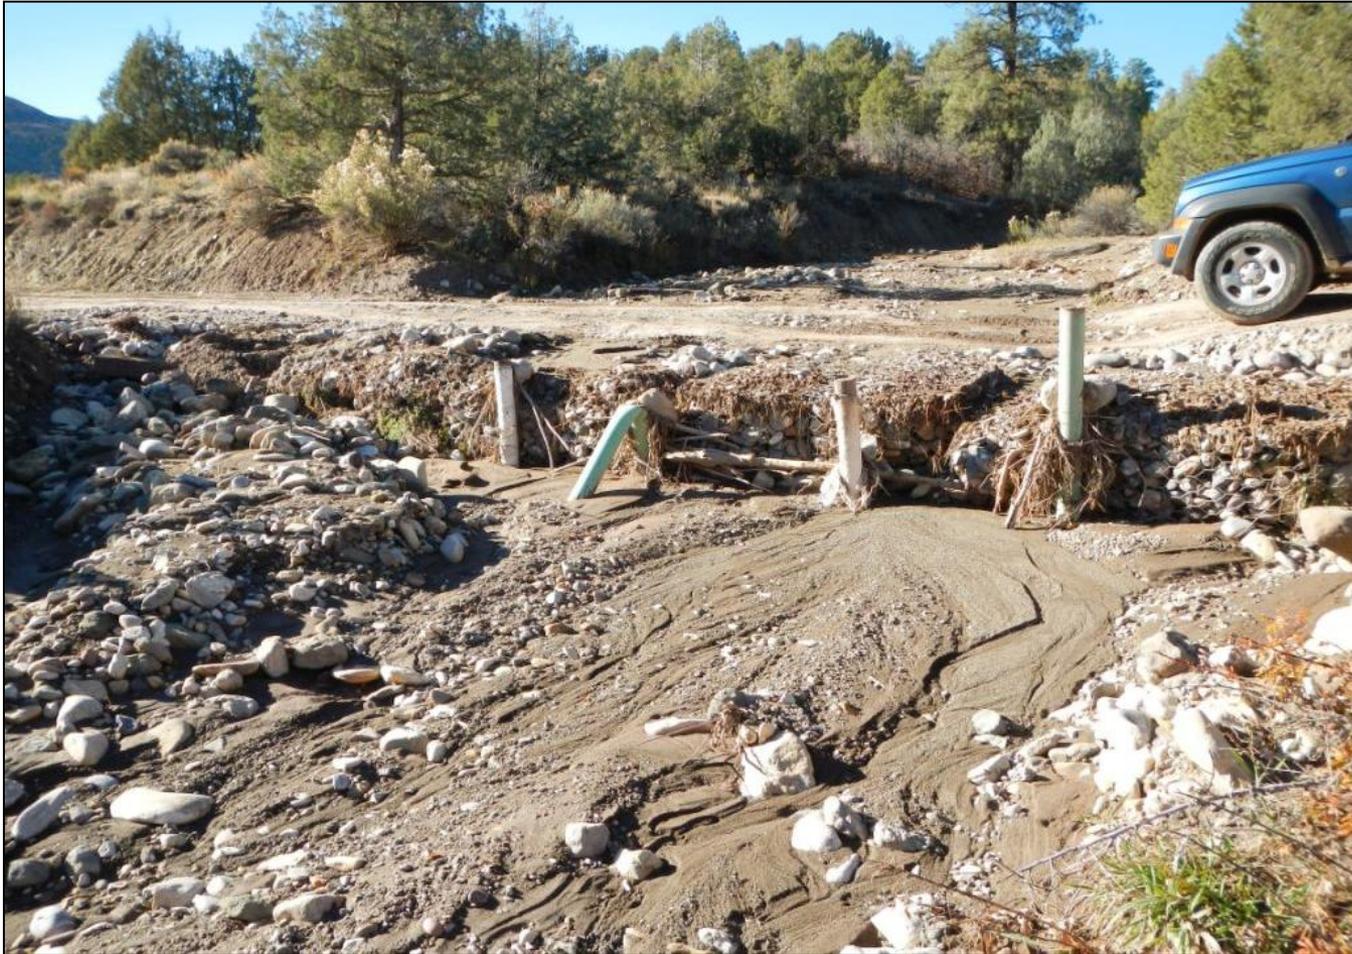
Photo 21. View of low water crossing on Budd Lane at approximately 0.3 mile.
