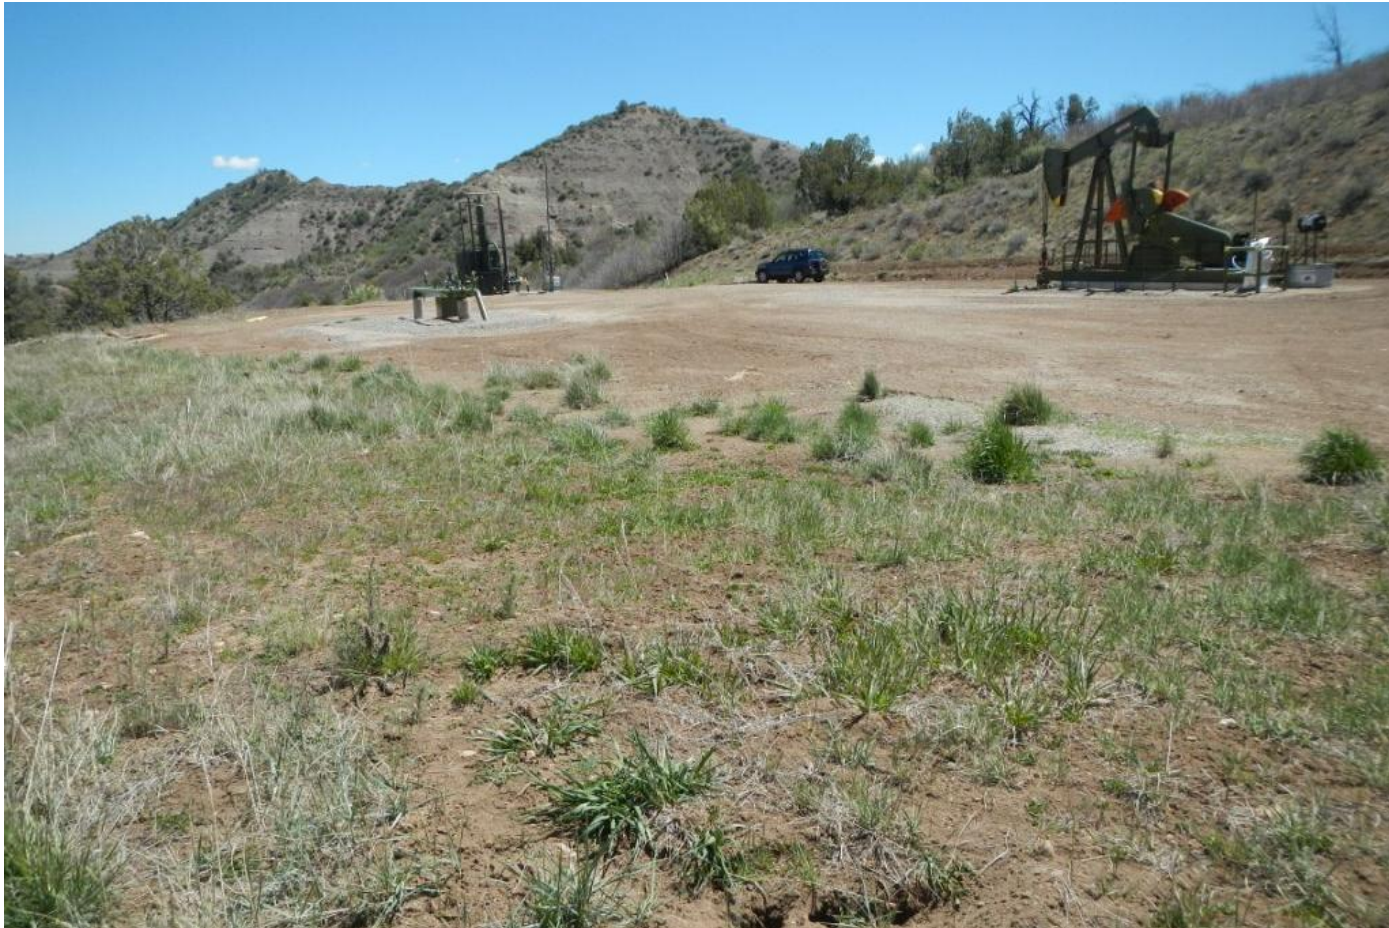
Photo 1. View of project area from northwestern corner facing center. Good revegetation within the interim reclamation area.

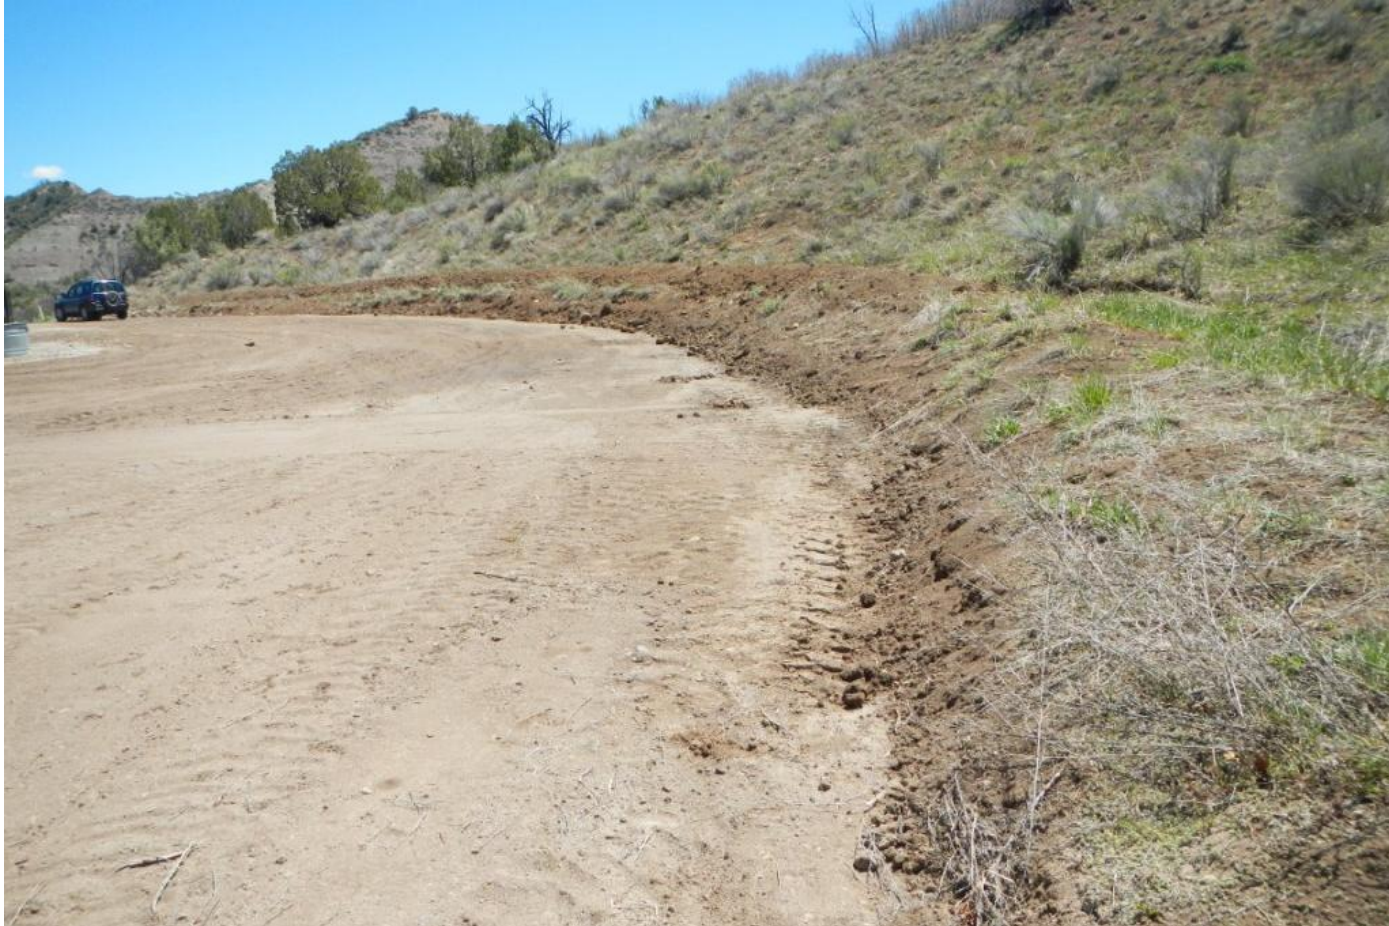
Photo 2. View of southern portion of project area from southwestern corner facing southeastward. Stormwater diversion channel and berm have recently been maintained.

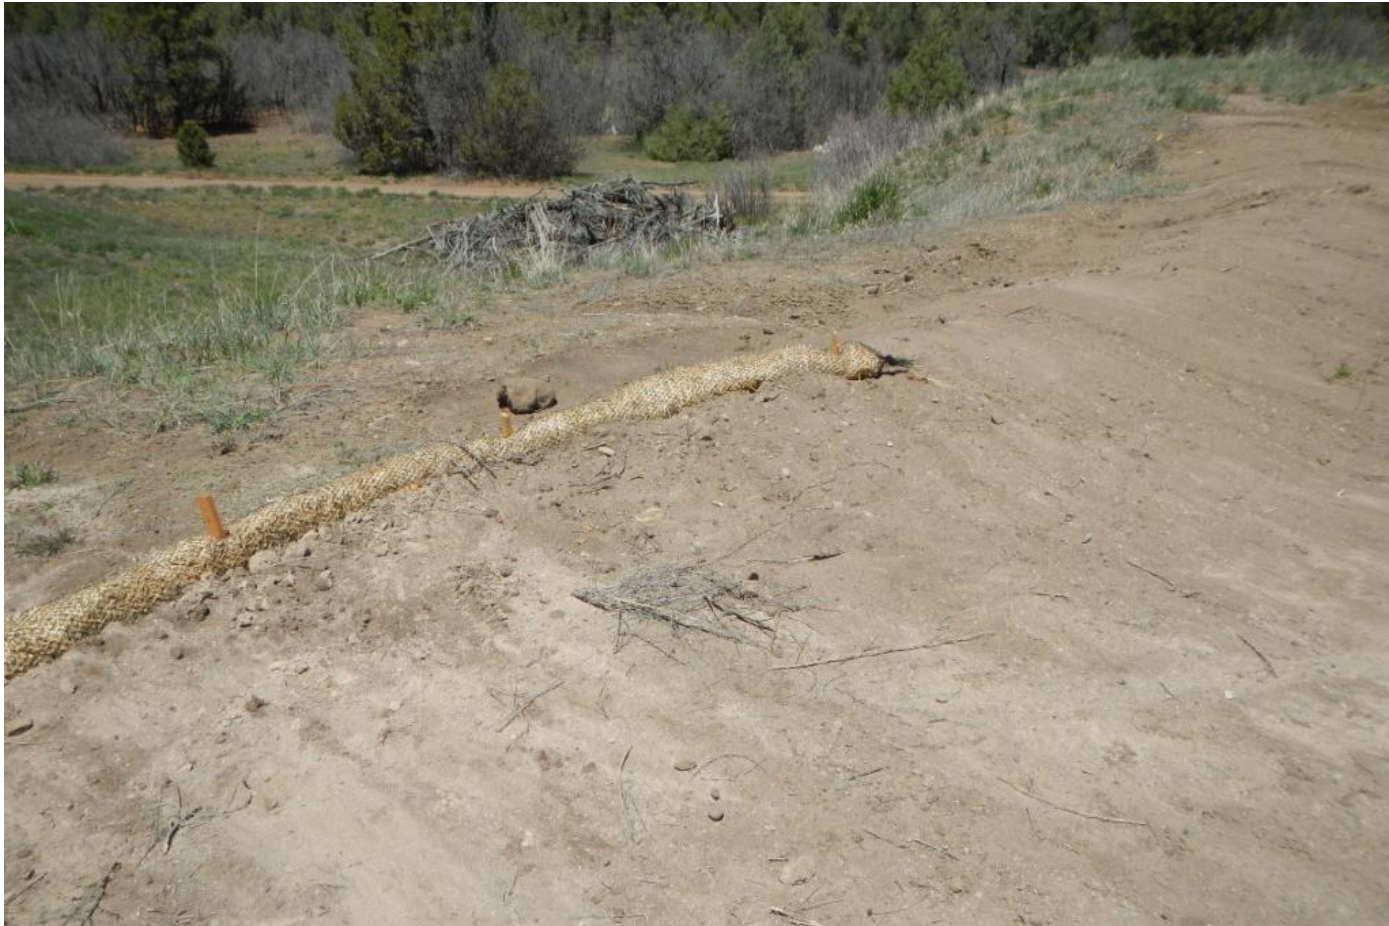
Photo 3. View of newly installed/maintained stormwater BMP along western edge of project area.

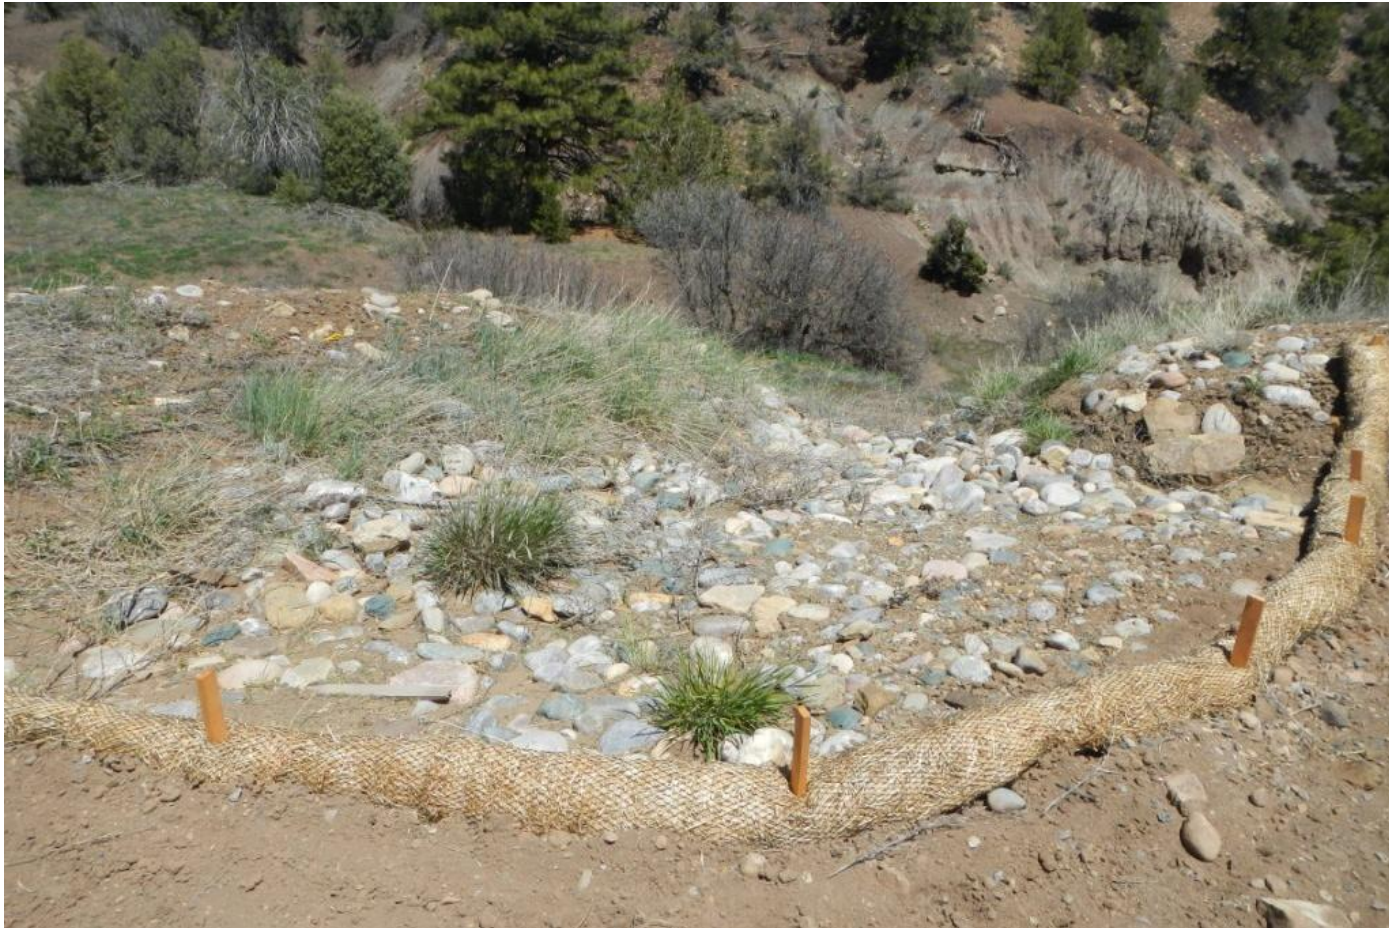
Photo 4. View of stormwater BMP within northern portion of interim reclamation area appears to be in good condition and functioning properly.

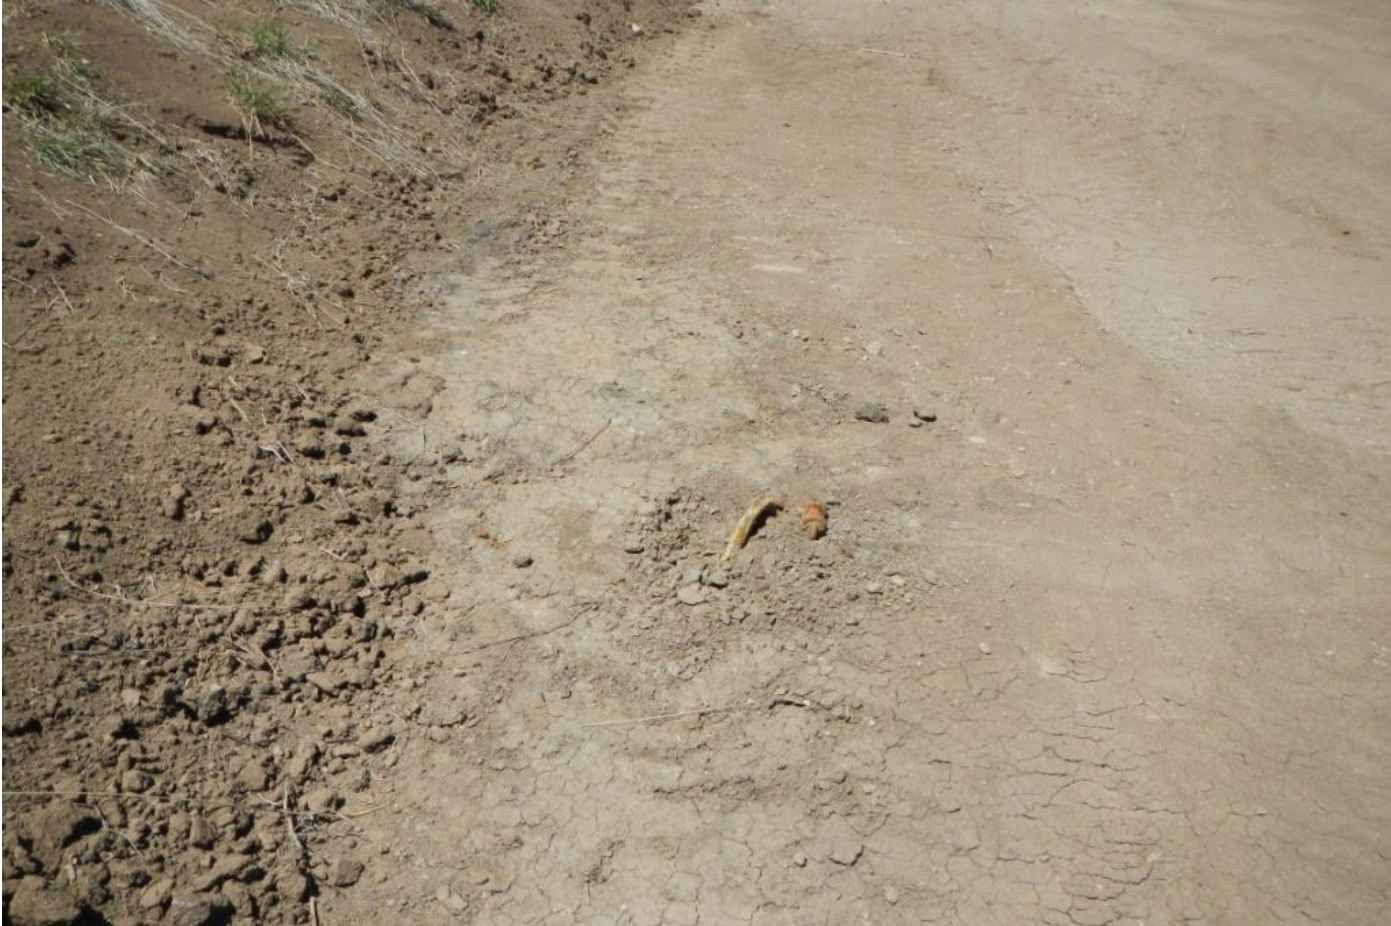
Photo 5. View of rig anchor that needs to be marked or removed.

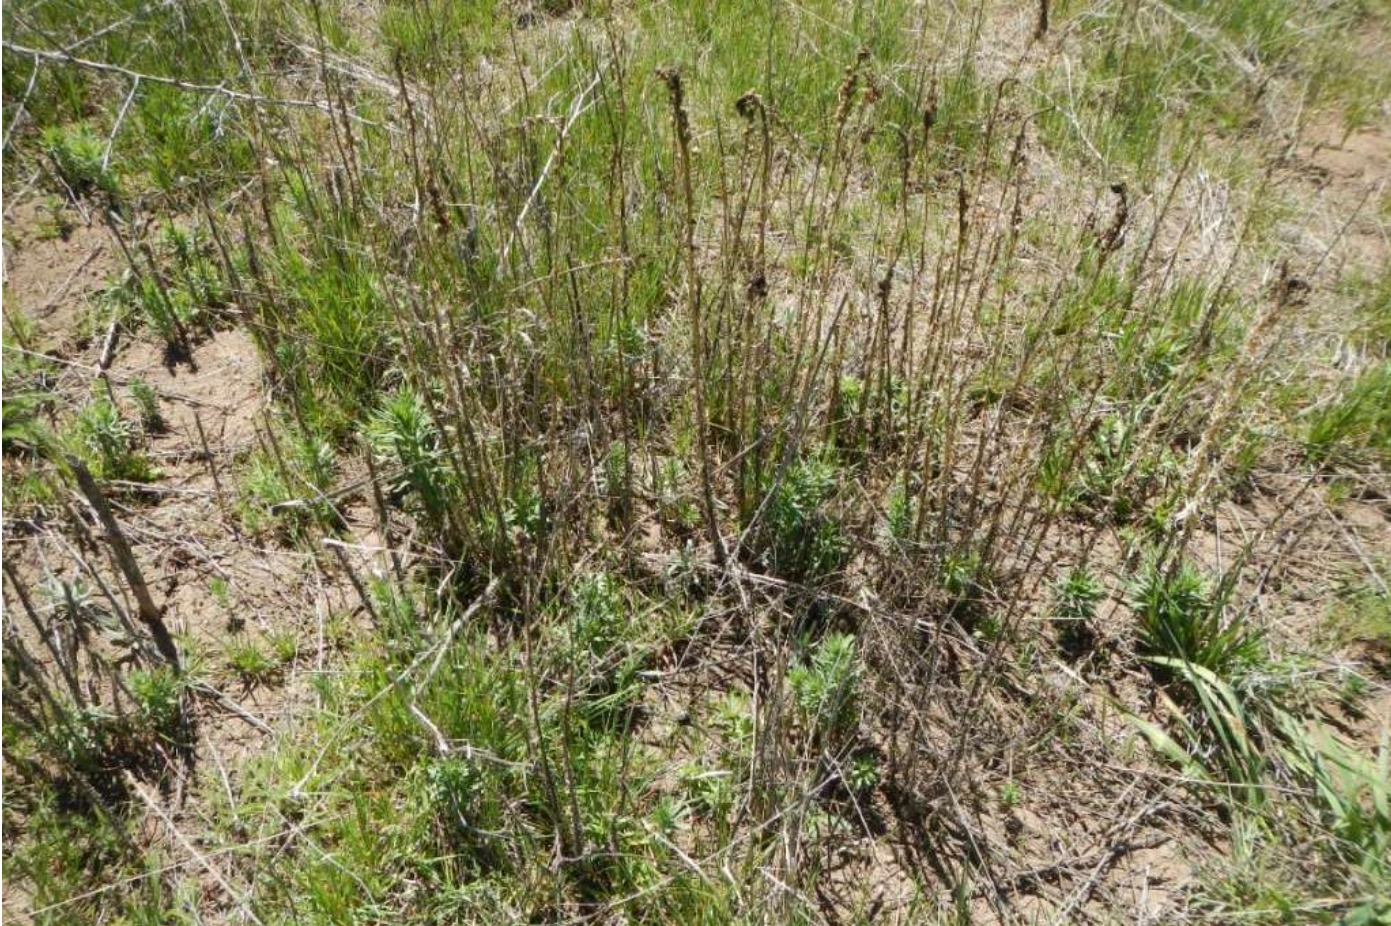
Photo 6. Yellow toadflax (*Linaria vulgaris*) within the project area.
