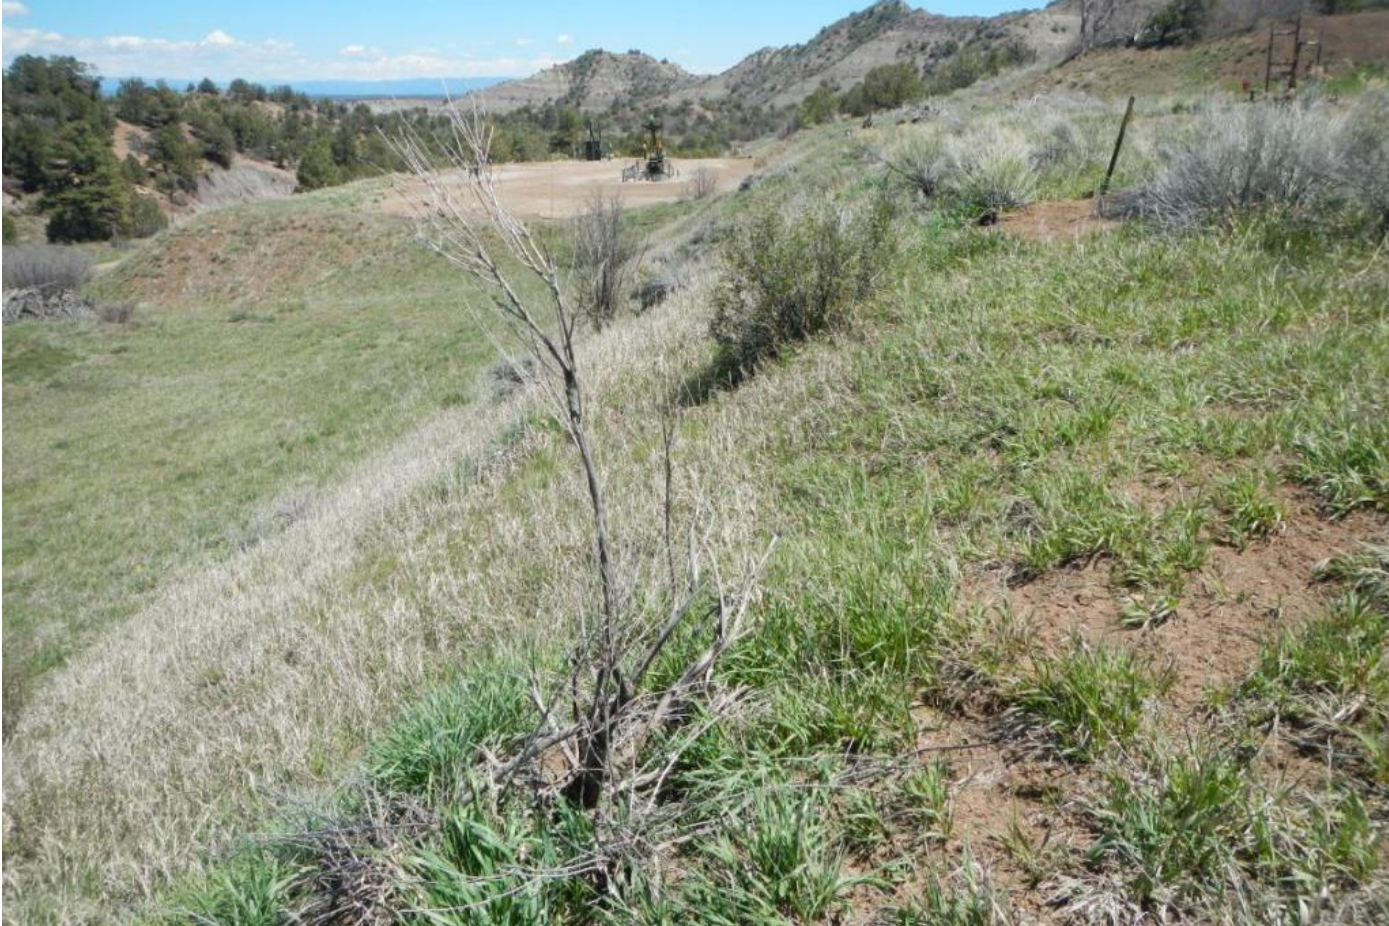
Photo 1. View of revegetation on northern fill slope facing eastward toward adjacent well pad. Smooth brome (*Bromus inermis*) is the dominant grass in the foreground.

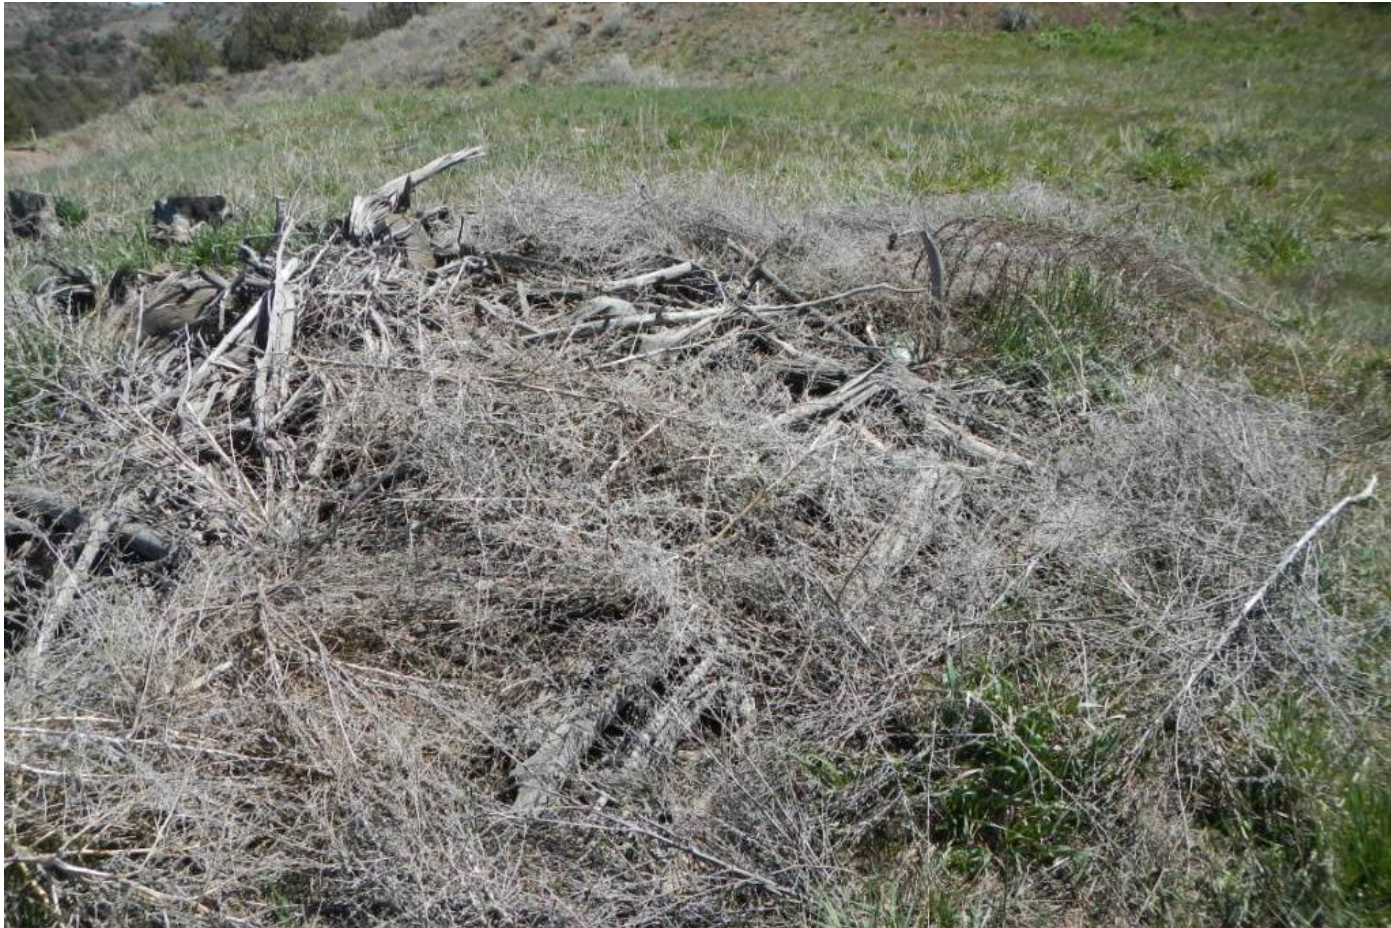
Photo 2. View of pile of woody debris and wire coil that needs to be removed from the interim reclamation area.

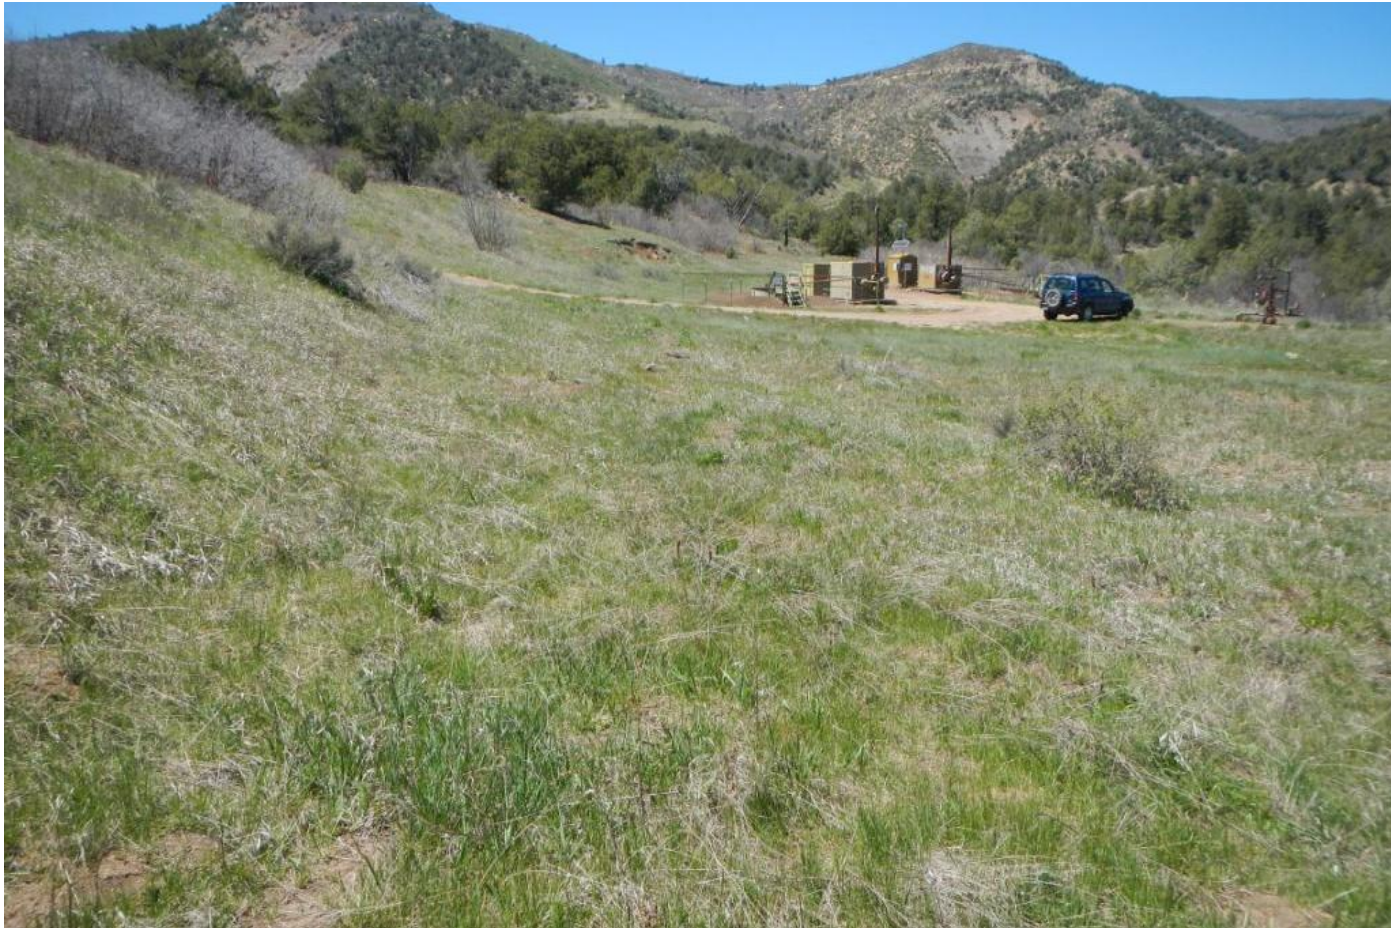
Photo 3. View from southeastern corner facing westward. Good revegetation within interim reclamation area.

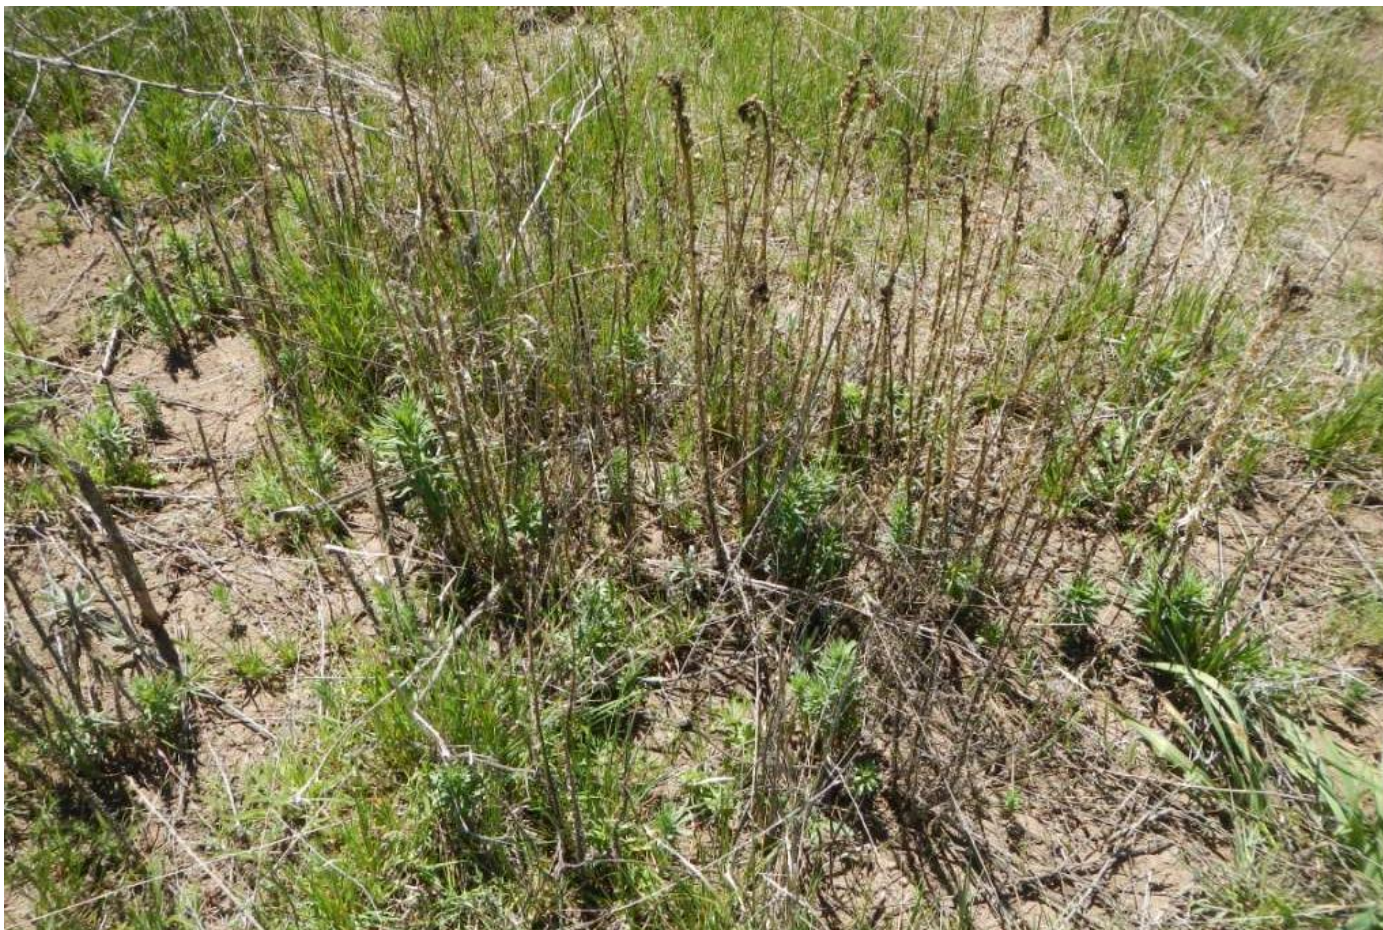
Photo 4. View of yellow toadflax (*Linaria vulgaris*) within the interim reclamation area. The largest infestation occurs on the northeastern portion of the project area along the cut-slope.

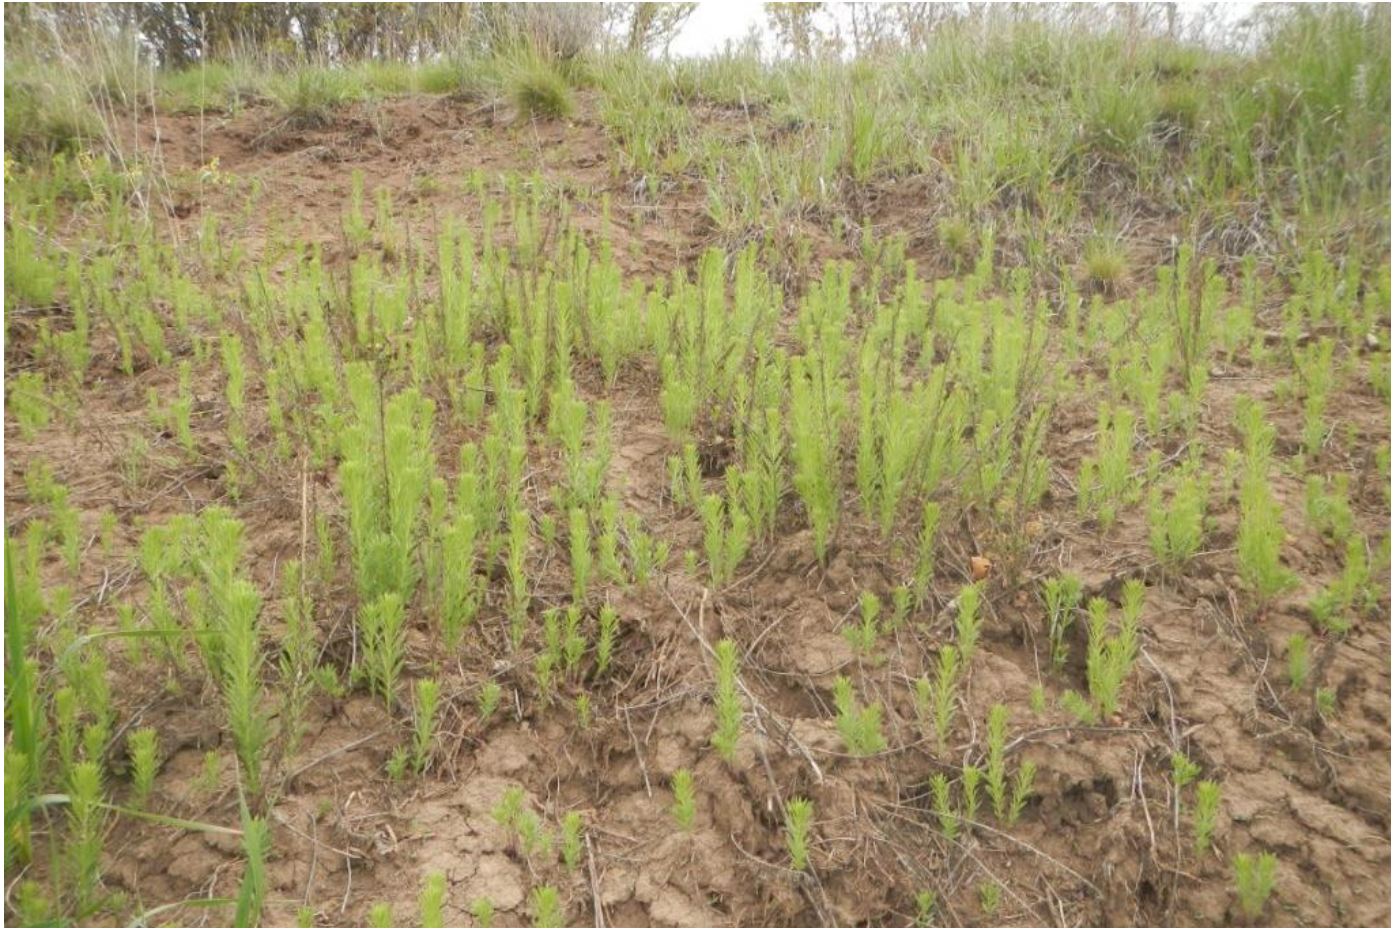
Photo 5. View of yellow toadflax along the northeastern cut-slope within the project area.

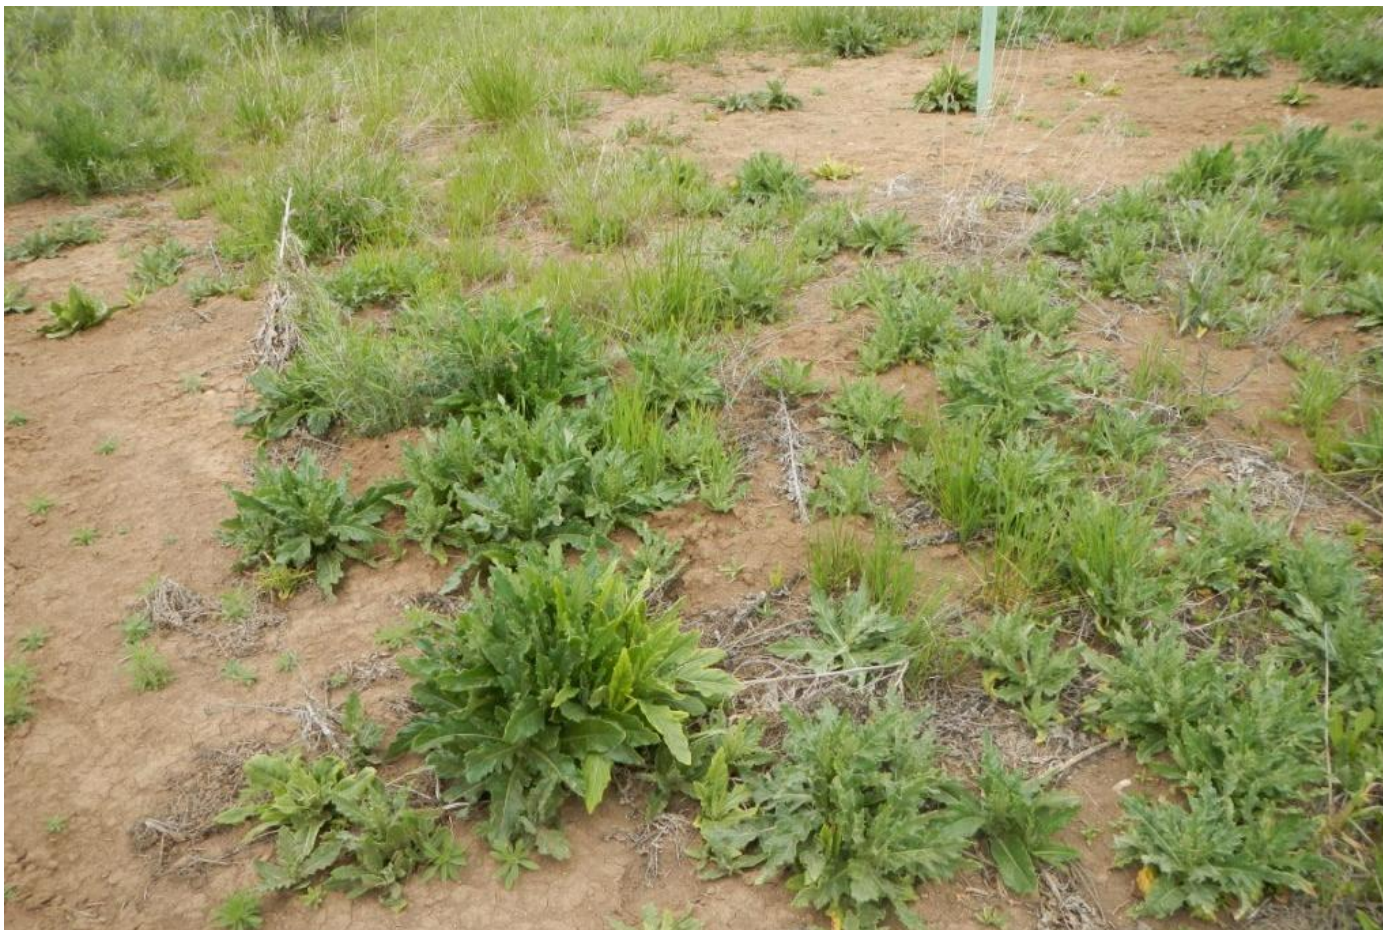
Photo 5. View of hundreds of Canada thistle (*Cirsium arvense*) plants growing on the well pad.

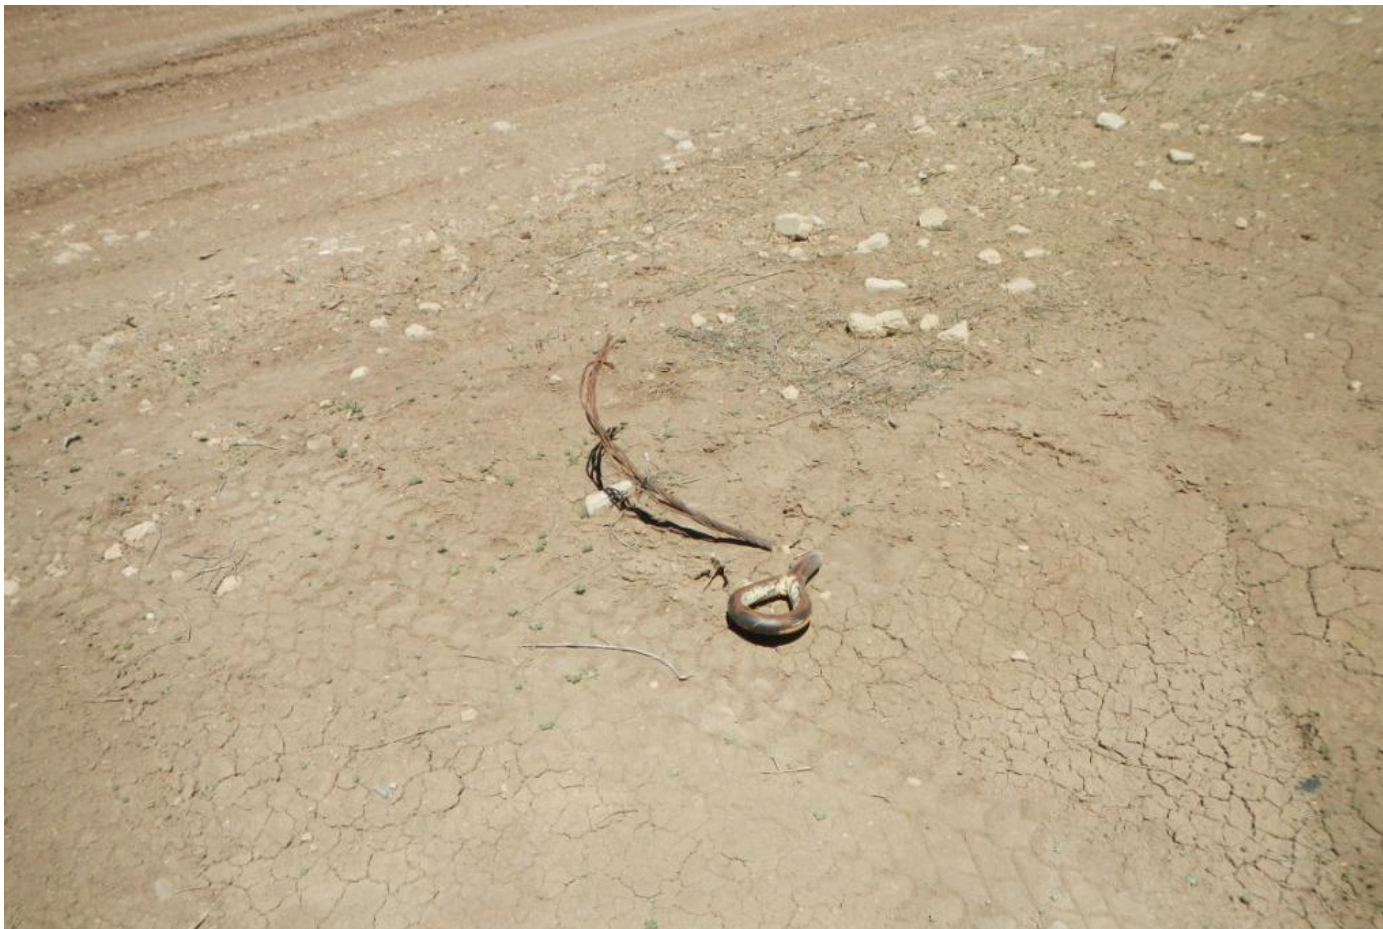
Photo 7. View of unmarked rig anchor and cable within project area.

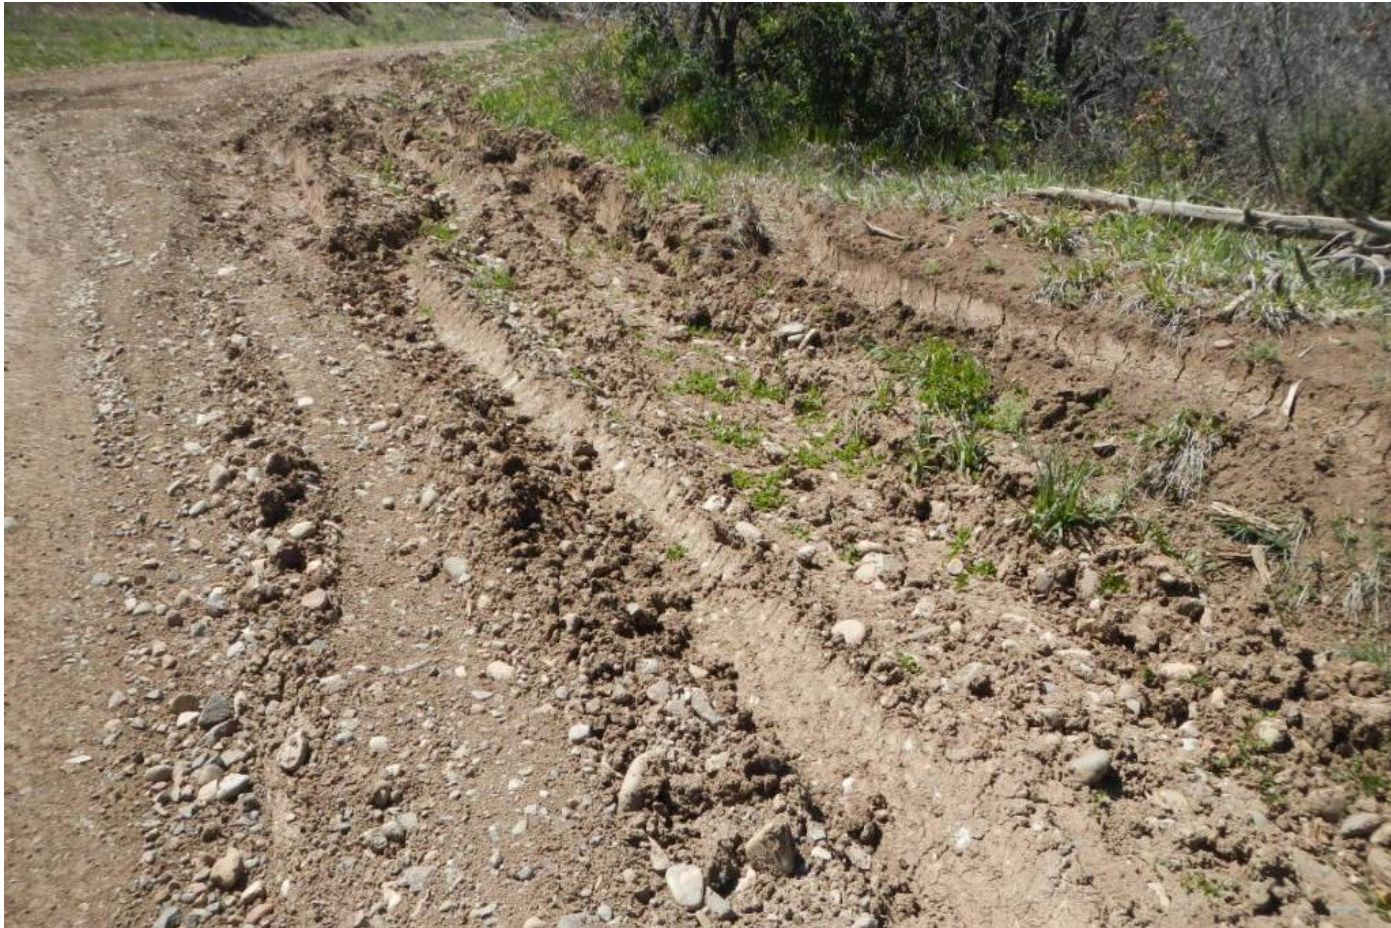
Photo 8. View of ruts and tire tracks extending off of the access road into the adjacent vegetation.

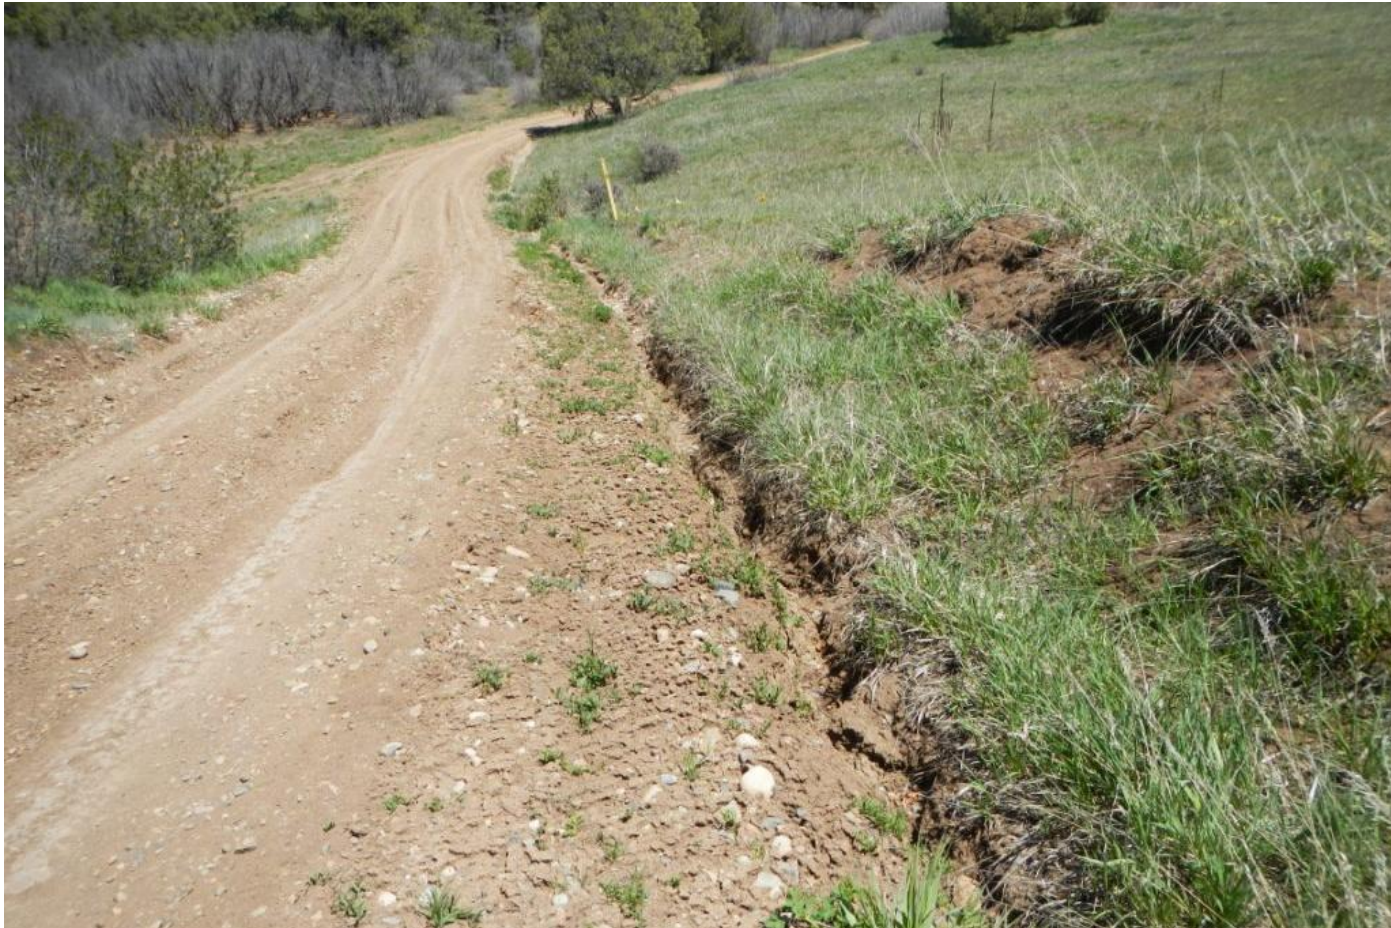
Photo 9. View of stormwater erosional channel forming along the edge of the access road.
