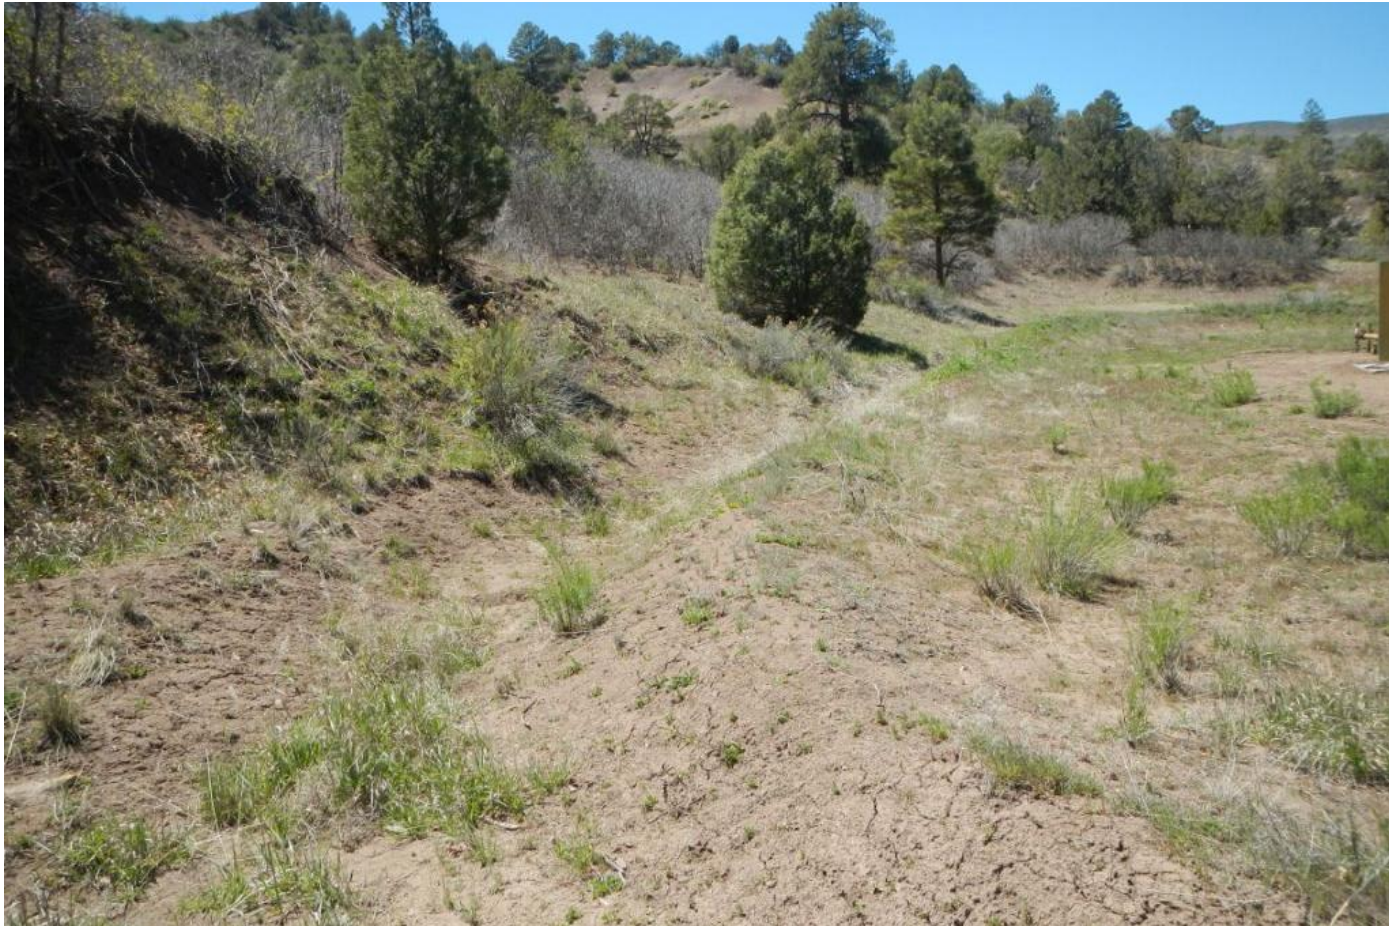
Photo 1. View of southern edge of project area from southeastern corner facing westward.

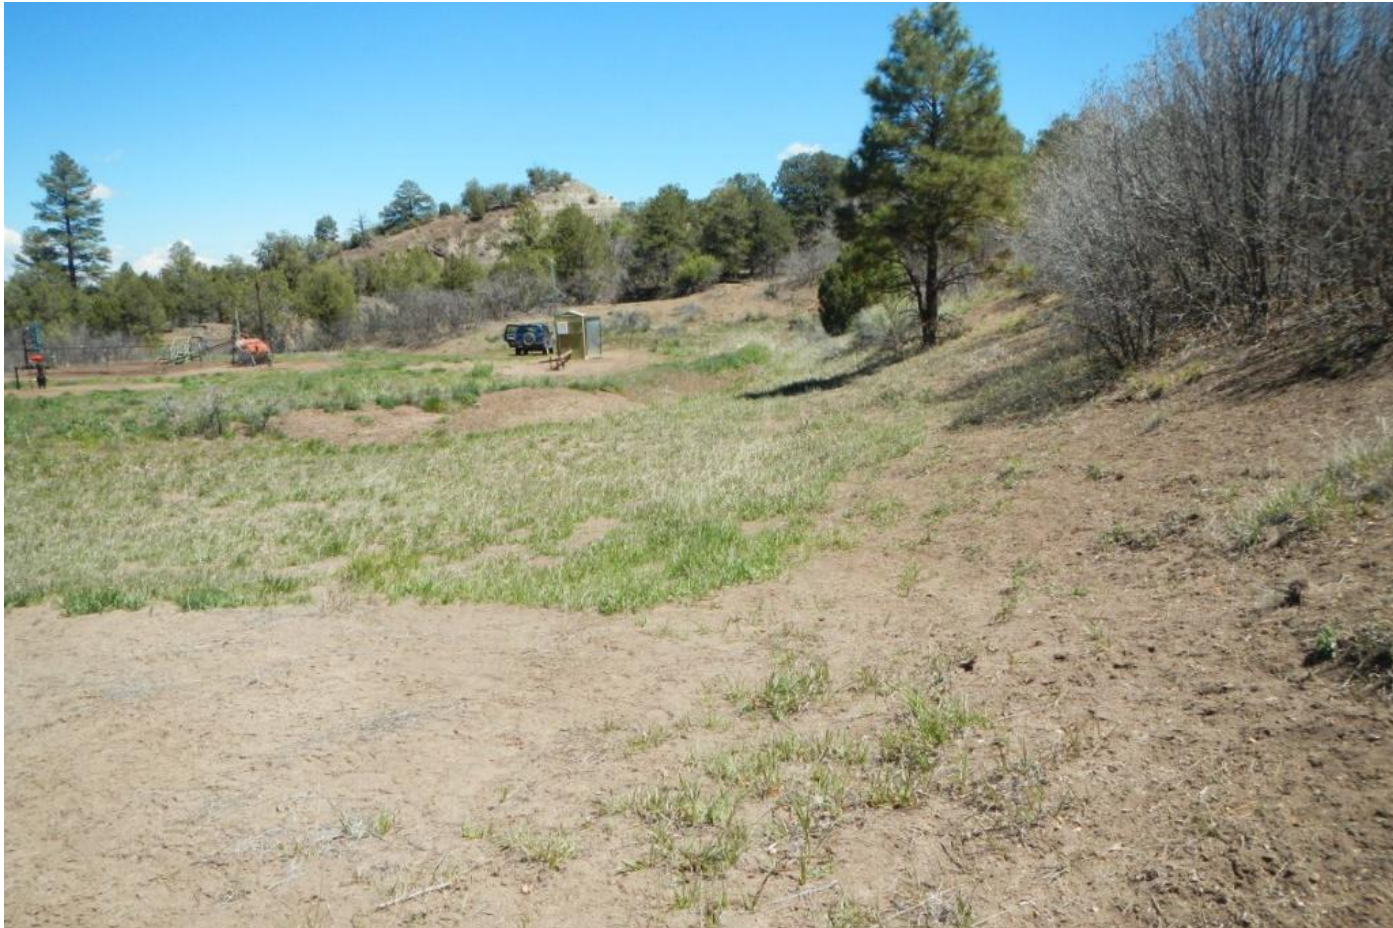
Photo 2. View of southwestern portion of project area facing eastward.

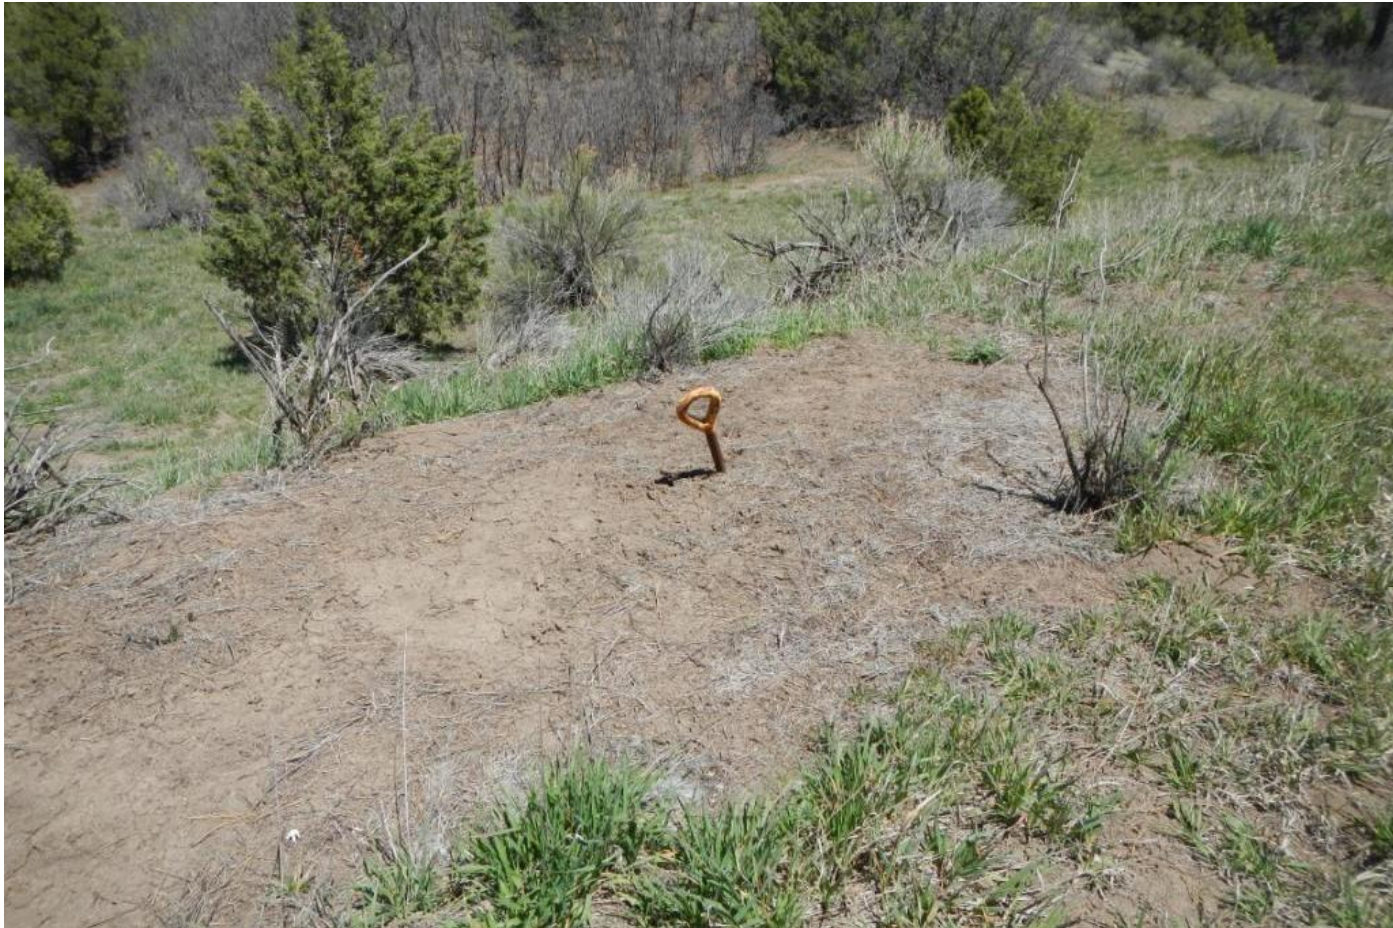
Photo 3. View of unmarked rig anchor.

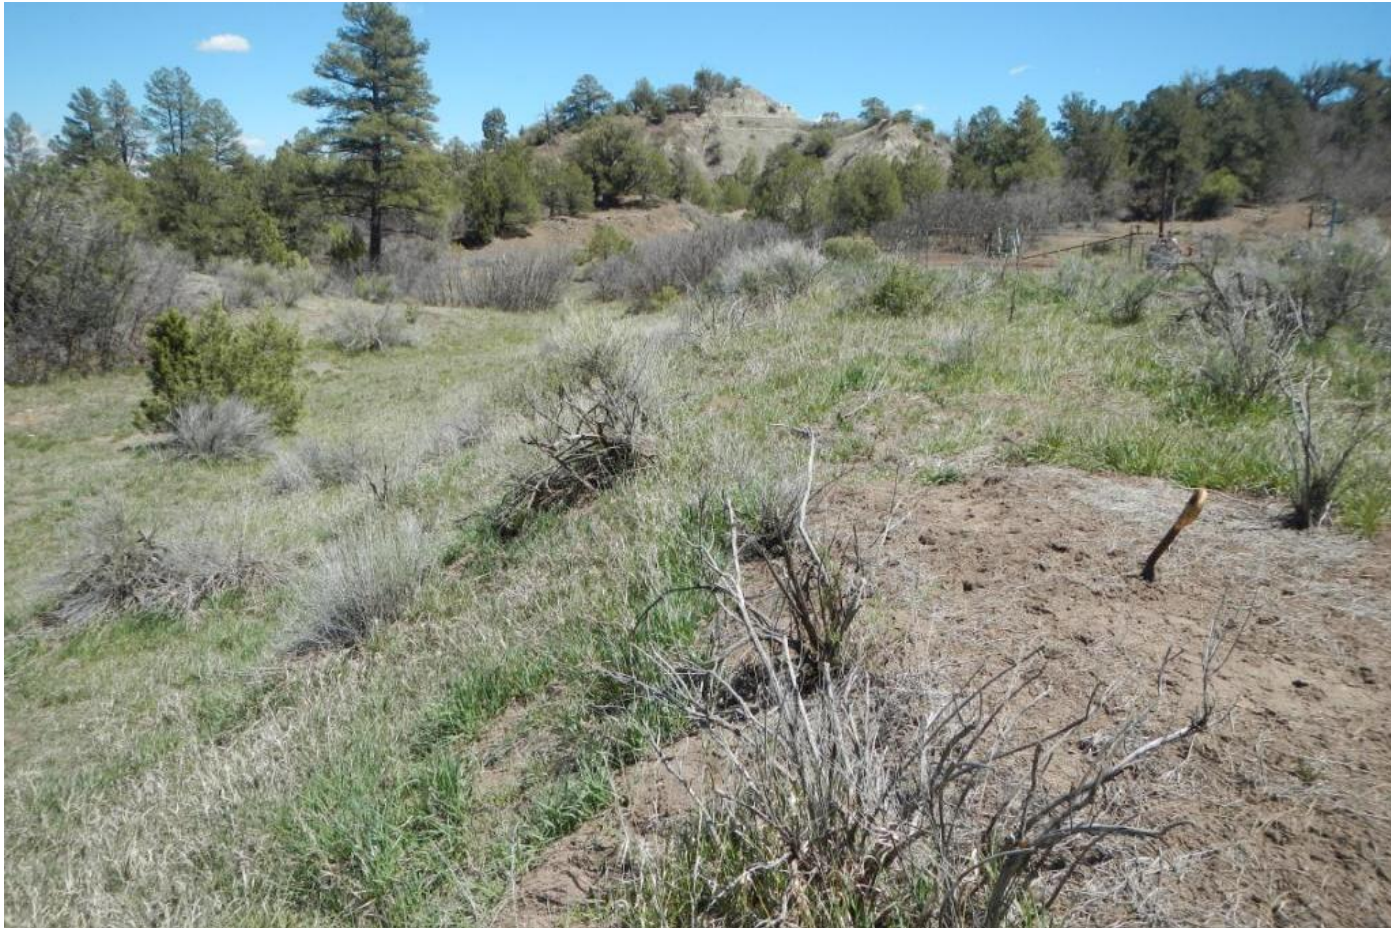
Photo 4. View of northern edge of project area from northwestern corner facing eastward.

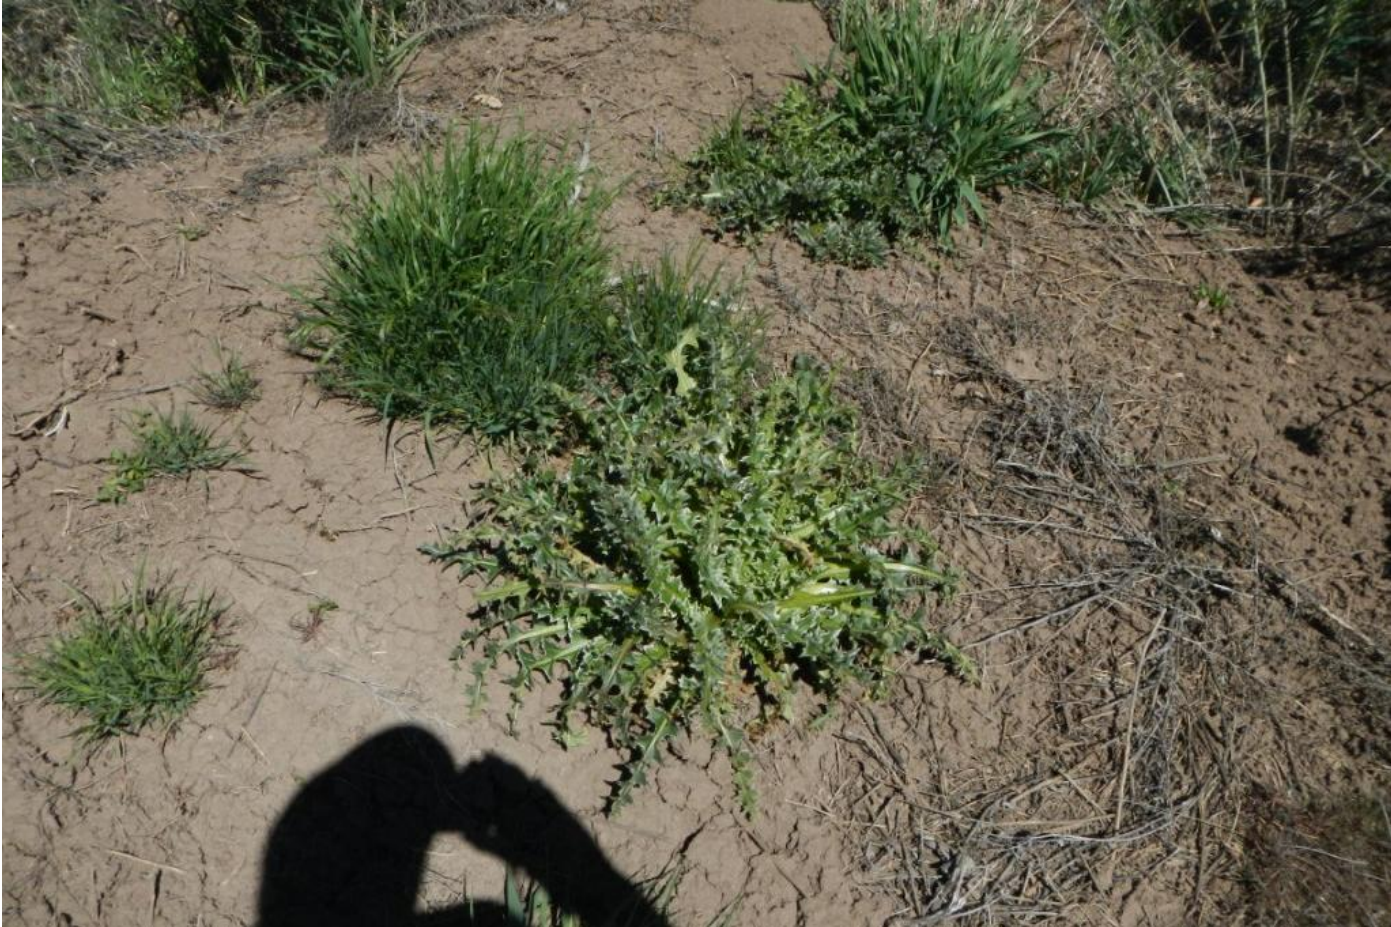
Photo 5. View of musk thistle within project area.

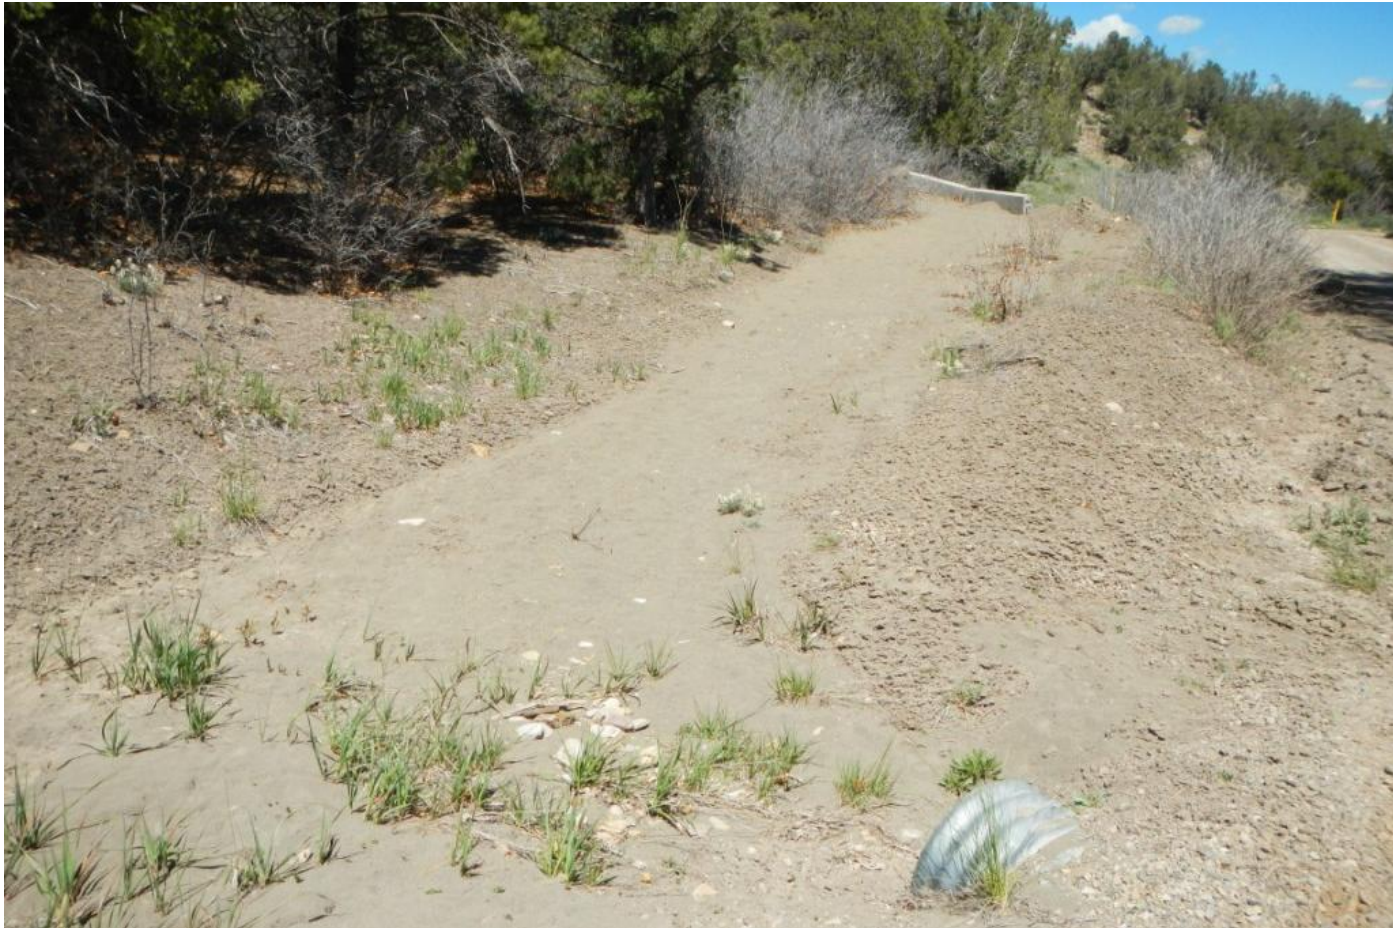
Photo 6. View of sediment filled drainage and culvert on access road.

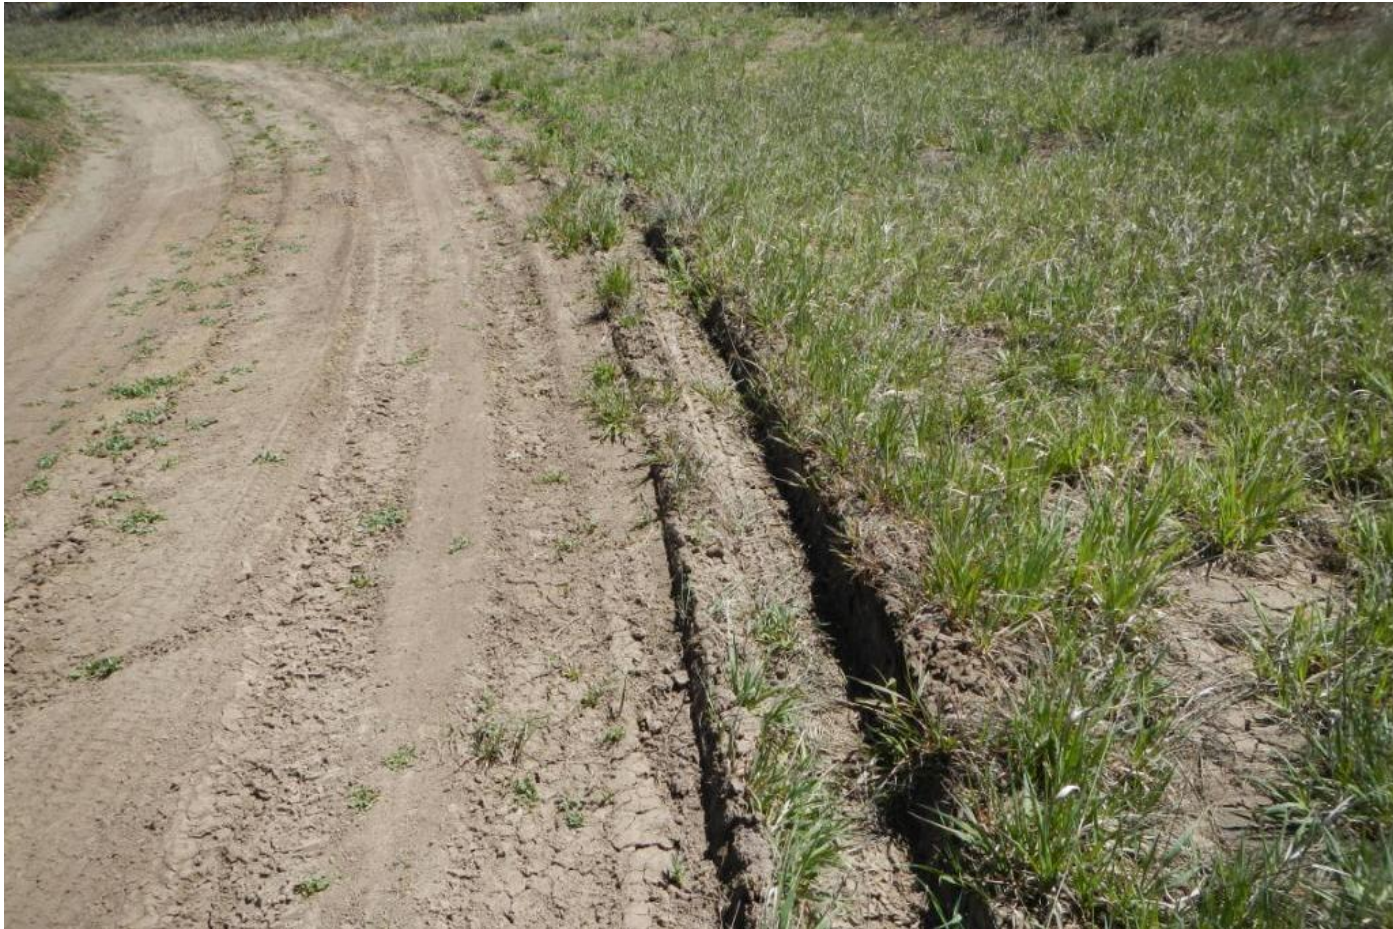
Photo 7. View of tire tracks driving off of road into vegetation along access road.

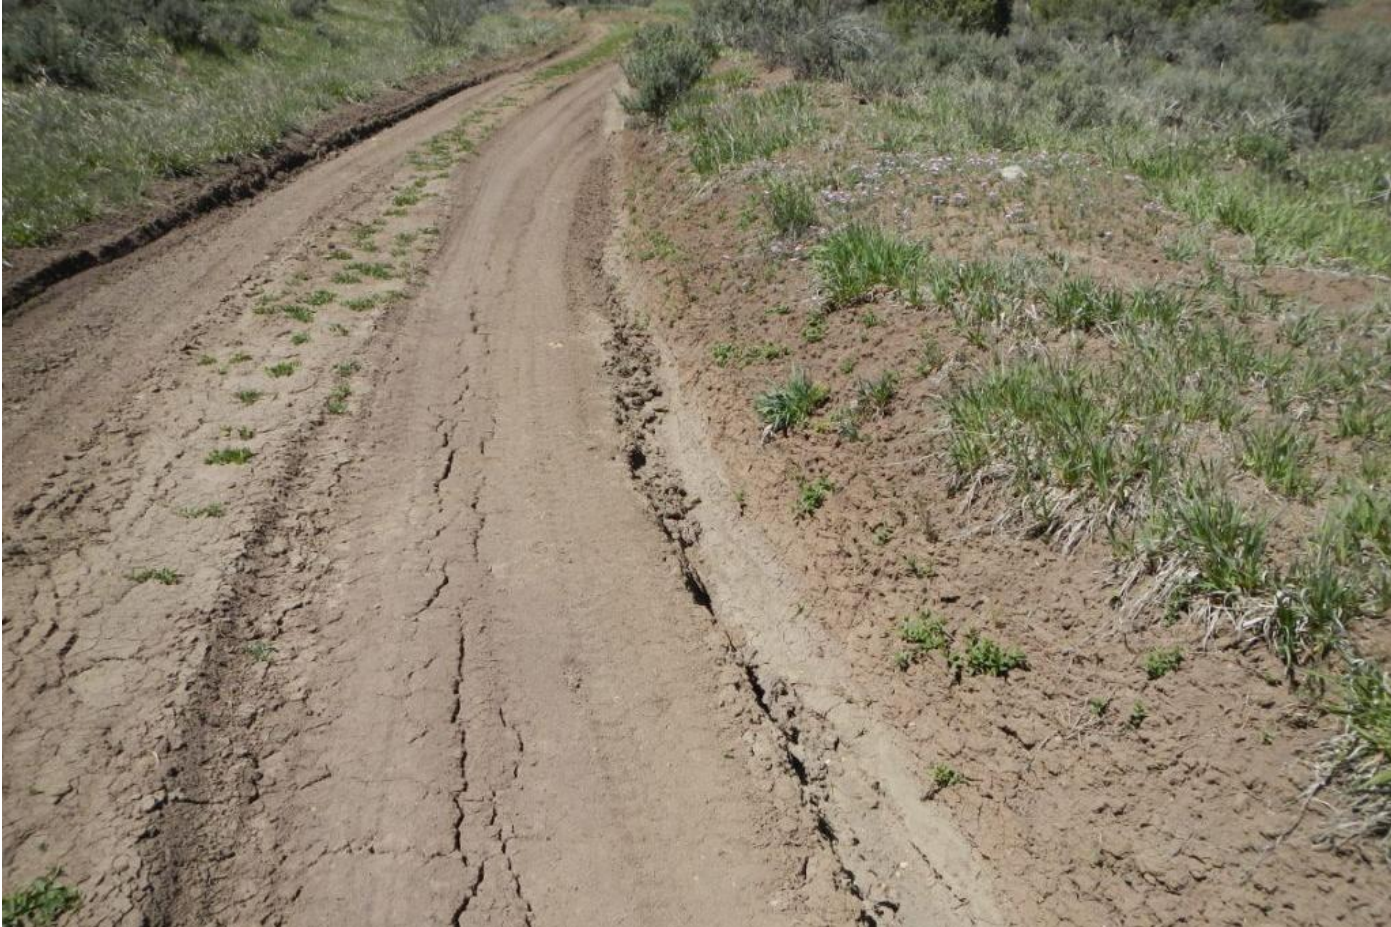
Photo 8. View of stormwater erosion channels that flow along both sides of access road.
