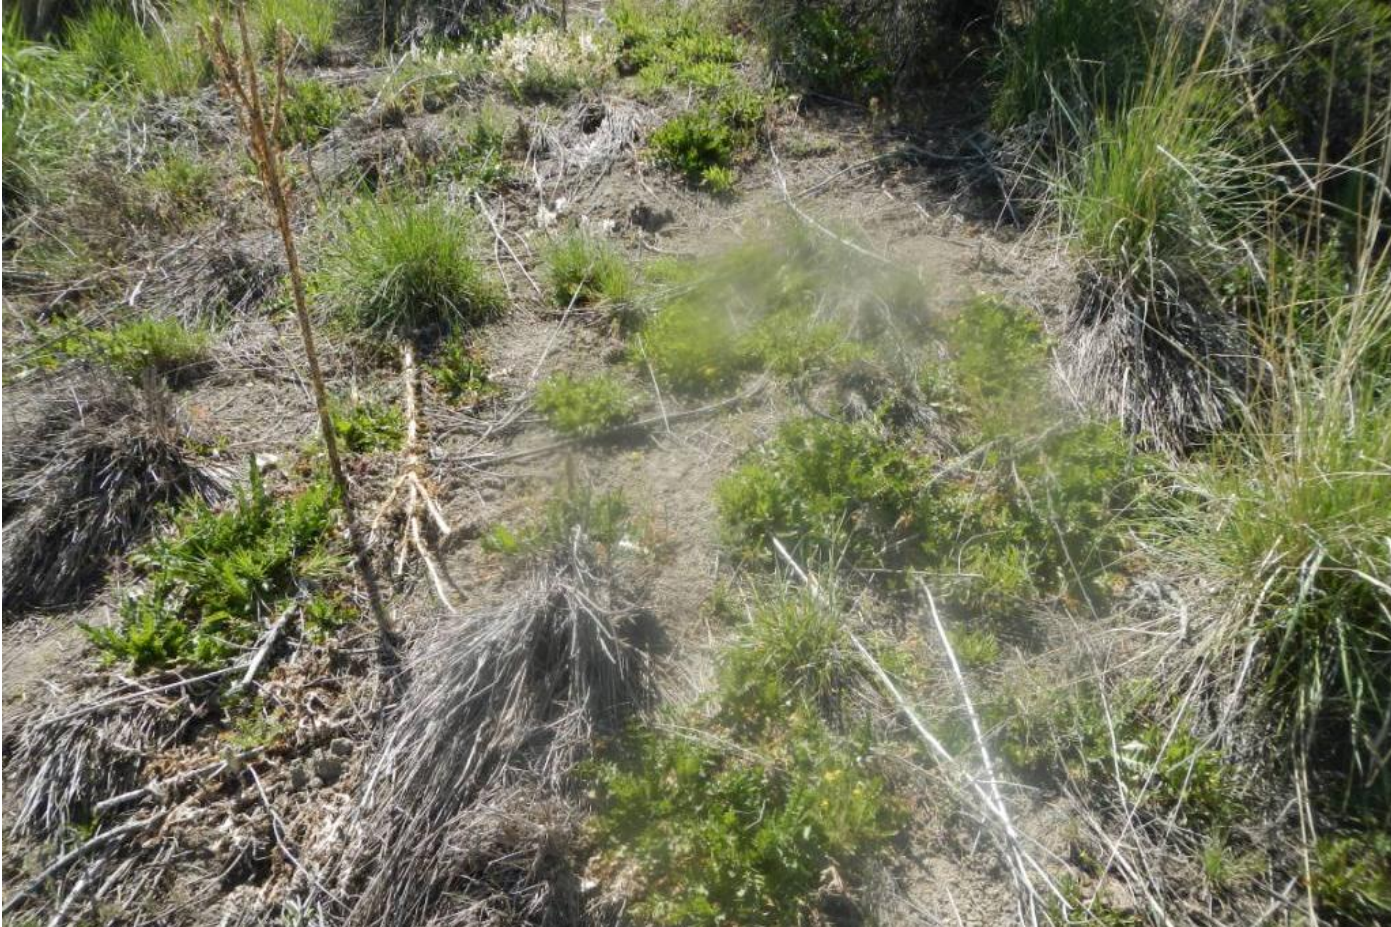
Photo 1. View of musk thistle (*Carduus nutans*) rosettes within the interim reclamation area.

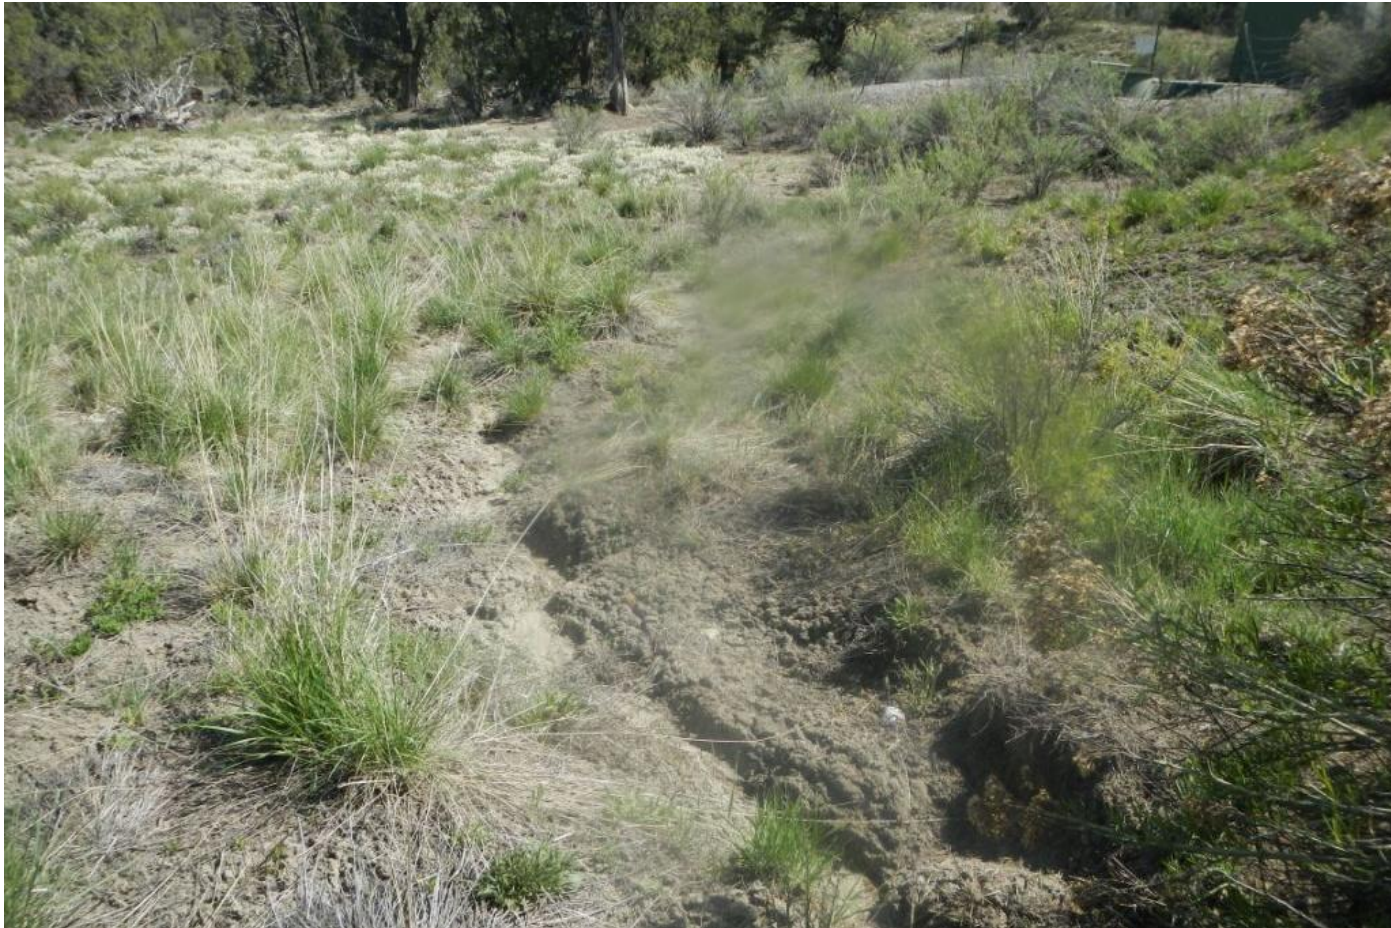
Photo 2. View of erosional channel forming within eastern portion of the interim reclamation area.

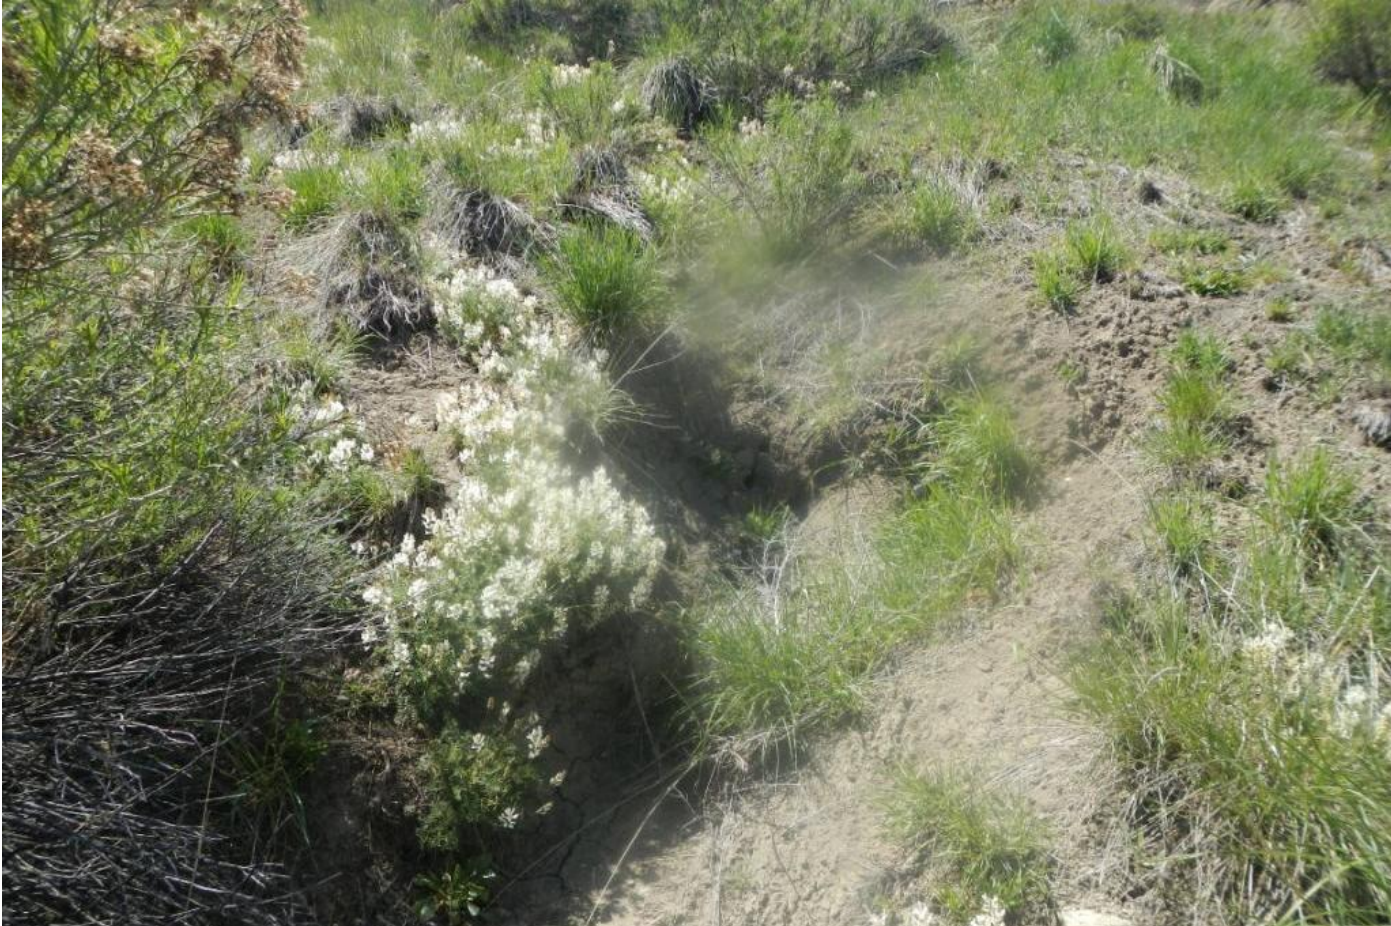
Photo 3. View of another erosional channel forming within the eastern portion of the interim reclamation area.
