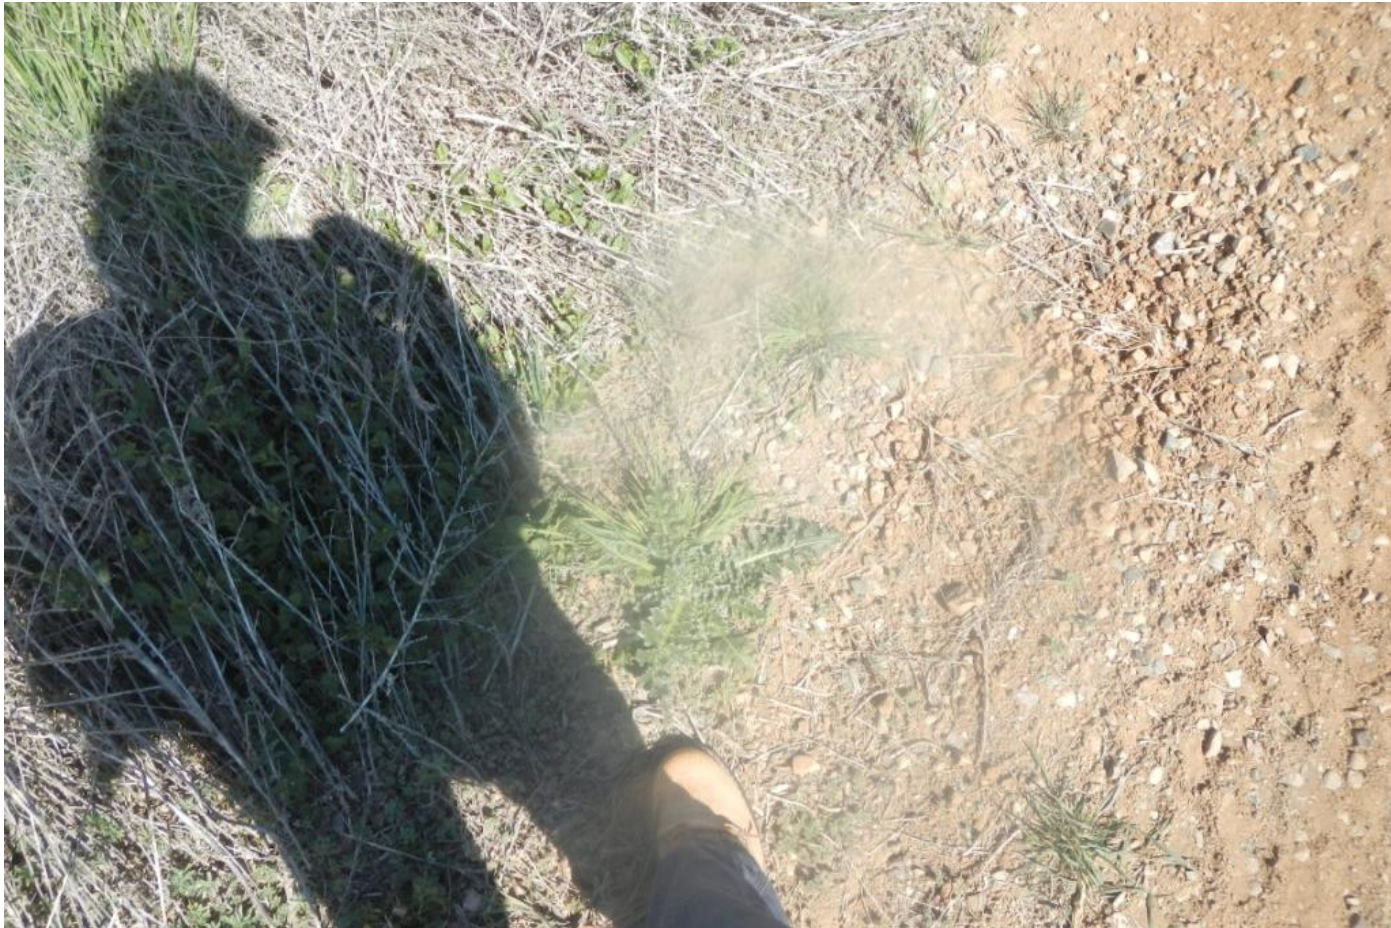
Photo 1. View of musk thistle (*Carduus nutans*) rosette within the project area.

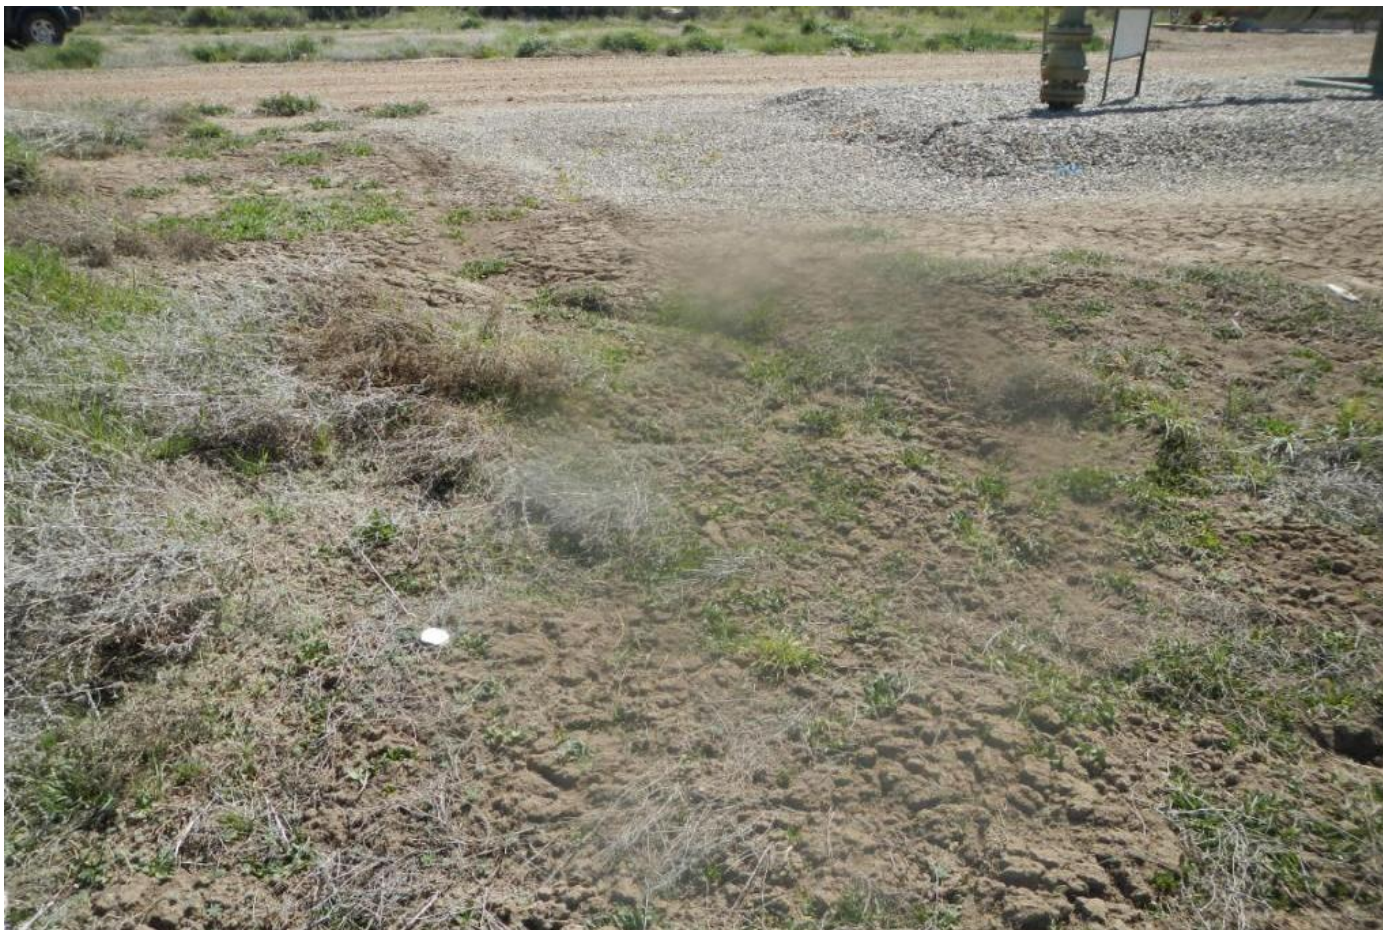
Photo 2. View of rill erosion from northern edge of the working area of the well pad.

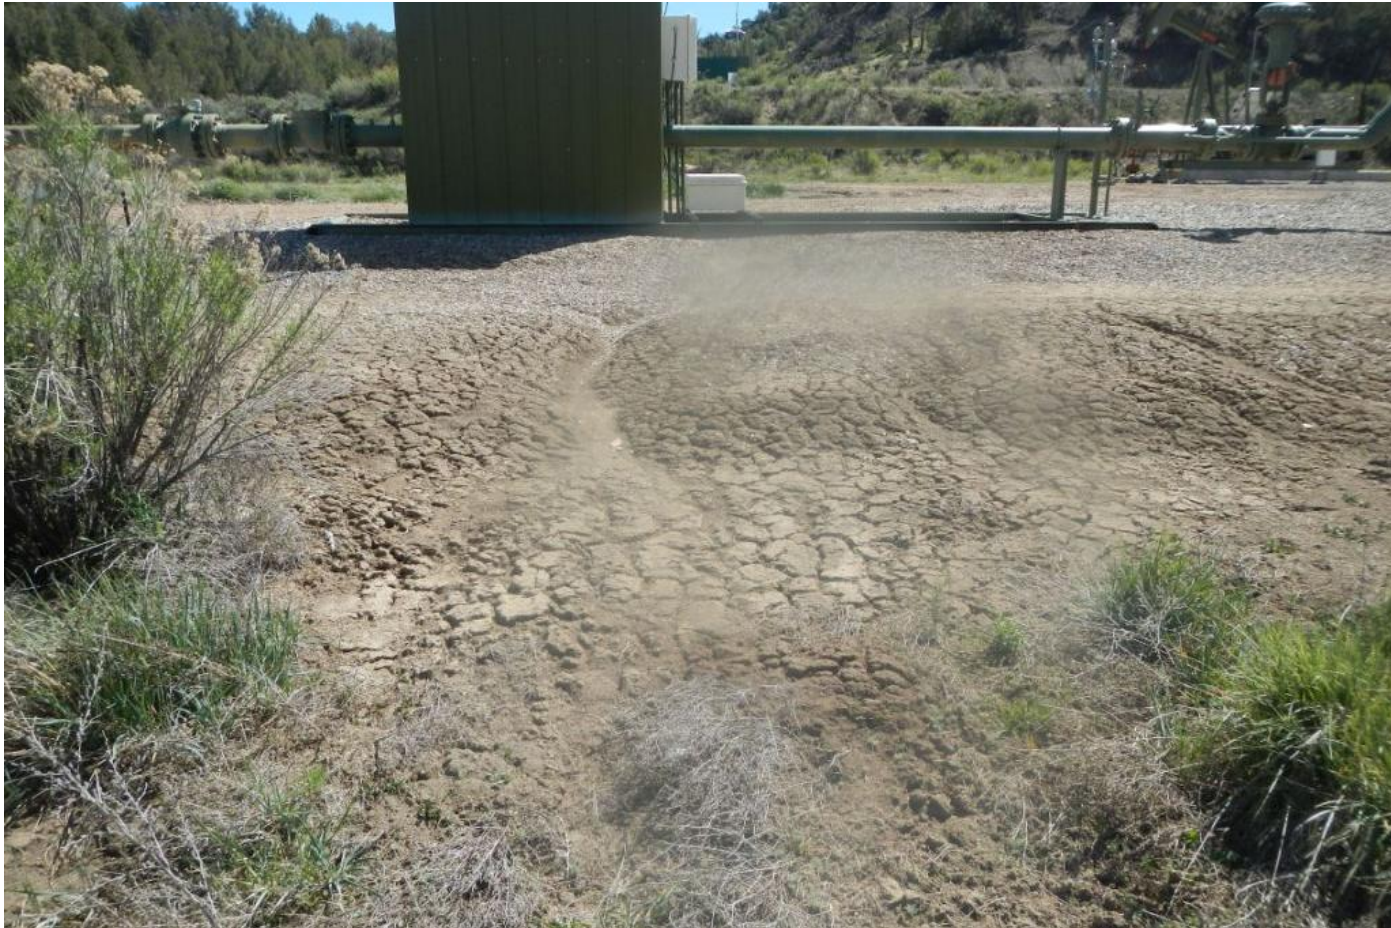
Photo 3. View of rill erosion continued along the northern edge of the working area of the well pad.

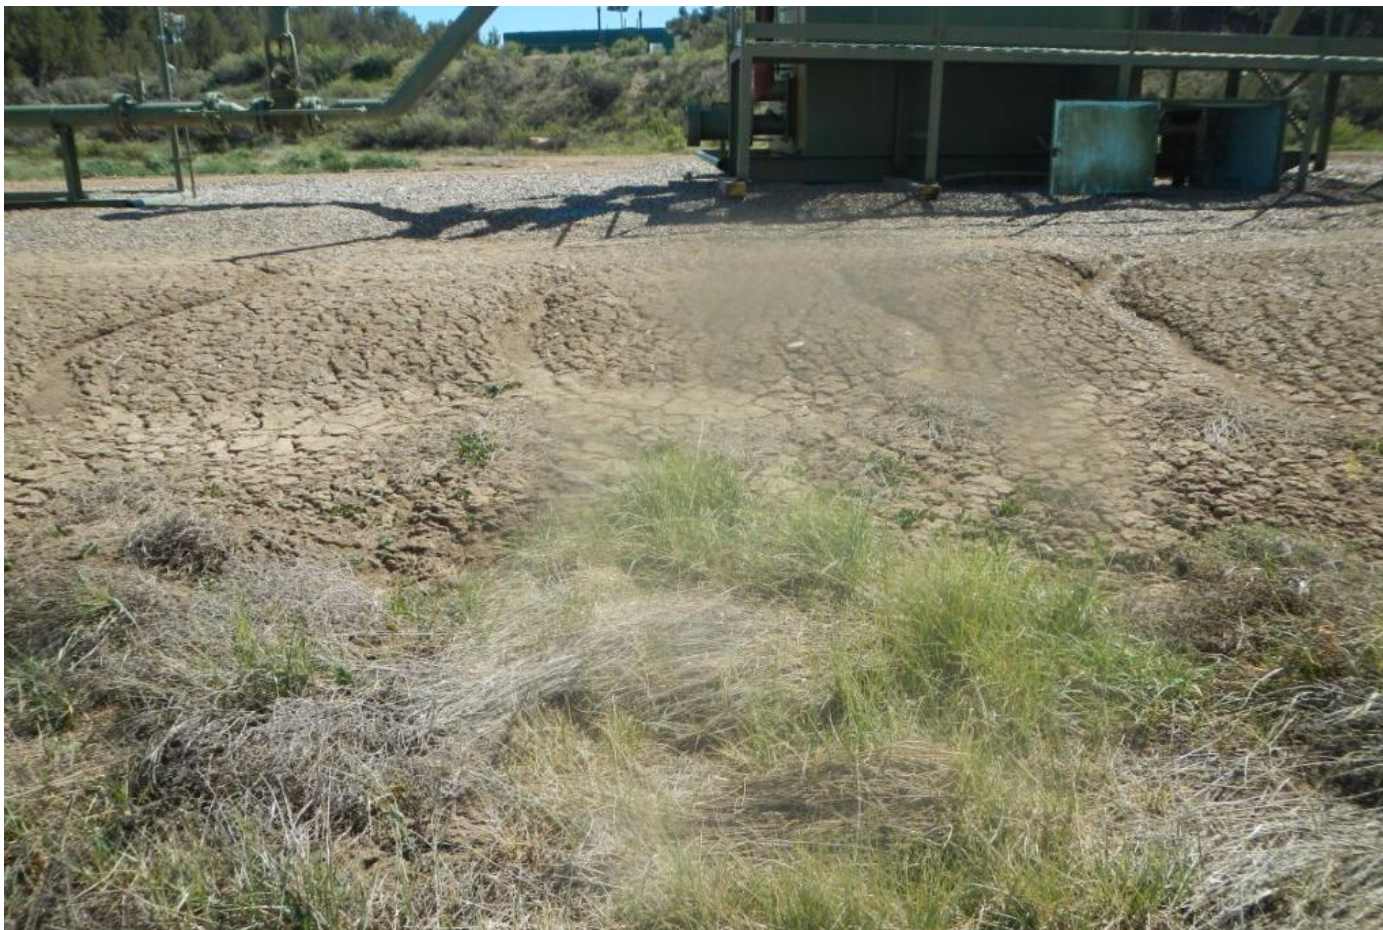
Photo 4. View of rill erosion continued along the northern edge of the working area of the well pad.

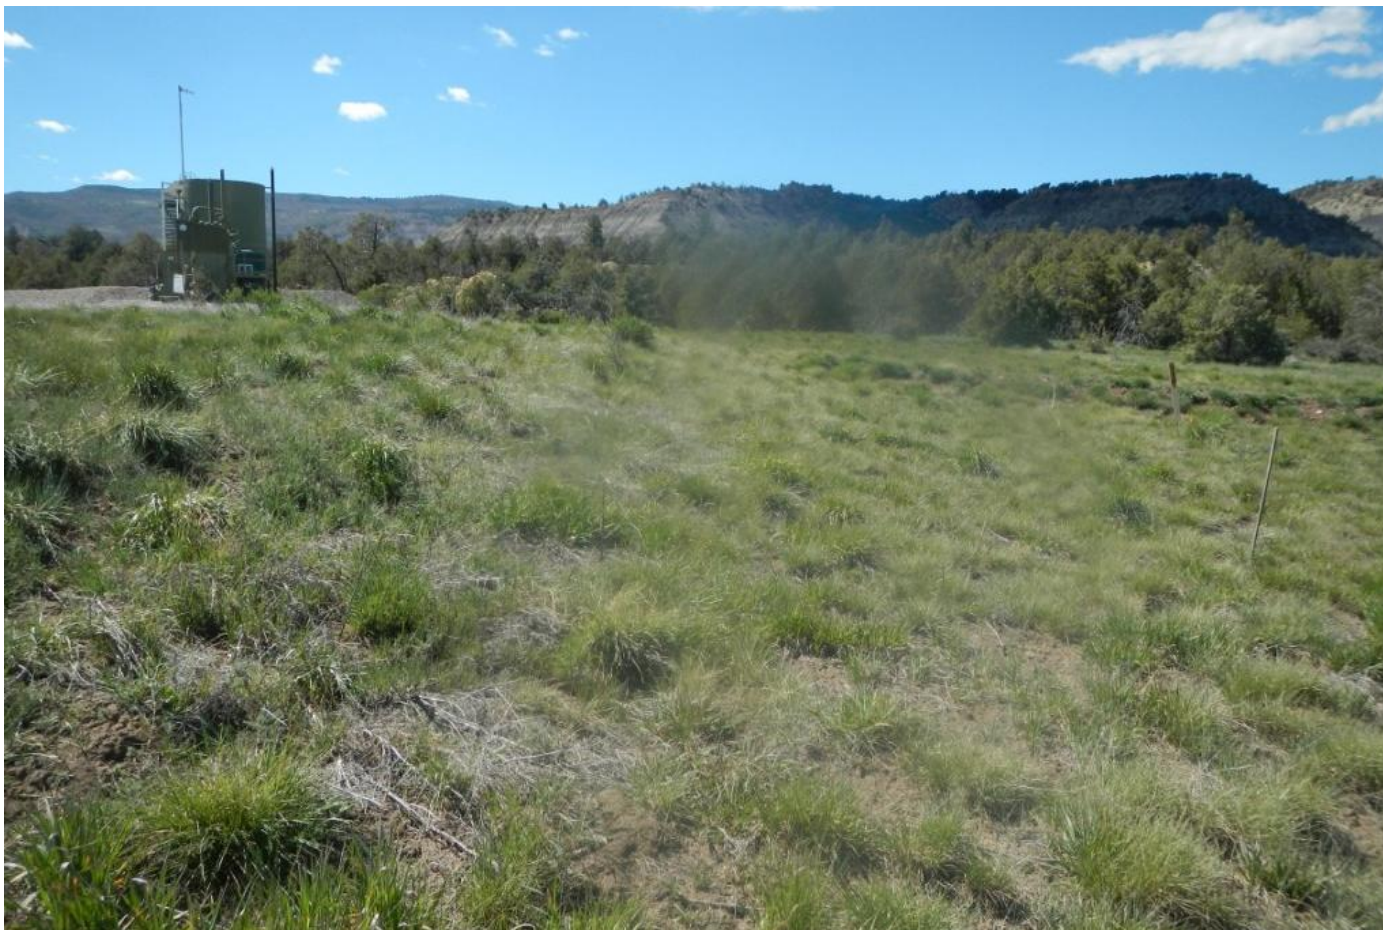
Photo 5. View of good revegetation within northern portion of the interim reclamation area.

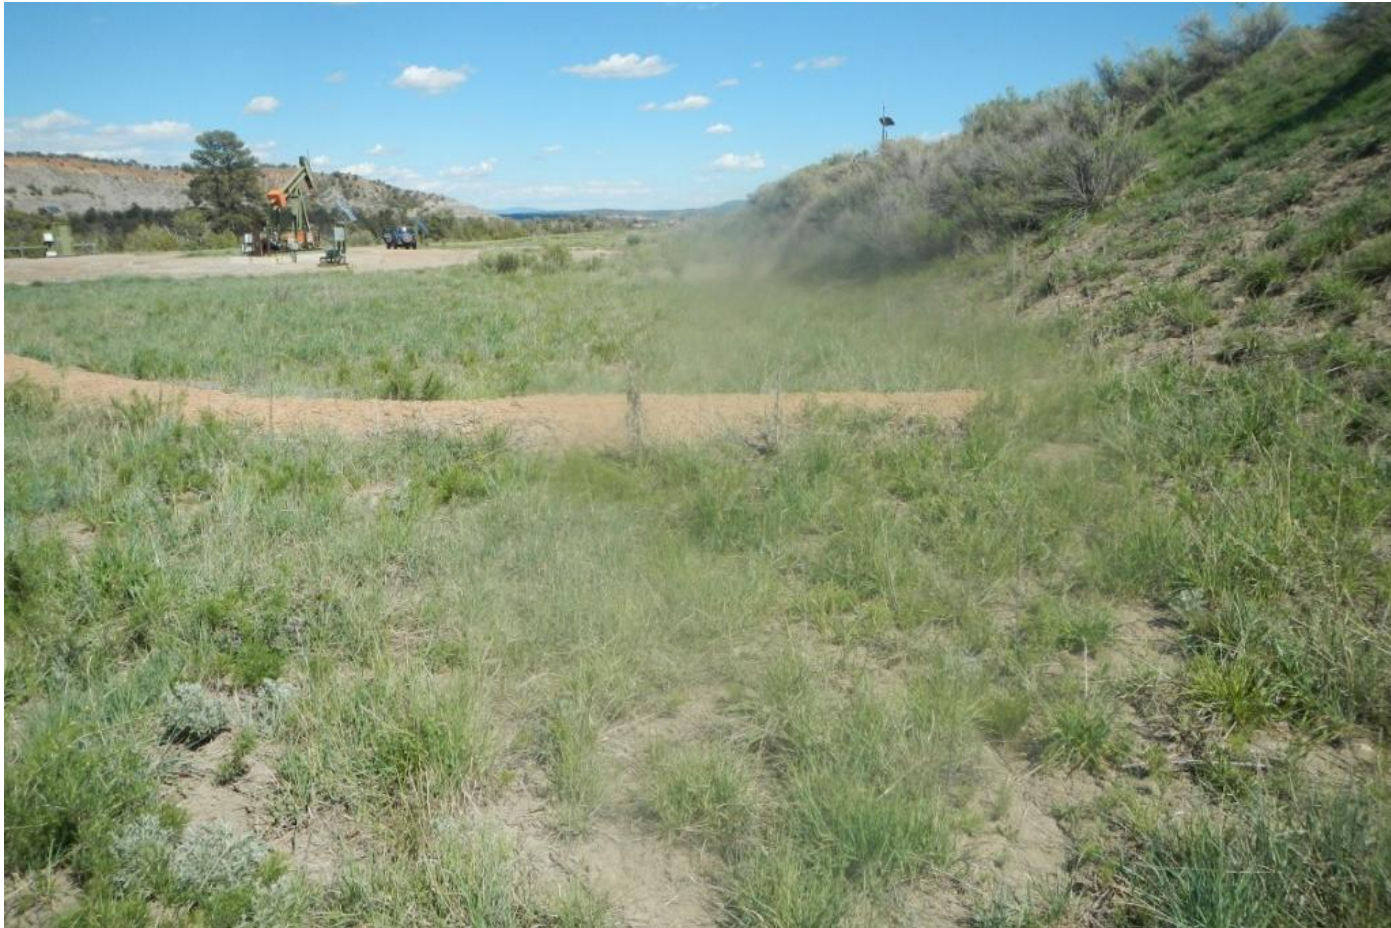
Photo 6. View of southern portion of the project area with good revegetation of areas no longer in use.
