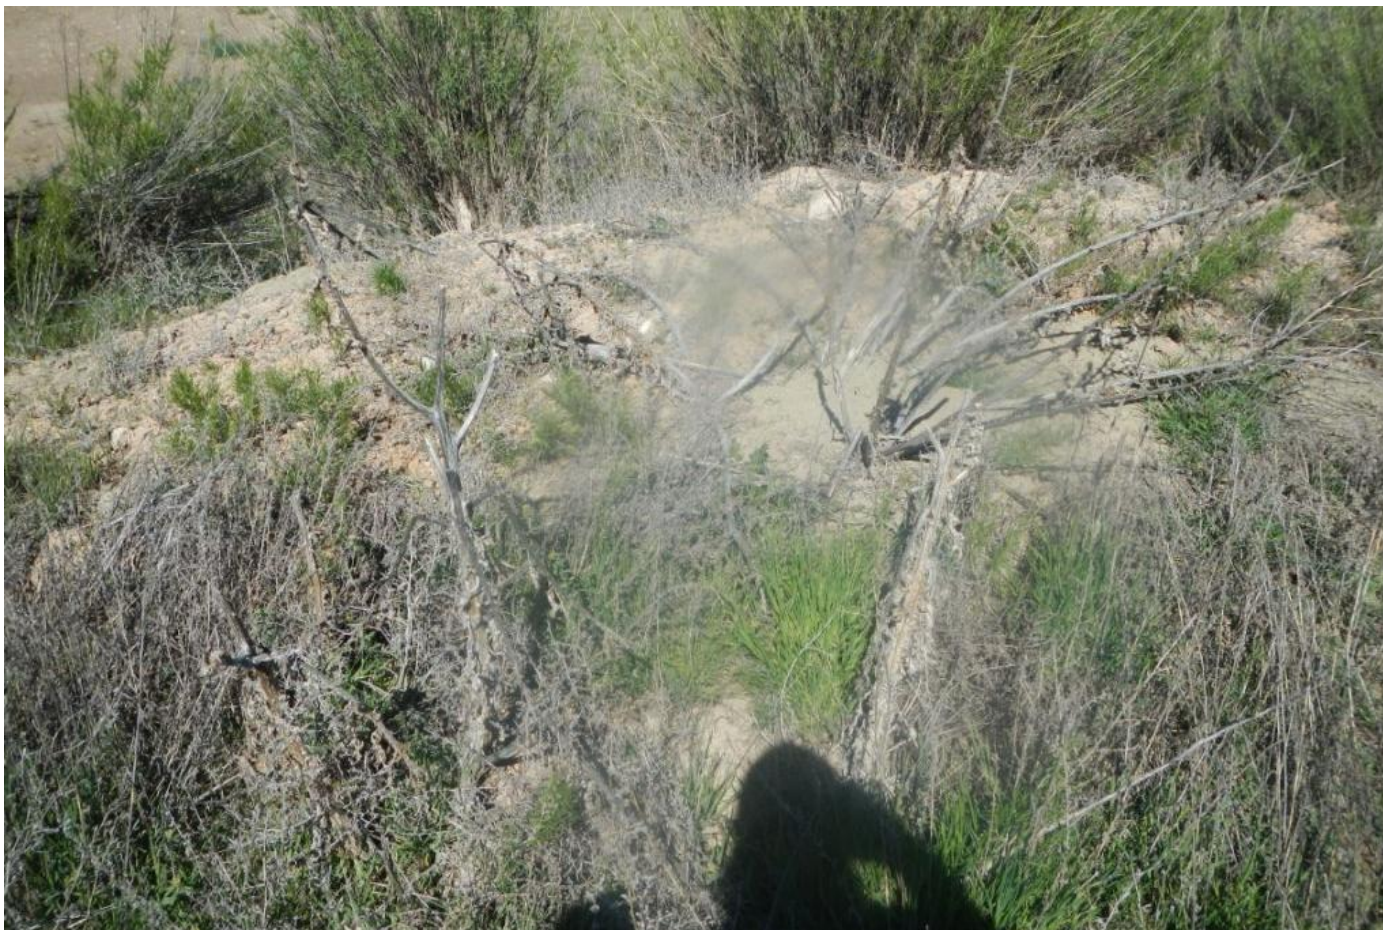
Photo 1. View of musk thistle (*Carduus nutans*) plants within northeastern corner of well pad.

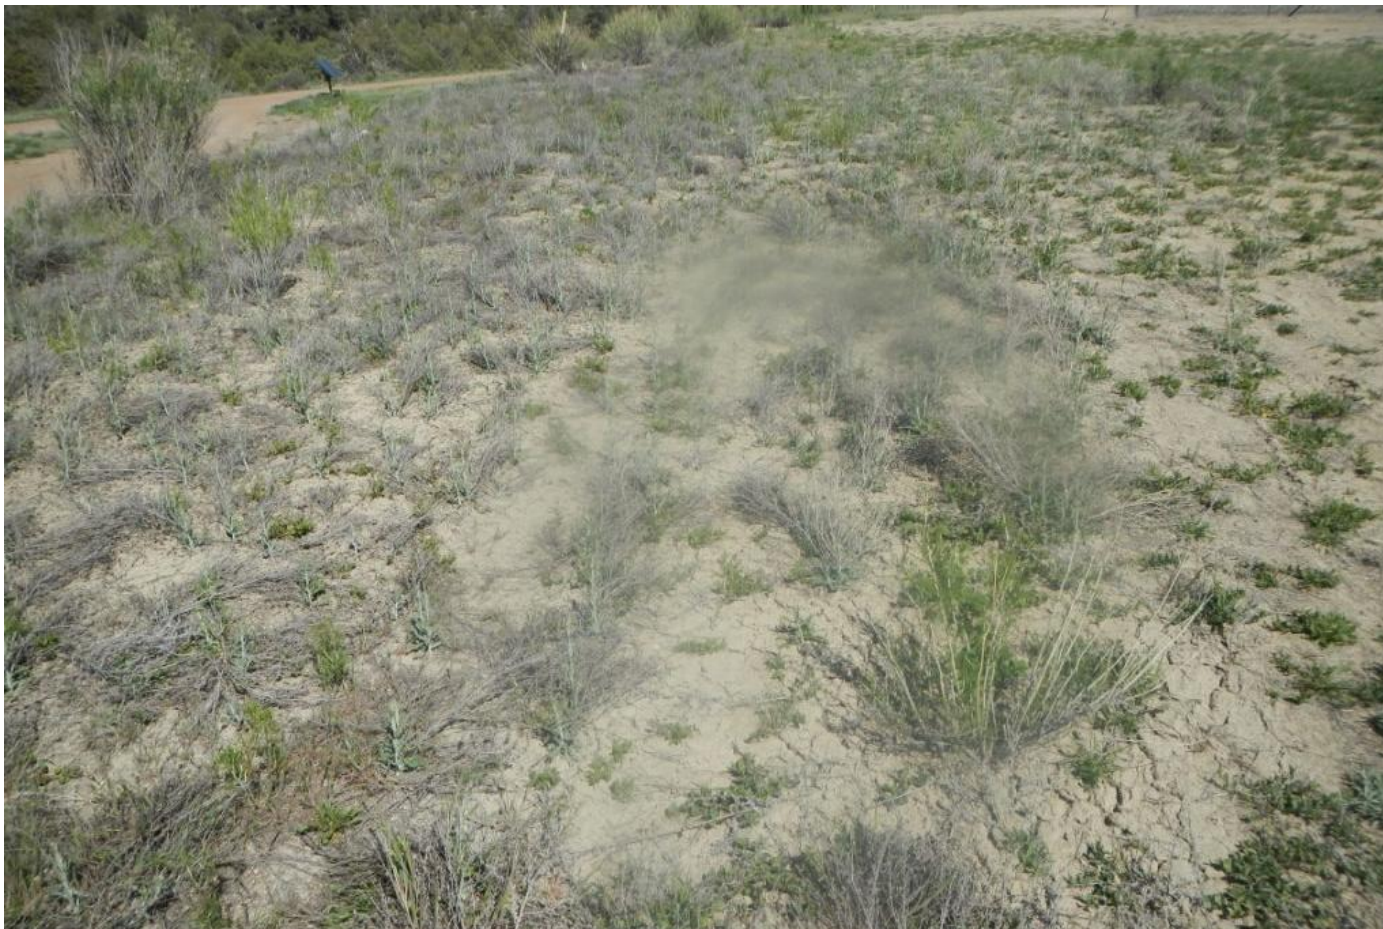
Photo 2. View of hundreds of Russian knapweed (*Acroptilon repens*; light green on left) within the northern portion of the interim reclamation area.

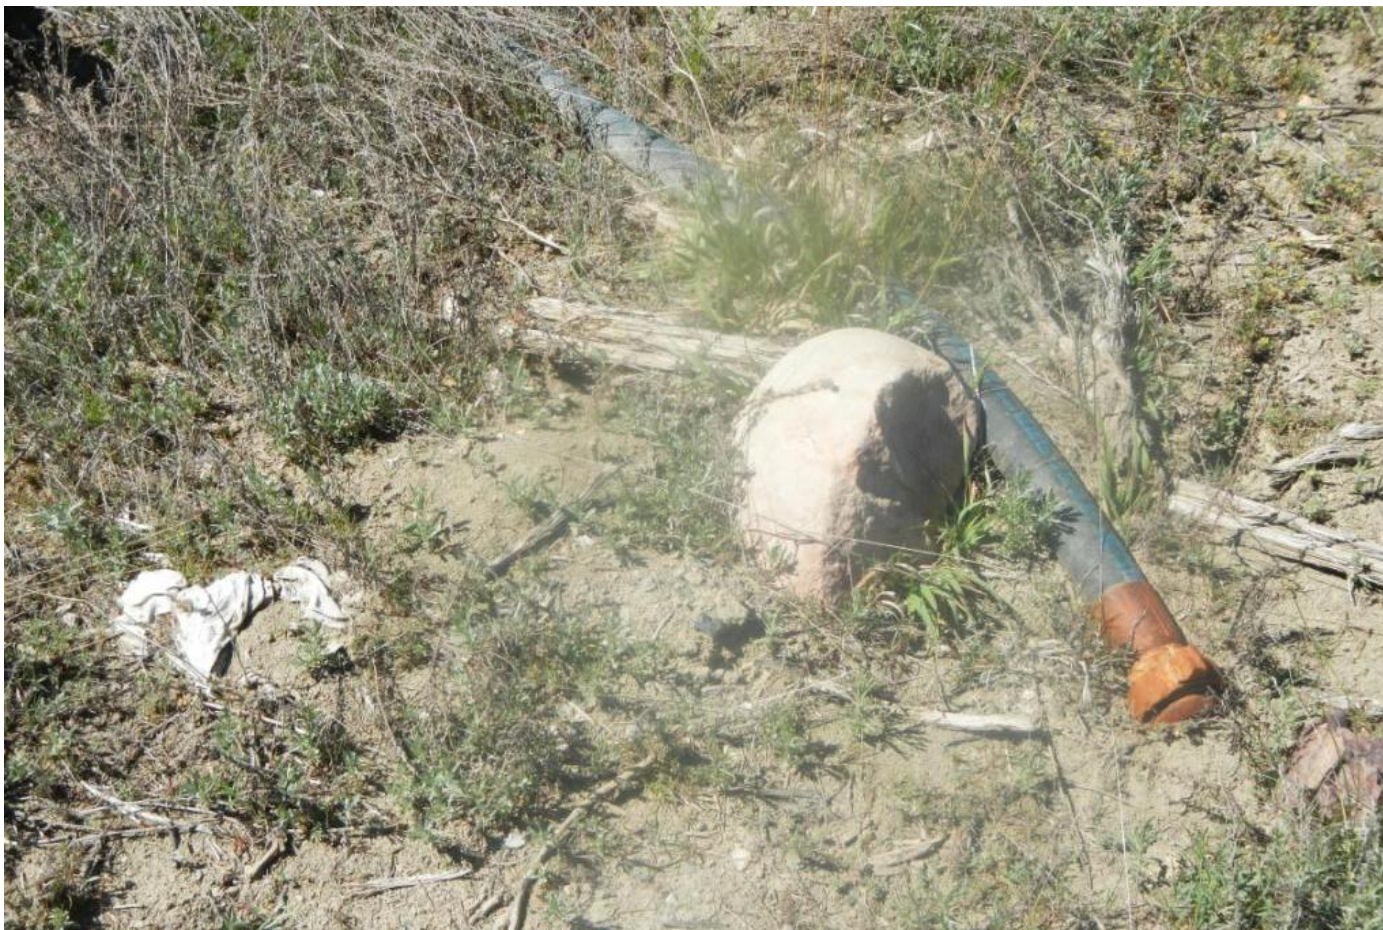
Photo 3. View of junk and debris on well pad.

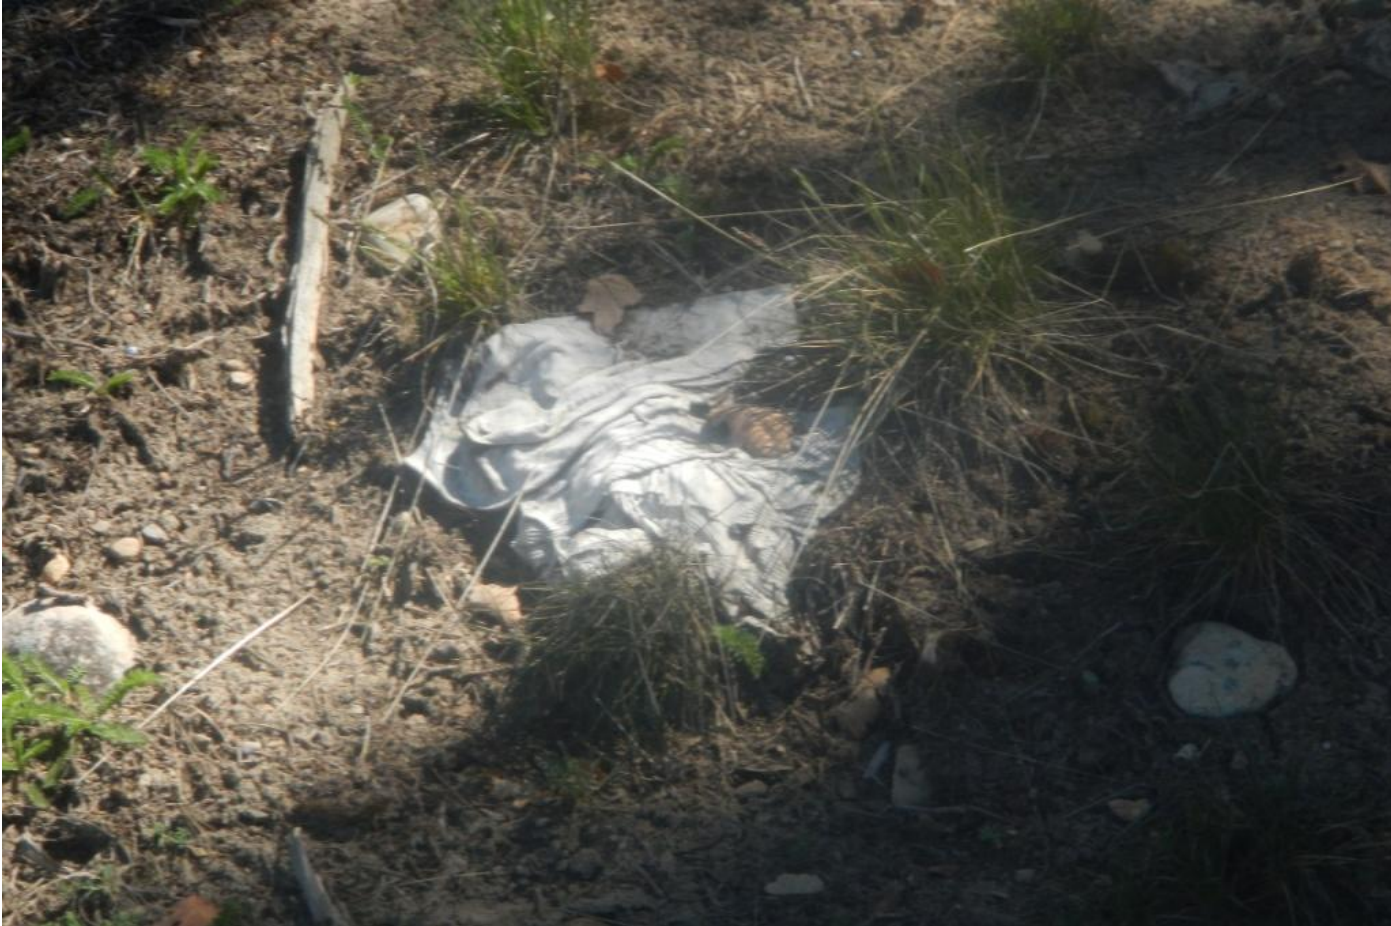
Photo 4. Another view of junk on the well pad.

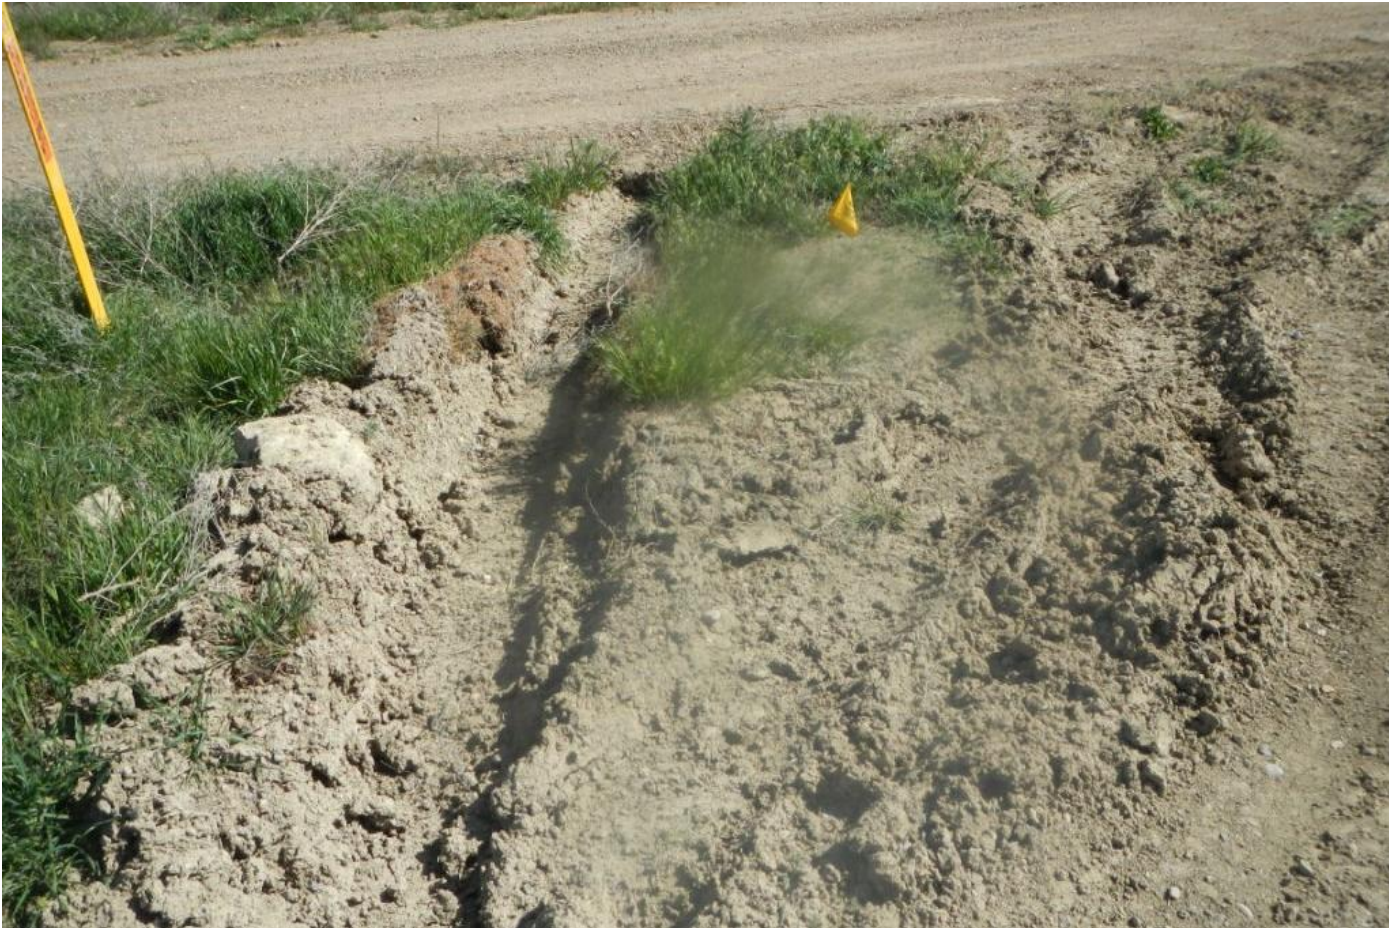
Photo 5. View of deep ruts and destroyed vegetation at well pad entrance.
