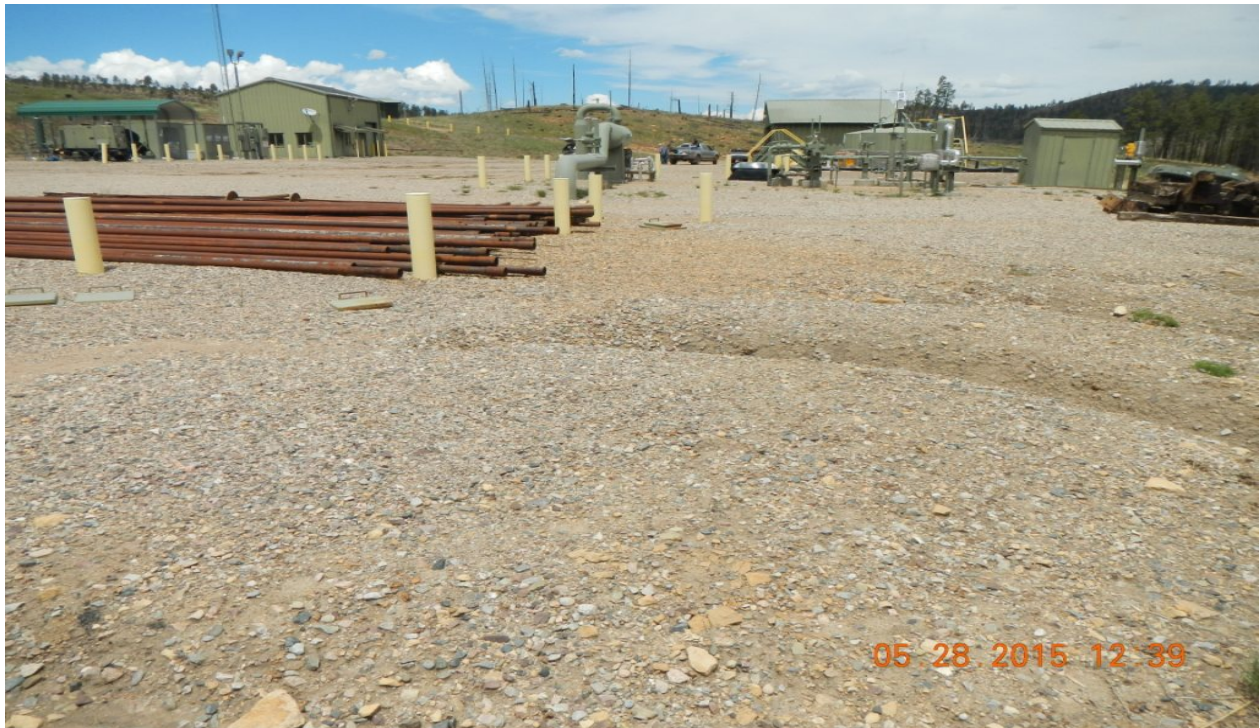
photo 1: South side of the location facing north.

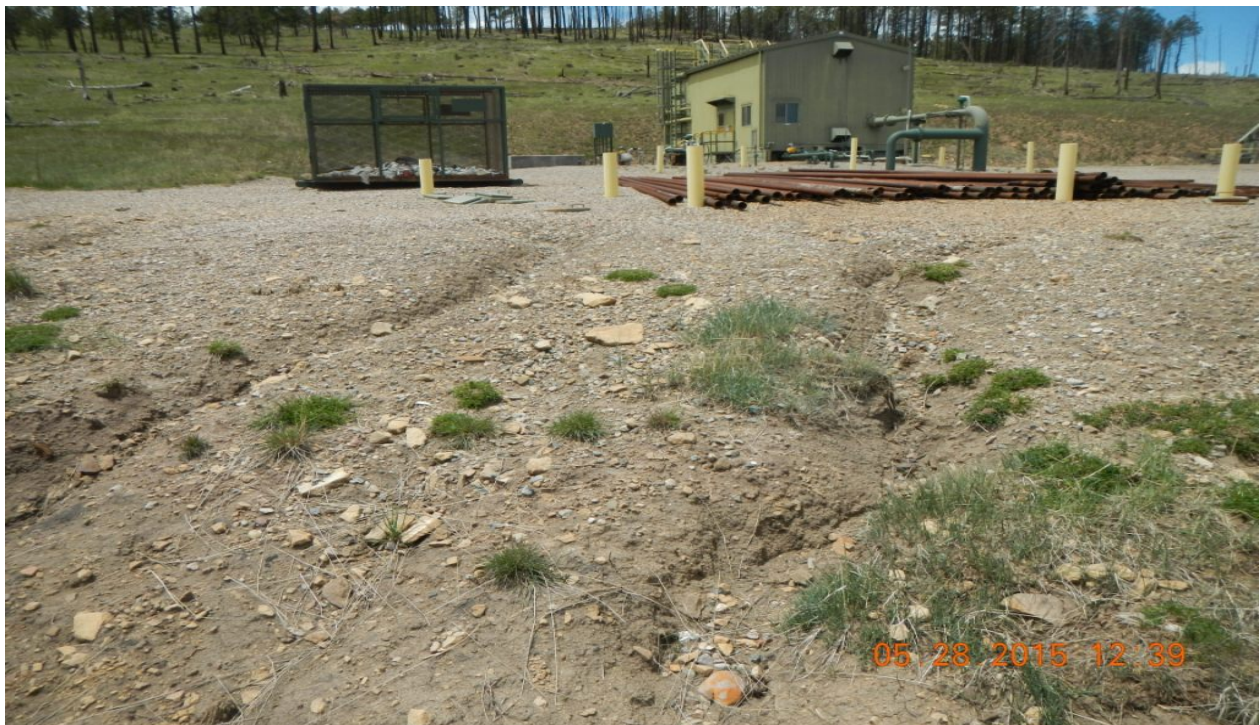
photo 2: Southeast side of location facing west. Erosion channels have formed along the east side of the pad.

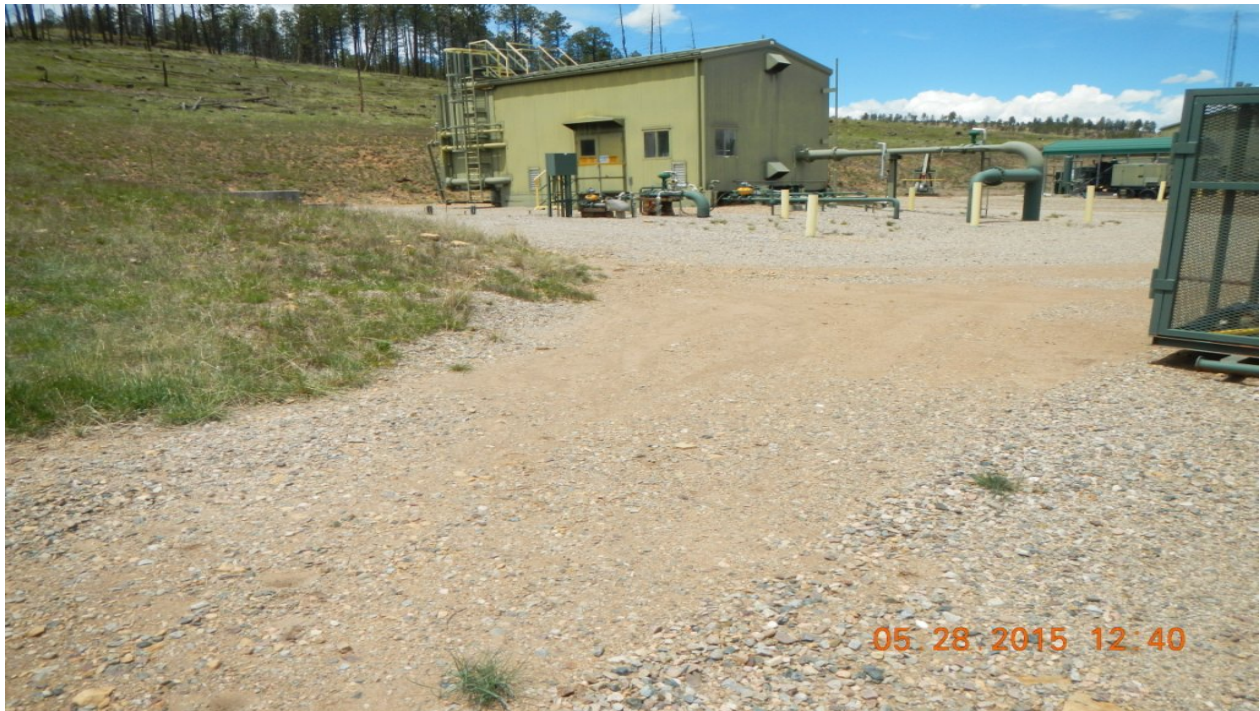
photo 3: South side of the location facing northwest towards the compressor.

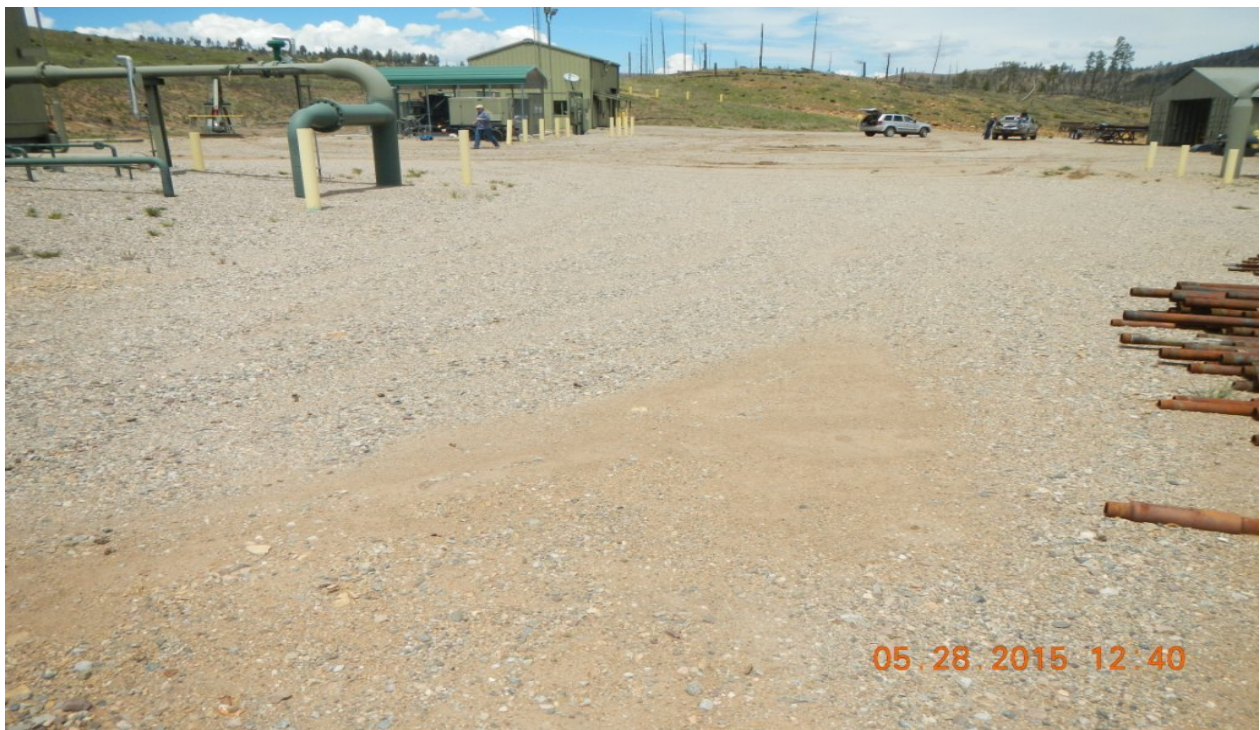
photo 4: Center of the location facing north.

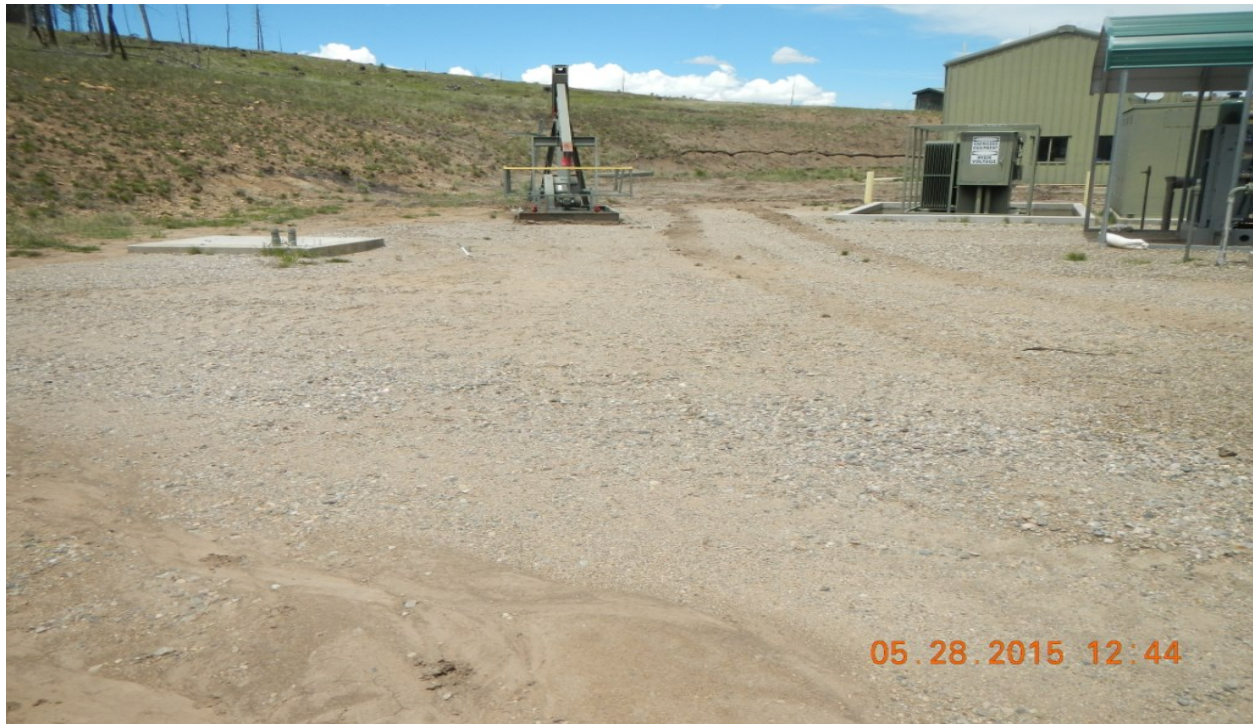
photo 5: West side of the location facing northwest towards the pump jack unit.

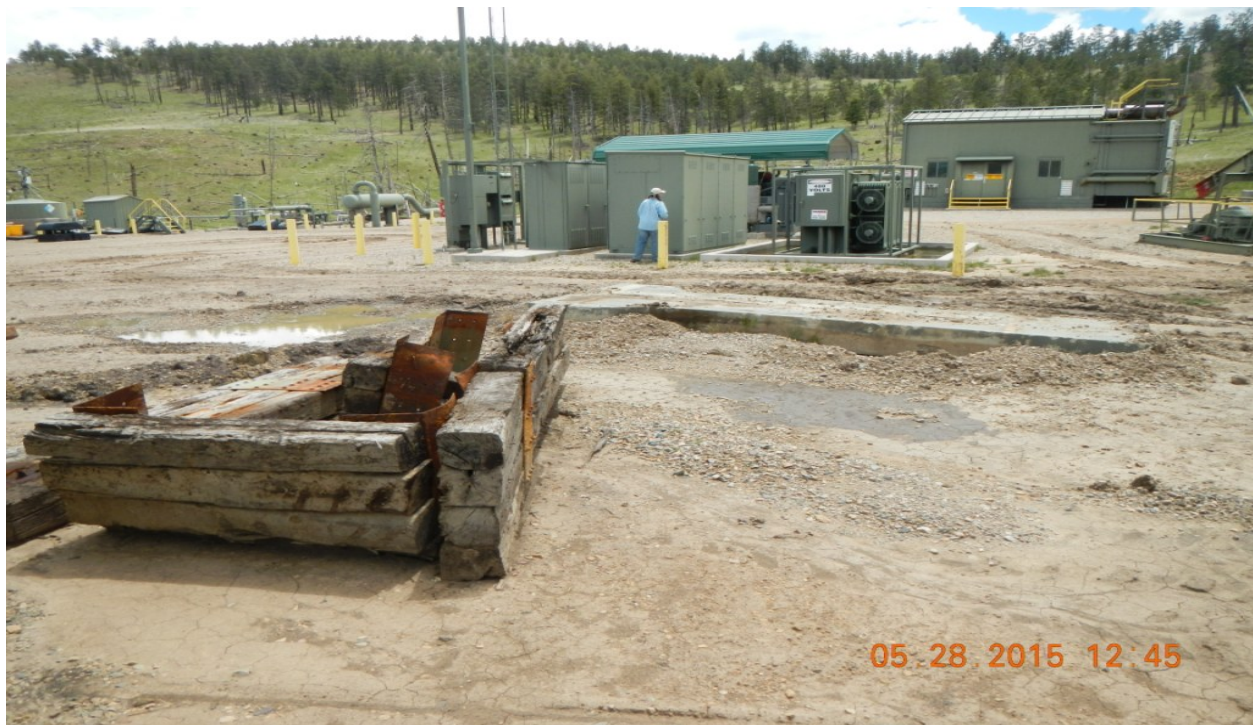
photo 6: West side of the location facing southeast.

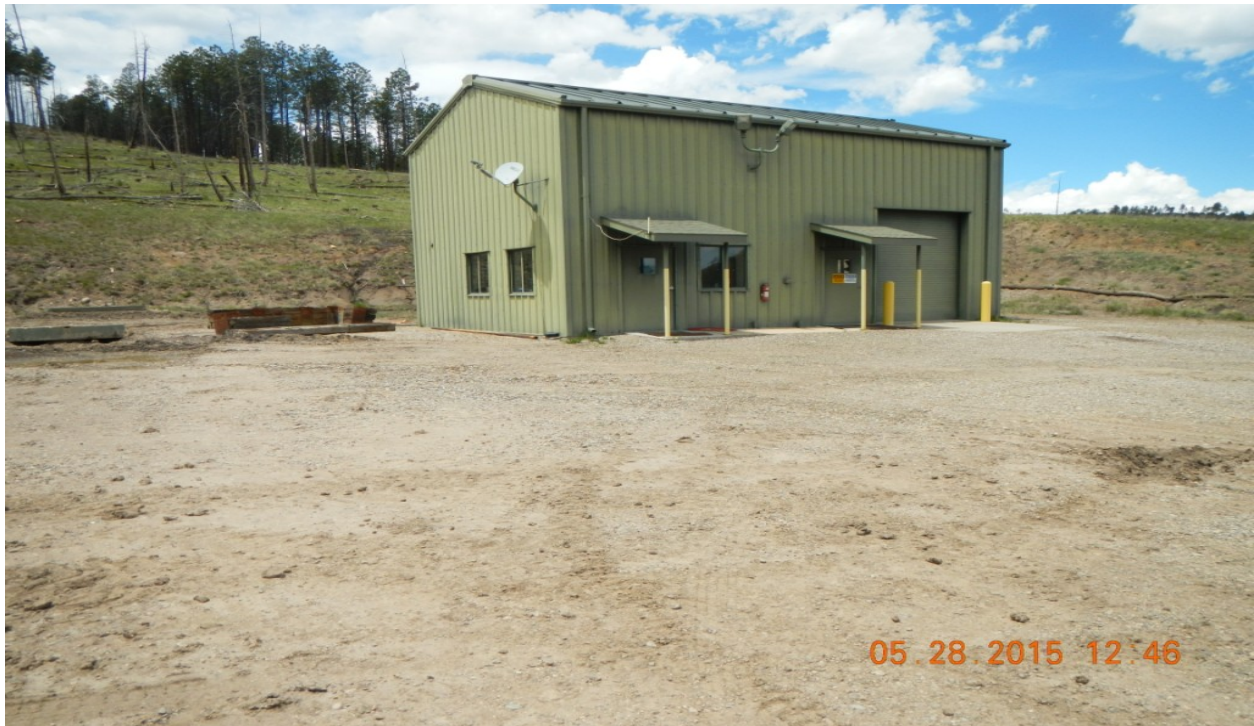
photo 7: Facing towards the northwest side of the location at the office building.

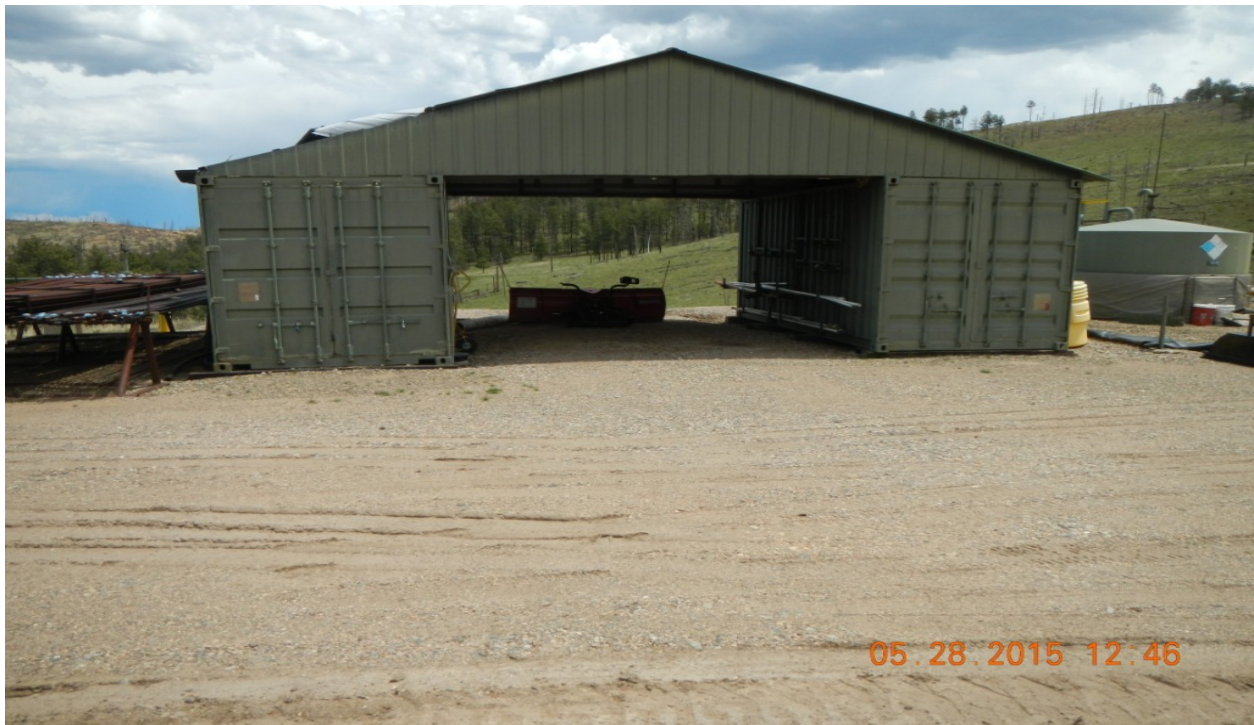
photo 8: Storage unit at the northeast side of the location.
