photo 1: Well sign on the location, GE-76-94.

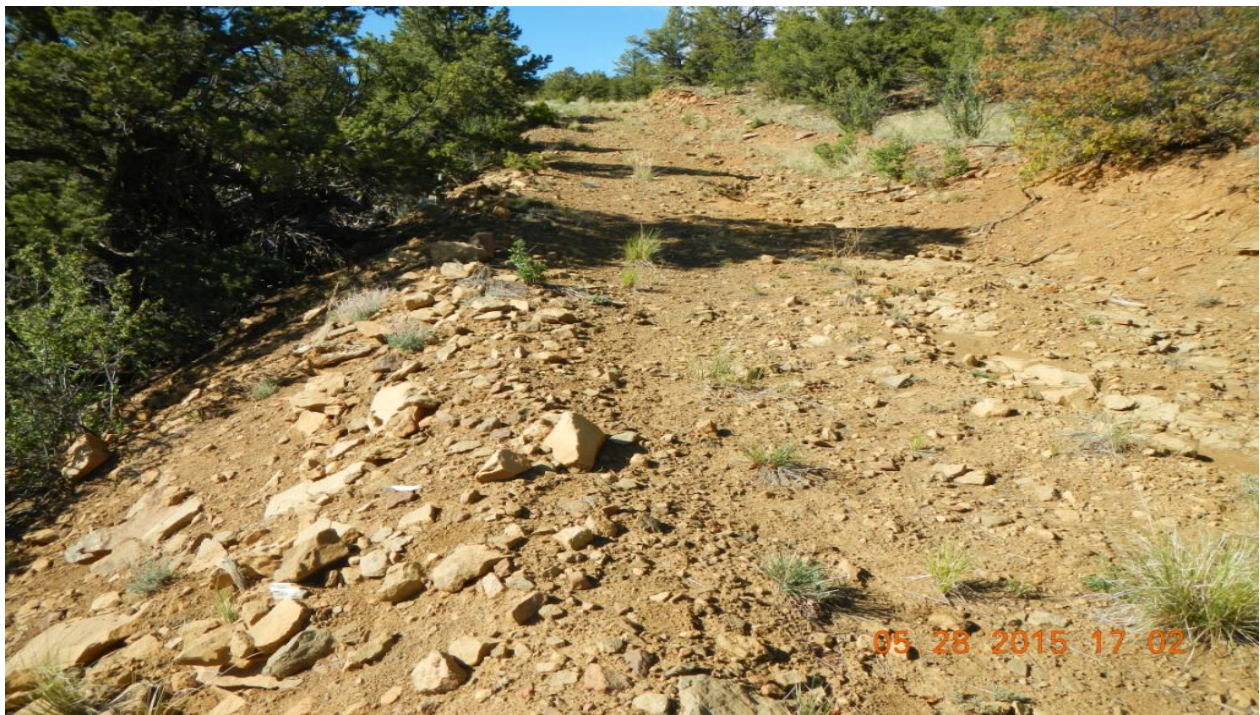
photo 2: Access road north towards the location.

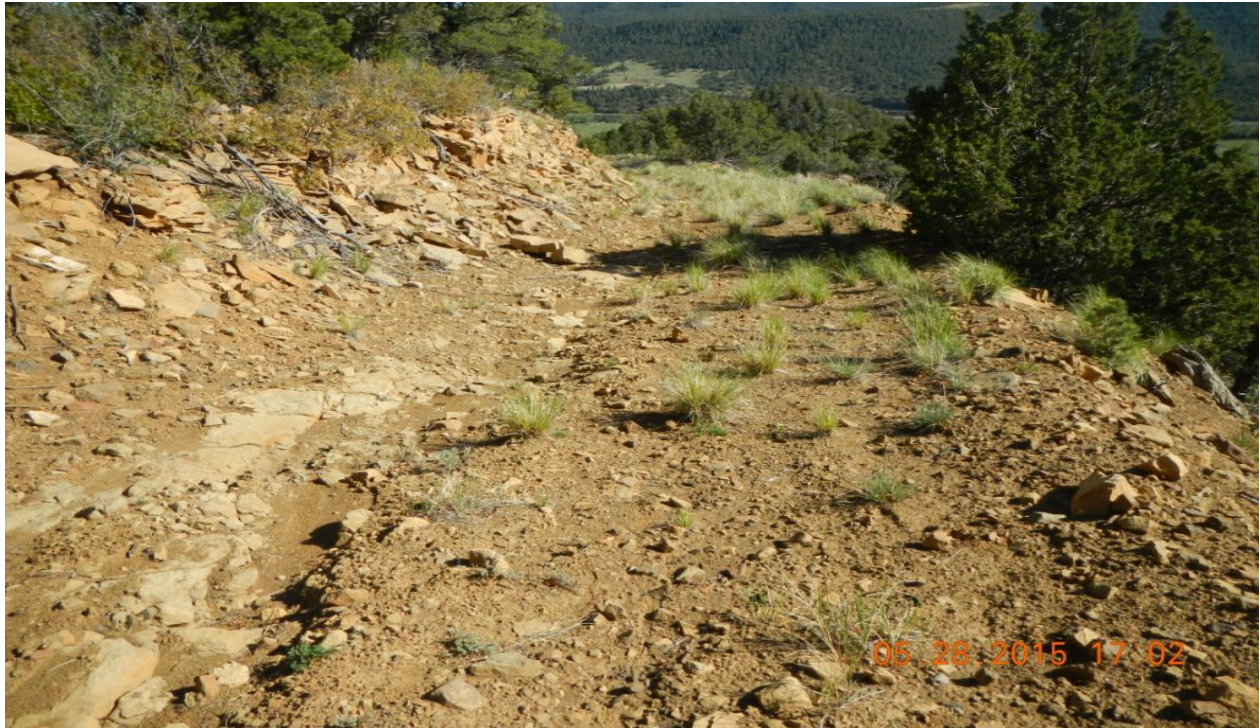
photo 3: Facing back down the access road towards the south.

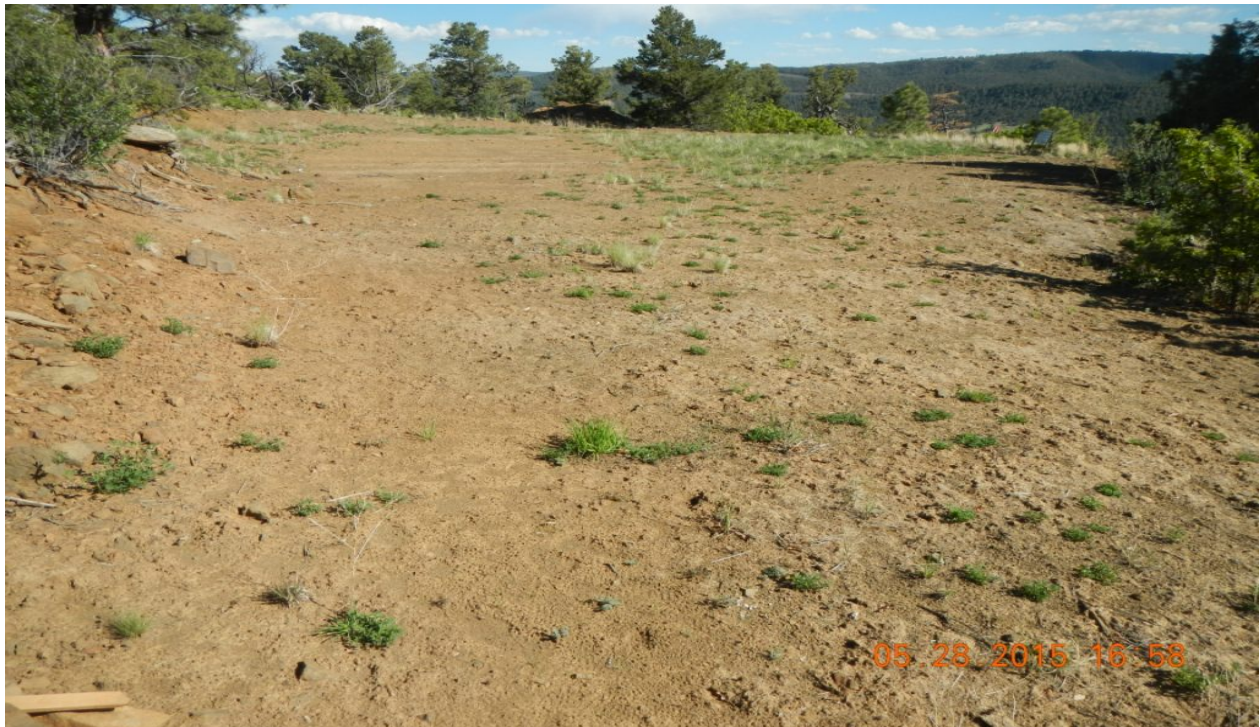
photo 4: Facing southeast towards the location.

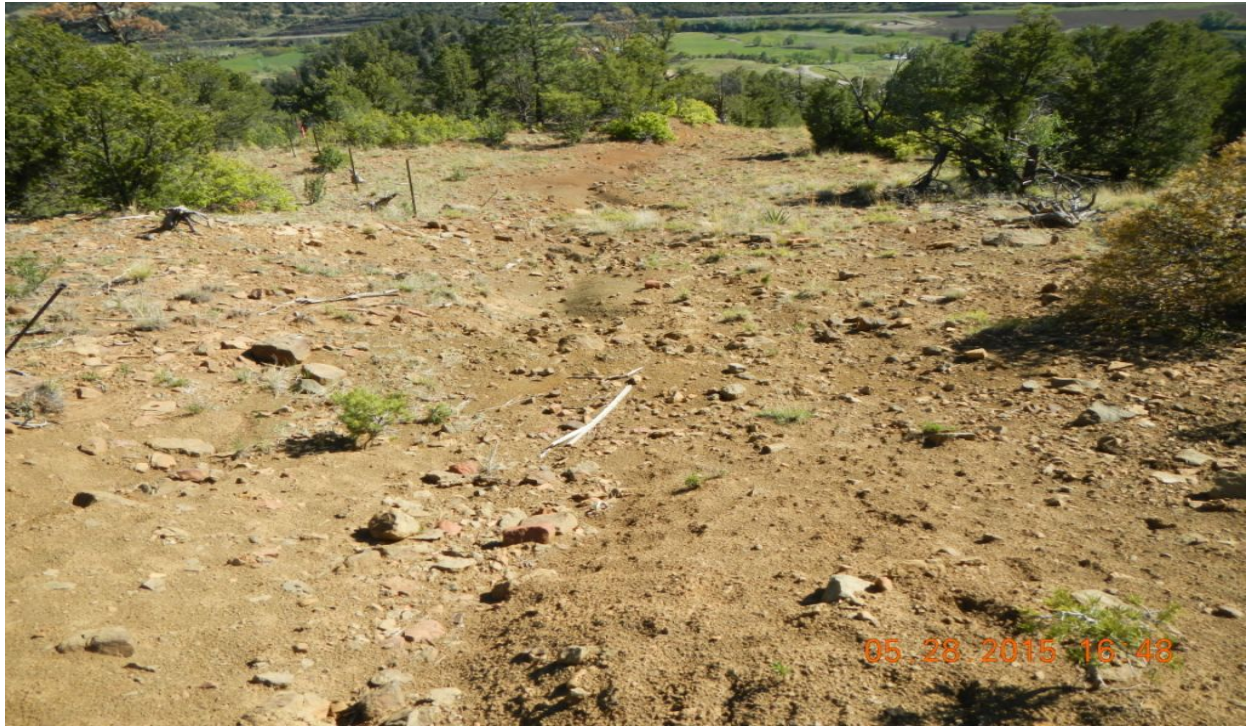
photo 5: South side of the location facing south where flowline disturbance occurred.

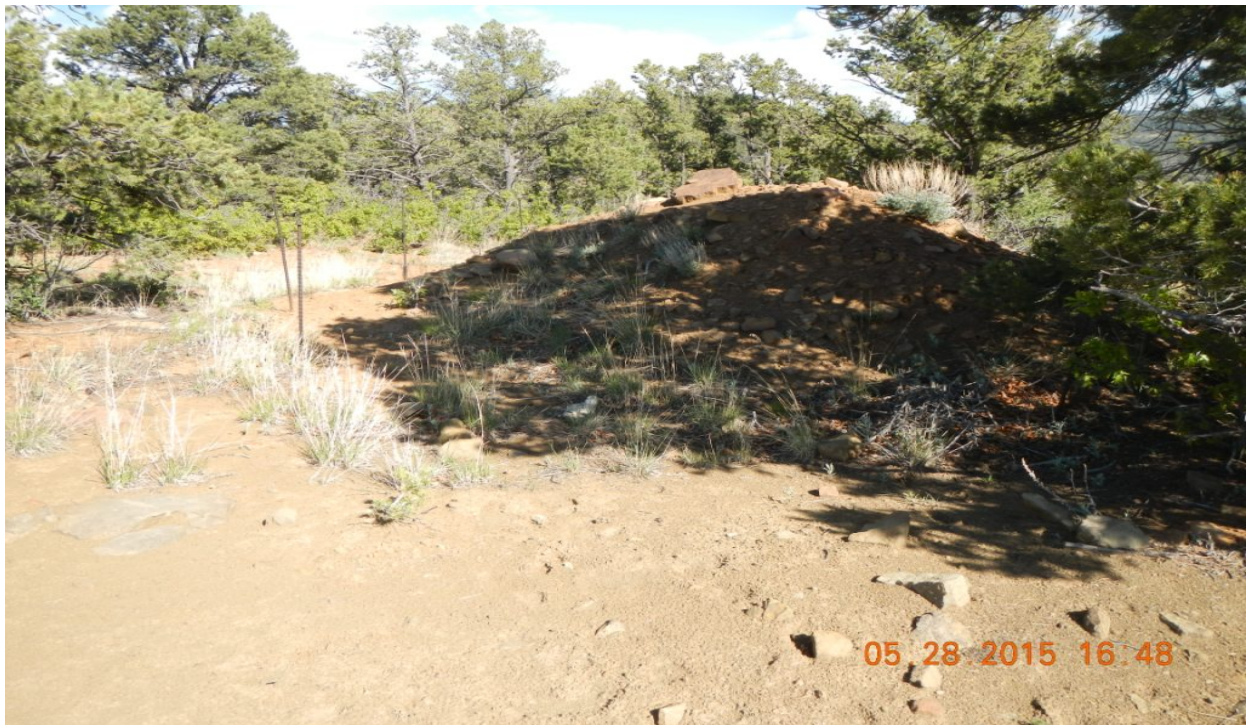
photo 6: Possible soil stockpile on the east side of the location.

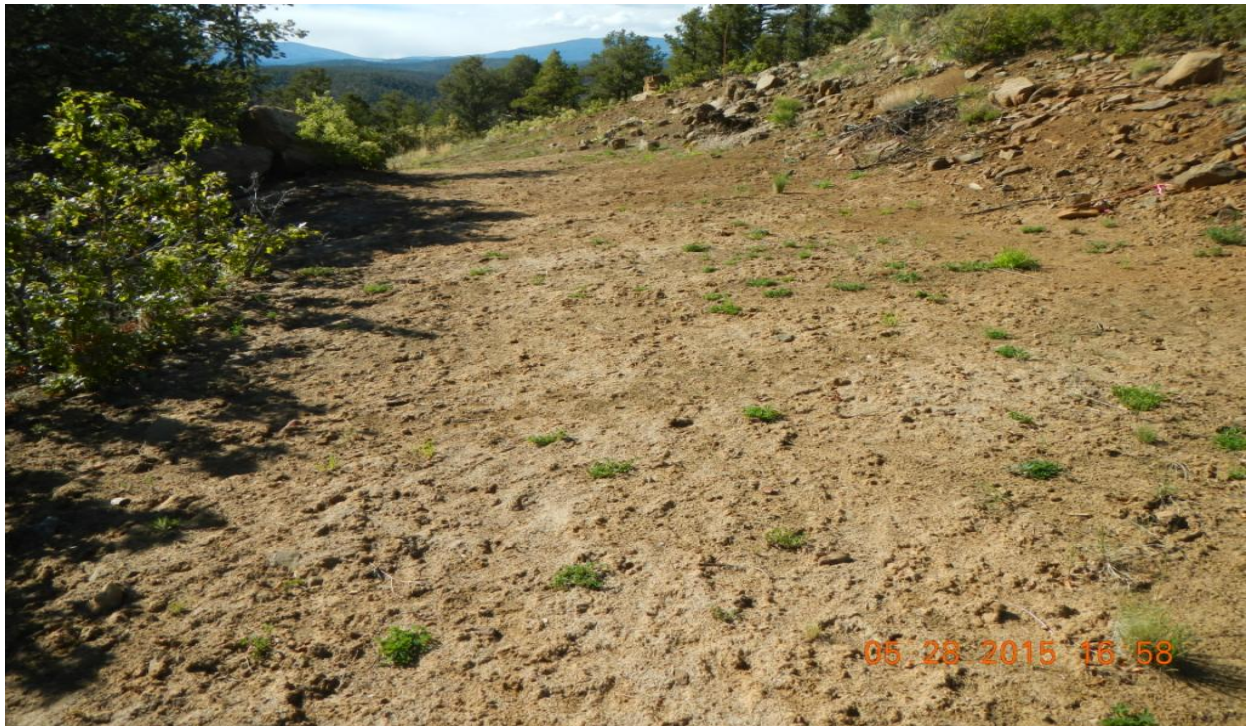
photo 7: West side of the location where a hydro-mulch was previously applied.

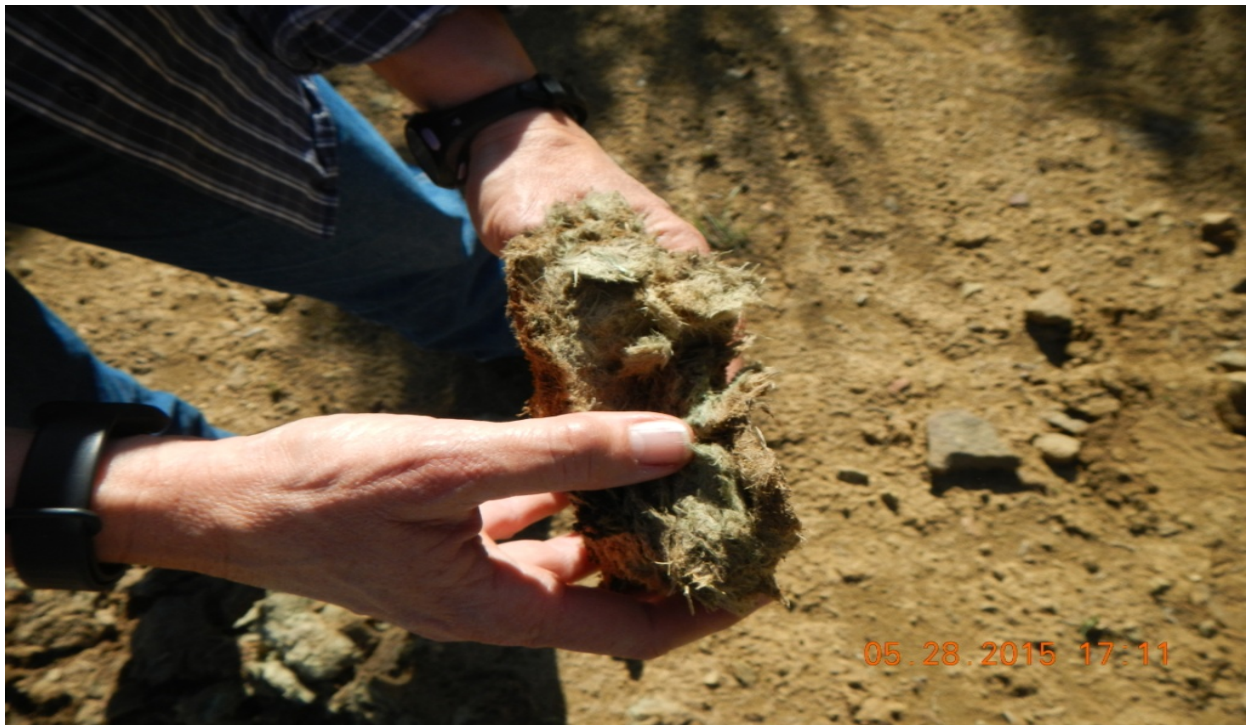
photo 8: Hydro mulch may have been applied to thick which may have impeded plant growth in this area.
