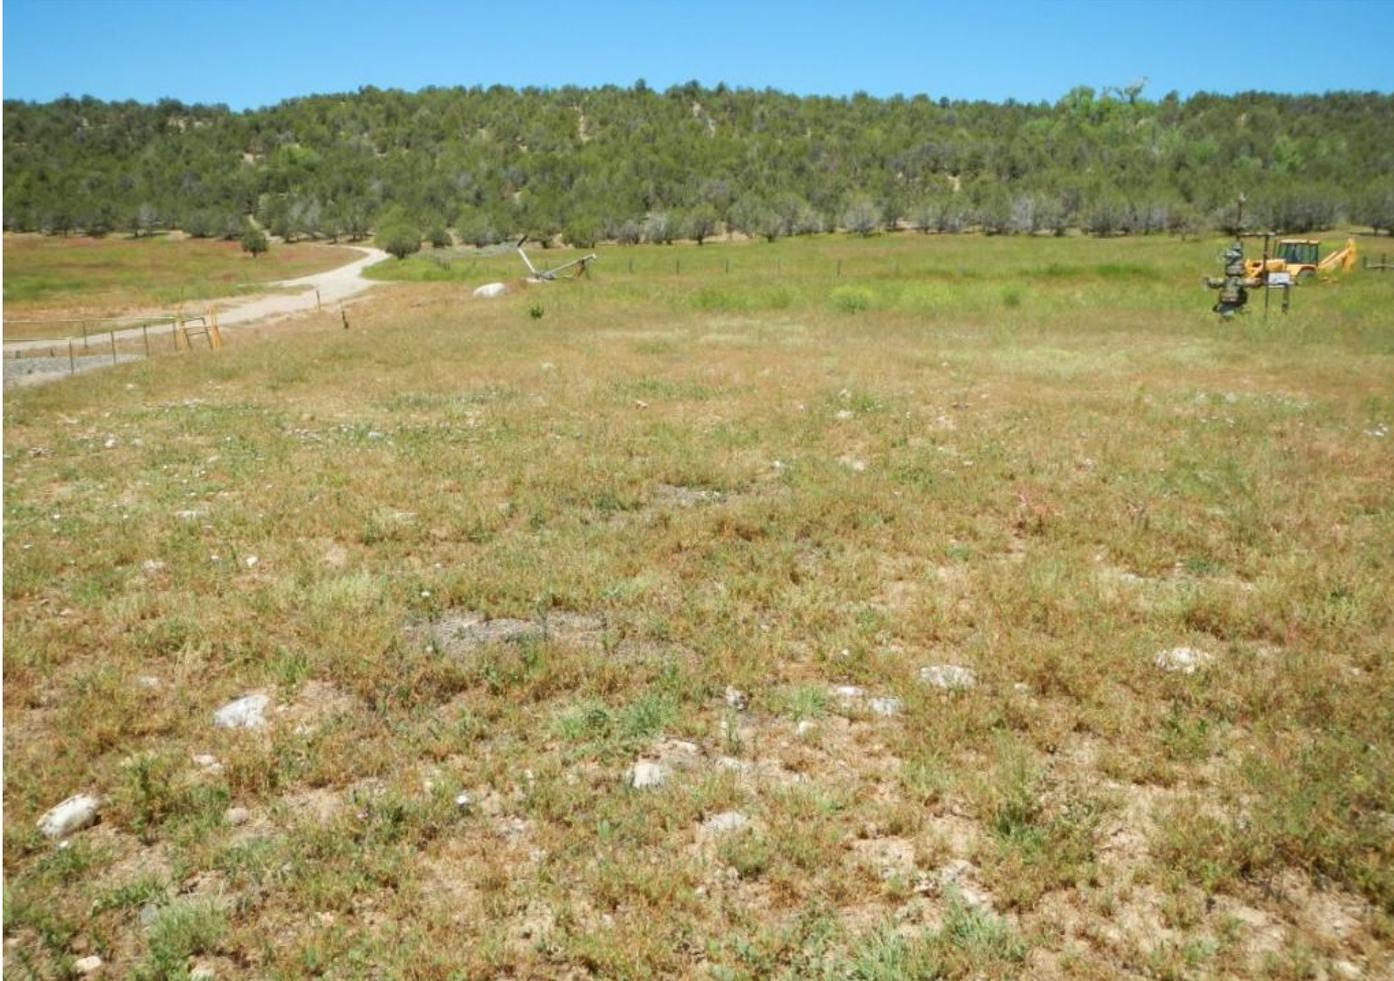
Photo 1. View of northern portion of project area from northeastern corner facing westward. Vegetation is largely ruderal weeds such as field bindweed (*Convolvulus arvensis*), flixweed (*Descurainia sophia*), and cranesbill (*Erodium cicutarium*). These are consistent with surrounding weedy pasture vegetation.

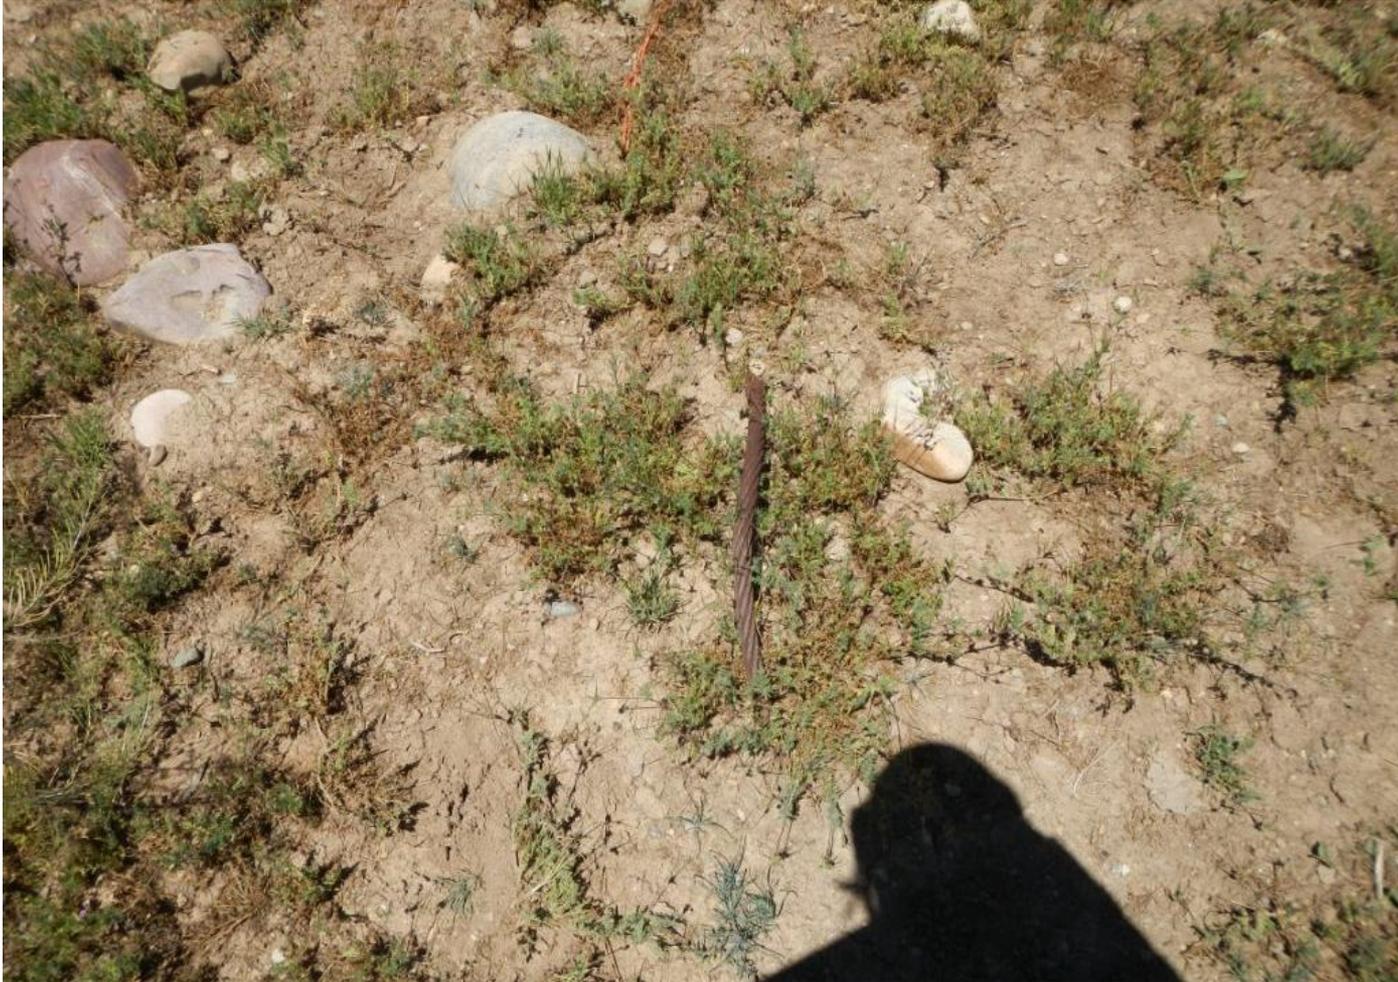
Photo 2. View of rig anchor cable in southeastern portion of project are that needs to be removed.

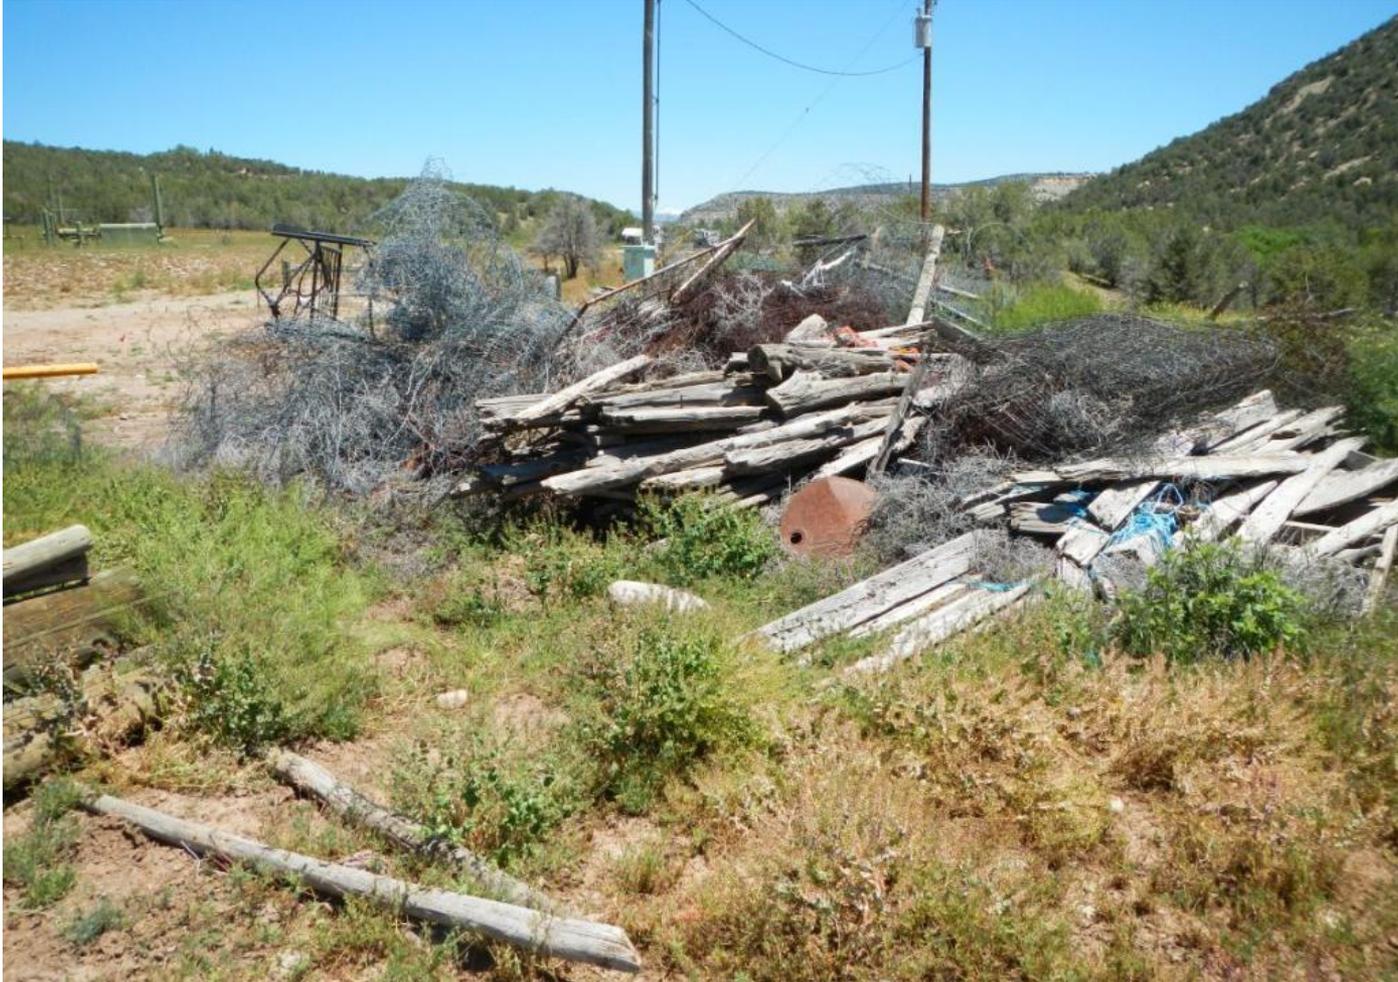
Photo 3. View of junk and debris in eastern portion of project area.

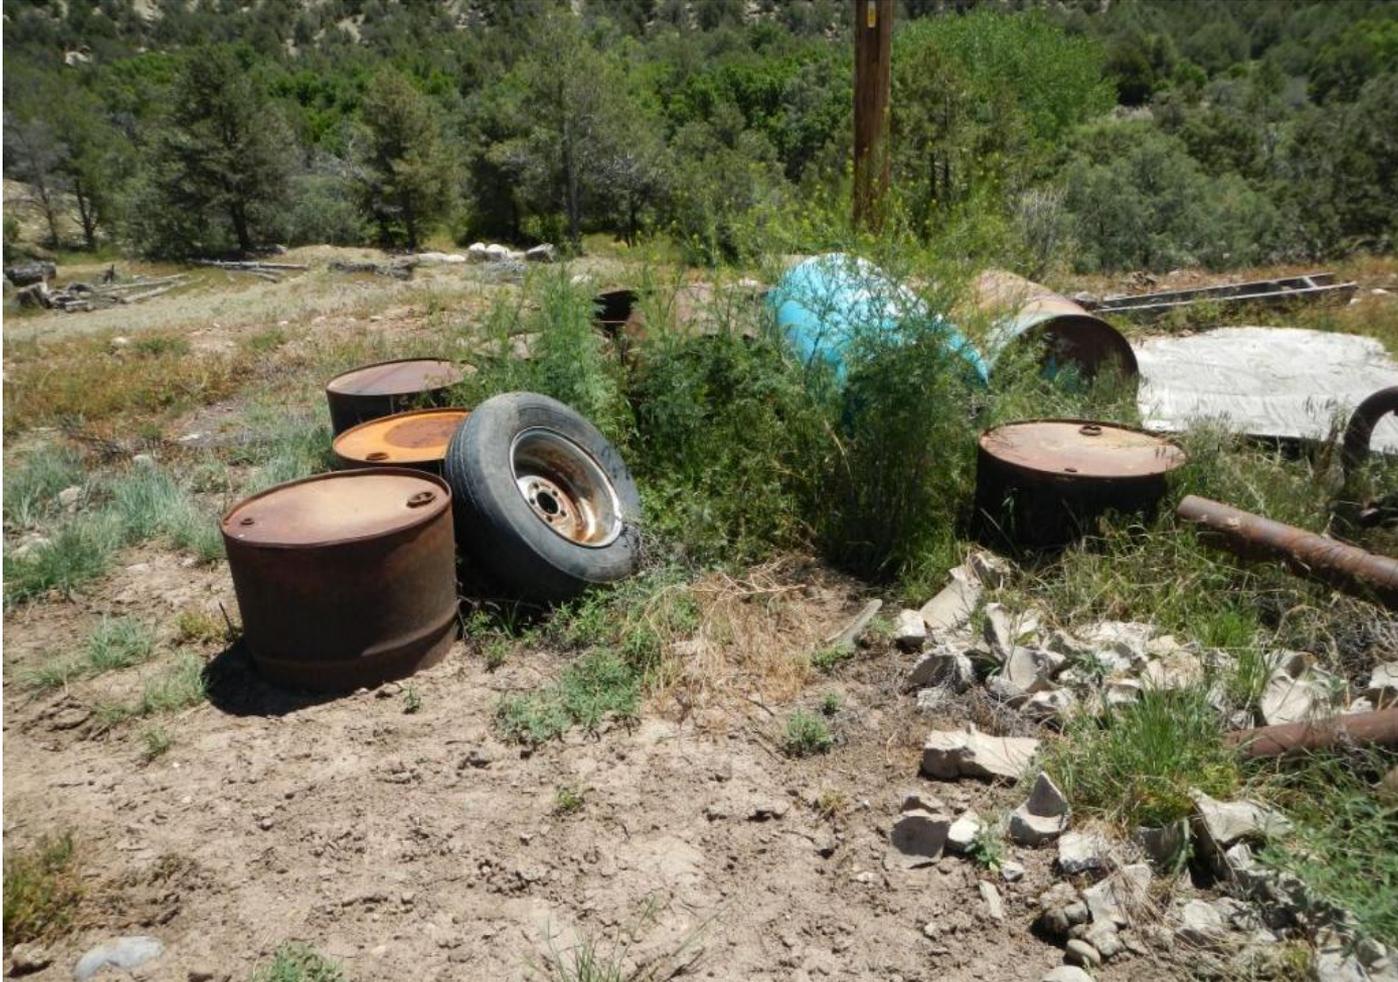
Photo 4. View of barrels, tire, and other junk and debris in eastern portion of project area.
