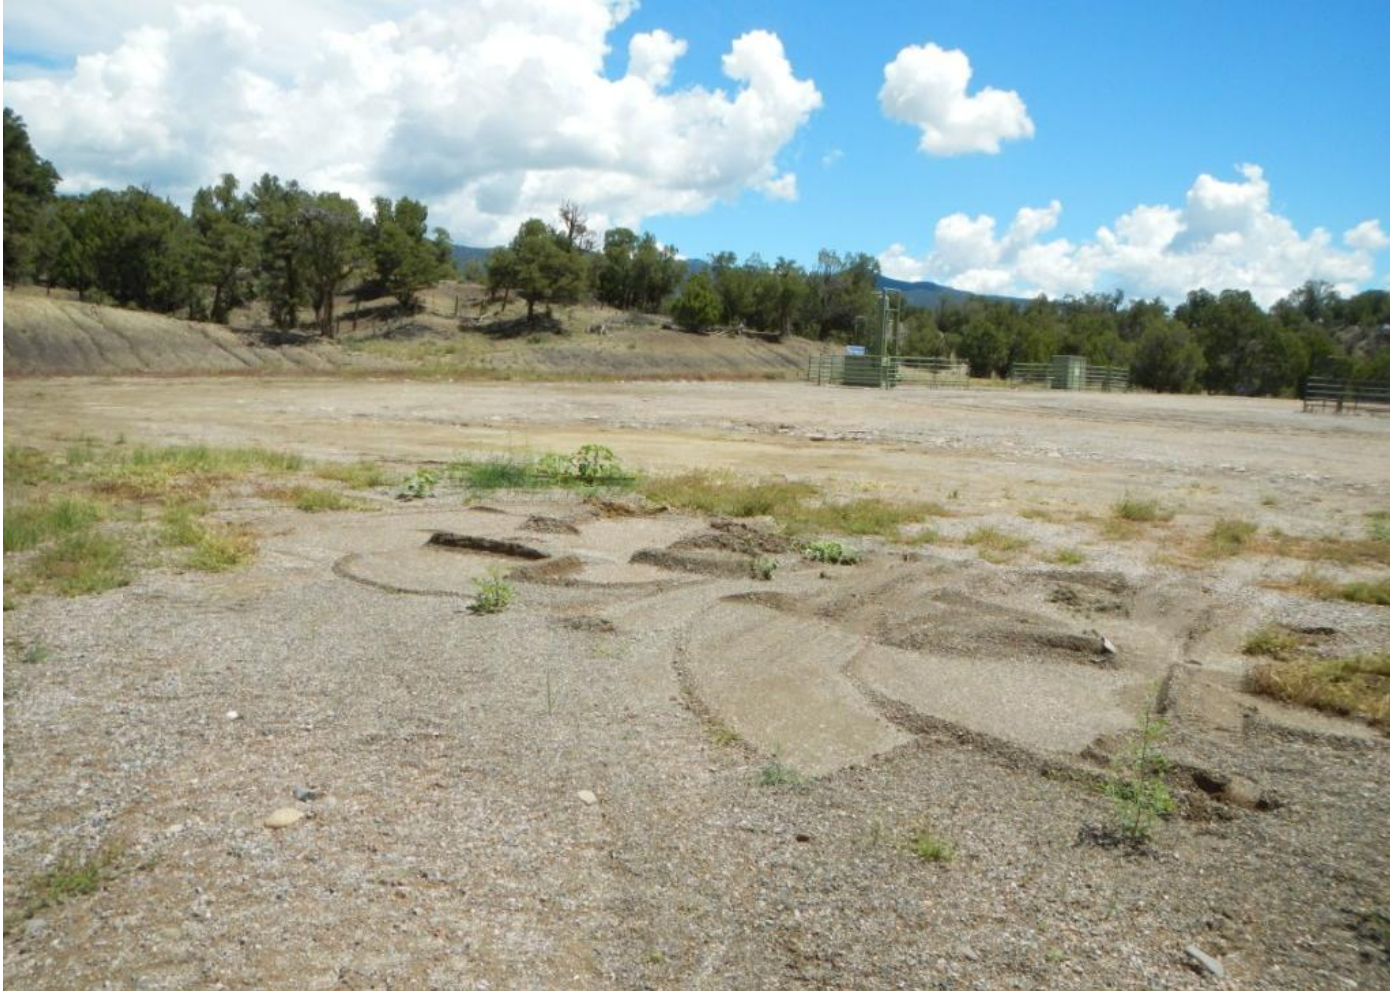
Photo 1. View from southwestern corner of well pad facing center. The area in the foreground (western portion of well pad) does not appear necessary for production operations.

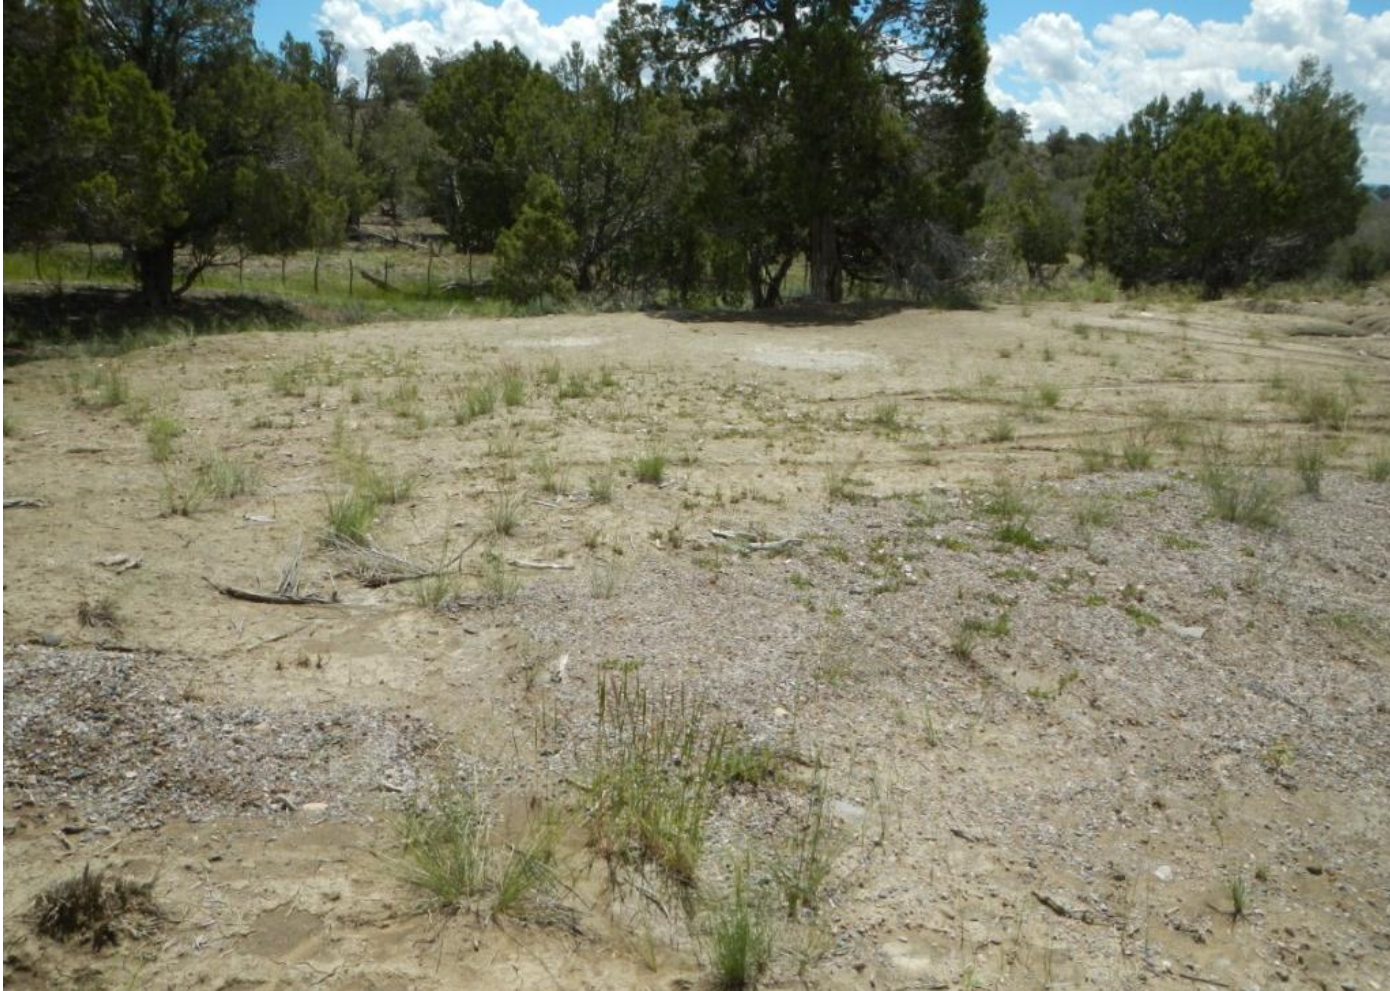
Photo 2. View of an approximately 50-foot-by-50-foot area in the northeastern portion of the well pad with poor revegetation that does not appear necessary for production operations.

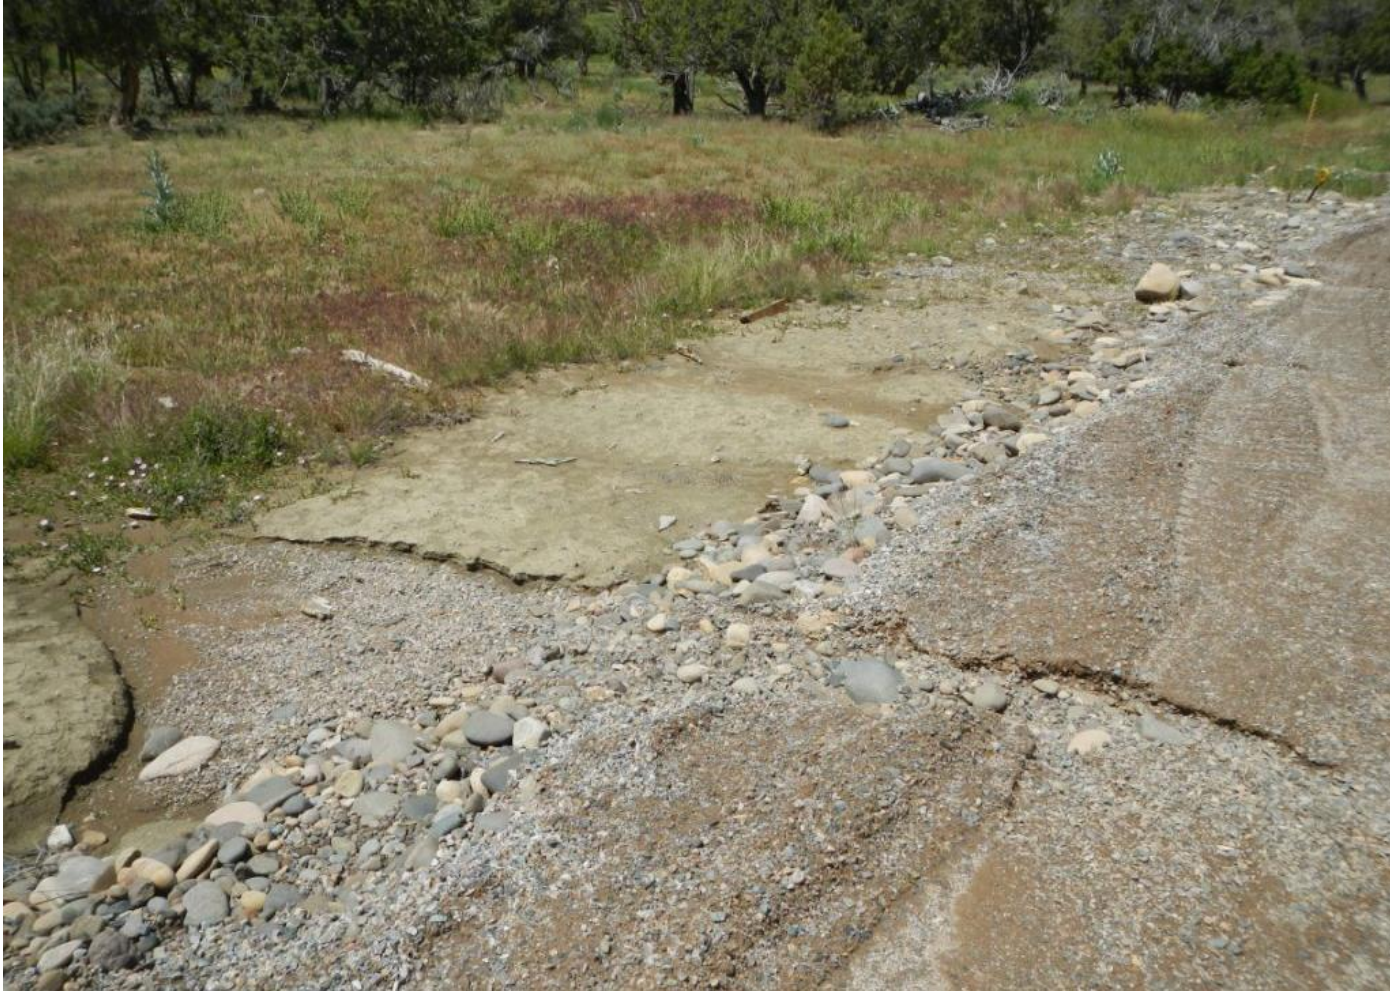
Photo 3. View of southern edge of project area. Rill erosion and sediment deposition at the toe of the slope is apparent.

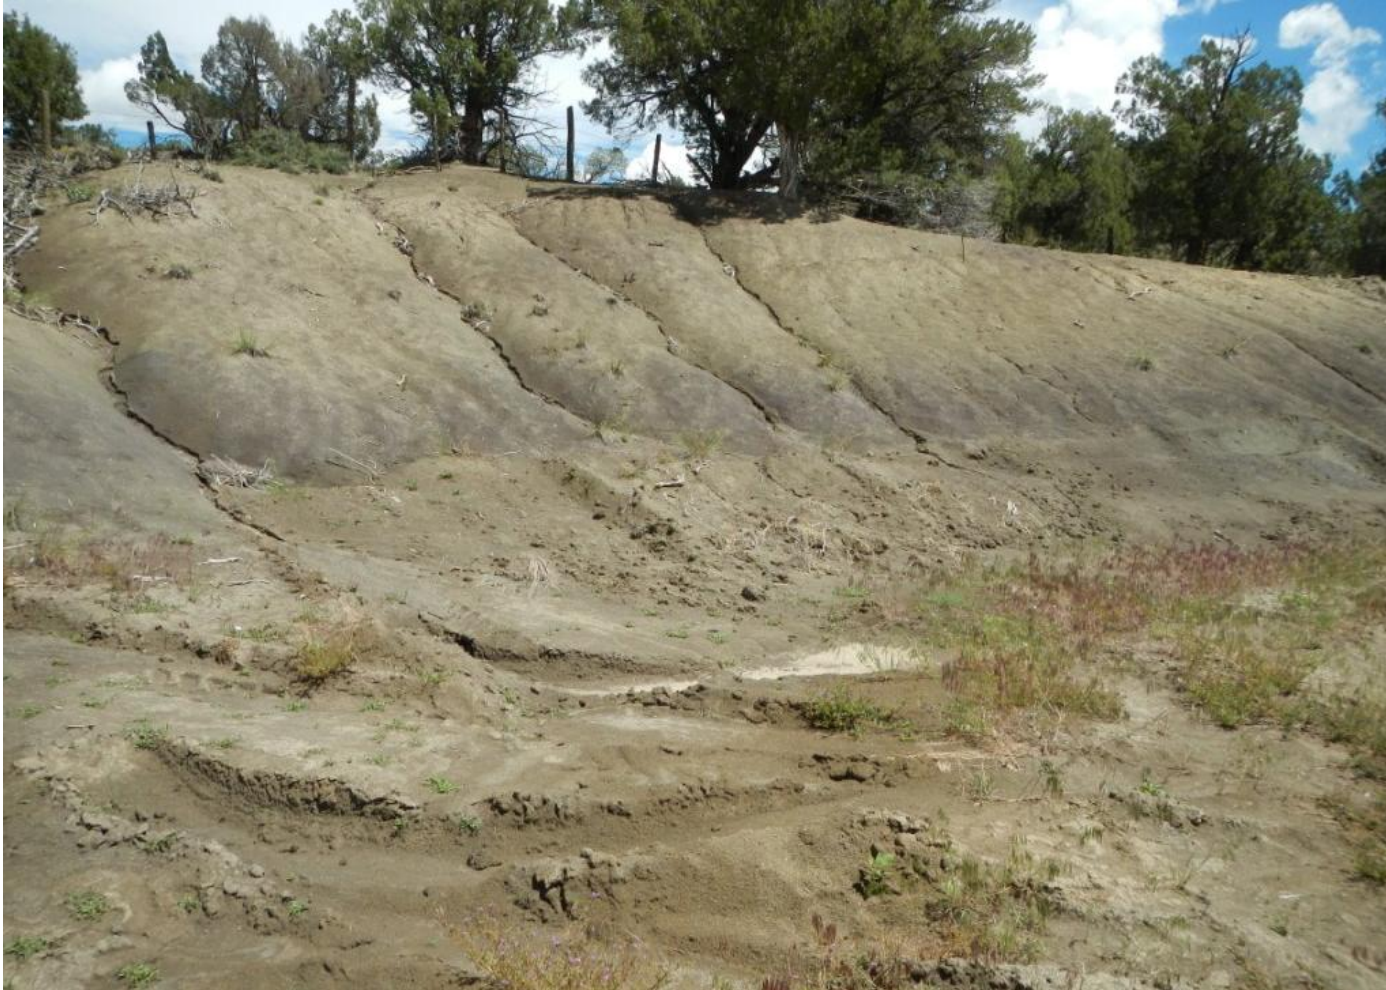
Photo 4. View of unprotected cut-slope in northwestern corner of project area. Rill erosion is apparent and little vegetation is established on the slope. Sediment that appears to have eroded off of the slope is visible in the foreground of the photo.

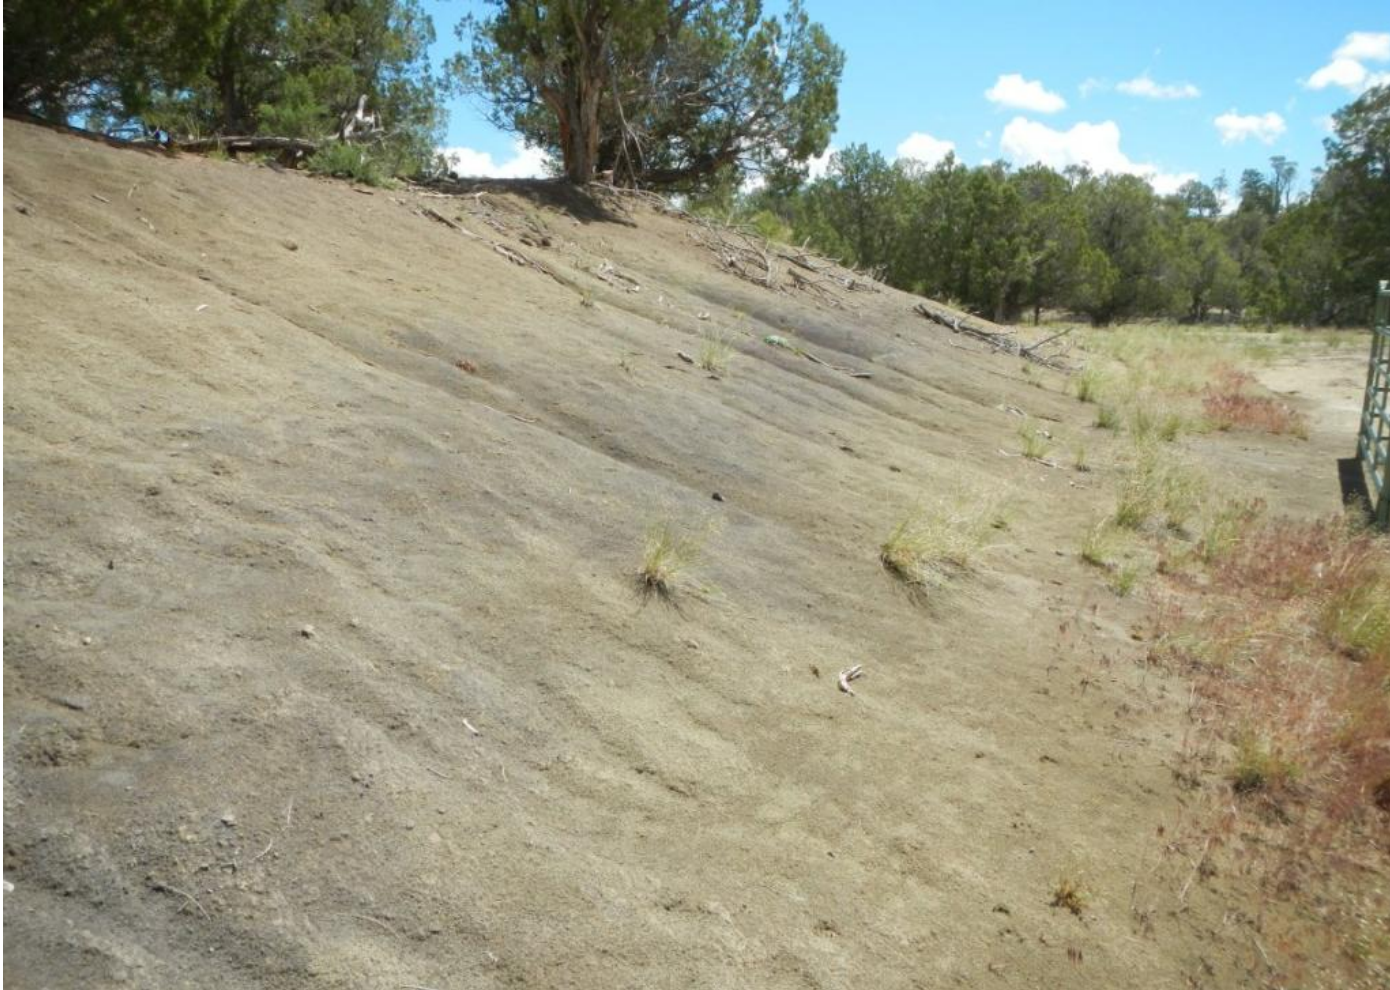
Photo 5. View of northern cut slope from northeastern edge facing eastward. Little vegetation on the slope. Indian ricegrass (*Achnatherum hymenoides*) and cheatgrass (*Bromus tectorum*) are growing in the eroded sediment at the toe of the slope.

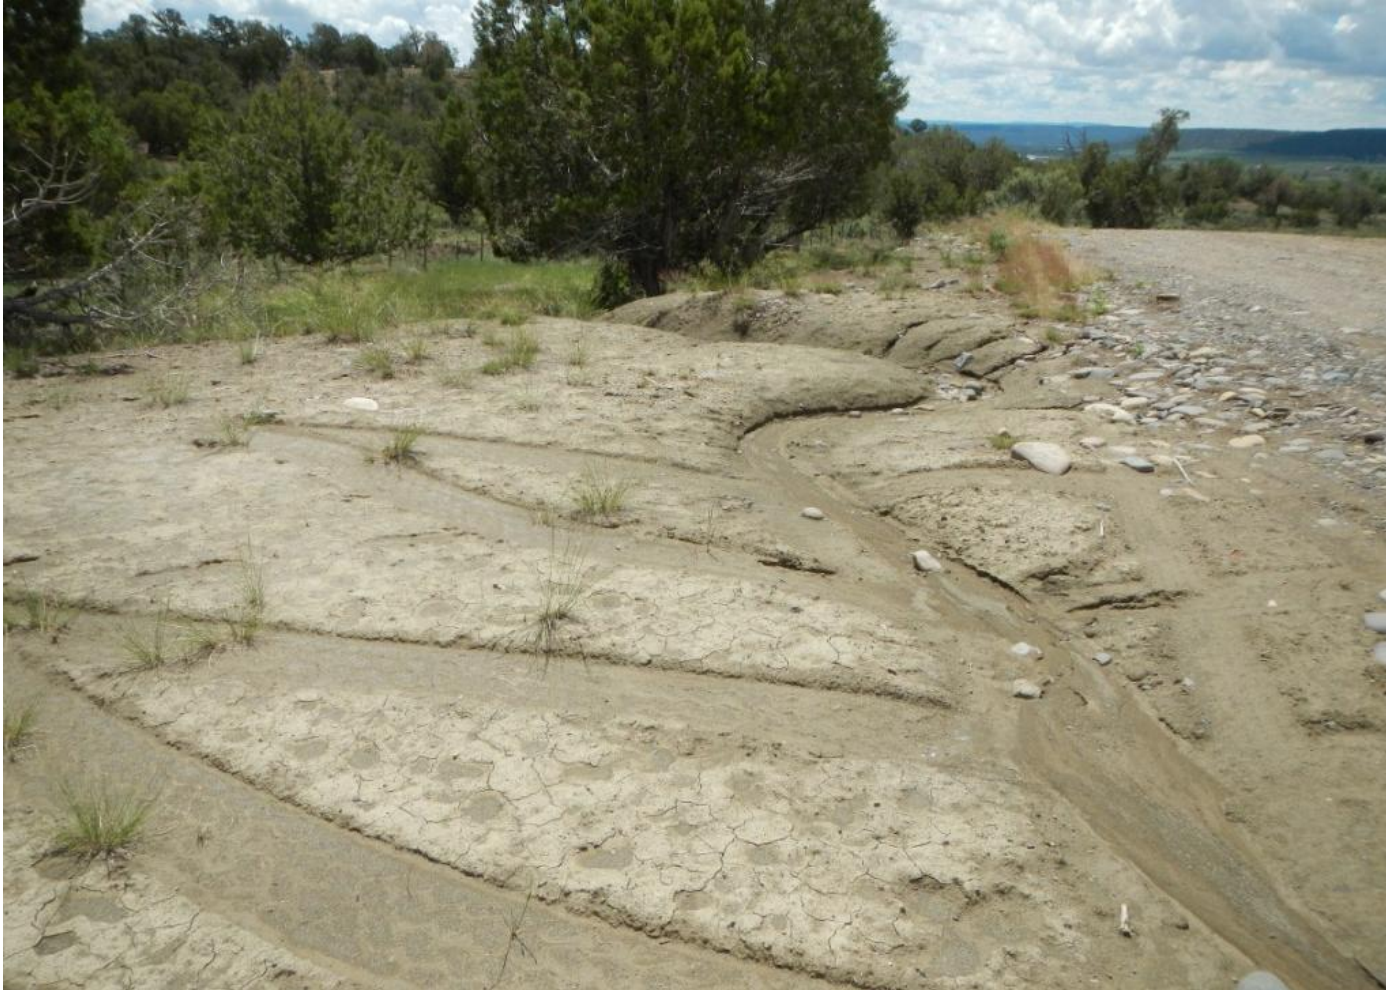
Photo 6. View of erosional channel in eastern portion of project area. This channel is approximately 2 feet wide and 2 feet deep.
