photo 1: New Elk 26-12

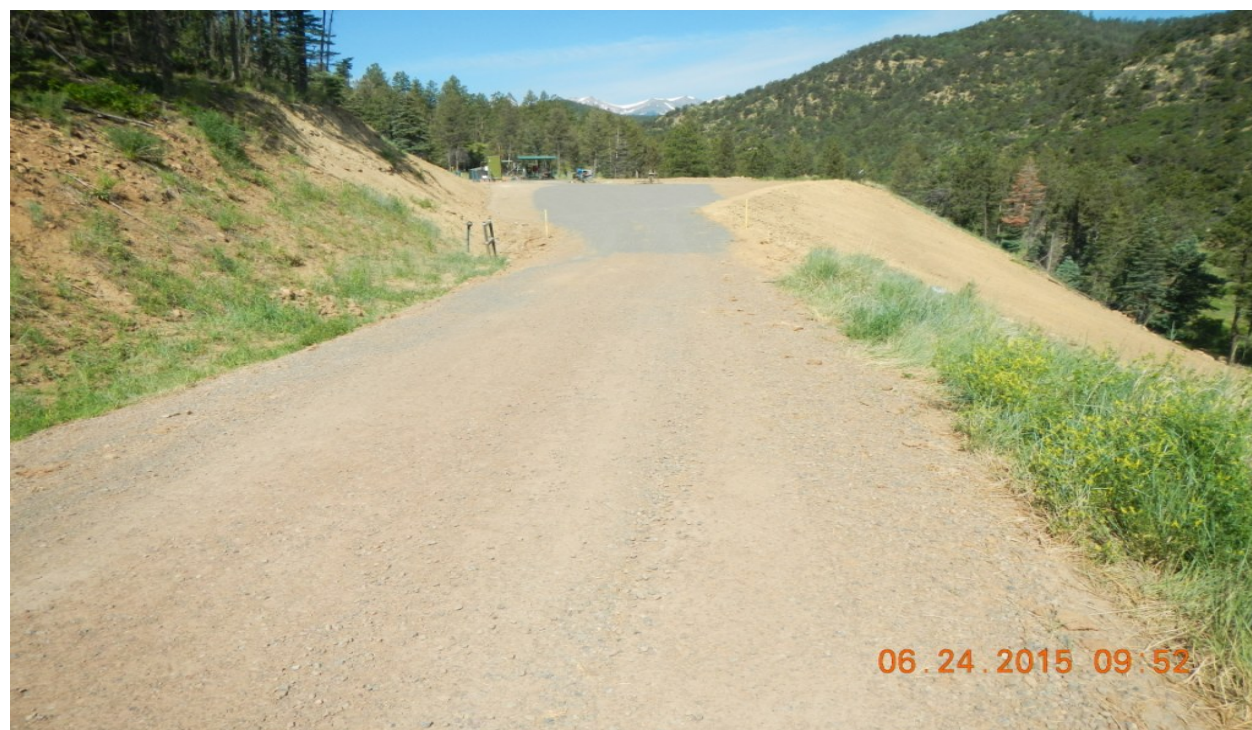
photo 2: Facing west towards the location from the access road.

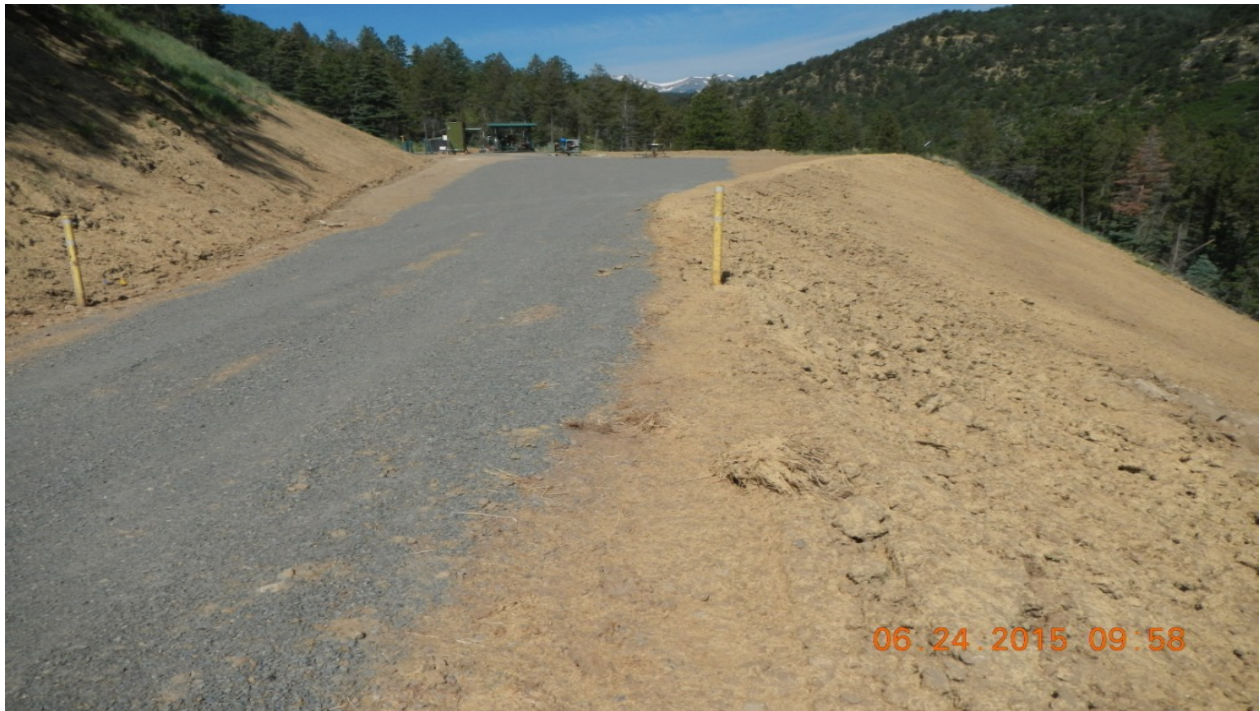
photo 3: Gravel has recently been spread on pad surface and location has recently been reclaimed.

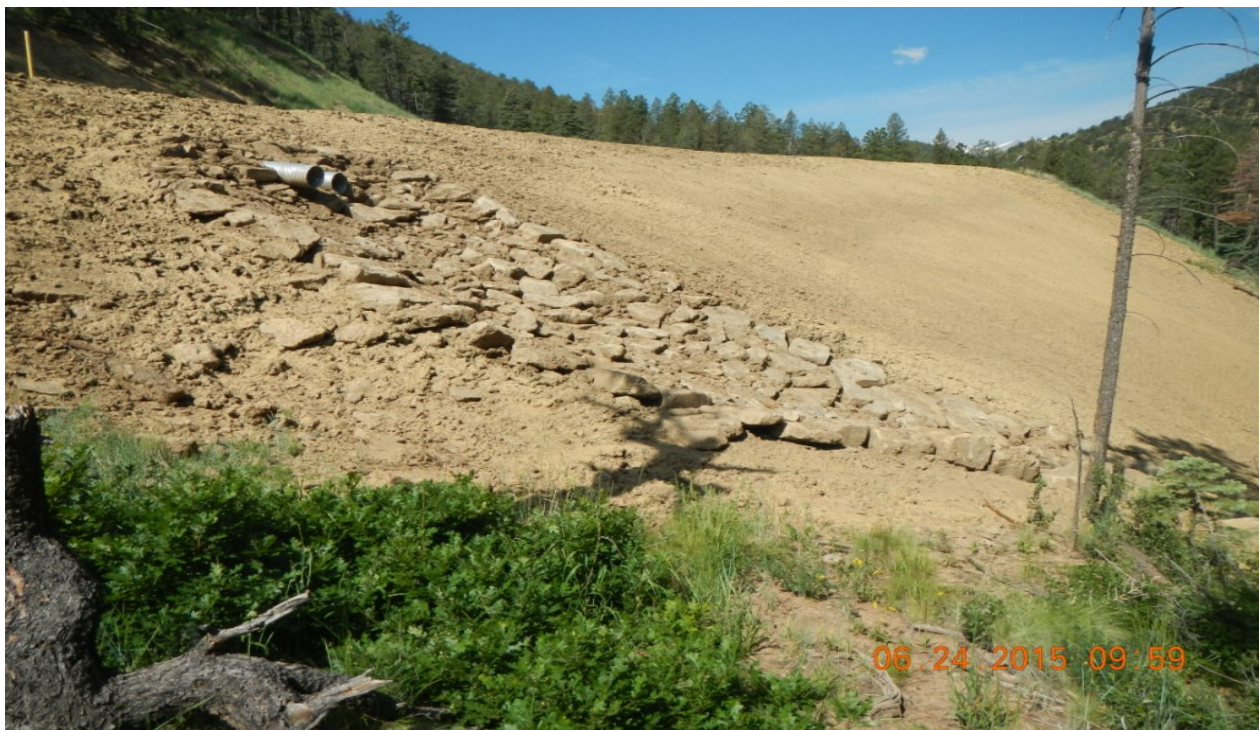
photo 4: Northeast corner of the location facing west. Culverts and rock outlet have been installed.

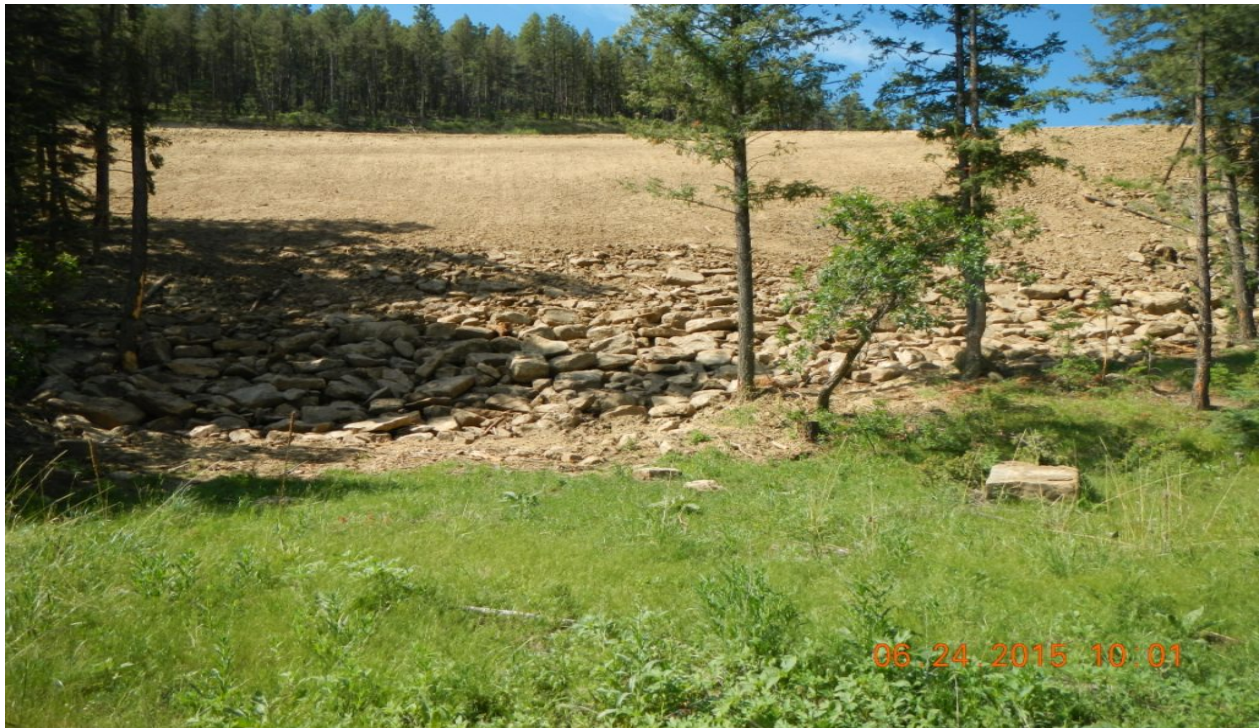
photo 5: North side of the location facing south.

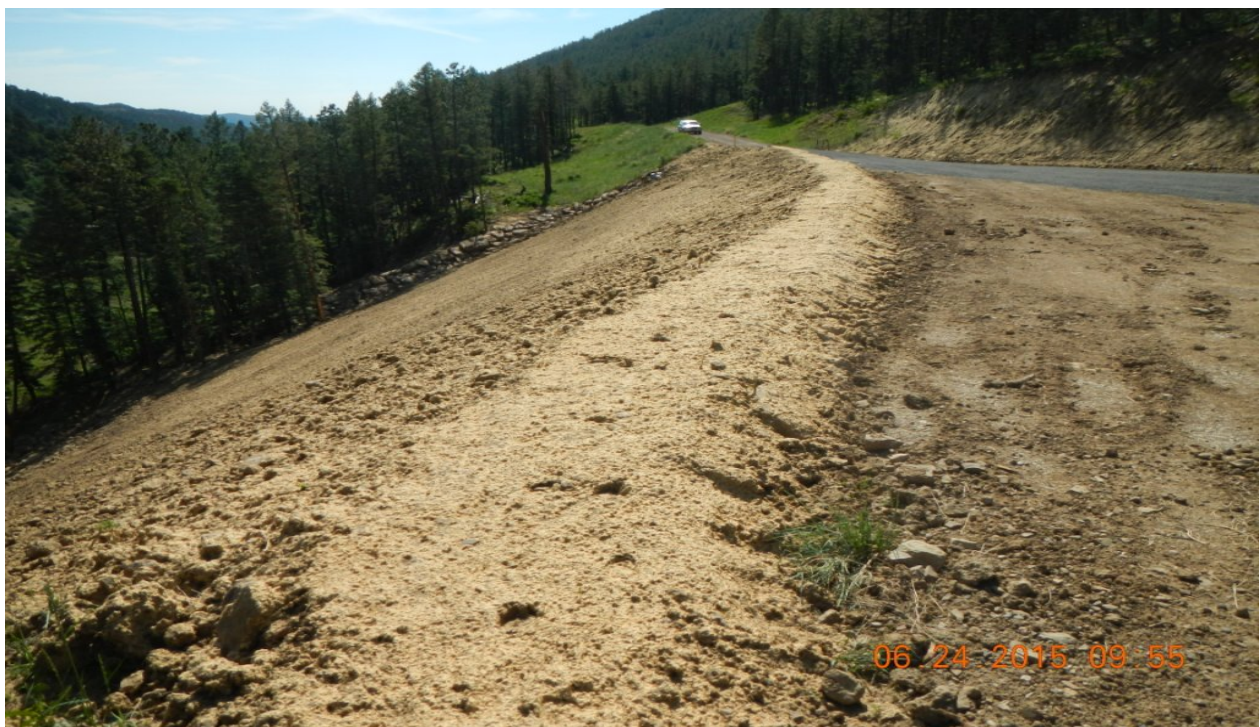
photo 6: Northwest corner of the location facing east. Slope has recently been hydro mulched/seeded.

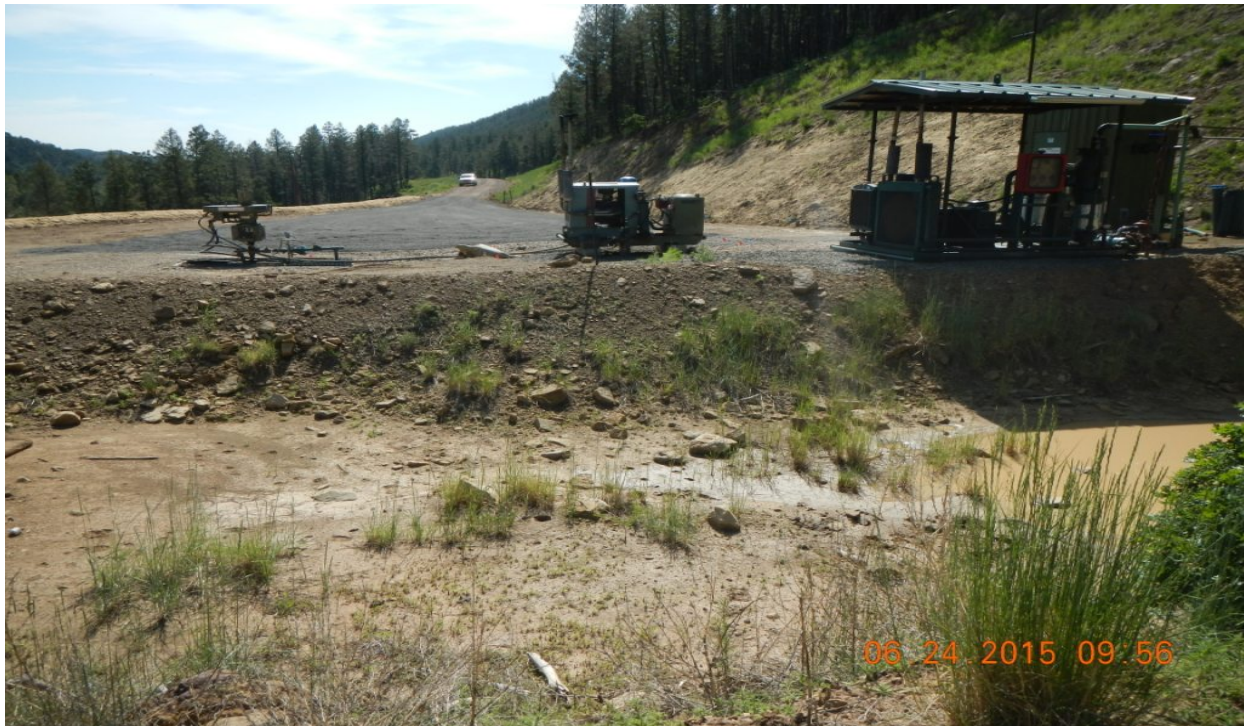
photo 7: West side of the location facing east.

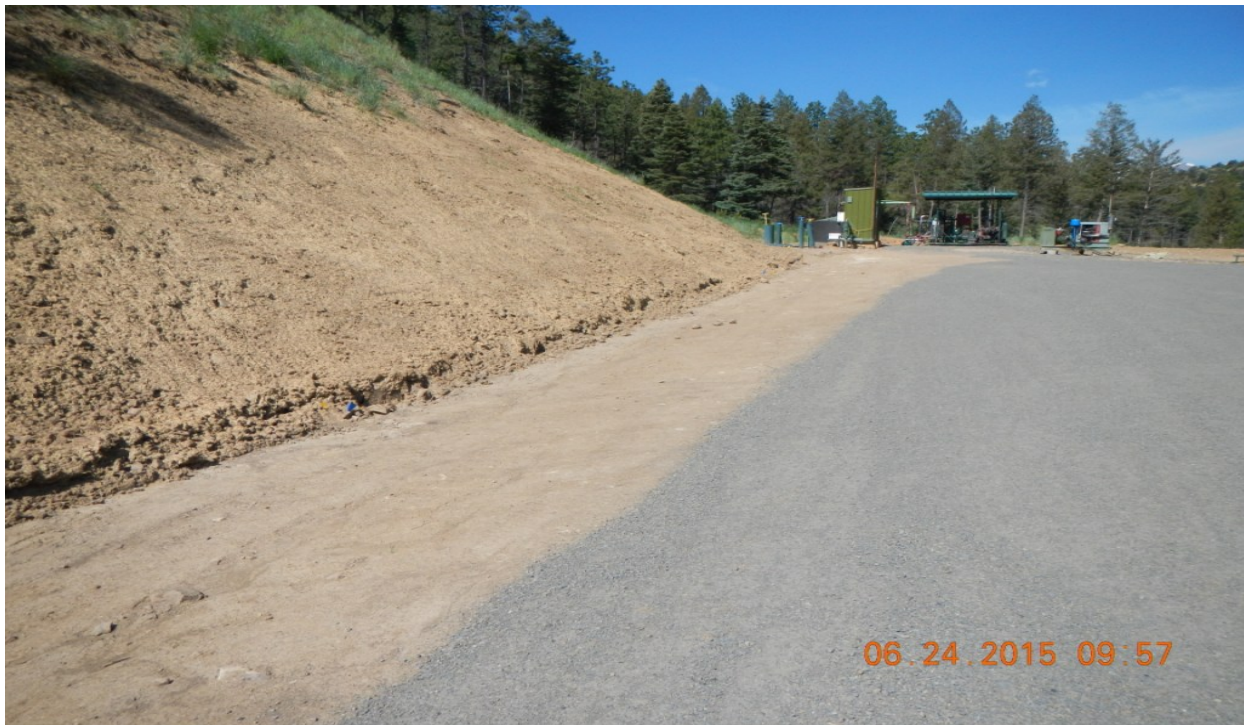
photo 8: Slope along the south side of the location has been hydro mulched/seeded.

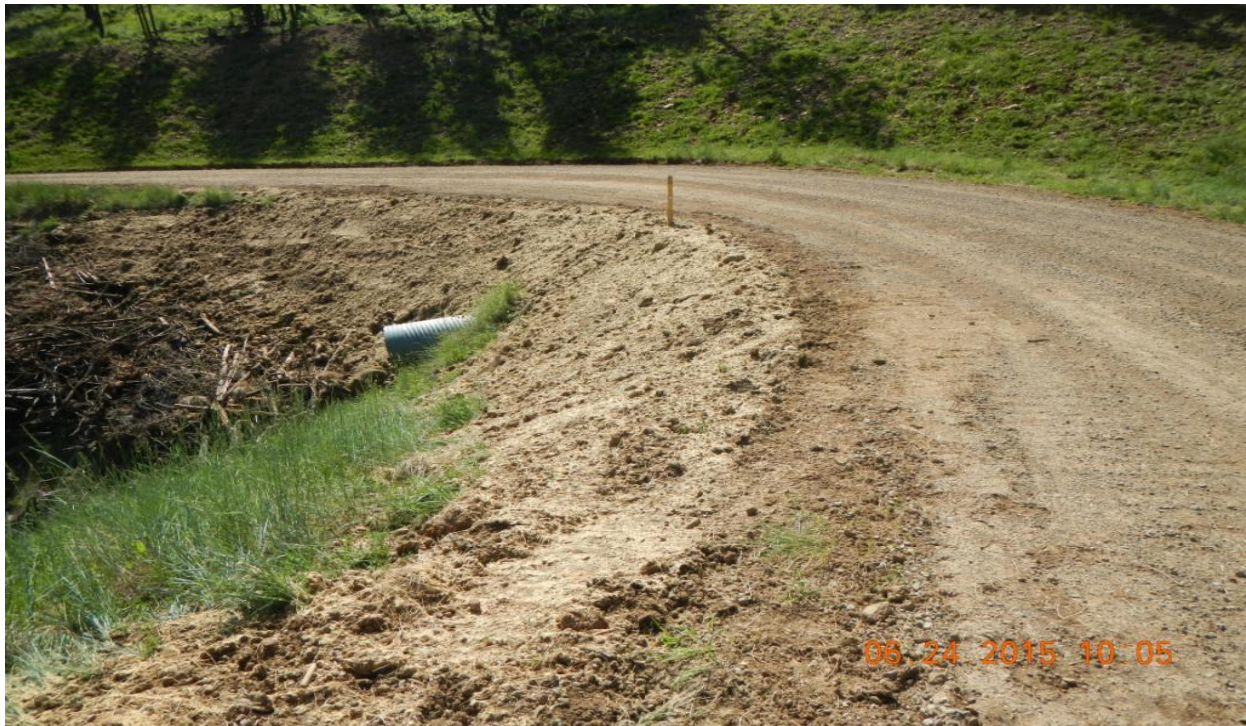
photo 9: Areas along the access road have recently been hydro mulched/seeded.

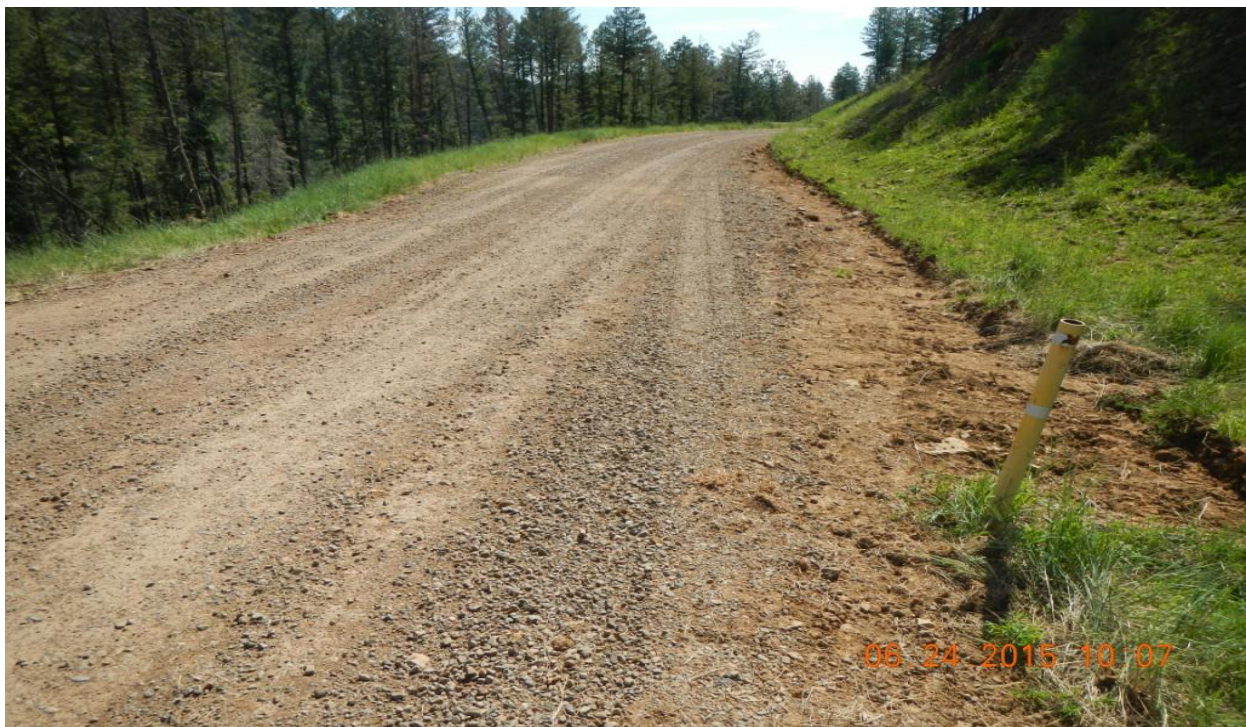
photo 10: The access road has recently been graded.
