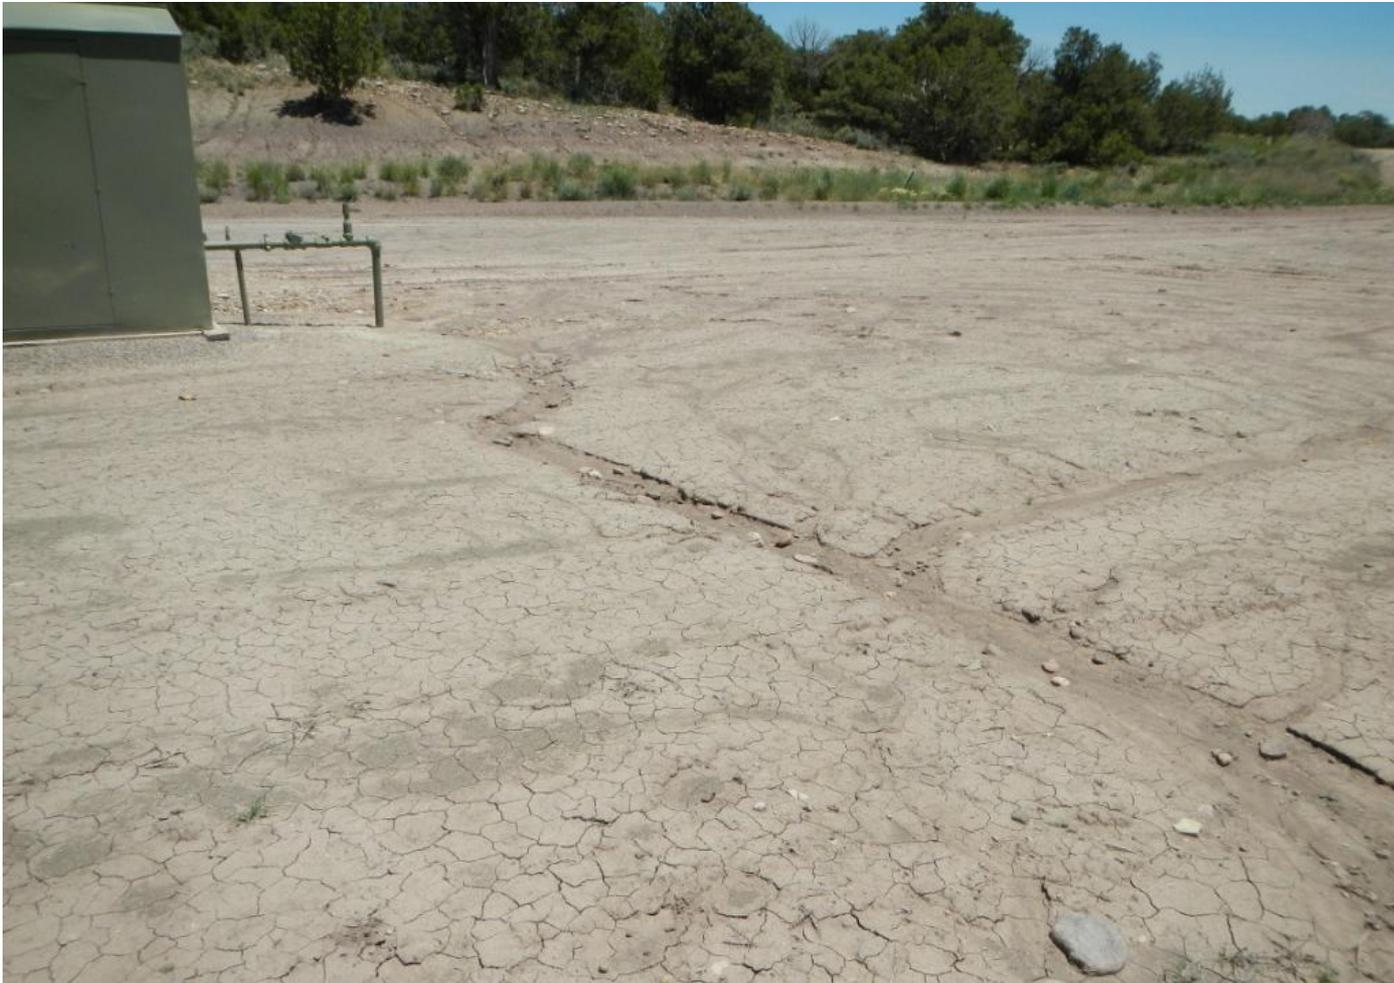
Photo 1. View of erosional channel forming within the well pad and flowing toward the southwestern portion of the project area.

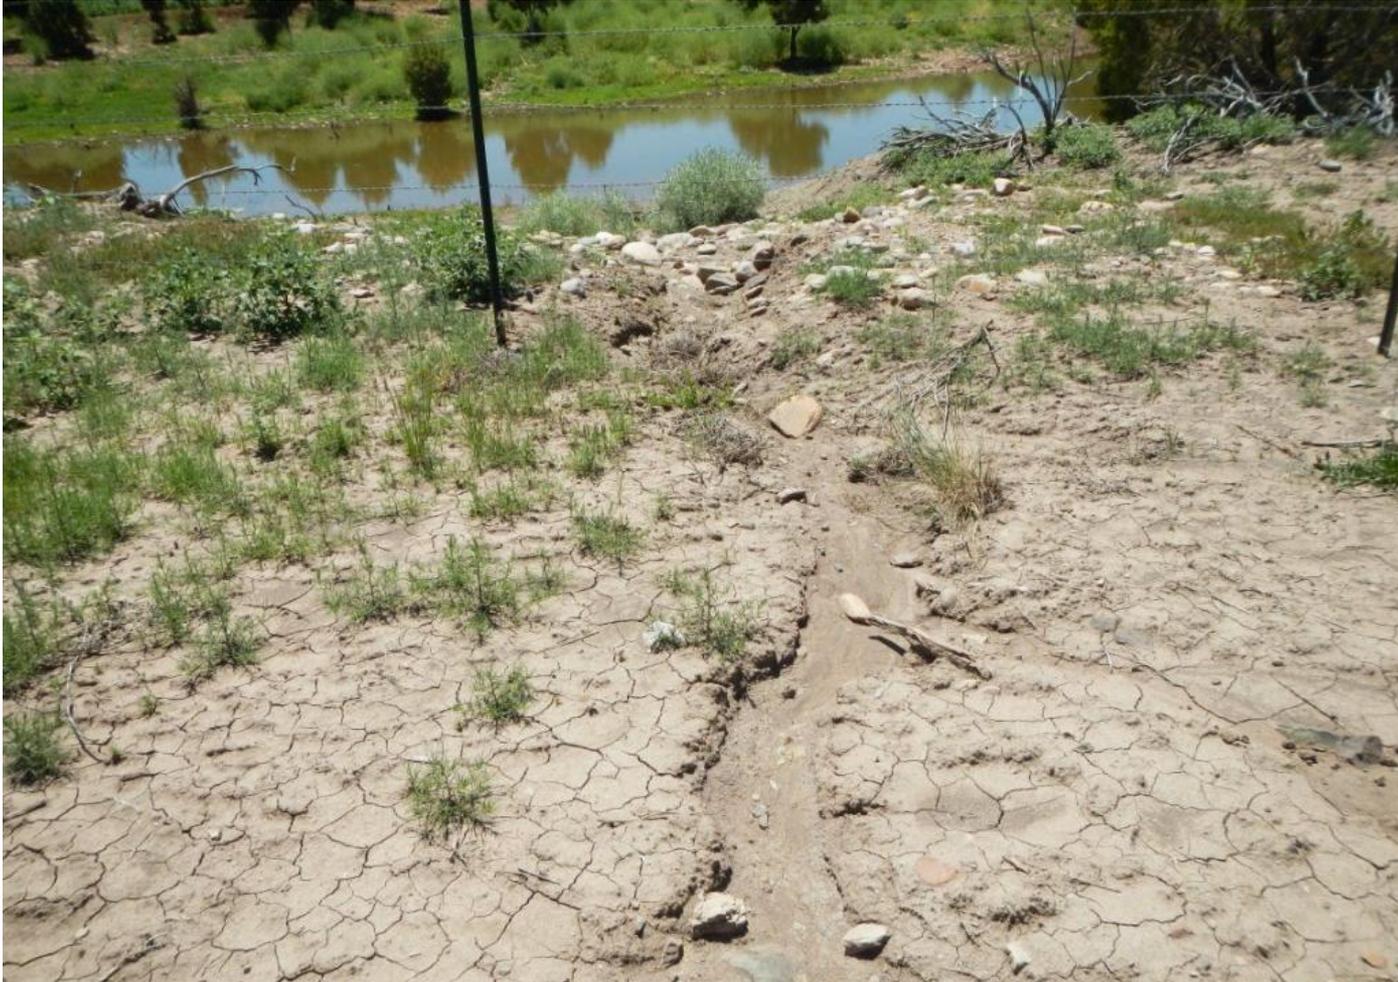
Photo 2. View of erosional channel, downstream from Photo 1. Erosional channel flows off of the project area directly to open water.

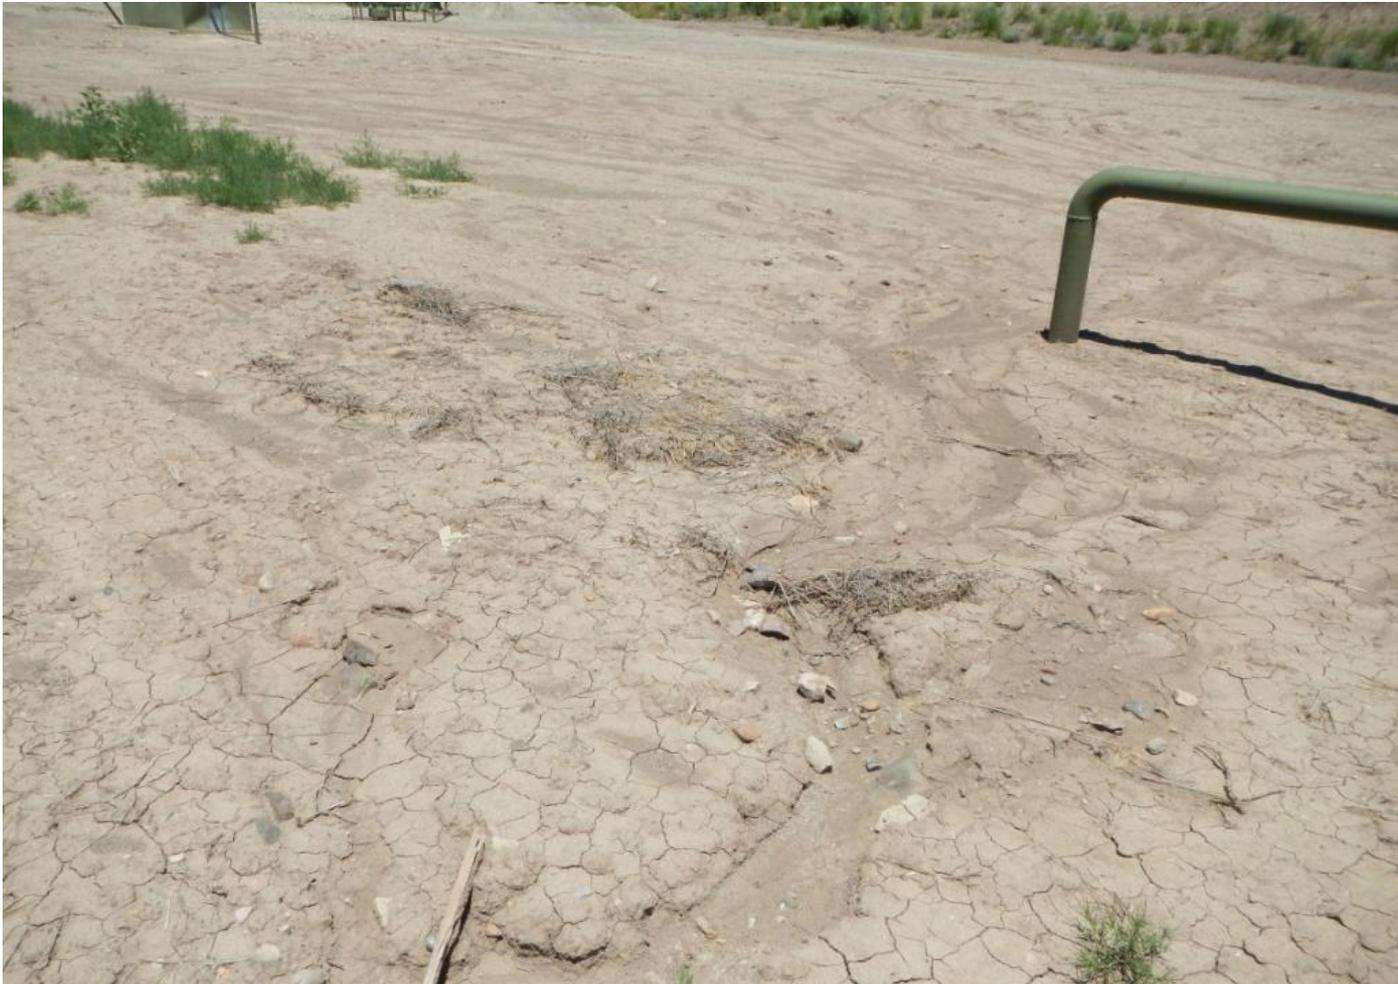
Photo 3. View of another erosional channel forming on well pad where concentrated stormwater flows off of the project area.

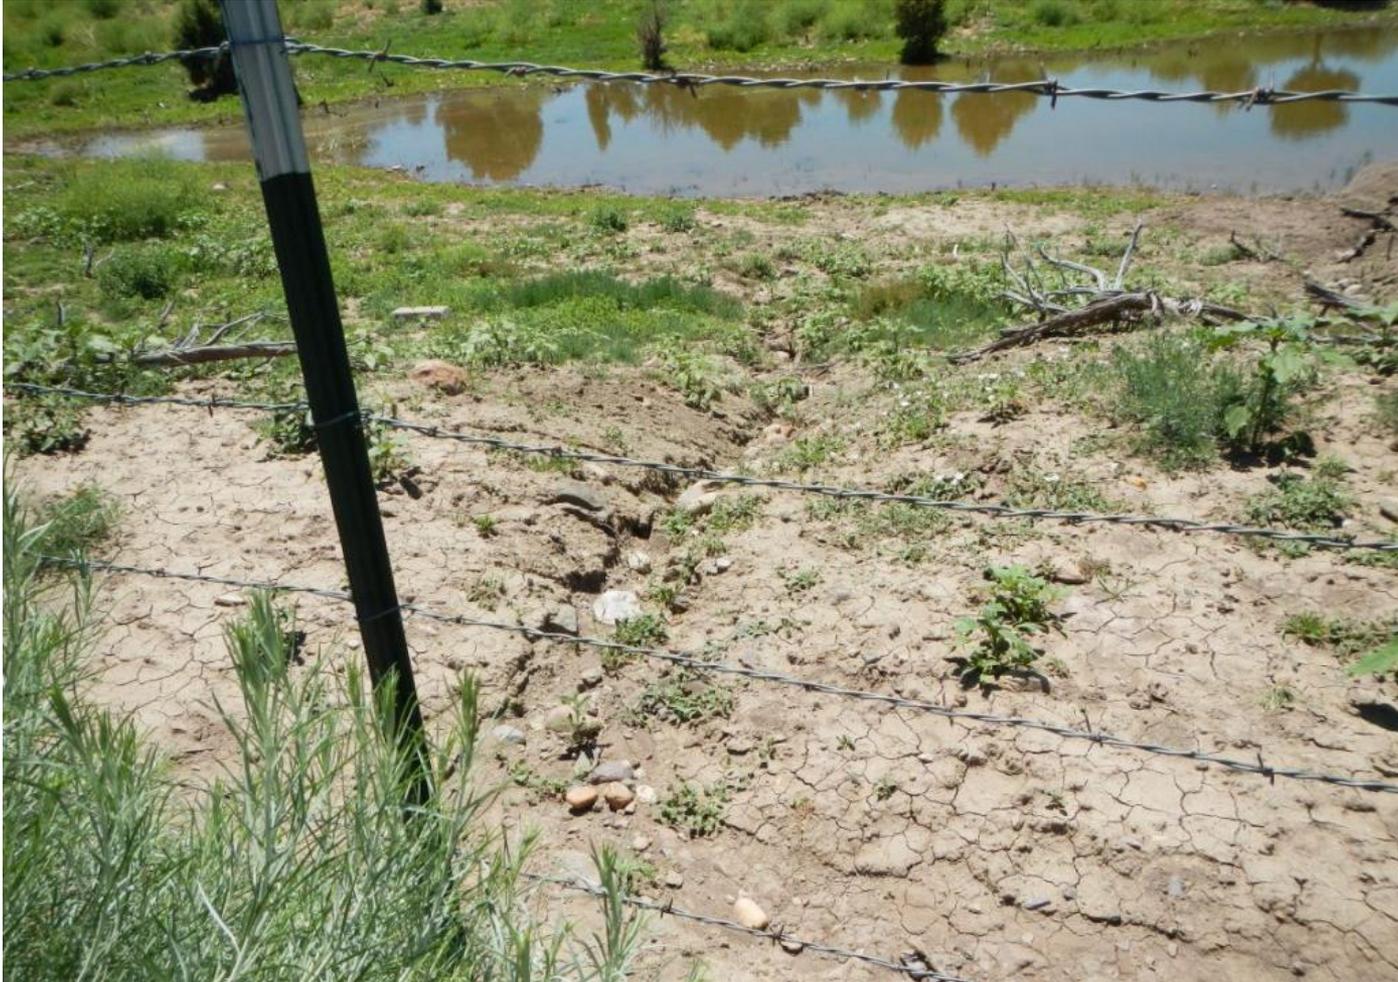
Photo 4. View of erosional channel downstream of Photo 3, where stormwater channel flows toward open water.

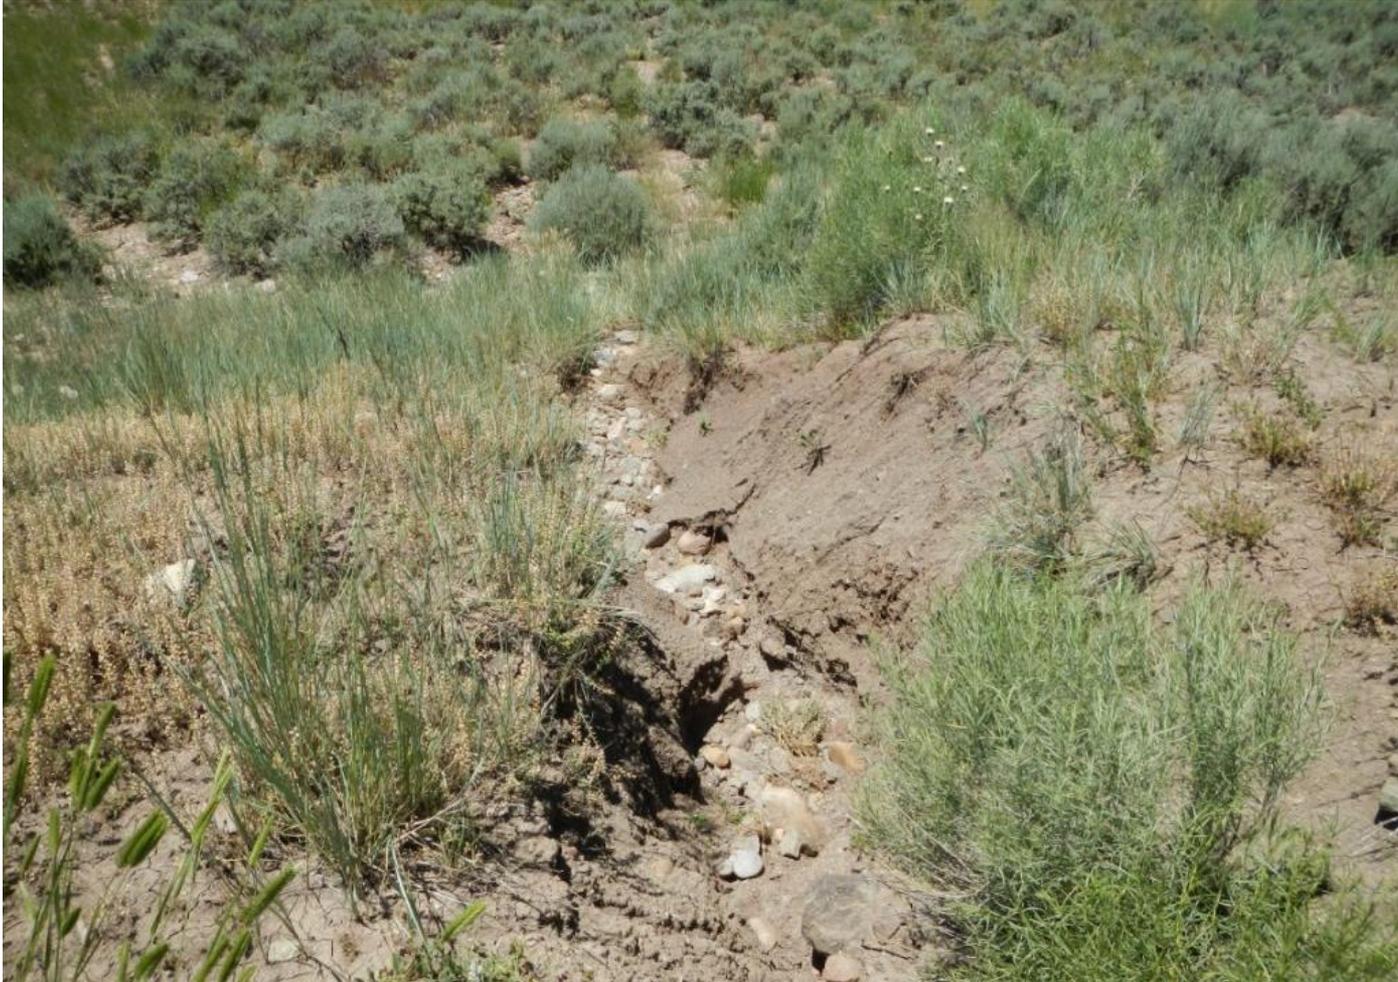
Photo 5. View of a gully (approximately 5 feet wide and 5 feet deep) forming within the western portion of the project area.

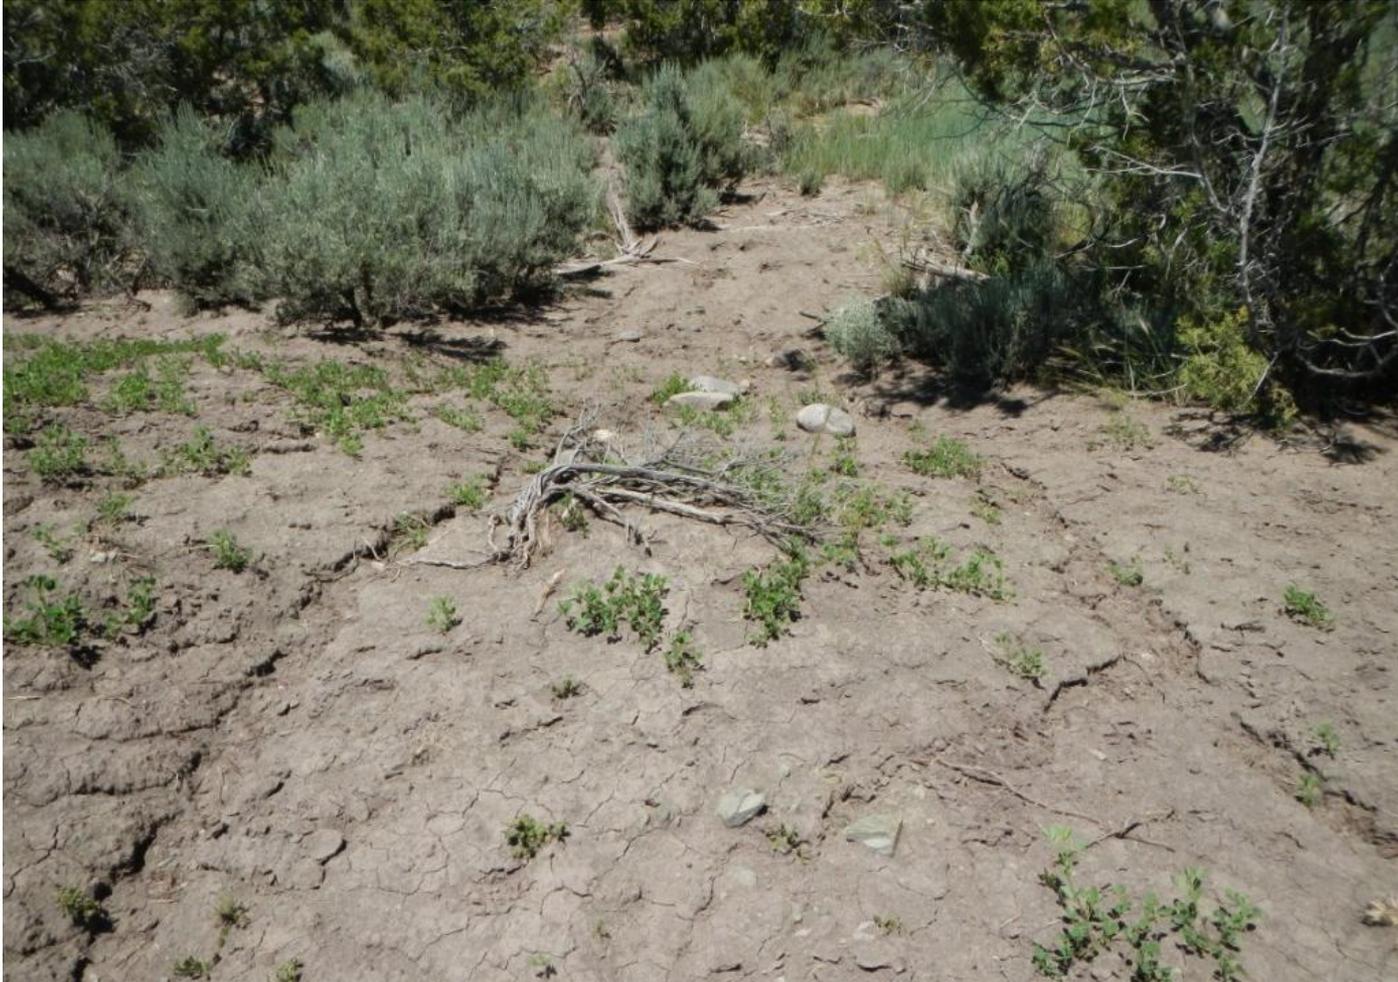
Photo 6. View of rill erosion within northern portion of project area (facing downslope). Evidence of sediment deposition at the toe of the slope area can be seen in background of photo.

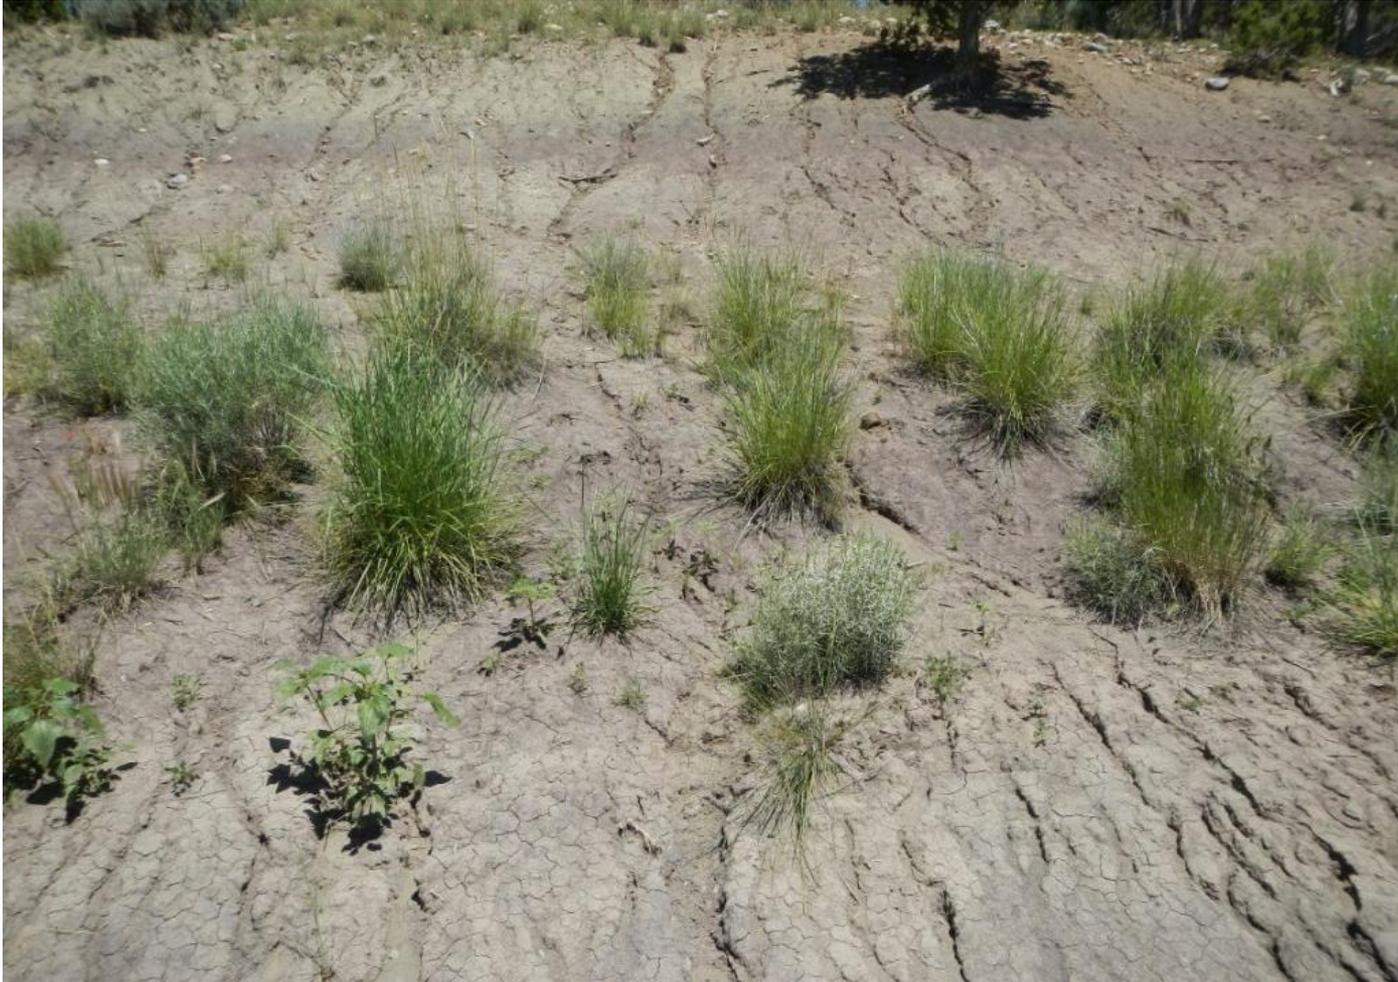
Photo 7. View of rill erosion within the eastern portion of the project area. Deep rills and significant sediment deposition at the toe of the slope are evidence that cut-slopes are not sufficiently stabilized.

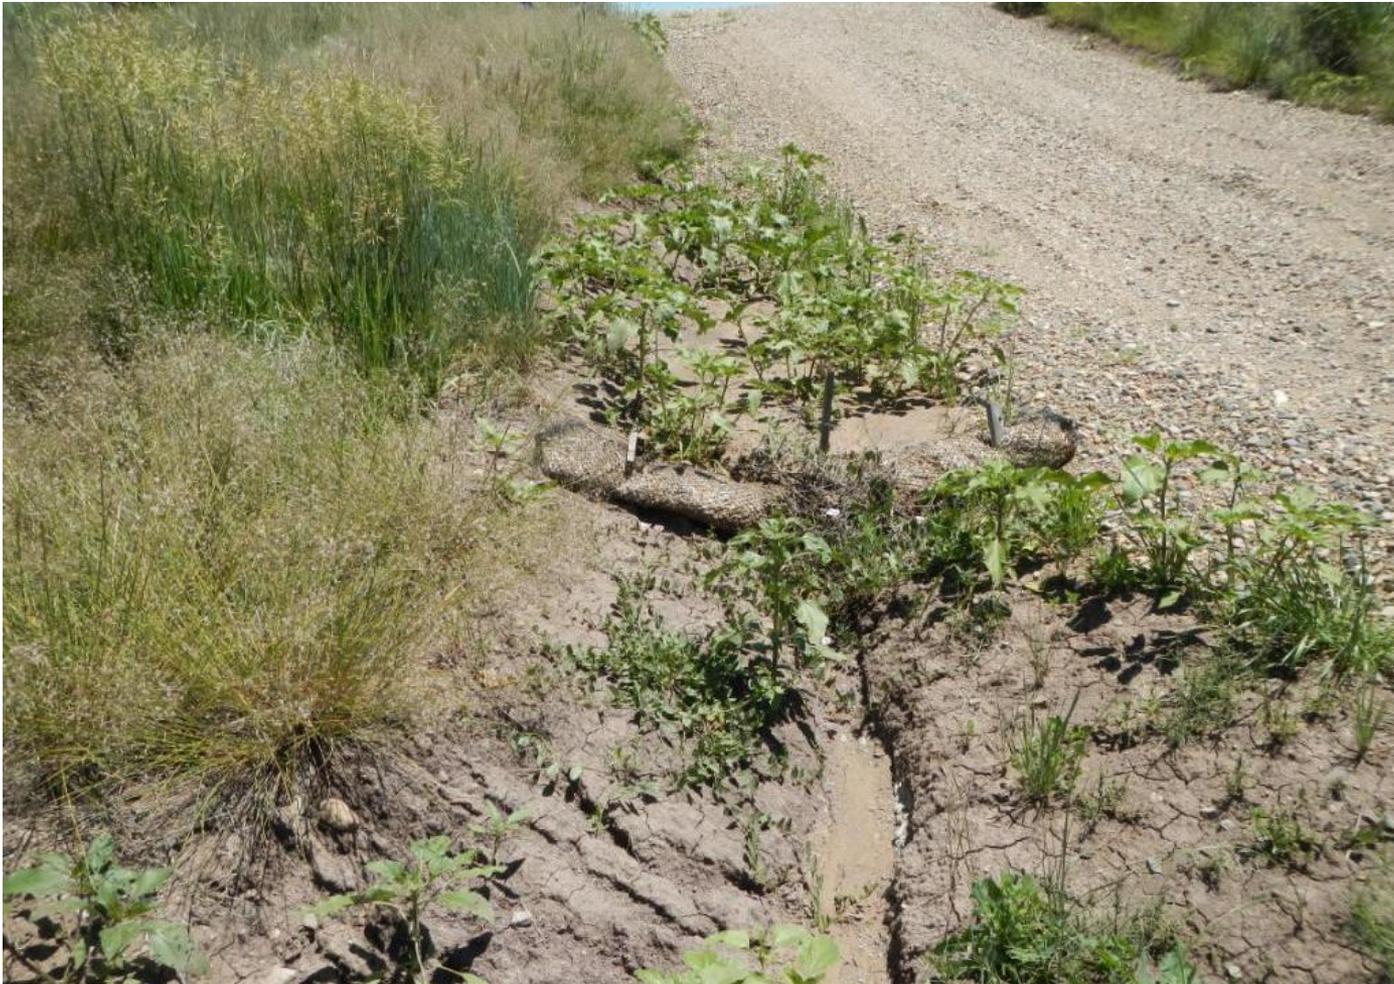
Photo 8. View of straw wattle along access road that is filled with sediment. It doesn't appear that this single straw wattle is a sufficient BMP to contain sediment flows along the access road.

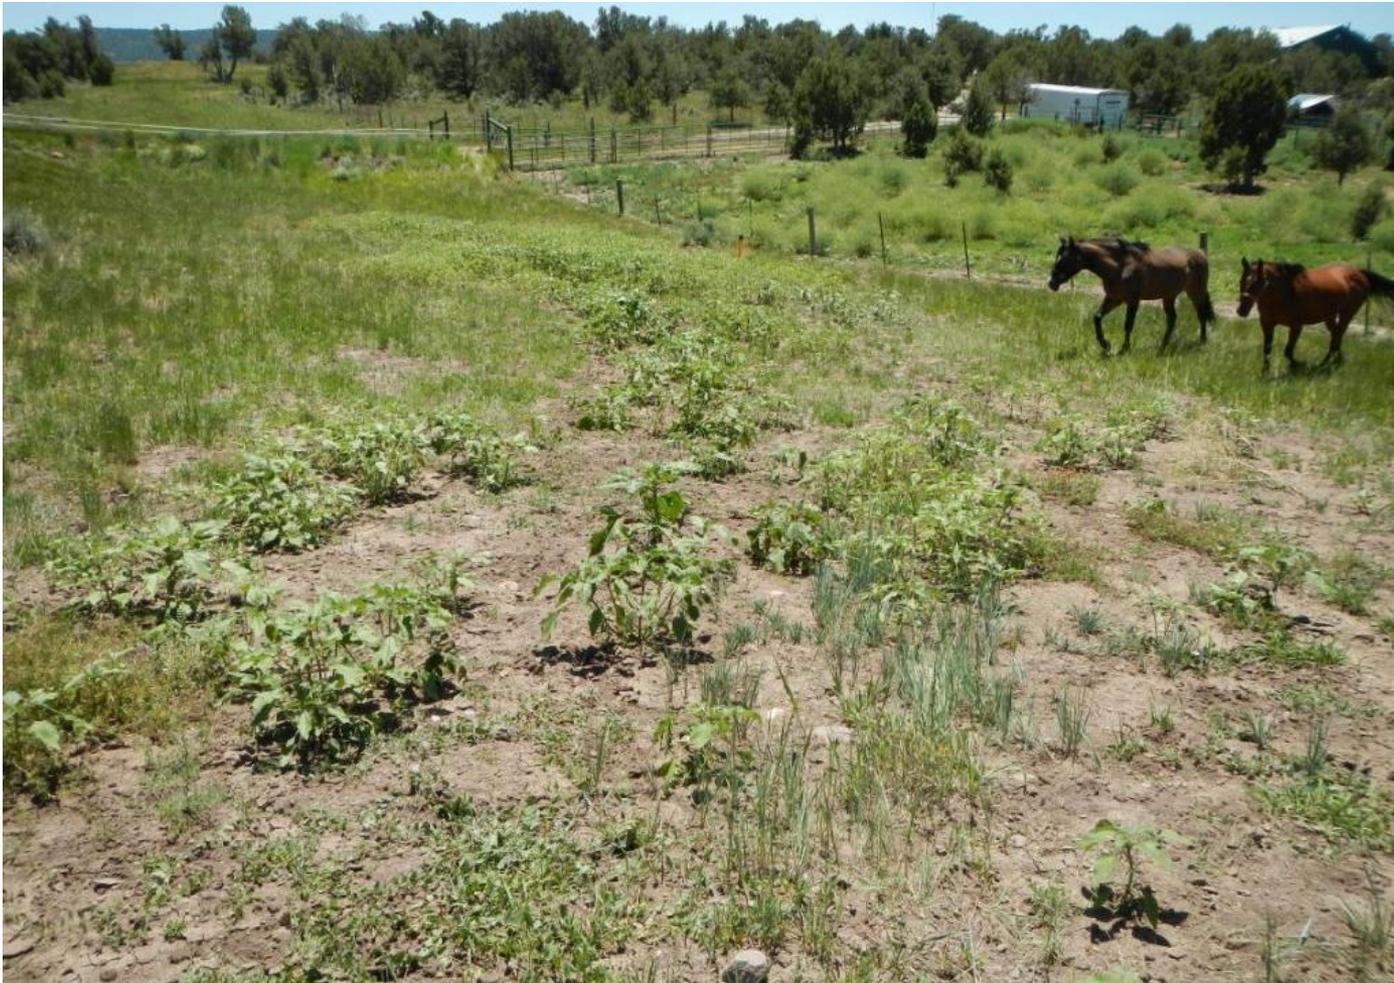
Photo 9. View of area south of well pad where subsidence over the flowline was recently repaired. Grasses such as western wheatgrass (*Pascopyrum smithii*) and ruderal species such as annual sunflower (*Helianthus annuus*) and field bindweed (*Convolvulus arvensis*) are becoming established here.
