photo 1: New Elk 30-03

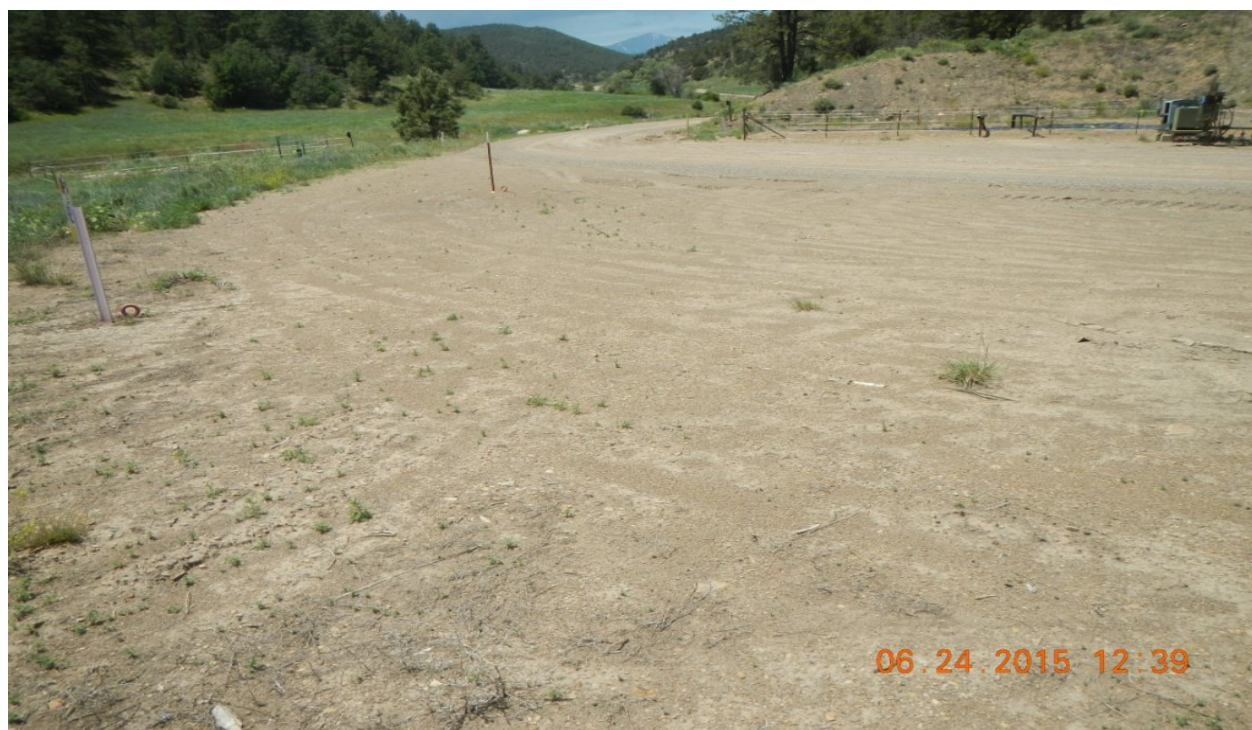
photo 2: Facing west towards the location. Area between the road has no vegetation growth.

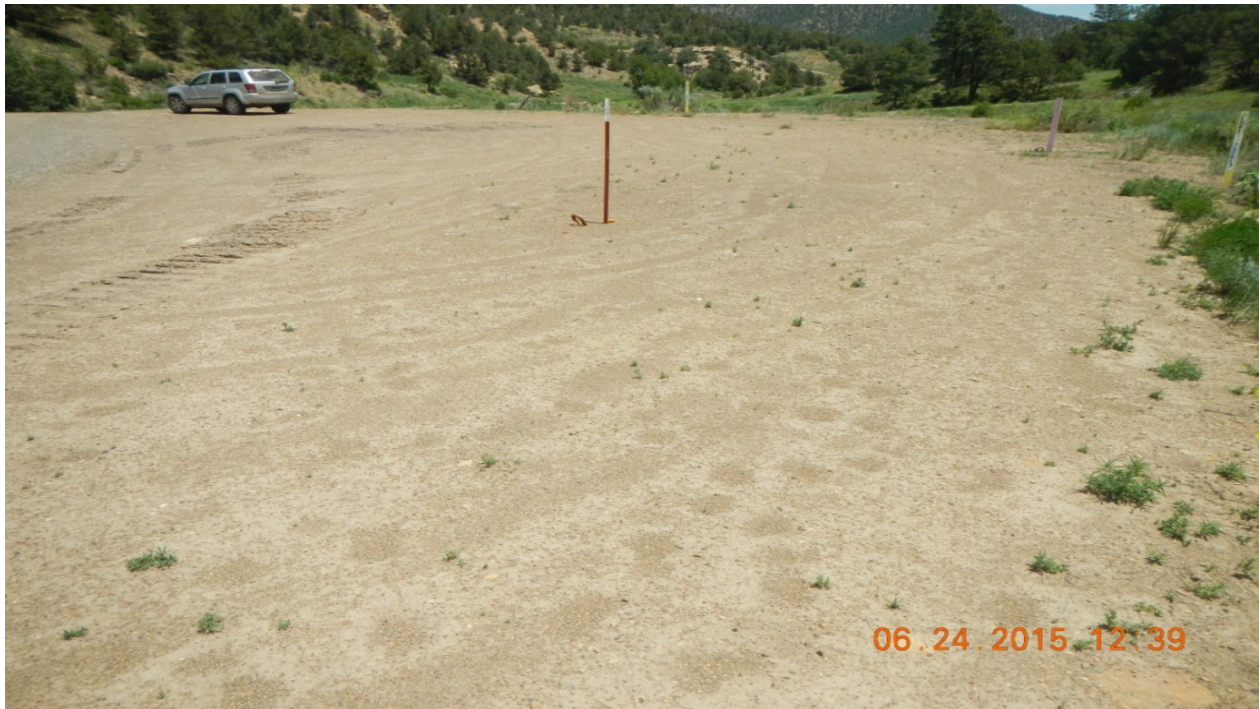
photo 3: Facing east towards the south side of the location which is not revegetated and is susceptible to erosion.

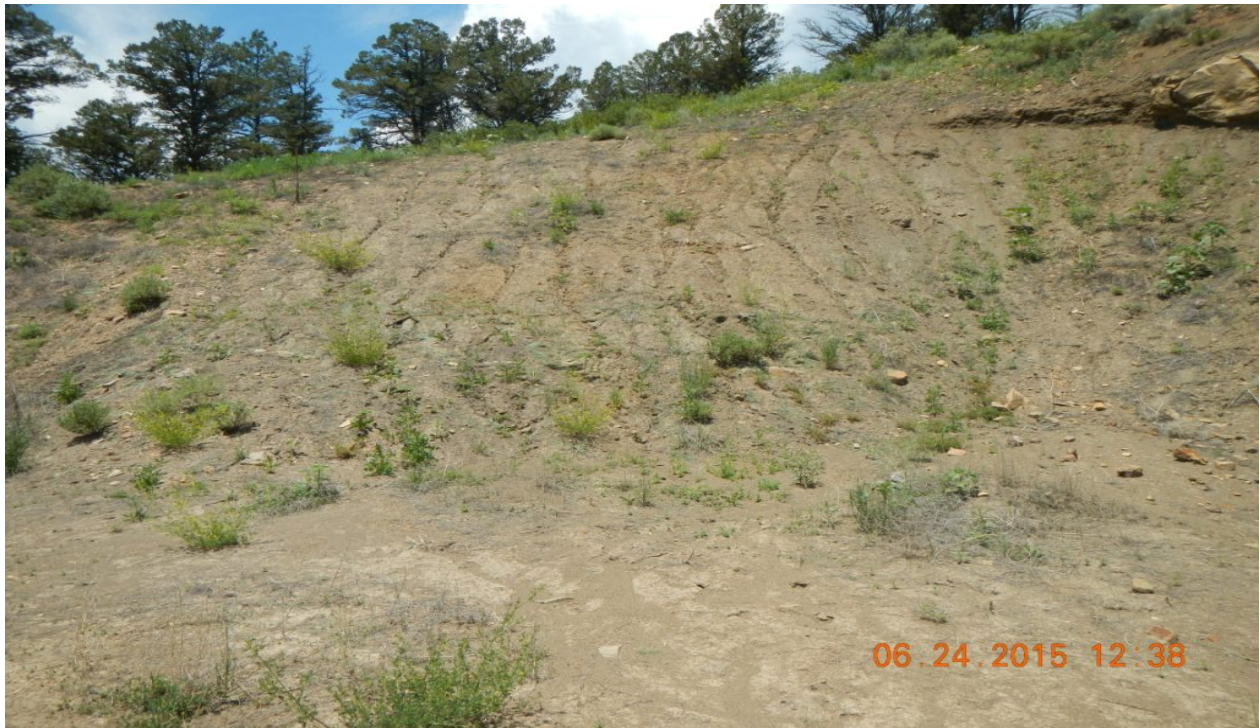
photo 5: Northwest side of the location has minimal vegetation growth and shows signs of erosion.

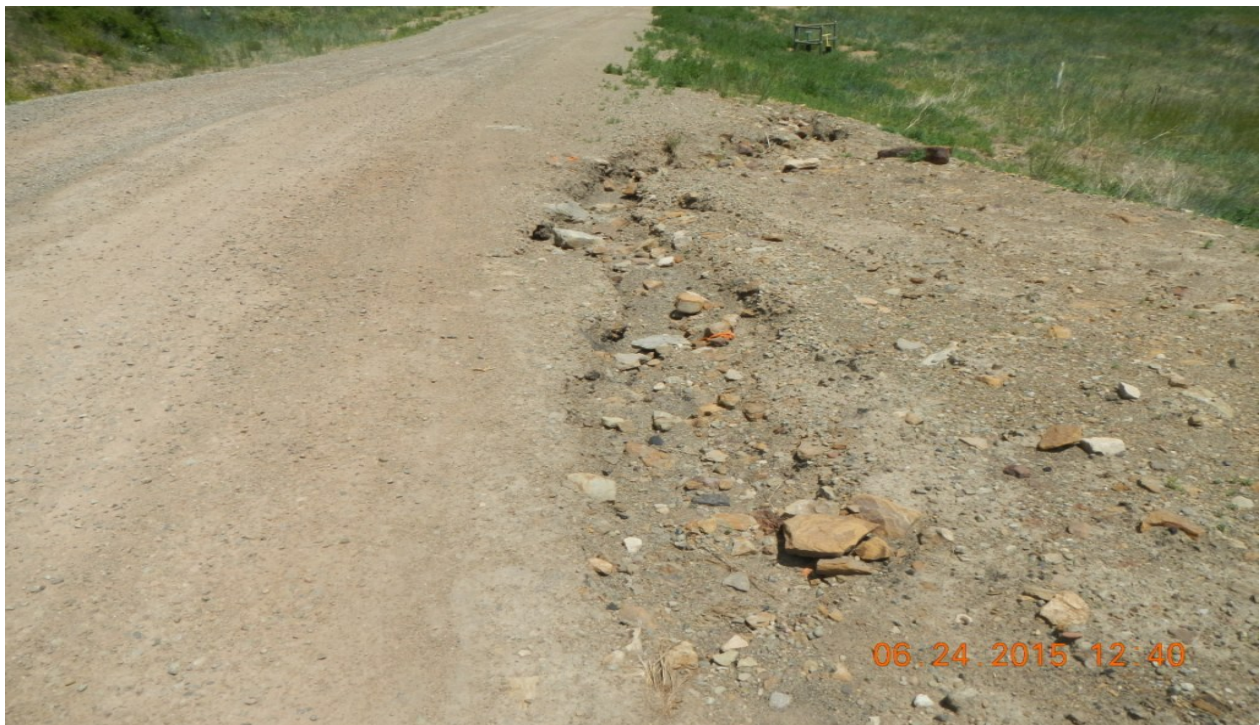
photo 6: Northeast side of the location along the access road where erosion channel has developed.

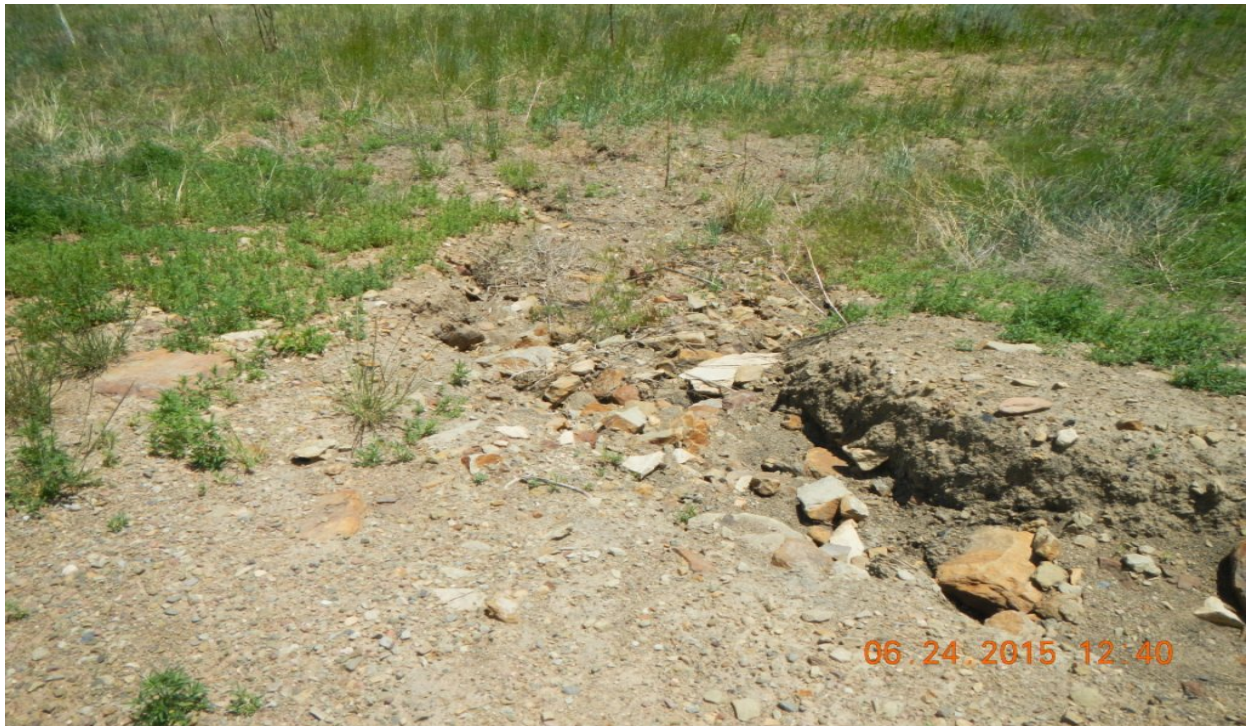
photo 7: Erosion at the east side of the location is transporting sediment out into the pasture.
