Surprise Unit 2-08H

Inspection# 673402219

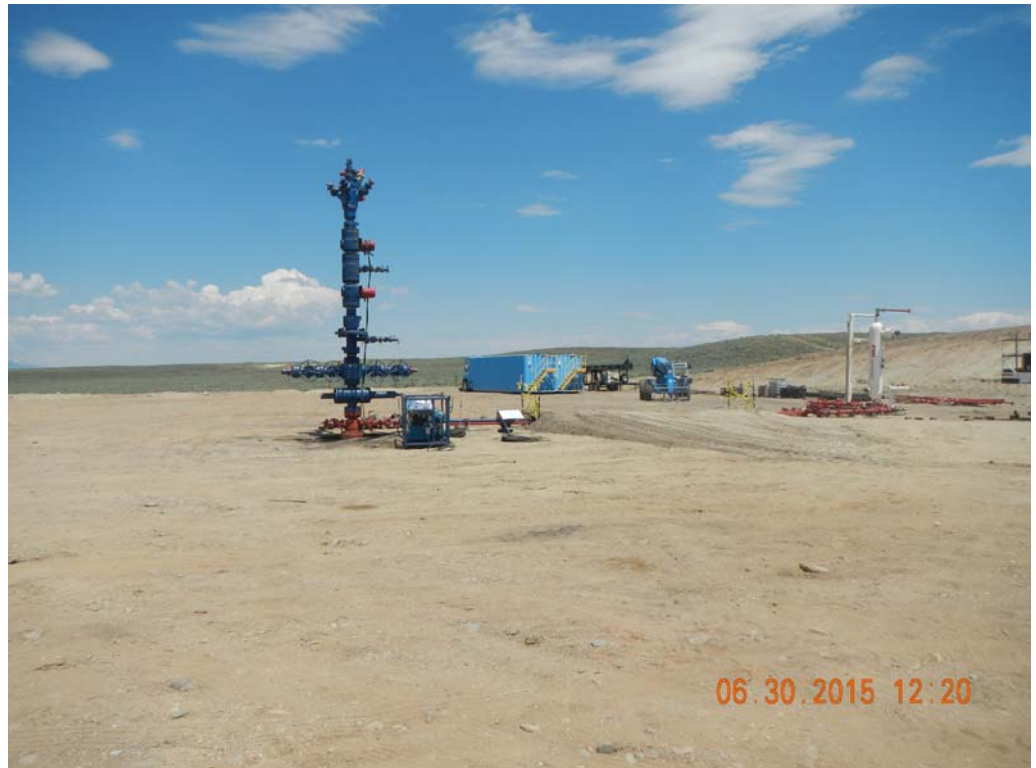
Frack tree on wellhead, 2 frack tanks, 1 light tower, 1 sand catcher. Iron has been connected to wellhead and dirt moved to create ramp over pipes.

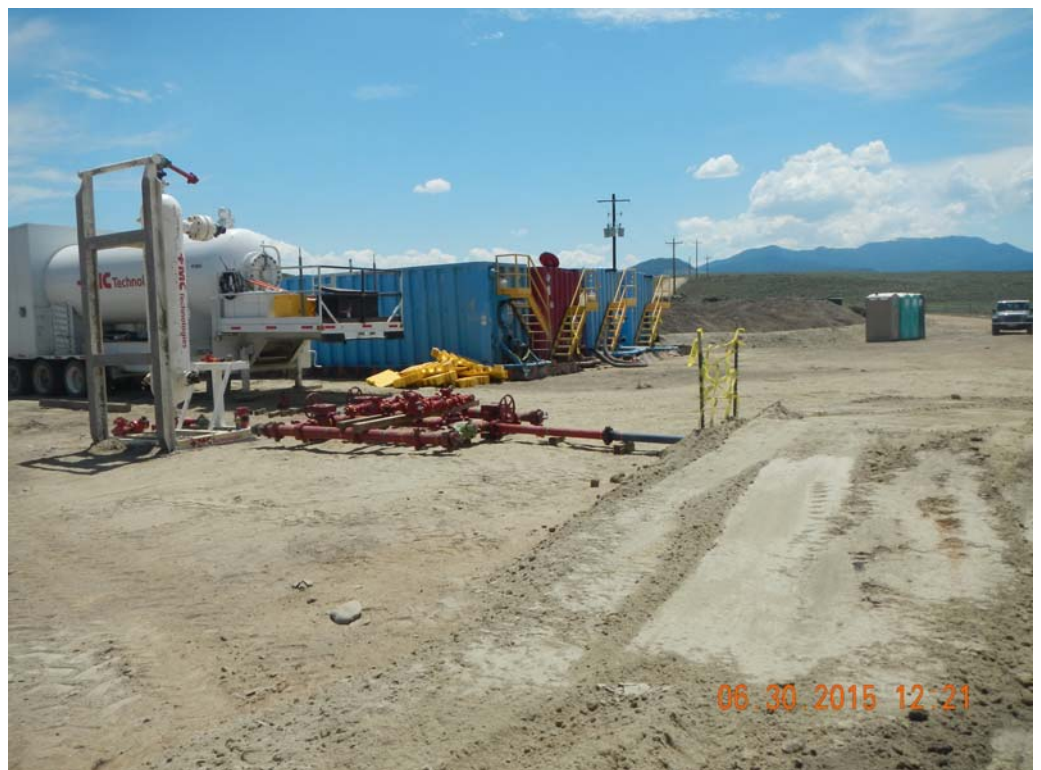
2 Sand catcher, 4 frack tanks (6 total on location), 4 portapotties.

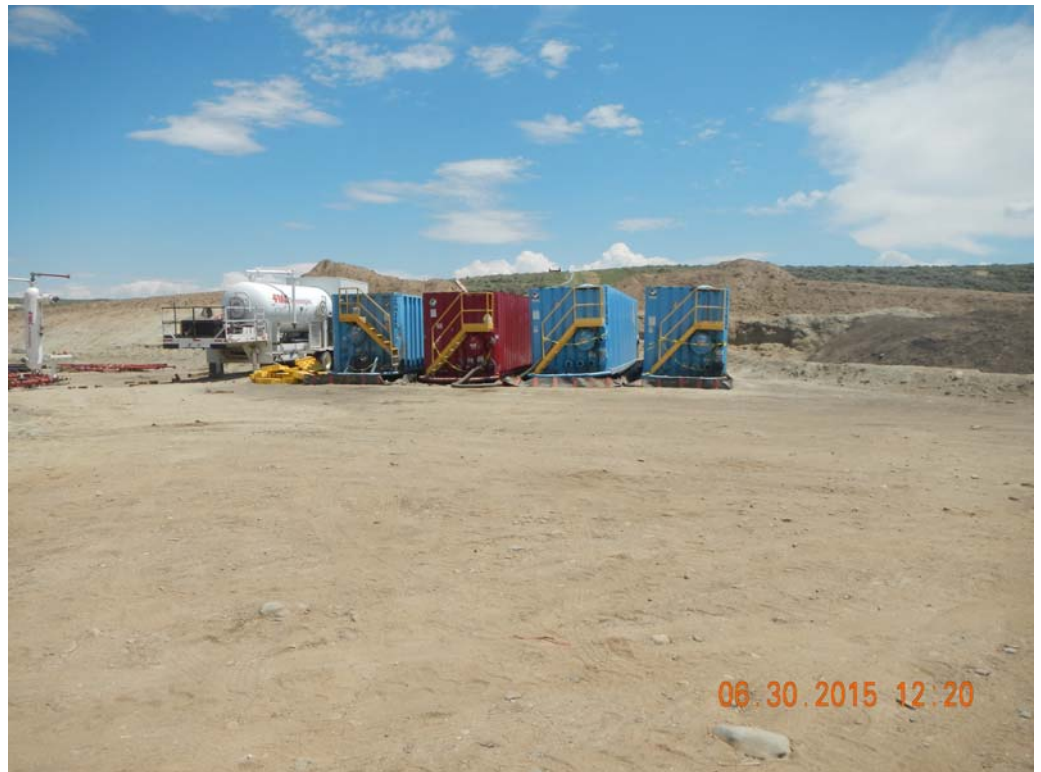
4 frack tanks, 2 sand
catchers

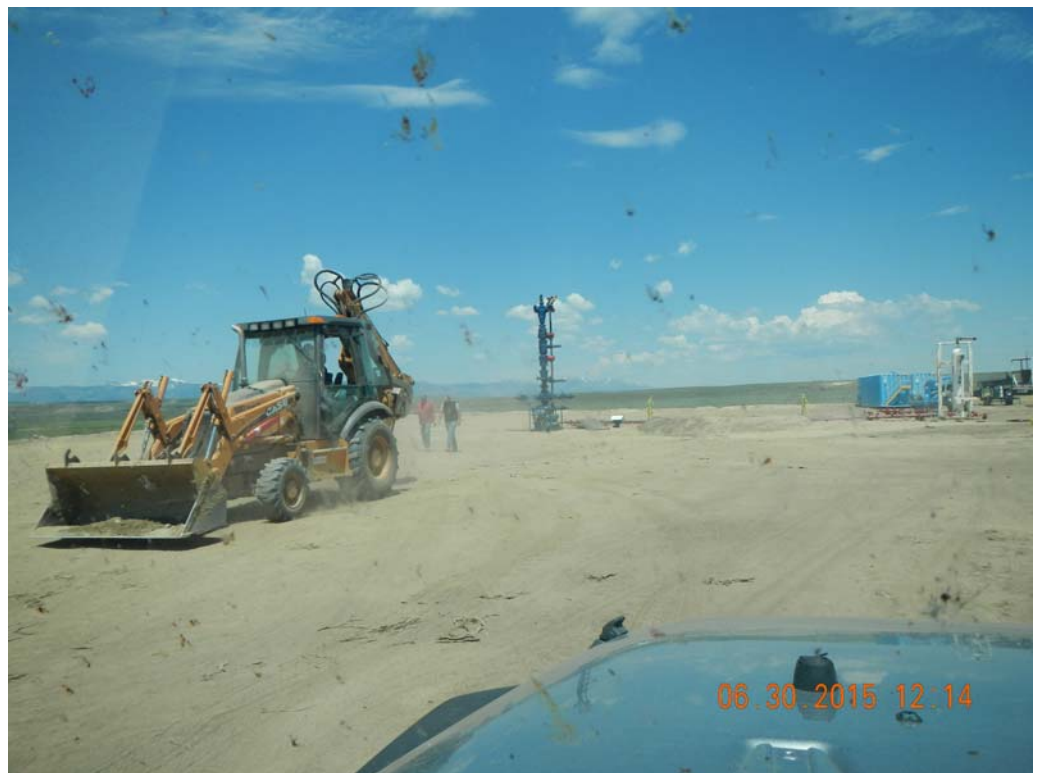
Backhoe and workers
leaving location upon arrival
of inspector.

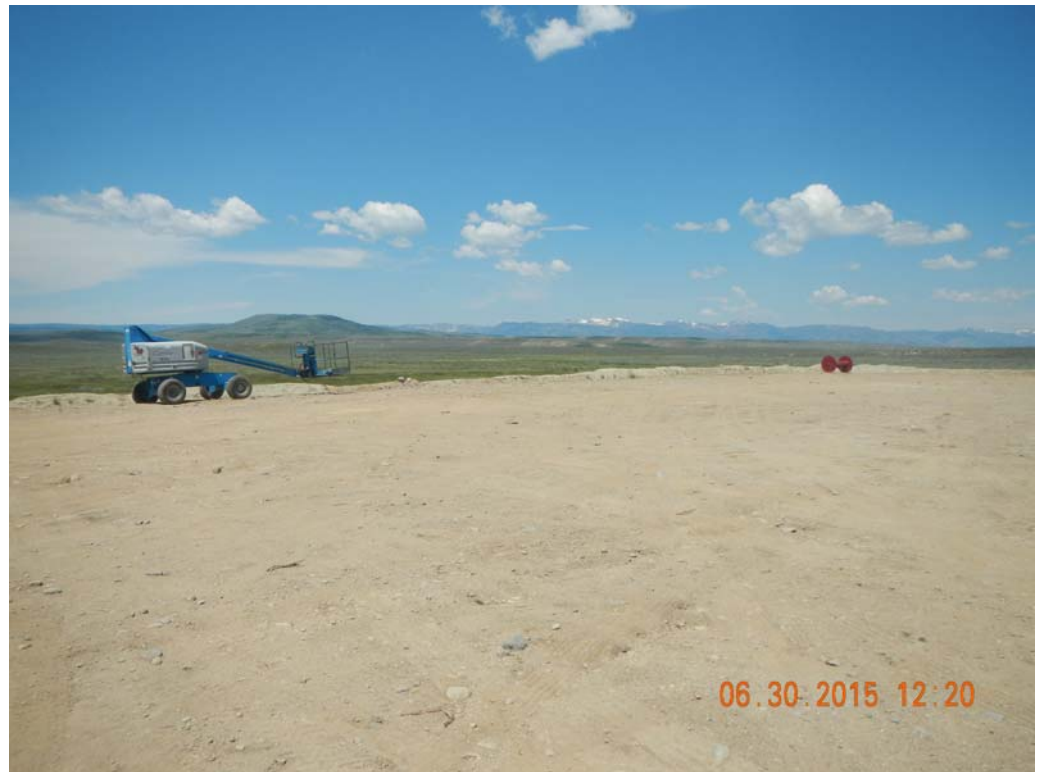
Man lift, hose rack, location
perimeter. No additional
downgradient perimeter
berming observed.

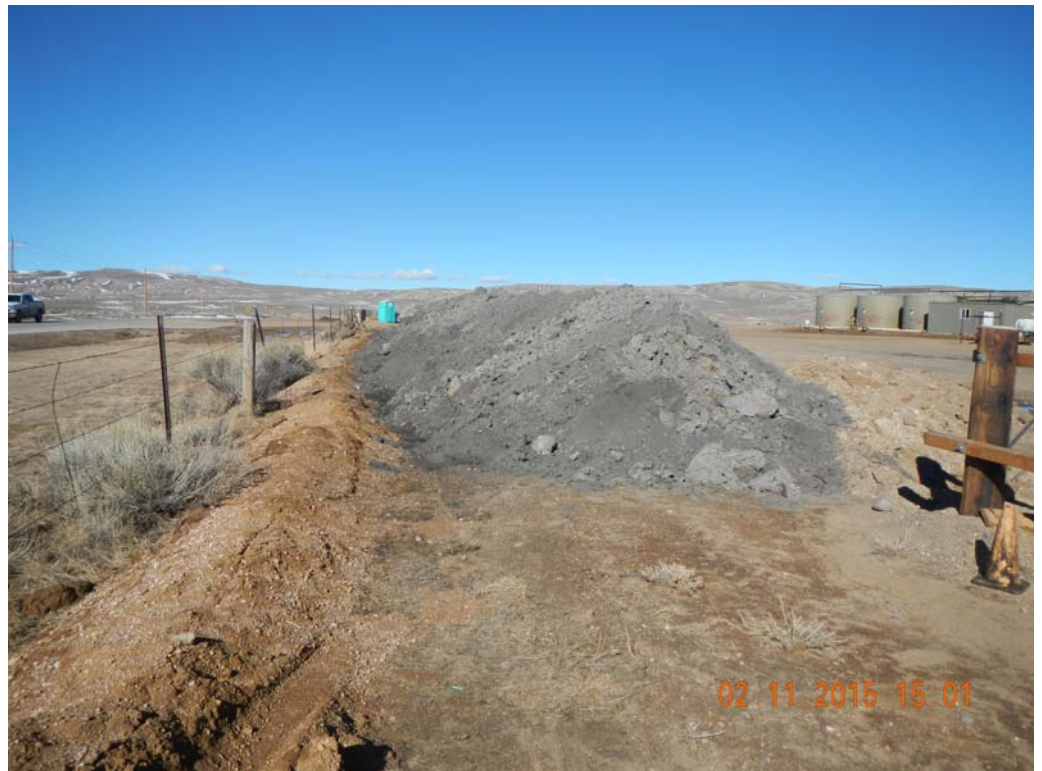
Cuttings with no berm.

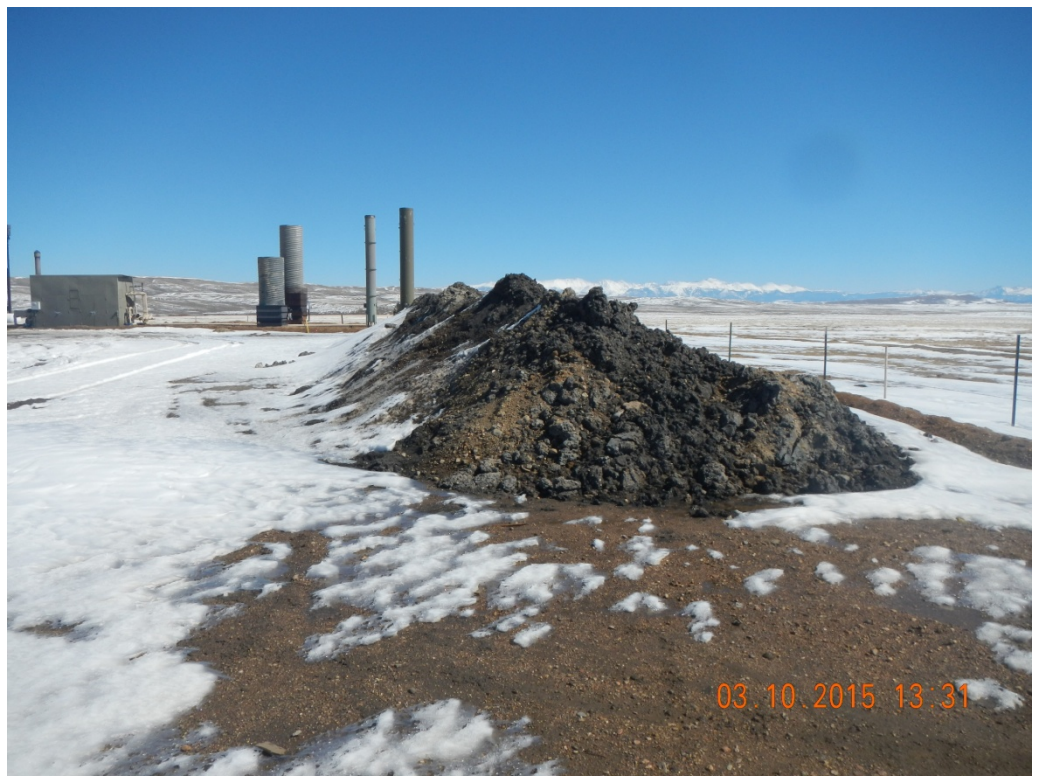
Cuttings with no berm.

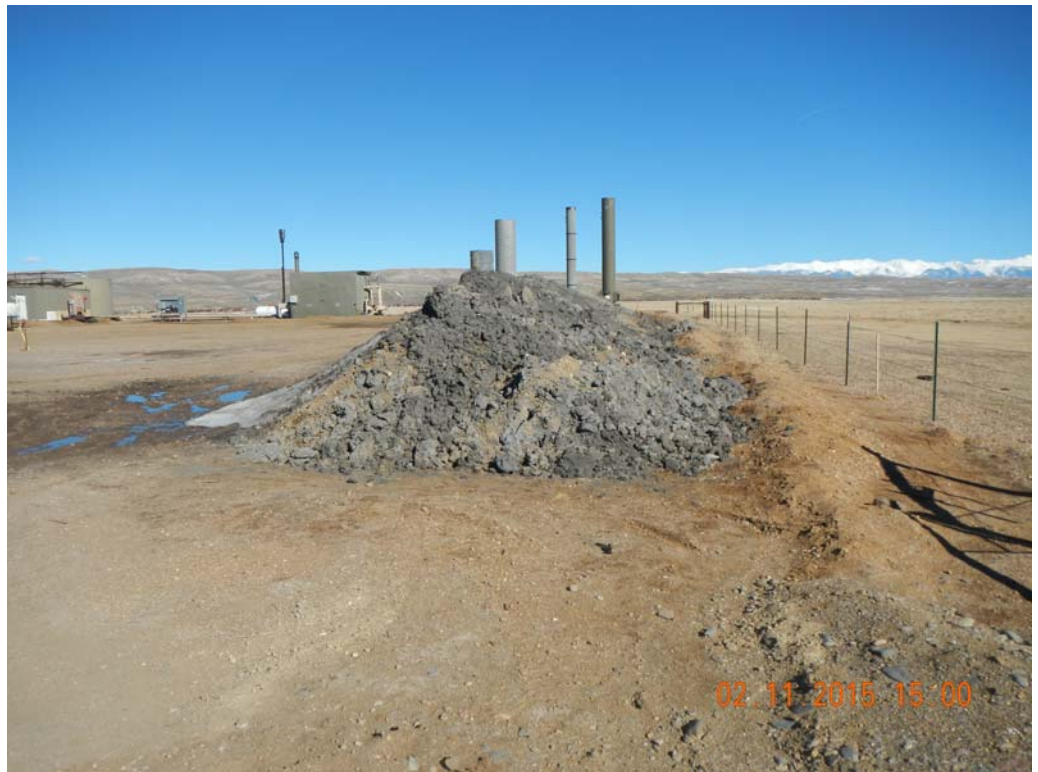
Cuttings with no berm.

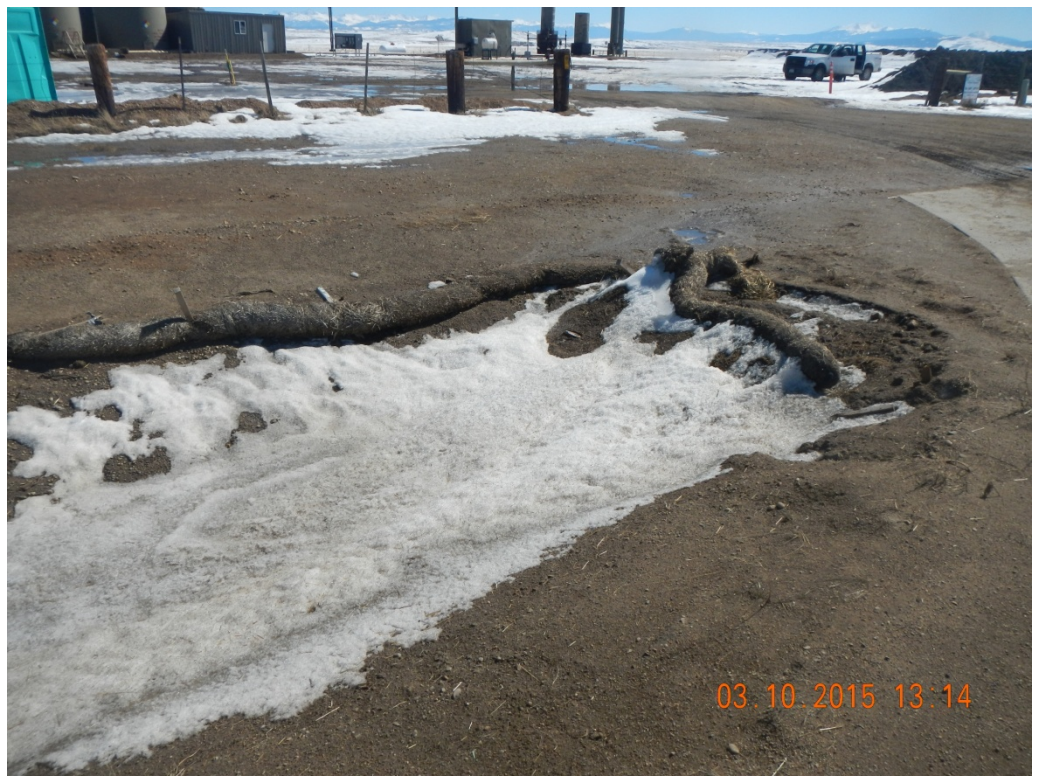
Waddles blocking culvert
at entrance.

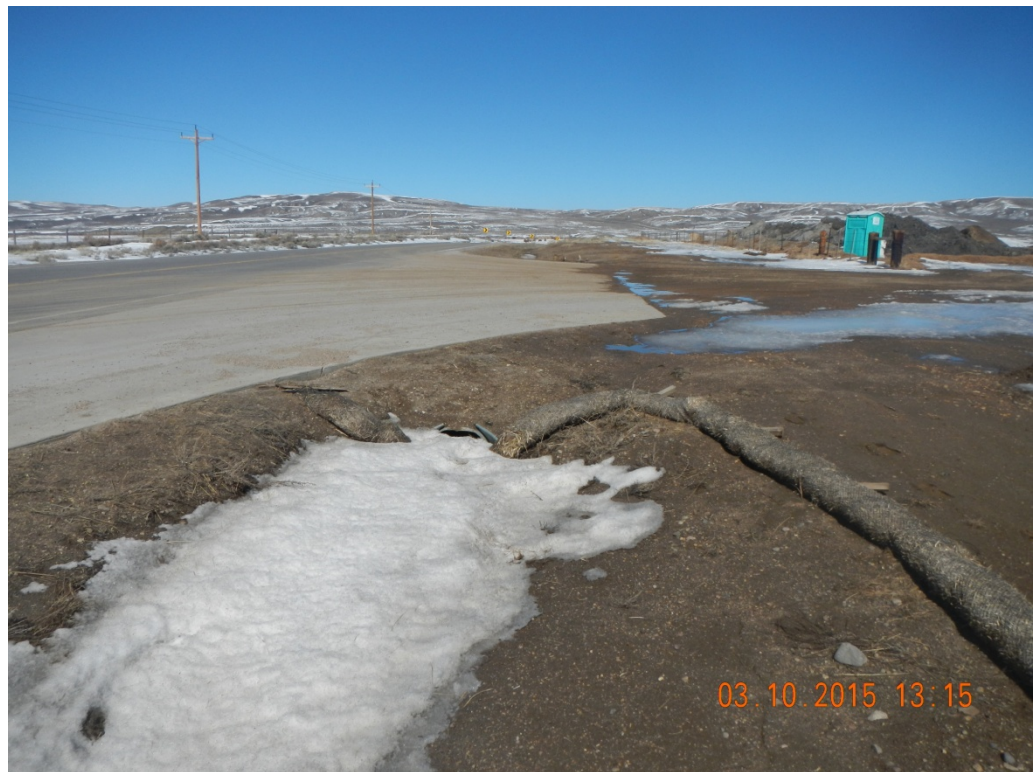
Waddles blocking culvert at entrance.

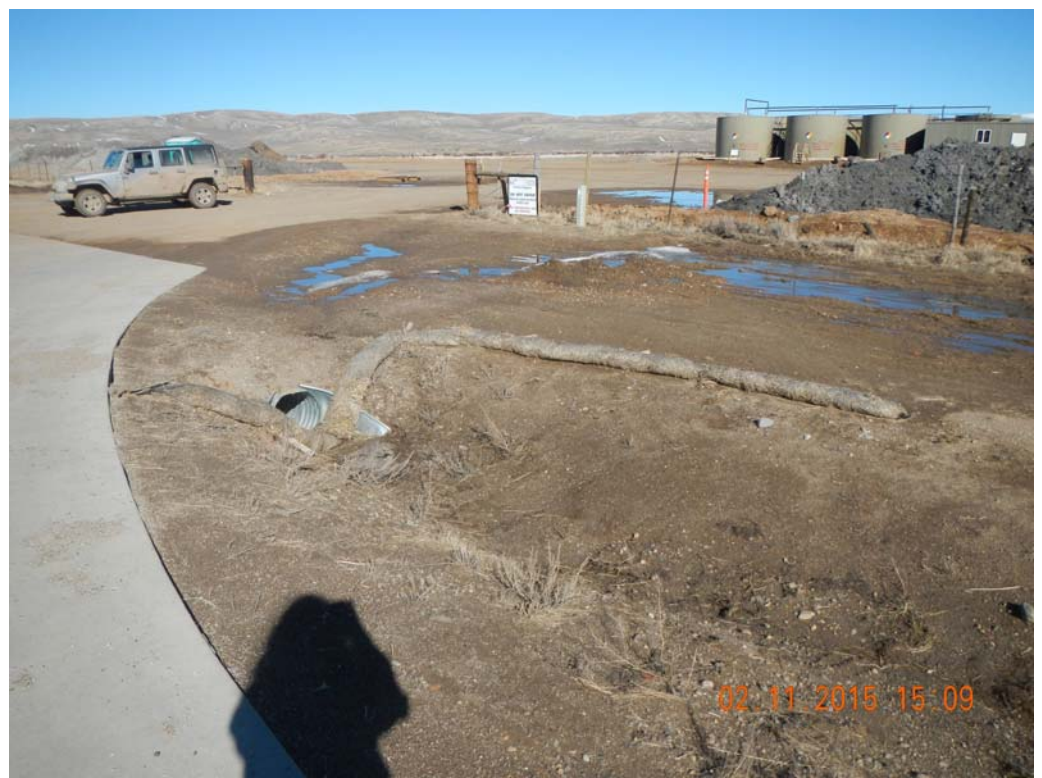
Waddles falling into culvert at entrance.

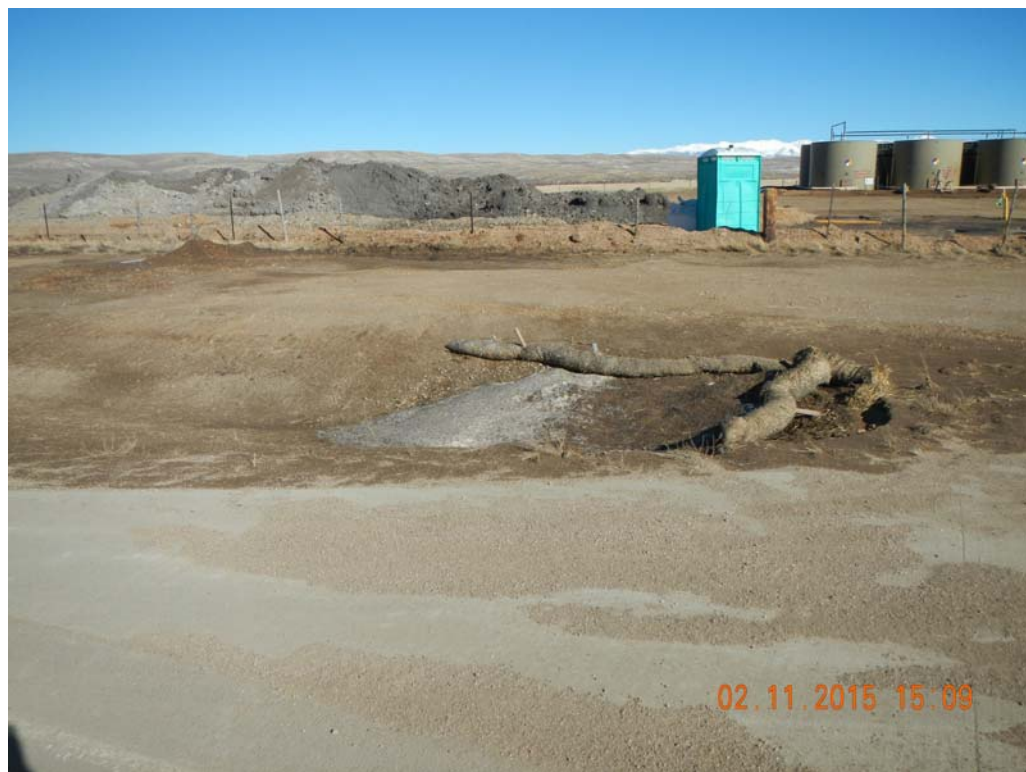
Waddles falling into culvert
at entrance.

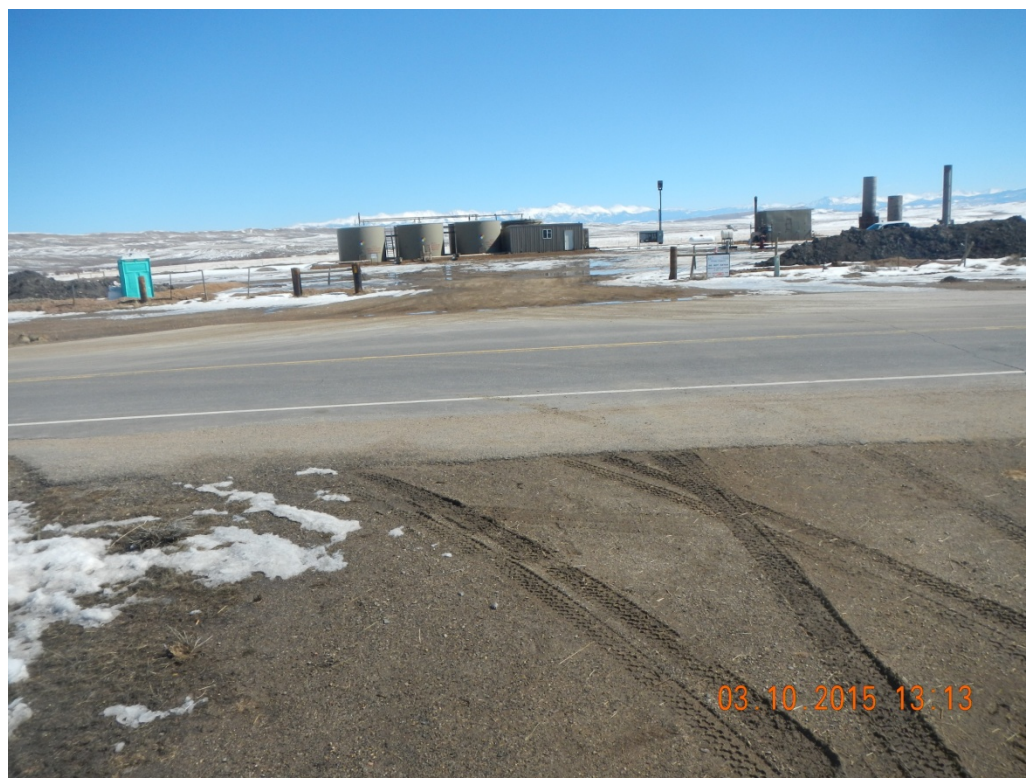
Vehicle tracking off of
location.
