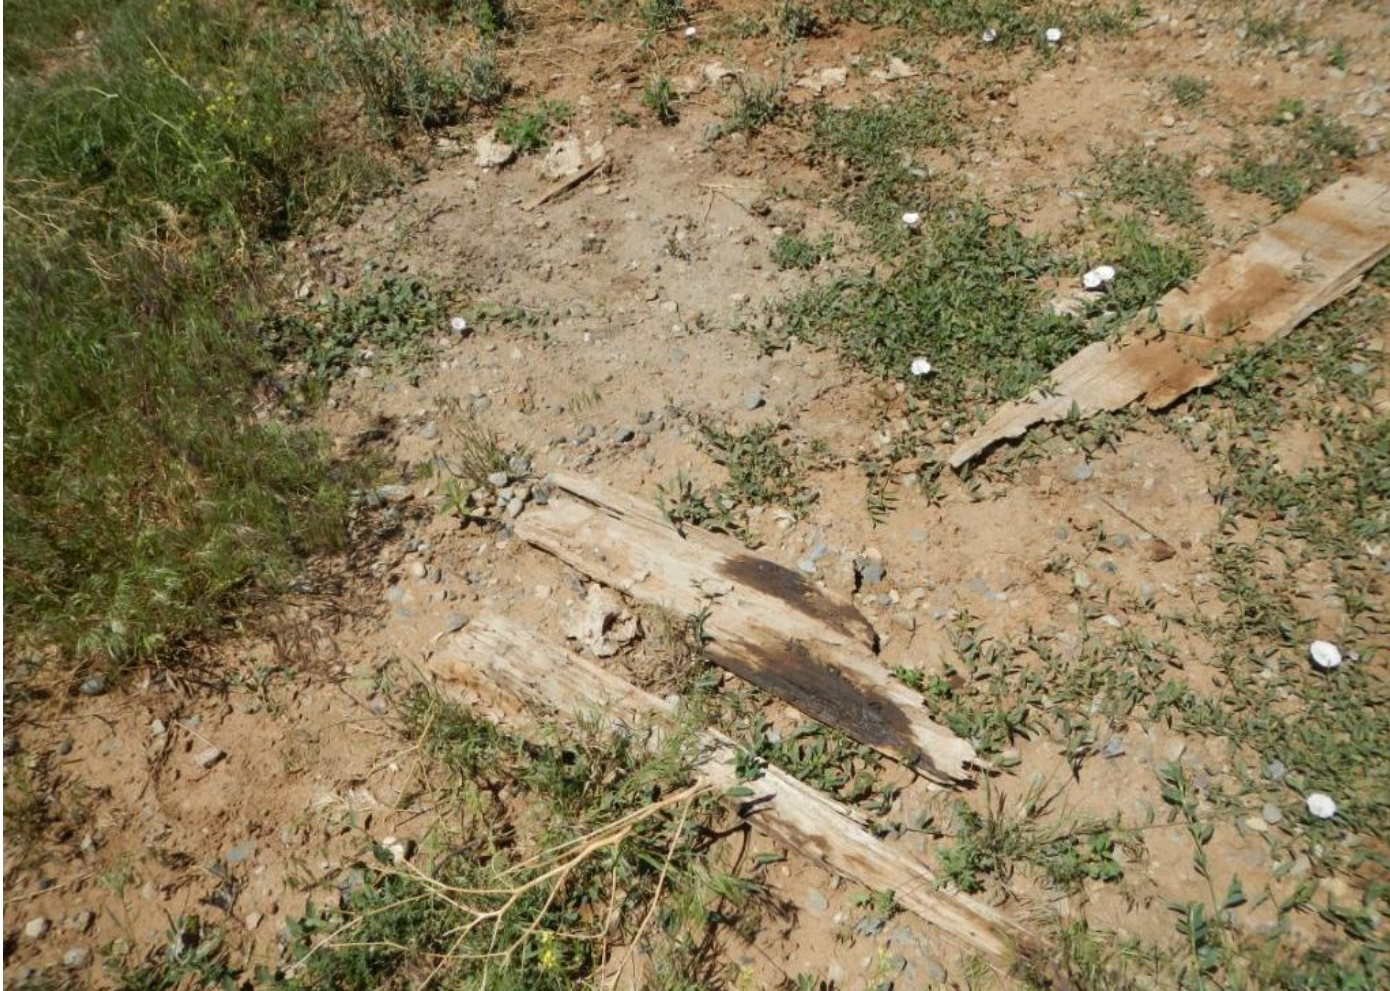
Photo 1. View of what appears to be oil staining on woody debris and gravel within the project area.

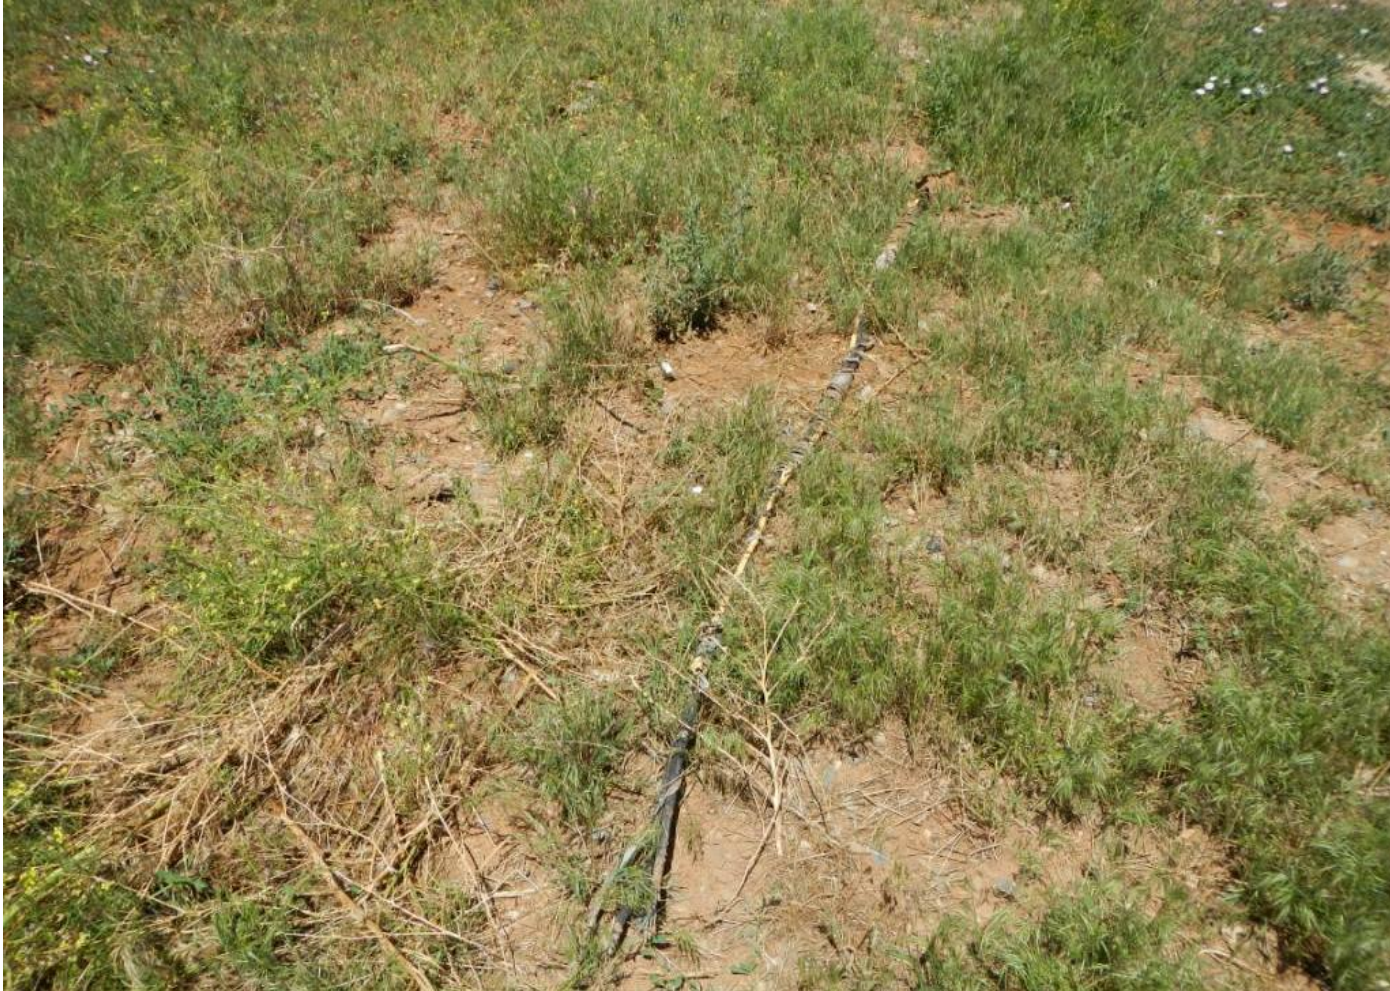
Photo 2. View of junk in project area.

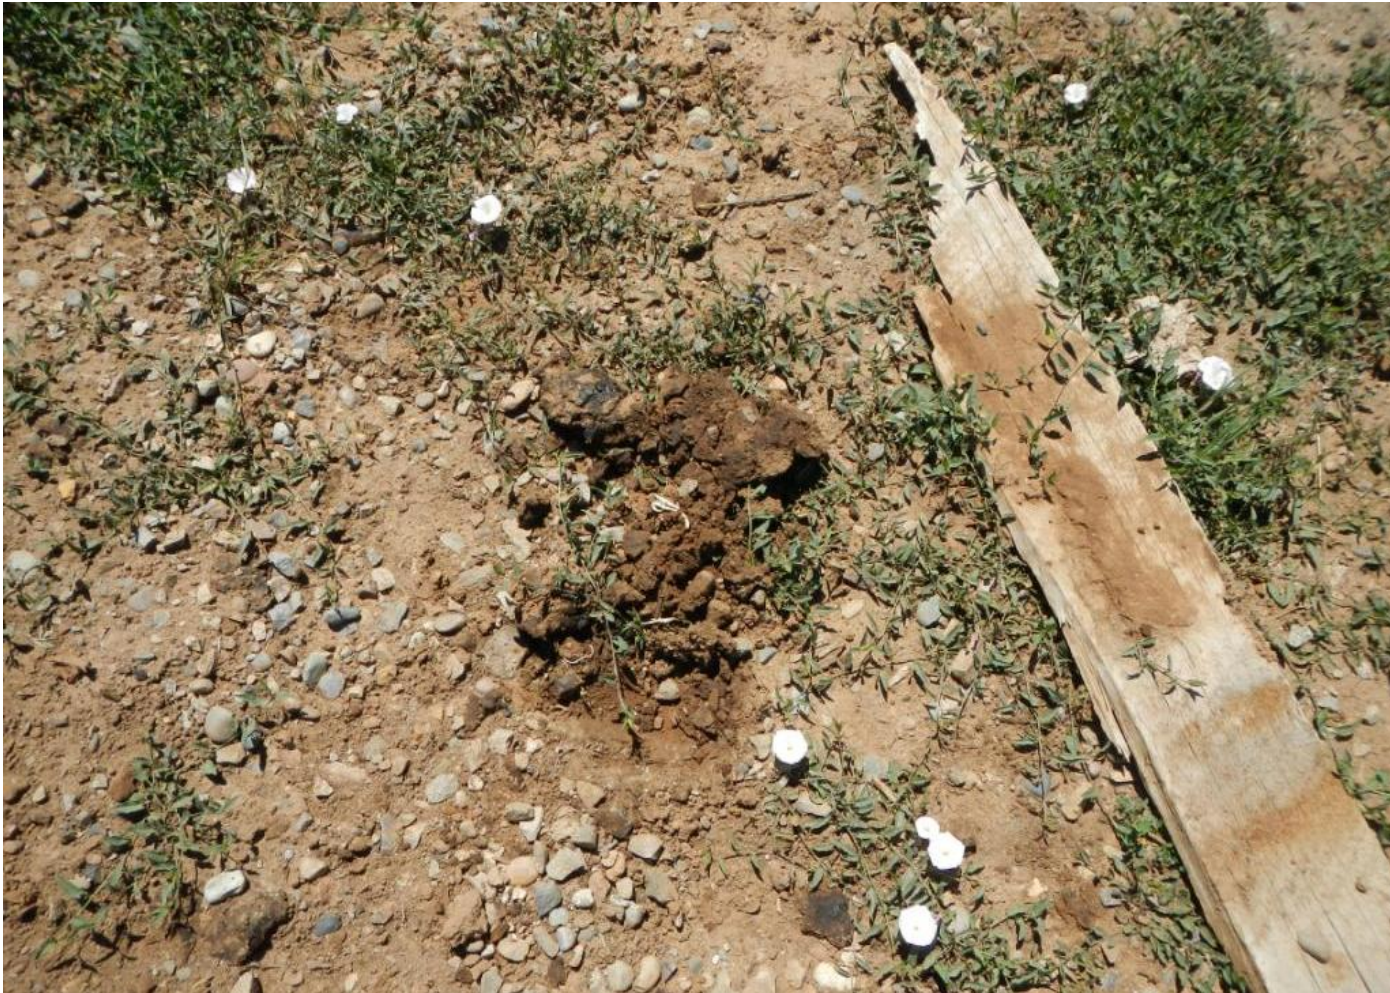
Photo 3. View of what appears to be oil stained soil and gravel within the project area.

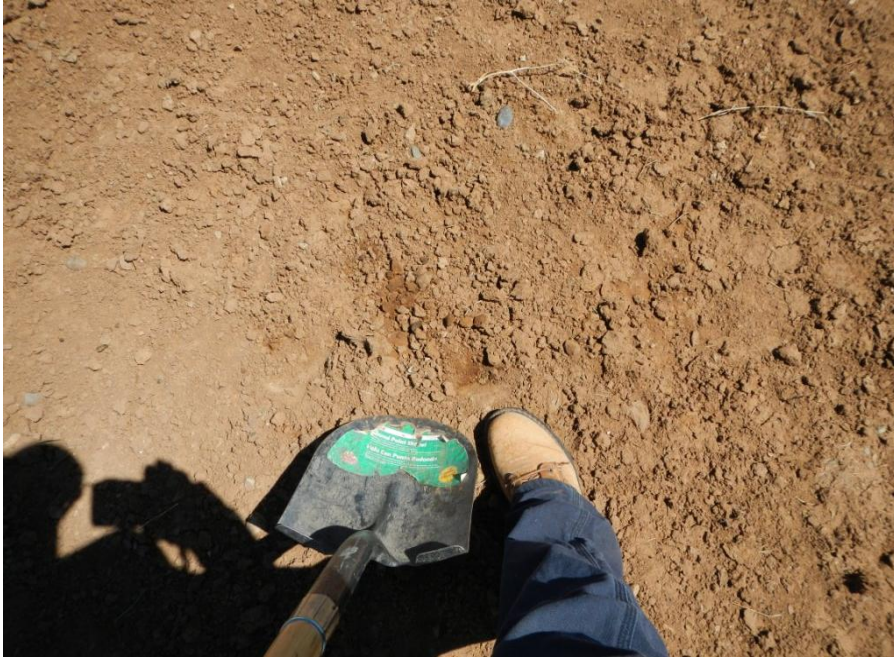
Photo 4. View of soil compaction within the project area (photo on left). Shovel cannot easily break soil. Can only dig approximately 2 to 3 inches.

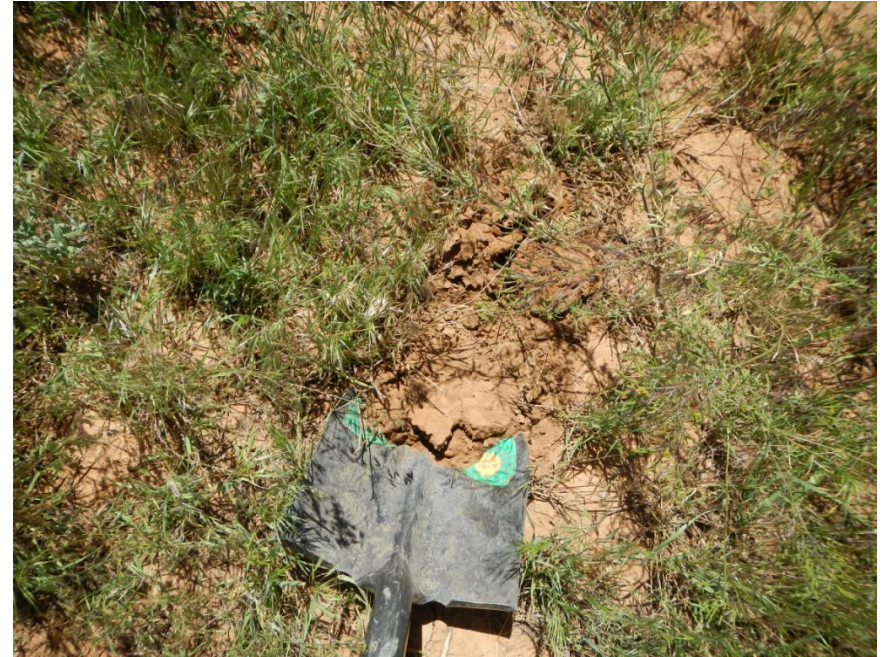
Photo 5. View of non-compacted soils outside of project area (photo on right). Soil is soft and easy to dig in. Photo is taken approximately 50 feet south of location in adjacent pasture.

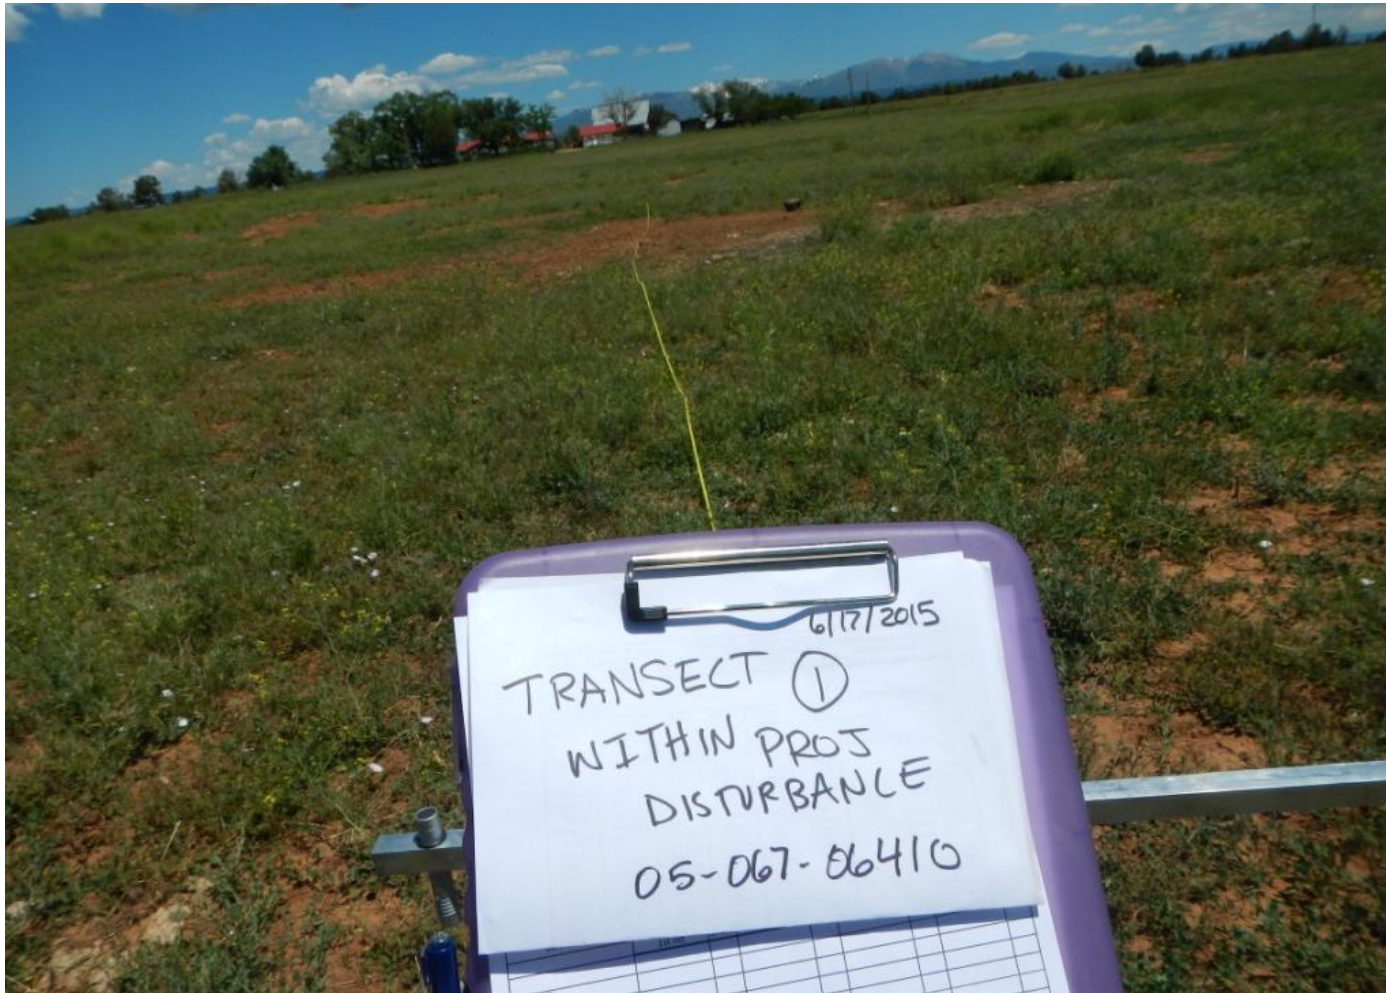
Photo 6. View of the beginning of the transect within the project area facing northward. The majority of the vegetation is field bindweed (*Convolvulus arvensis*) and Russian knapweed (*Acroptilon repens*).

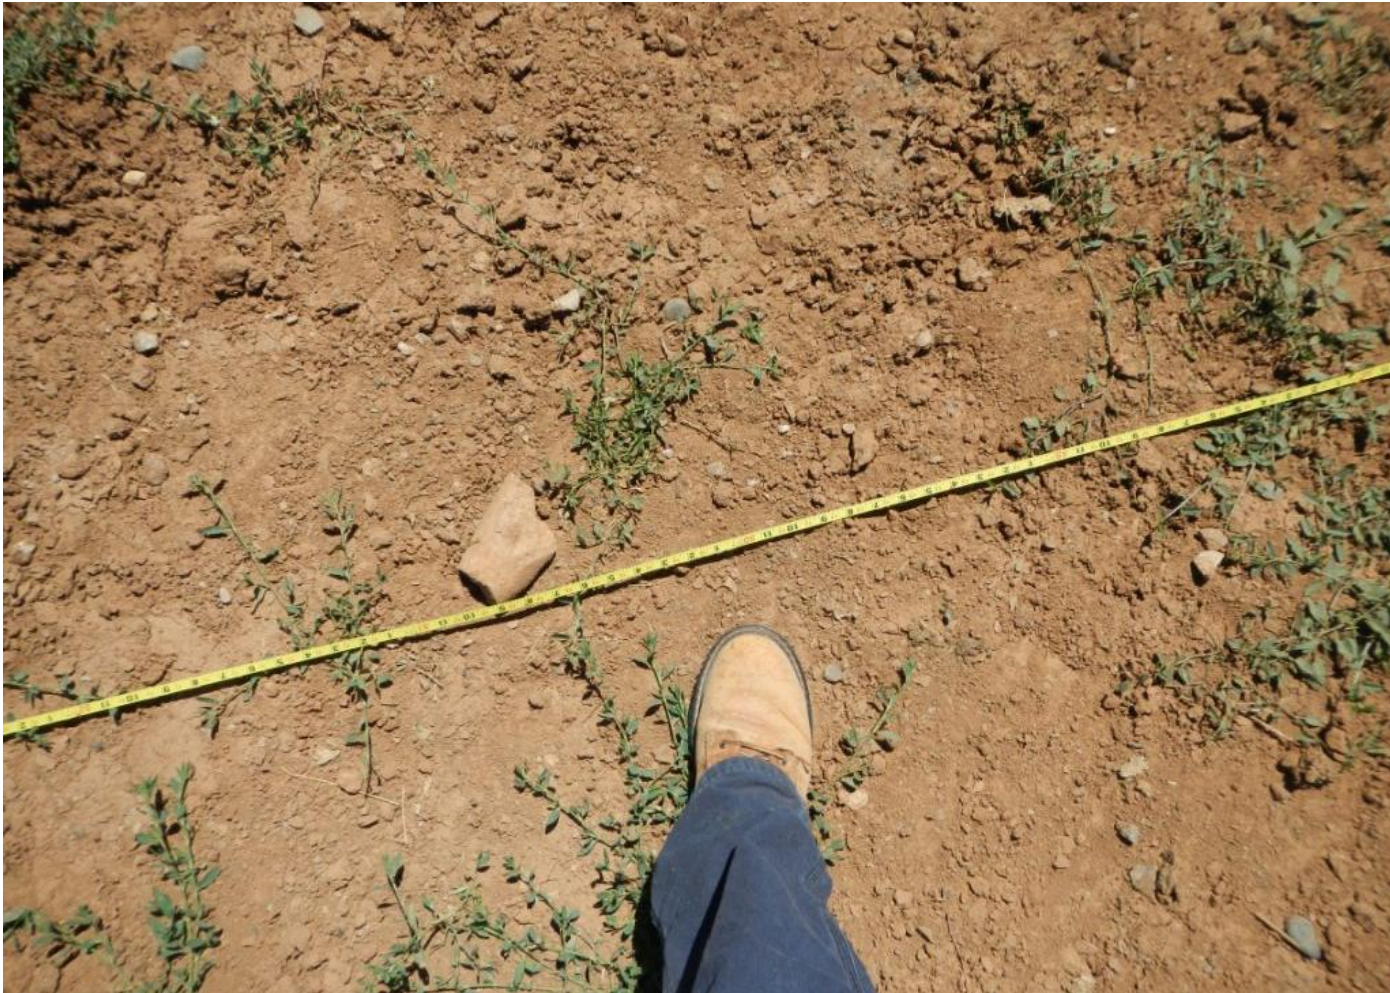
Photo 6. Birdseye view of midpoint along transect. Vegetation is field bindweed.

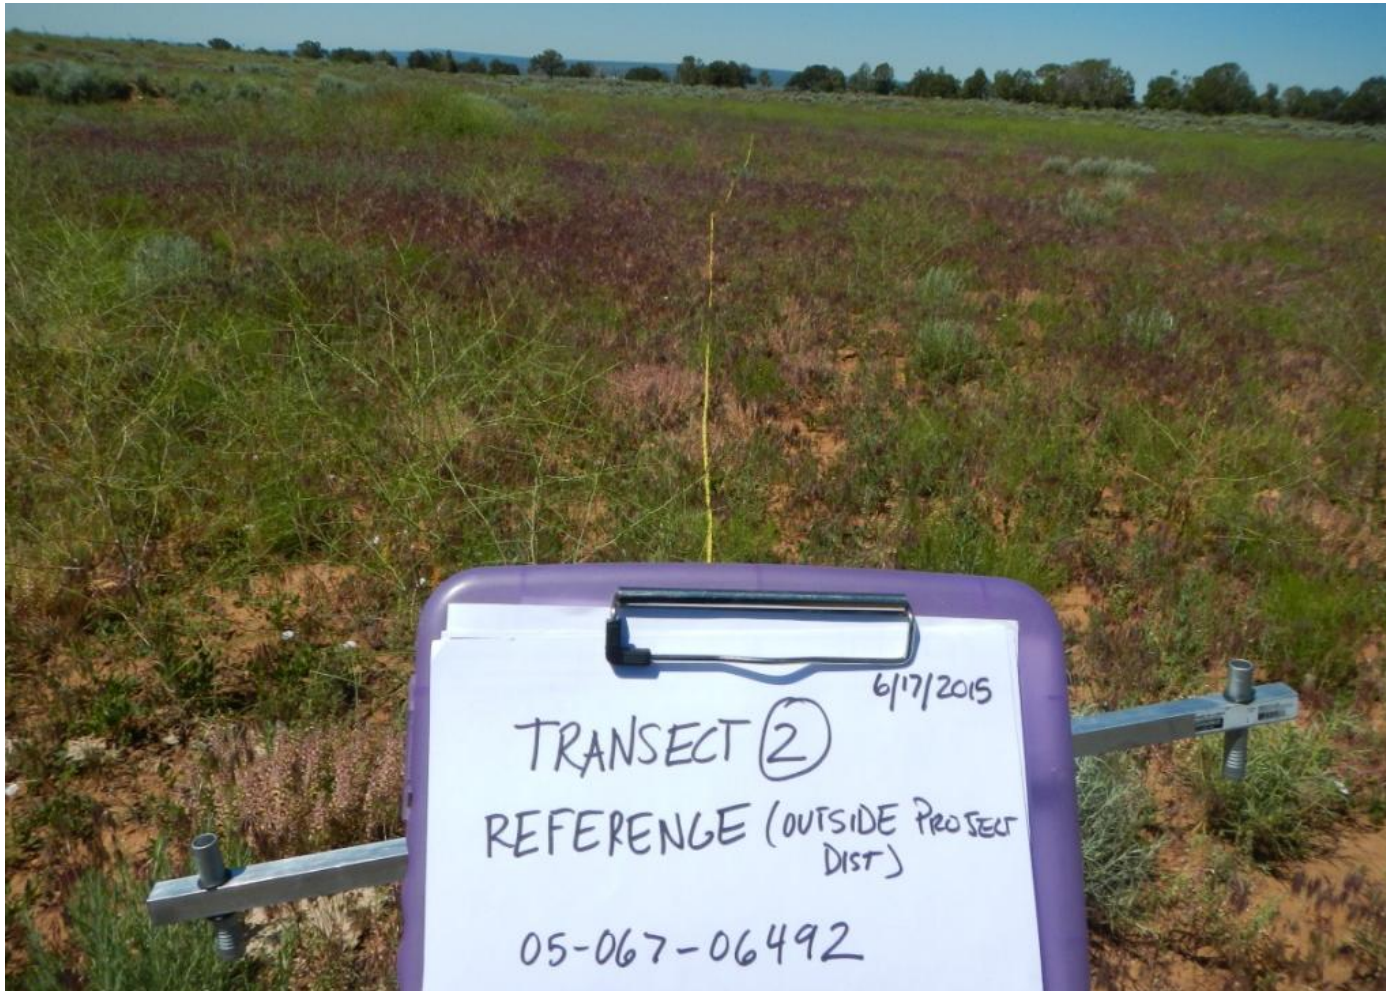
Photo 7. View of Reference Area Transect outside of project area facing northeastward. Vegetation is a mix of ruderal weeds such as cheatgrass (*Bromus tectorum*) and tumbled mustard (*Sisymbrium altissimum*) as well as native species such as rubber rabbitbrush (*Ericameria nauseosa*) and snakeweed (*Gutierrezia sarothrae*). This Reference Transect was also used for the nearby 067-06492 location.

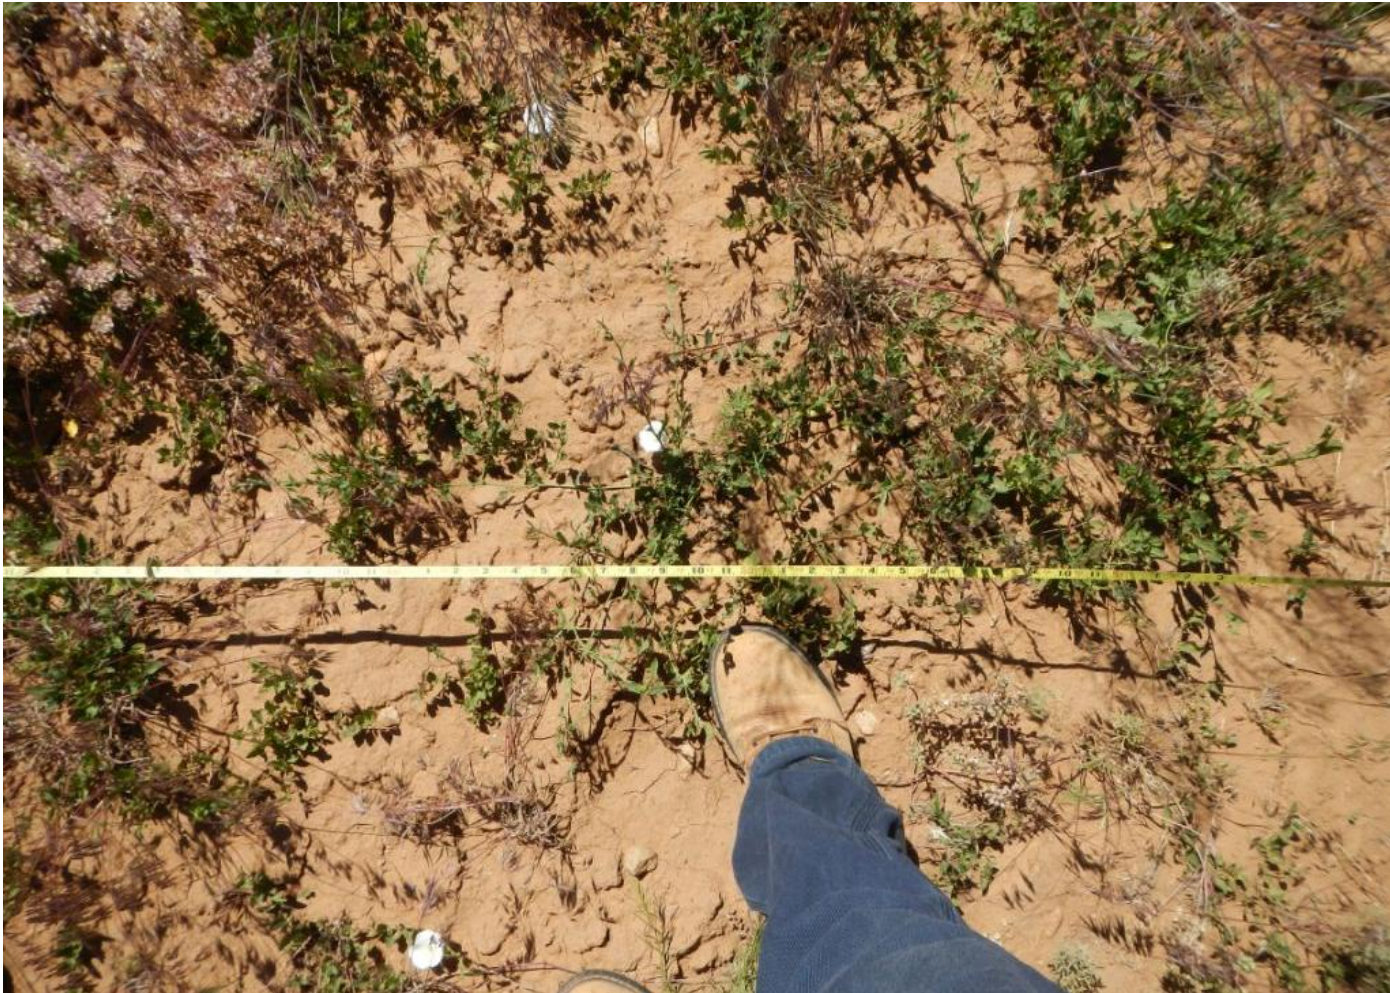
Photo 8. Birdseye view of vegetation at mid-point along reference transect.
