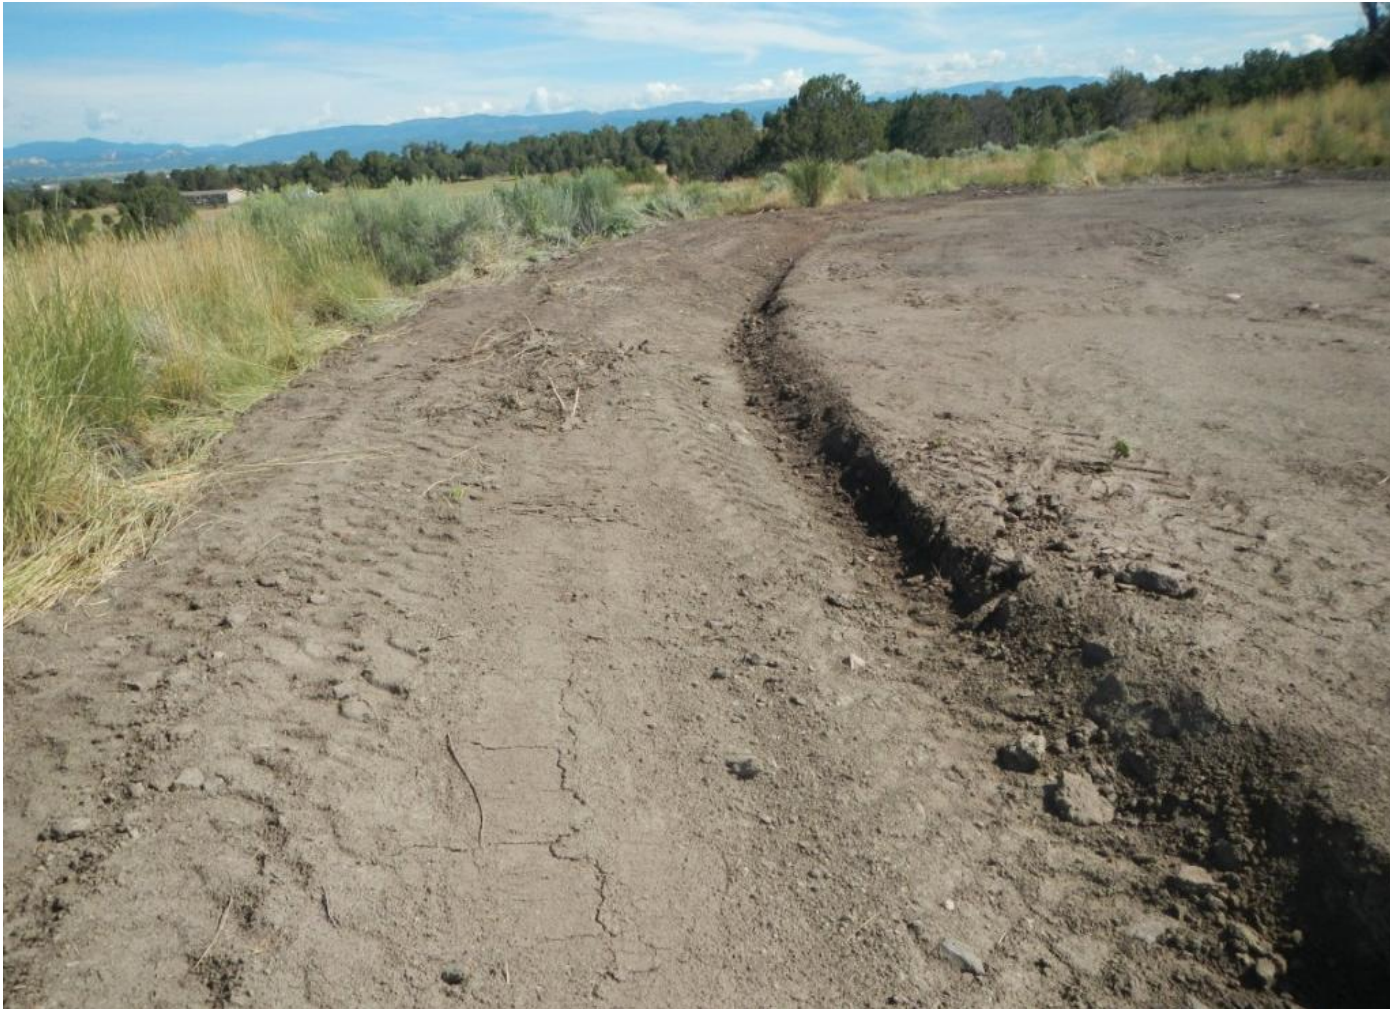
Photo 1. View of newly installed diversion along western edge of working area.

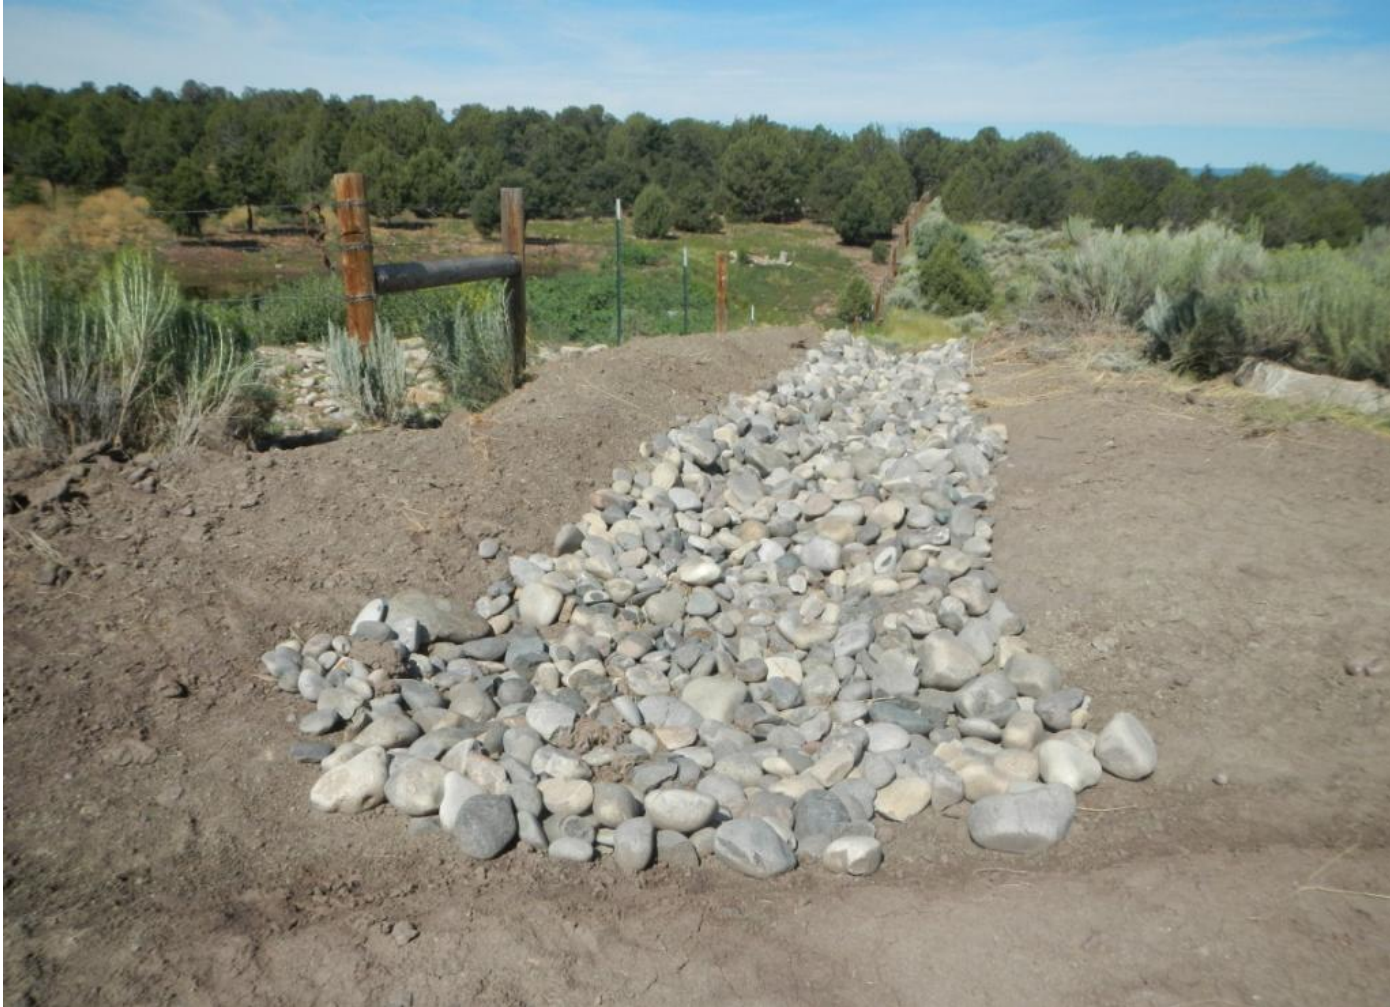
Photo 2. View of cobble run-down in western portion of project area.

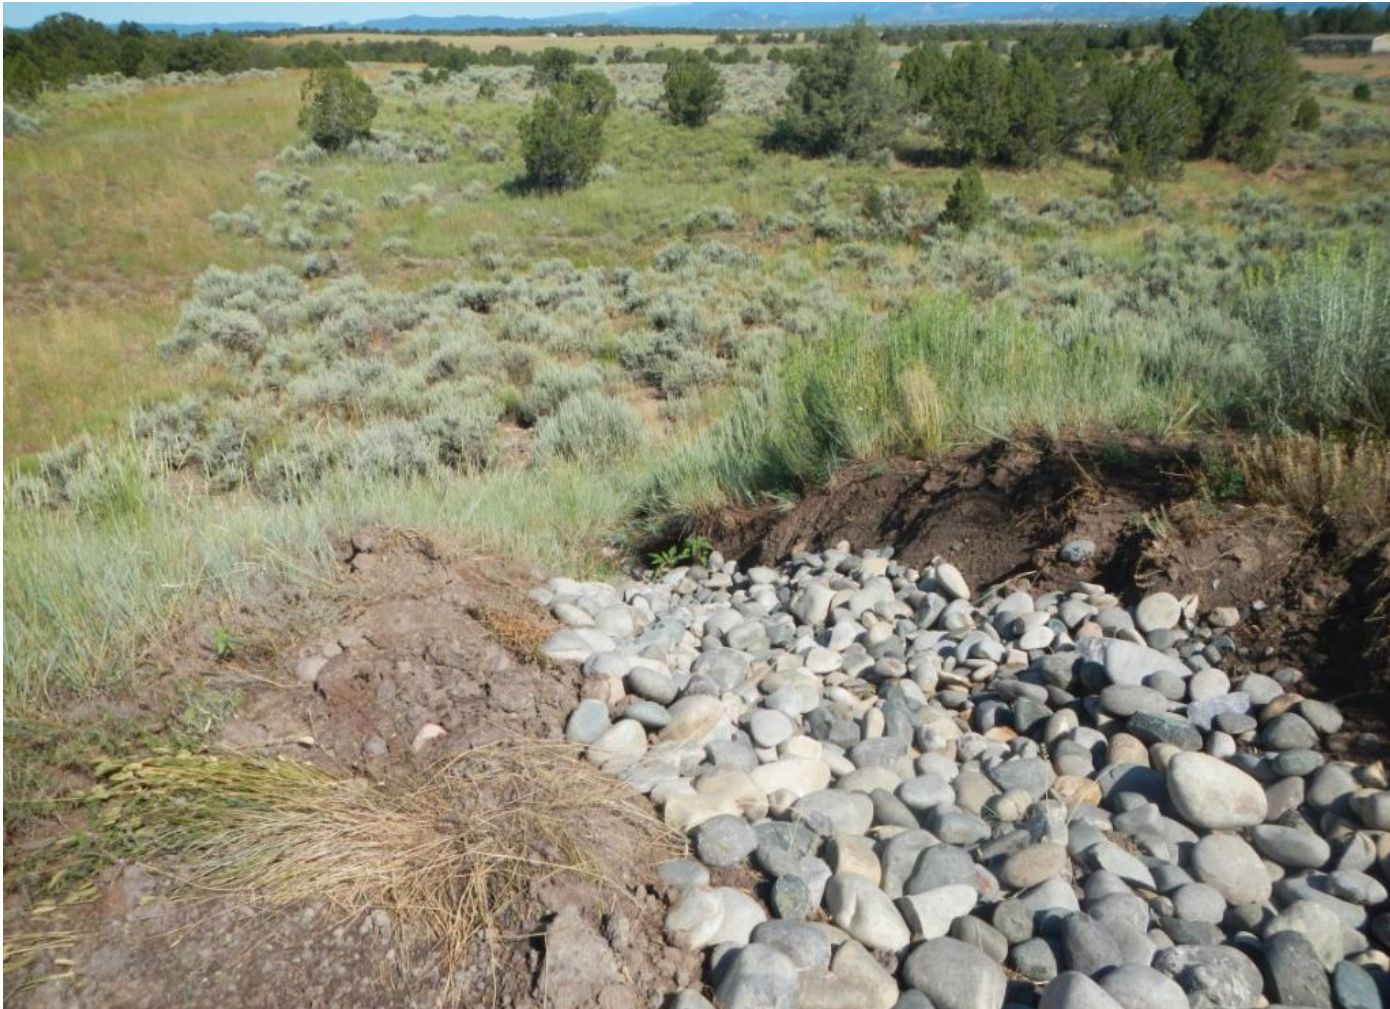
Photo 3. View of cobble run-down in northwestern portion of project area.

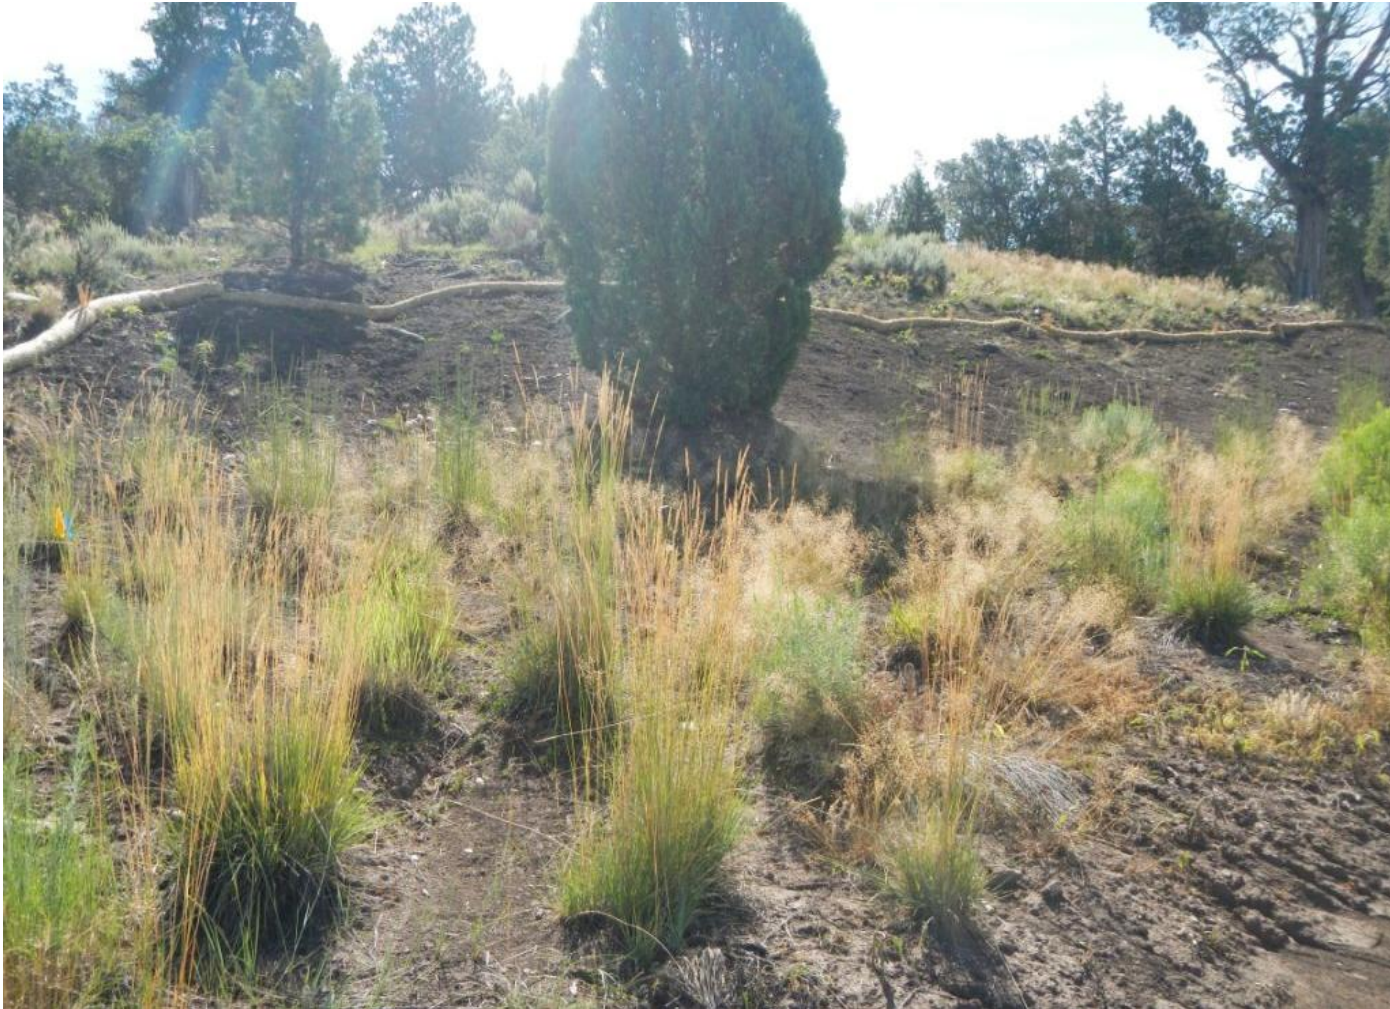
Photo 4. View of newly installed straw wattle near the top of the eastern cut-slope.

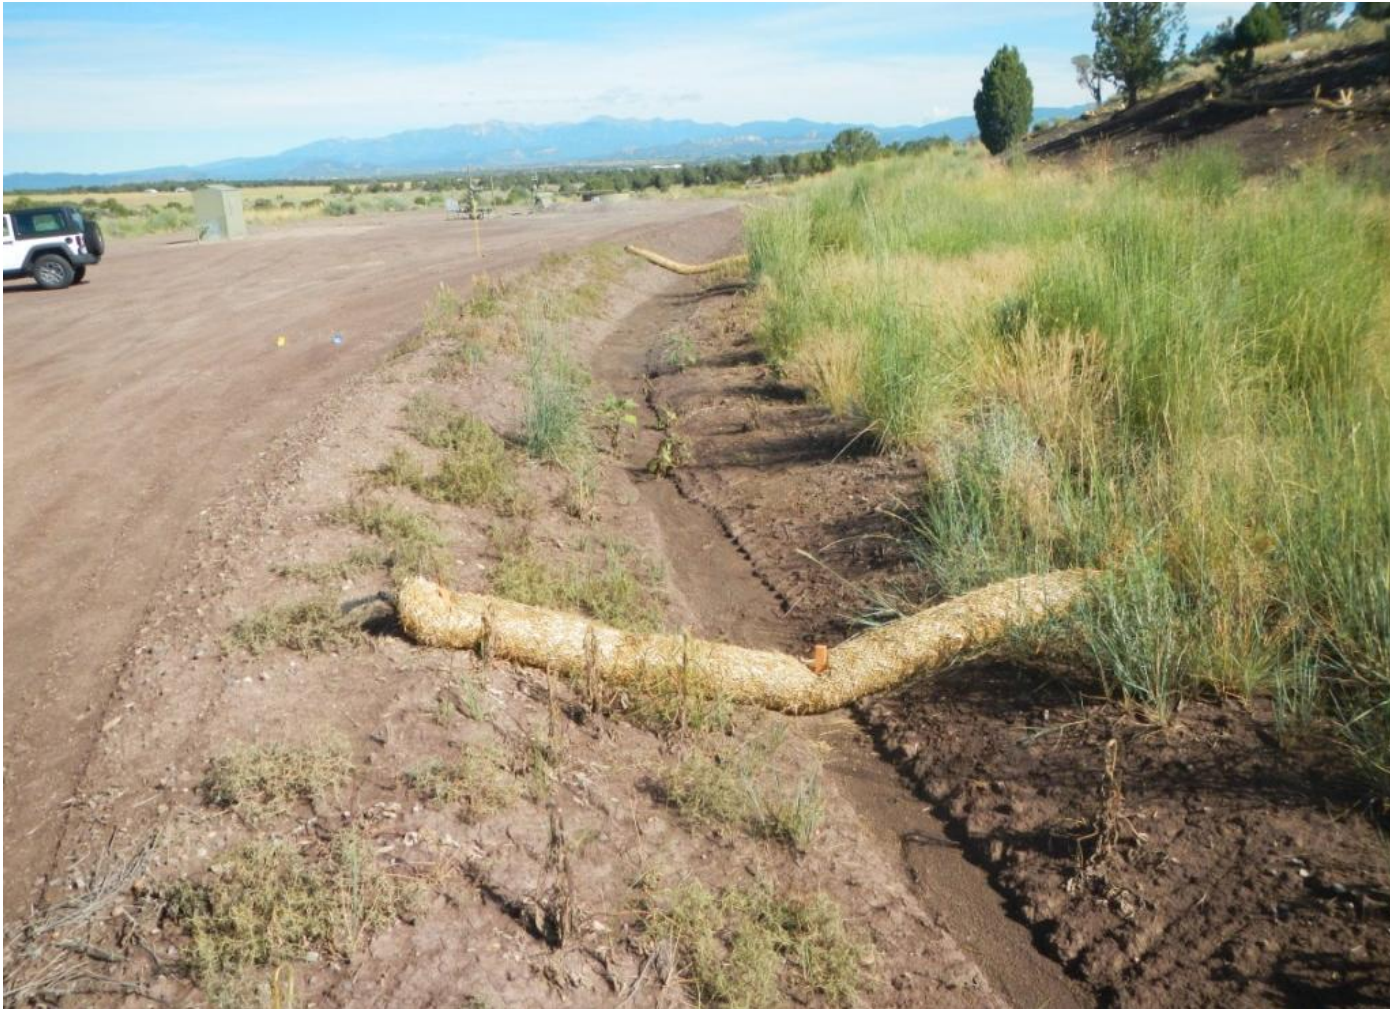
Photo 5. View of newly installed straw wattles within eastern diversion.
